**KOMITE NASIONAL KESELAMATAN TRANSPORTASI
REPUBLIC OF INDONESIA**

Aircraft Serious Incident Investigation Report

Boeing 737-800; PK-GFA

2 June 2015

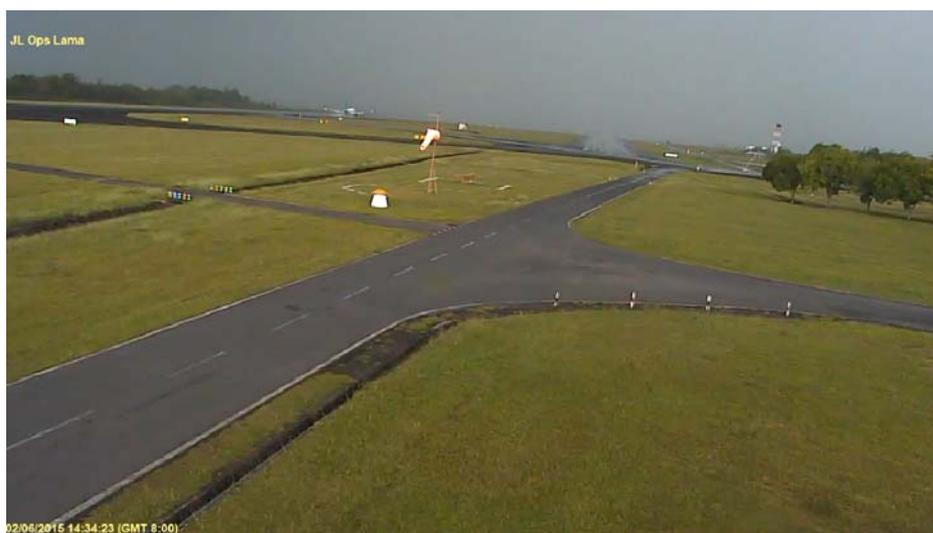
Figure 2: Airport CCTV footage of the aircraft touched down

During landing flare, the thrust levers were closed however the aircraft floated. The Cockpit Voice Recorder (CVR) data revealed that the interval between Enhanced Ground Proximity Warning System (EGPWS) call 'ten' to touchdown was 16 seconds. The Flight Data Recorder (FDR) recorded that after passing 20 ft to touchdown was 13 seconds. The pilot noticed the aircraft has passed taxiway Alpha prior to touchdown. After touched down, the aircraft encountered heavy rain.

The flight crew did not consider a go around as they aware that the takeoff area of the runway 13 was mountainous area and might jeopardized the flight.

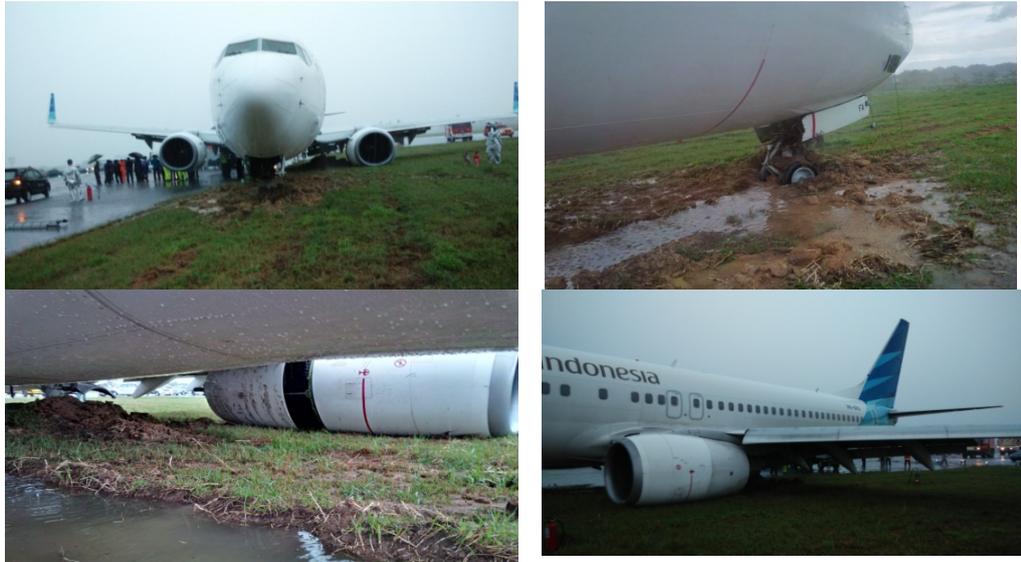
Figure 3: Aircraft position and condition after stop

The aircraft stopped at the left side of the stopway with the nose landing gear and left main landing gear stuck at the mud while the right main landing gear remain on the stopway pavement. No one injured on this serious incident.

The crew did not feel normal aircraft deceleration the PF then applied manual braking with intention to increase deceleration. Noticed that the end of the runway was near, the PIC turned the aircraft slightly to the left. The aircraft stopped at the left side of the stopway with the nose landing gear and left main landing gear stuck at the mud while the right main landing gear remain on the stopway pavement.

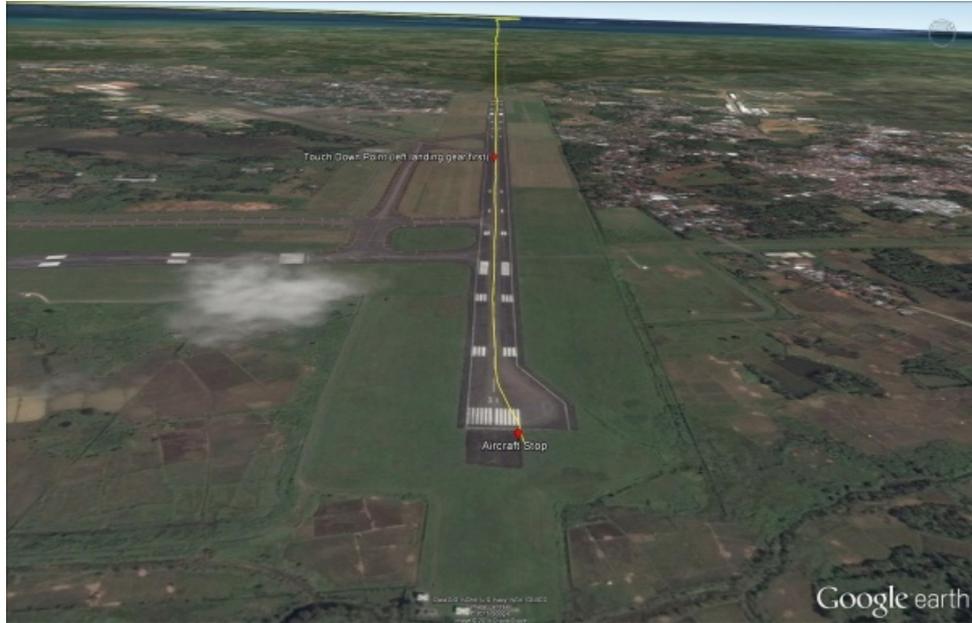
Figure 4: Super imposed from Google earth and CCTV just after aircraft touch down

According to the coordinates recorded by the FDR the aircraft touchdown was approximately 1,435 meters from beginning runway 13 and stopped at approximately 1,095 meters after touchdown.

During the 13 seconds floated at ground speed of 170 kts to 150 kts, the aircraft has travelled for 1,075 meters over the runway. Based on this calculation, the aircraft might touchdown at approximately 1,375 meters from the beginning of the runway. The required runway for the aircraft to stop was approximately 3,175 meters while the runway length available was 2,500 meters. This calculation was relevant to the FDR data that the aircraft touch down at the middle of the runway approximately after passing the taxiway Charlie.

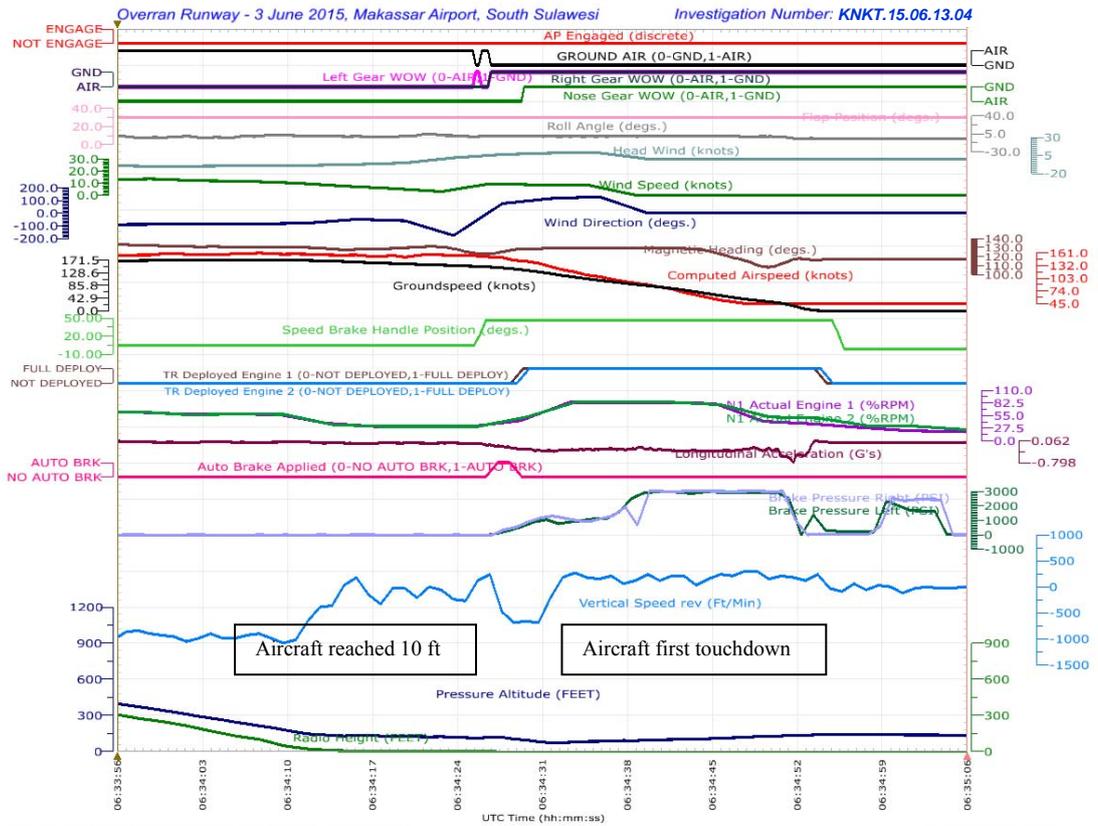
Figure 5: The graph of relevant FDR parameters

The FDR data indicated that the aircraft was on correct approach path during the approach.

- At 06:34:13 UTC, the aircraft passing 20 ft AGL with airspeed of 157 kts and ground speed of 170 kts. The tail wind was approximately 9 kts.
- At 06:34:26 UTC, the left main landing gear touchdown at speed of 154 kts and ground speed 150 kts. Followed by right main landing gear 1 second and nose landing gear 4 seconds later. The headwind was 6 kts.
- The aircraft touched down after passing taxiway Charlie. The distance between the aircraft touch and the aircraft stop was approximately 1,095 meter.

The FDR recorded that after passing 20 ft AGL, the aircraft floated for approximately 13 seconds. During this period, the airspeed indicated 157 kts and decreased to 154 kts while touchdown. The ground speed was recorded 170 kts and decreased to 150 kts on touchdown. As of the ATIS before descend, informing that the runway in use was runway 03, wind condition 240°/7 kts (variable 200° - 290°), while the FDR recorded that 20ft the wind changed from tailwind 9kts to headwind 6kts.

This data showed that the ground speed has decreased 20 kts while the air speed decreased 3 kts. Slight decrement of air speed indicated that only slight change of air velocity movement on the wing surface. This condition resulted in minor changed on the lift produce by the wing. This means that the wing still produced sufficient lift to the aircraft and made the aircraft floated.

The significant differences between the reduction of the ground speed and airspeed was result of the change in wind condition, from tailwind to head wind. The change of wind direction might have not been anticipated by the pilot and ATC.

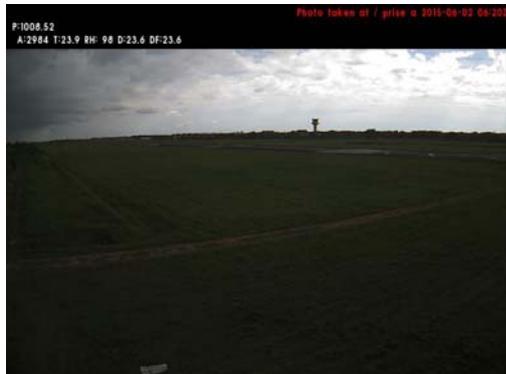
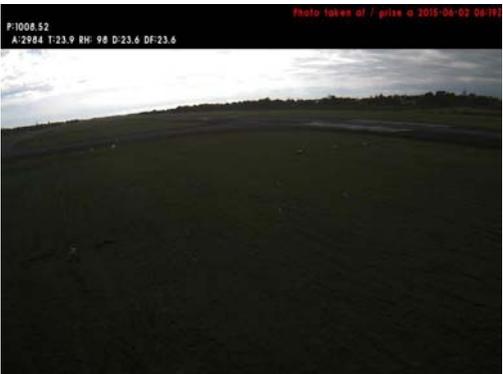
Figure 6: Visual weather observed at 06.19 and 06.20 UTC

Visual weather observed toward runway 03 (south east view)	Visual weather observed toward runway 31 (north west view)
Time: 06.20 UTC	Time: 06.19 UTC

The black clouds and rain that visible by the pilot and ATC was indication that the cumulonimbus has reached the mature stage. During the mature stage, the downdraft will push down out of the thunderstorm, hit the ground and spread out. This downward force created the headwind to the runway. The head wind from the downward force did not reach the final area and the final area was still affected by the local wind. This condition has made the aircraft has tailwind on final and changed to head wind while flew over the runway.
