Accident Investigation Coordinating Committee

Aircraft Accident Report 2015/04

Final Report on the Accident to
Viking Air DHC-6-300, 8Q-MAN
Near Kuredu Resort, Maldives
02 July 2015

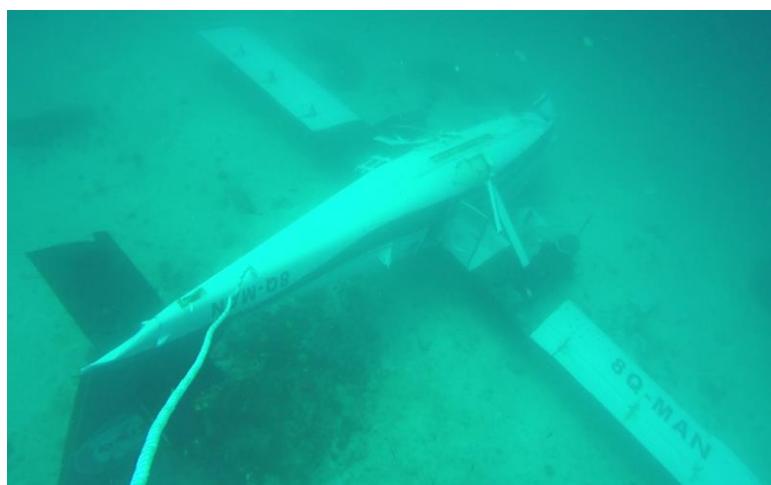
Figure 1: Aircraft wreckage

The wreckage was approximately 3 km southeast of Kuredu Resort at a depth of 36.5 m. The aircraft was found lying upside down. Aircraft parts such as steps, a part of the left horizontal stabilizer was found near the aircraft. A few passenger bags, mobile phones, boarding passes were also recovered from the area.

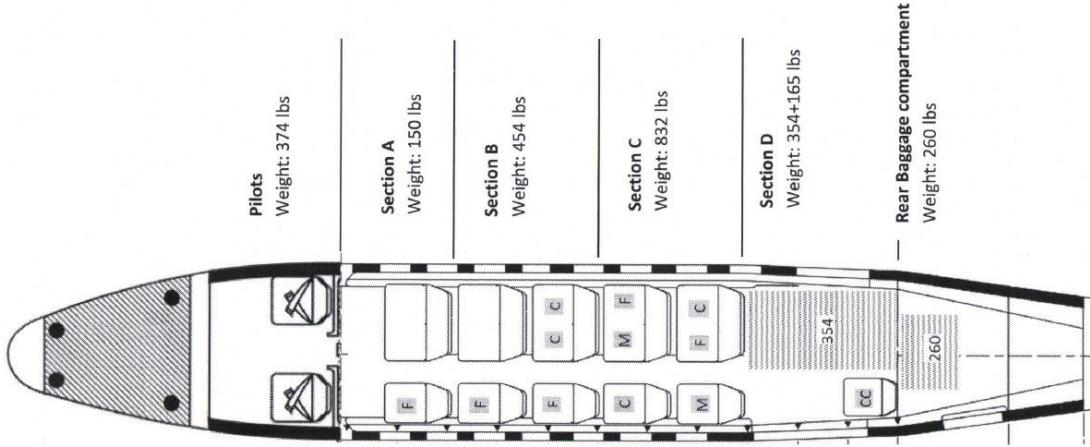
Figure 2: Distribution of crew, passengers and baggage (KOM-KUR flight)

Calculations based on Figure 2 (and the index data in section 1.6.7) indicate the aircraft centre of gravity at Komandoo was significantly aft of the approved limit using any of the indices available to the crew. The CG index at Komandoo should have been less than 13.6.

It should be noted Figure 2 indicates 297 lb of baggage was loaded into the rear compartment even though the Aircraft Loading Manual section 2.2 requires all heavy bags to be loaded in to cabin baggage area.
