ACCIDENT

Aircraft Type and Registration:	Airbus A321-231, G-EUXF
No & Type of Engines:	2 International Aero Engine V2533-A5 turbofan engines
Year of Manufacture:	2004 (Serial no: 2324)
Date & Time (UTC):	19 July 2015 at 2122 hrs
Location:	Glasgow Airport
Type of Flight:	Commercial Air Transport (Passenger)
Persons on Board:	Crew - 7 Passengers - 200
Injuries:	Crew - None Passengers - None
Nature of Damage:	Damage to underside of aft fuselage and drain mast
Commander's Licence:	Airline Transport Pilot's Licence
Commander's Age:	54 years
Commander's Flying Experience:	10,980 hours (of which 6,864 were on type) Last 90 days - 143 hours Last 28 days - 57 hours
Information Source:	AAIB Field Investigation

Synopsis

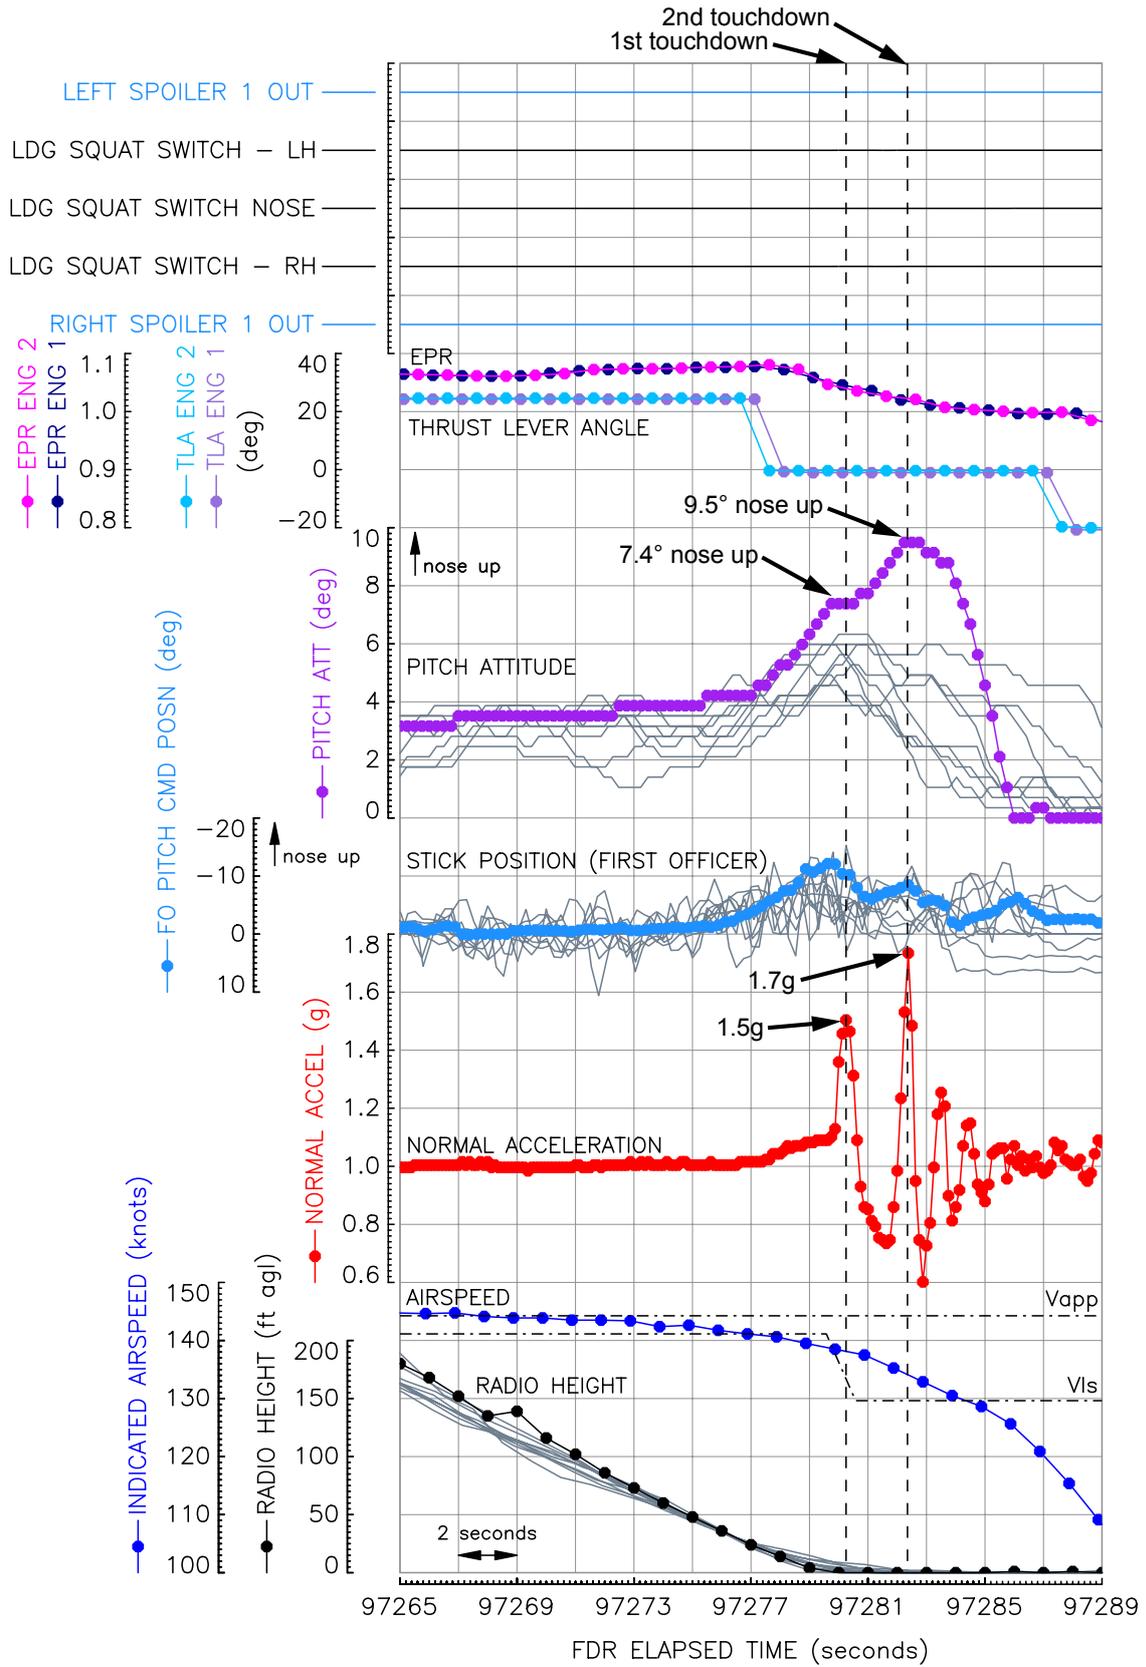
The aircraft's flight data recorder (FDR) and cockpit voice recorder (CVR) were downloaded and their recorded information was analysed. The salient FDR data for the tailstrike event is presented at Figure 1.

Figure 1 starts with the aircraft descending through 180 ft agl, at 145 KIAS (V_{APP}), just under 15 seconds before touchdown. At about 50 ft agl, nose-up pitch inputs were made by the co-pilot to commence the flare. The aircraft responded and started to pitch up (from a nominal 4° nose-up) at a rate of 1.5°/sec. The sidestick was progressively pulled further back throughout the flare and the thrust levers closed at about 25 ft agl. There was a small check in the aft-stick at -10° input² before reaching a recorded peak value of 12° prior to touchdown. The aircraft pitch attitude levelled off at 7.4° nose up for 1 second during which the aircraft touched down, at 138 KIAS, with a maximum recorded normal acceleration of 1.5g.

The aft-stick input was maintained but reduced to -6.5° just as the ground spoilers deployed. The aircraft continued to pitch nose-up and became airborne again, before touching down at 134 KIAS with a nose-up pitch attitude of 9.5° (the PFR recorded a maximum pitch attitude of 9.8° at touchdown³) and a maximum recorded normal acceleration of 1.7g. It remained at this pitch attitude for about 0.5 s before reducing as the aircraft was de-rotated. The nosewheel touched down 3 seconds later.

For comparison, Figure 1 also shows the pilot pitch input, aircraft pitch attitude and aircraft radio altimeter height for ten previous landings recorded on the FDR. These are aligned in time at the point when the aircraft descended through 30 ft agl. The recorded minimum (nose-up) pitch attitude at touchdown was 3.9° and the maximum was 6.3°, giving an average of about 5°. The range of aft-stick inputs on these landings vary considerably compared with the control inputs on the tailstrike event. Similar peak aft inputs are evident; however, these appear transient.

FDR data for the tailstrike event and elements of ten previous landings (grey traces)

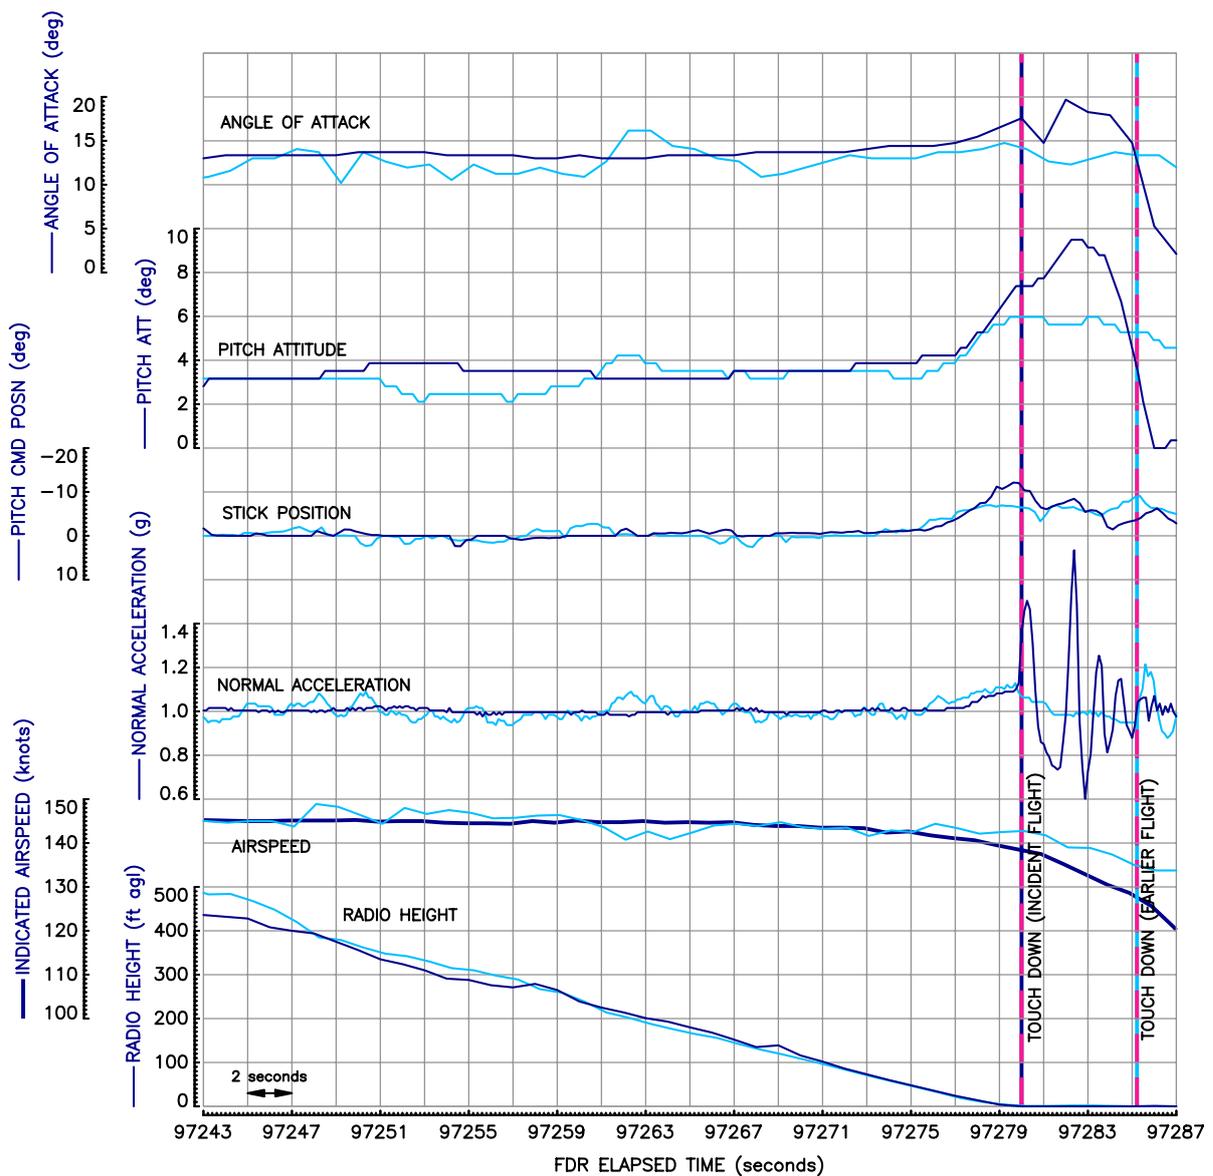
Figure 2 compares the tailstrike event with one of the previous landings (light blue traces), also aligned in time at 30 ft agl. The flight profile and aircraft attitudes are similar until about 50 ft agl when the flare is initiated. The earlier flight shows a positive aft sidestick input to a maximum of 7° over 3 seconds, without any loss in airspeed. However, for the tailstrike event, the aft stick input is initially slower but reaches a maximum of 12° aft over a period of 4 seconds, just prior to touchdown, during which the airspeed decays by about 4 kt. For both landings, the thrust levers are reduced to idle at 25 ft RA. However, the airspeed decays more gradually on the earlier flight and touchdown occurs 5 seconds later than on the tailstrike event.

Comparison of data on the tailstrike event (dark blue) with an earlier landing on G-EUXF (light blue)
