**FINAL REPORT OF RUNWAY EXCURSION ACCIDENT OF AIR BAGAN
AIRCRAFT ATR-72 (XY-AIH) AT YANGON INTERNATIONAL AIRPORT ON
JULY, the 24th, 2015**

SYNOPSIS

Registered owner and operator	: Air Bagan Airlines
Aircraft type	: ATR-72
Nationality	: Republic of the Union of Myanmar
Registration	: XY- AIH
Place of Occurrence	: Yangon International Airport N 16°54' 59.54", E 96 8' 25.23"
Date& Time	: 24 July 2015 at 24h 54 Local time (UTC + 6h 30)
Type of operation	: Scheduled Passenger Domestic Flight
Phase of operation	: Landing on Runway- 21
Persons on Board	: Crew- 5 Passengers- 49

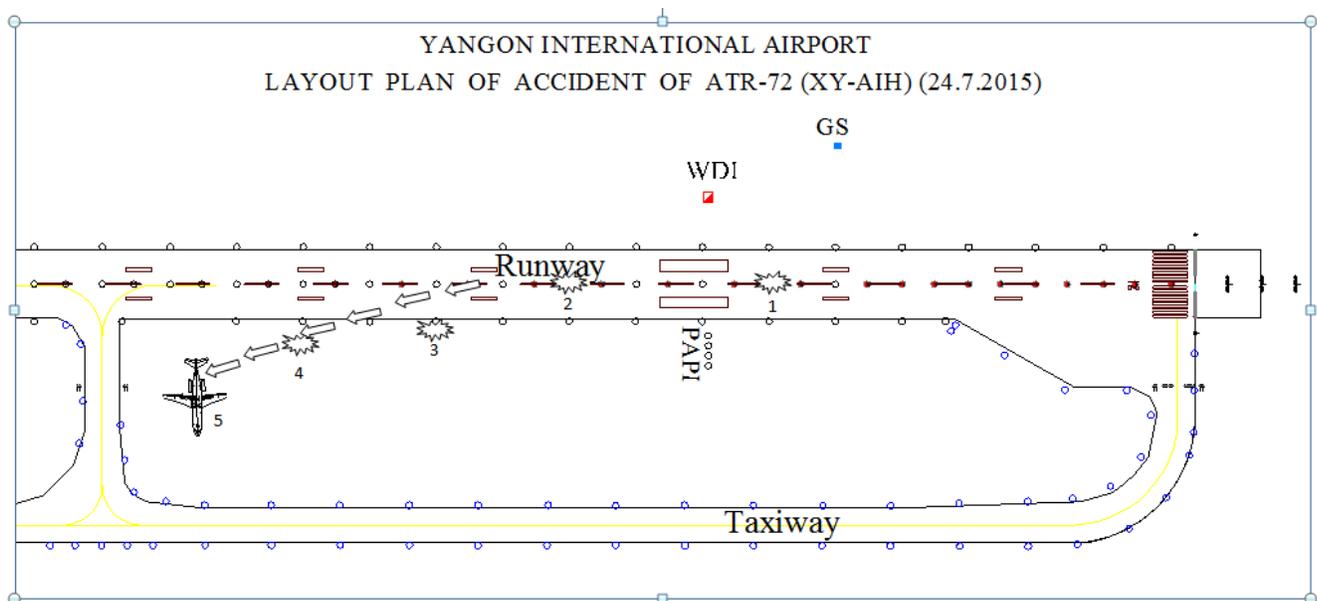
At decision height (250ft), runway was insight, runway lightings were able to be seen so the aircraft continued though there was light rain. At about 50 ft, more rain was falling suddenly consequently visibility became poor. So the pilot took over control of the aircraft. A few seconds later the aircraft made hard landing and skidded and veered off the left side of the runway to the muddy strip, came to rest about 2800ft from the threshold and 75ft from the runway edge.

Figure 1. Layout of Accident Site

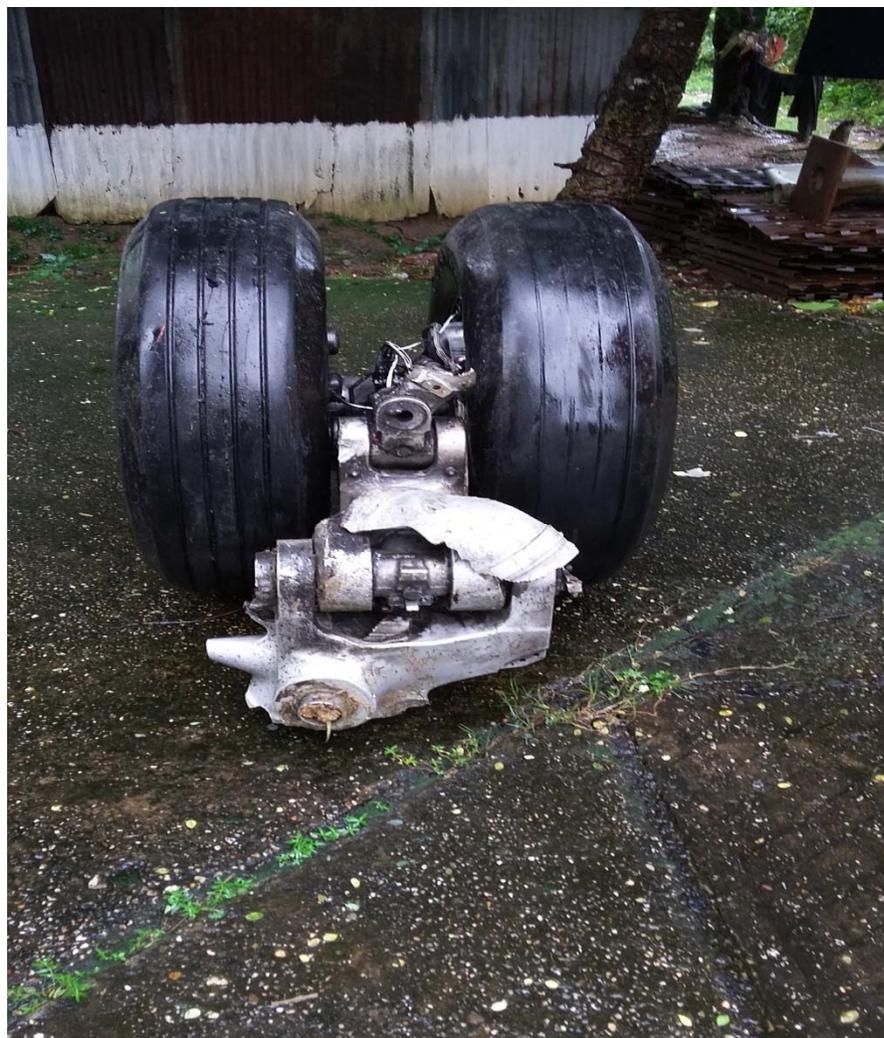
- (a) L/H main landing gear collapsed and broken (**Figure 2**)
 - (i) its trunnion leg broken into pieces
 - (ii) left hand shock absorber broken into pieces
- (b) R/H main landing gear's shock absorber broken (**Figure 3**)
- (c) Nose landing gear collapsed and folded (**Figure 4**)
- (d) Aircraft fuselage skin (between frame no.46 and 47, between frame 28D and 29) deformed, wrinkled and torn (**Figure 5**)
- (e) Left hand propeller's blades broke into pieces (**Figure 6**)
- (f) PSU (Passenger Service Unit) Panels fell down

Figure 2 Broken L/H main landing gear

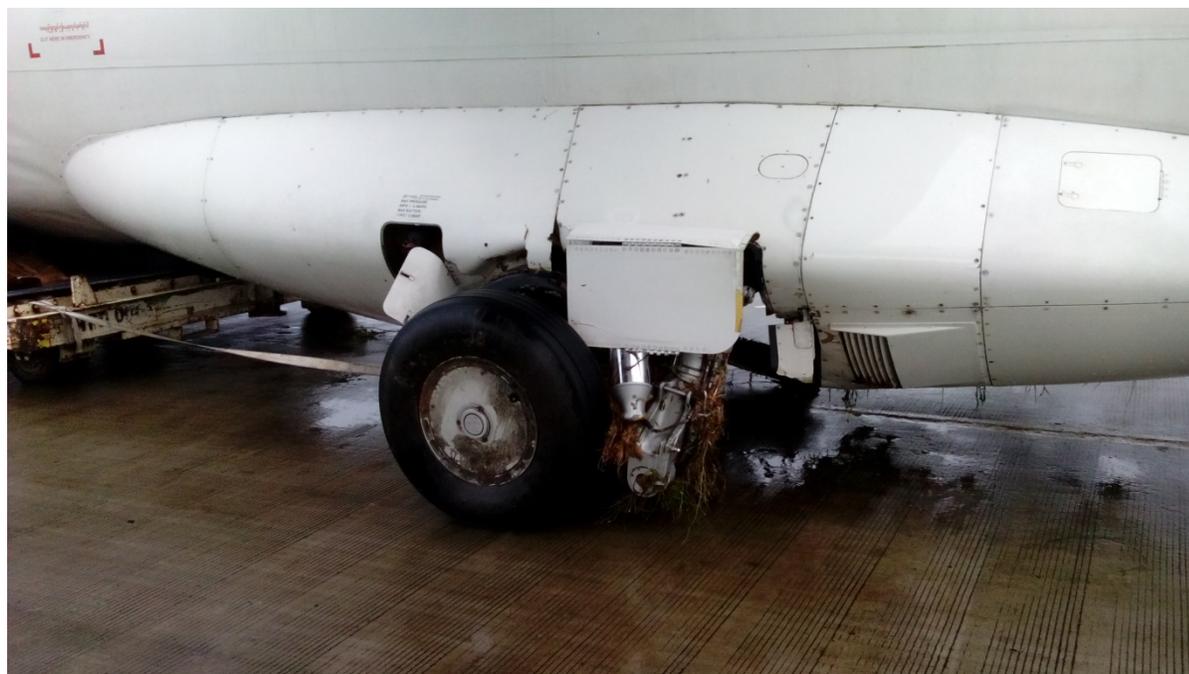
Figure 3 Broken R/H main landing gear

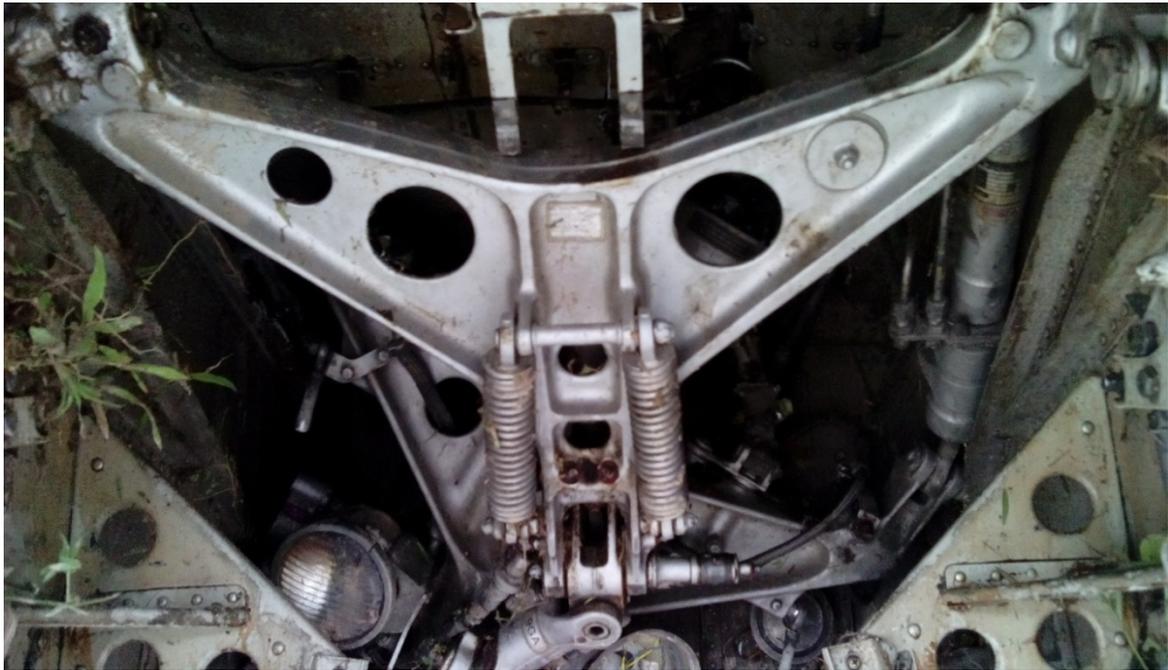
Figure 4 Collapsed Nose landing gear

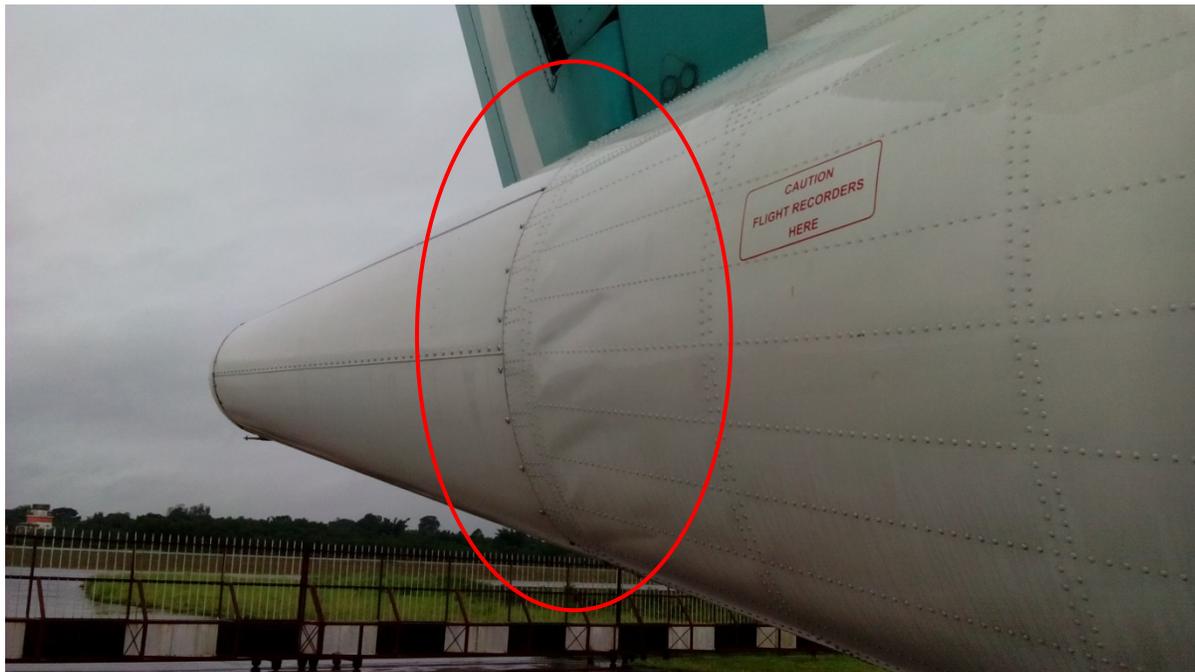
Figure 5 Wrinkled and deformed fuselage skin

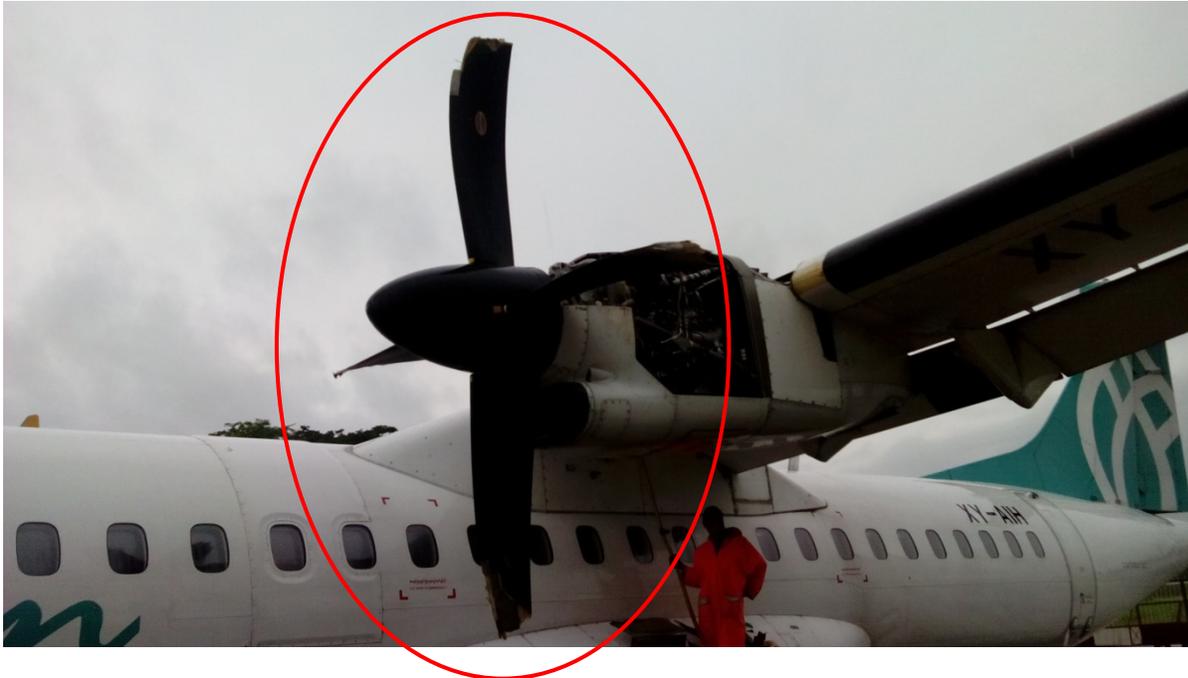
Figure 6 Broken propeller's blades

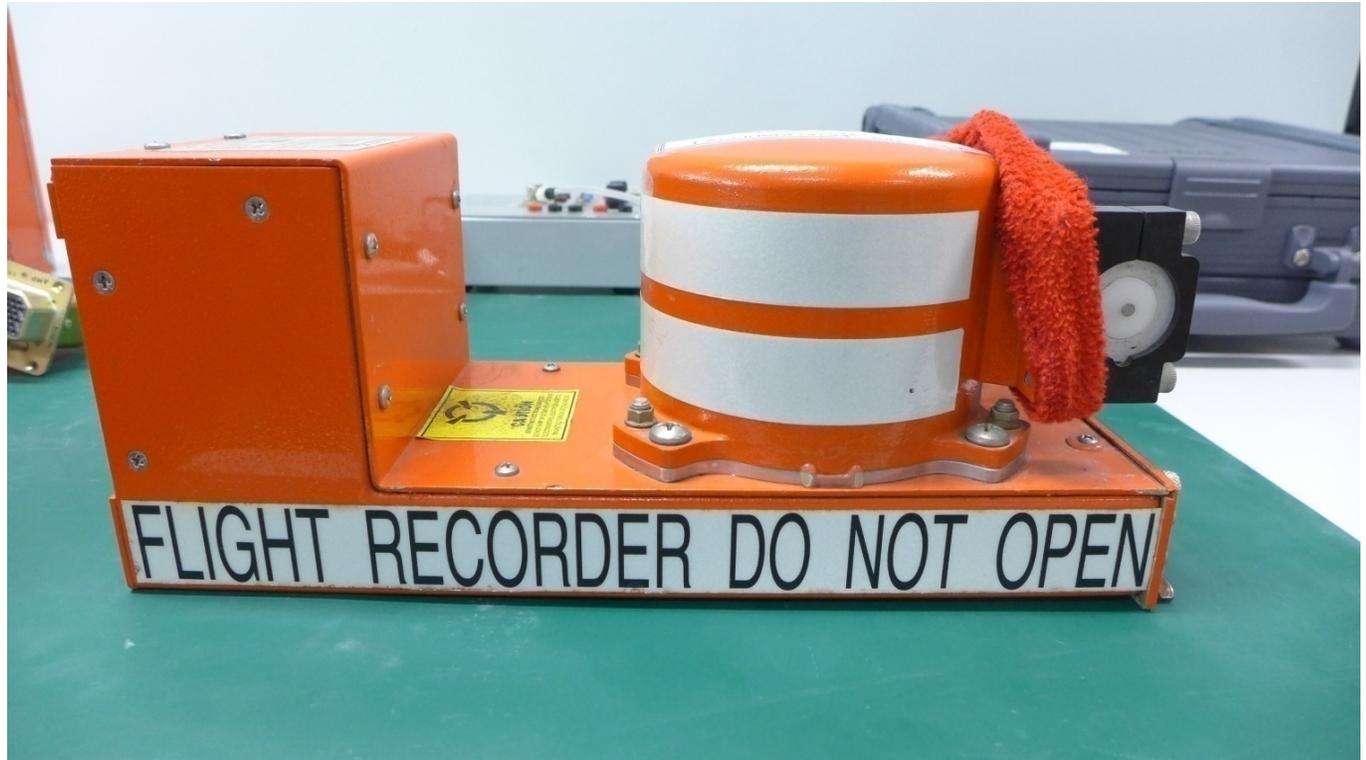
Figure 7 Flight Data Recorder

There was no damage observed to the flight recorders. The interface pins for both recorders were checked and they appeared to be in good condition.

The recording quality of the FDR data was of good quality. The FDR contained the last 57 hours and 41minutes of aircraft operation. The data frame had 289 parameters.

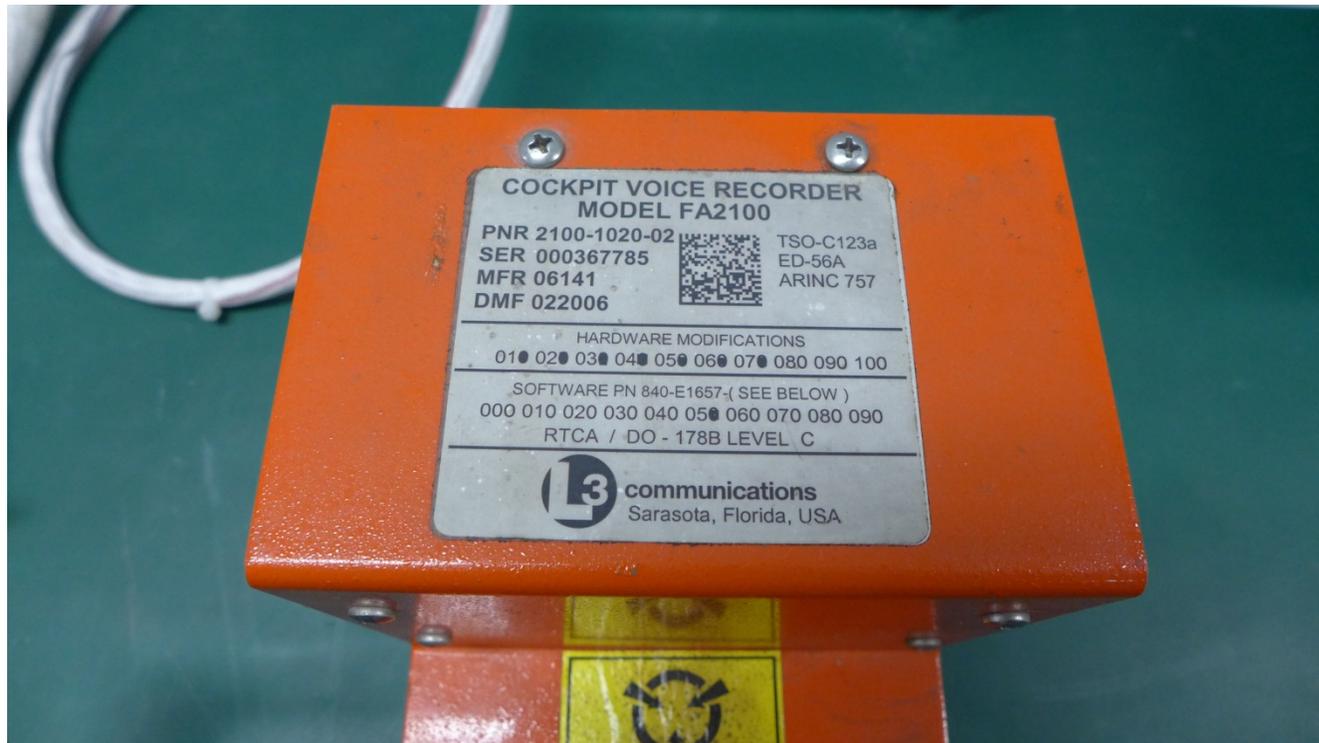
Figure 8 Cockpit Voice Recorder

The CVR contained two hours of 4 channel recordings. Channels 1 and 3 were of good quality. Channel 2 had a continuous tone at a frequency range of 400 Mhz through the recording. However this did not affect the transcription of the CVR. The Cockpit Area Microphone was of poor quality. The microphone appears to be too sensitive too noisy.
