National Transportation Safety Board Aviation Accident Final Report

Location:	San Diego, CA	Accident Number:	WPR15MA243B
Date & Time:	08/16/2015, 1103 PDT	Registration:	N442RM
Aircraft:	NORTH AMERICAN ROCKWELL NA265-60SC	Aircraft Damage:	Substantial
Defining Event:	Midair collision	Injuries:	4 Fatal
Flight Conducted Under:	Part 91: General Aviation - Other Work Use

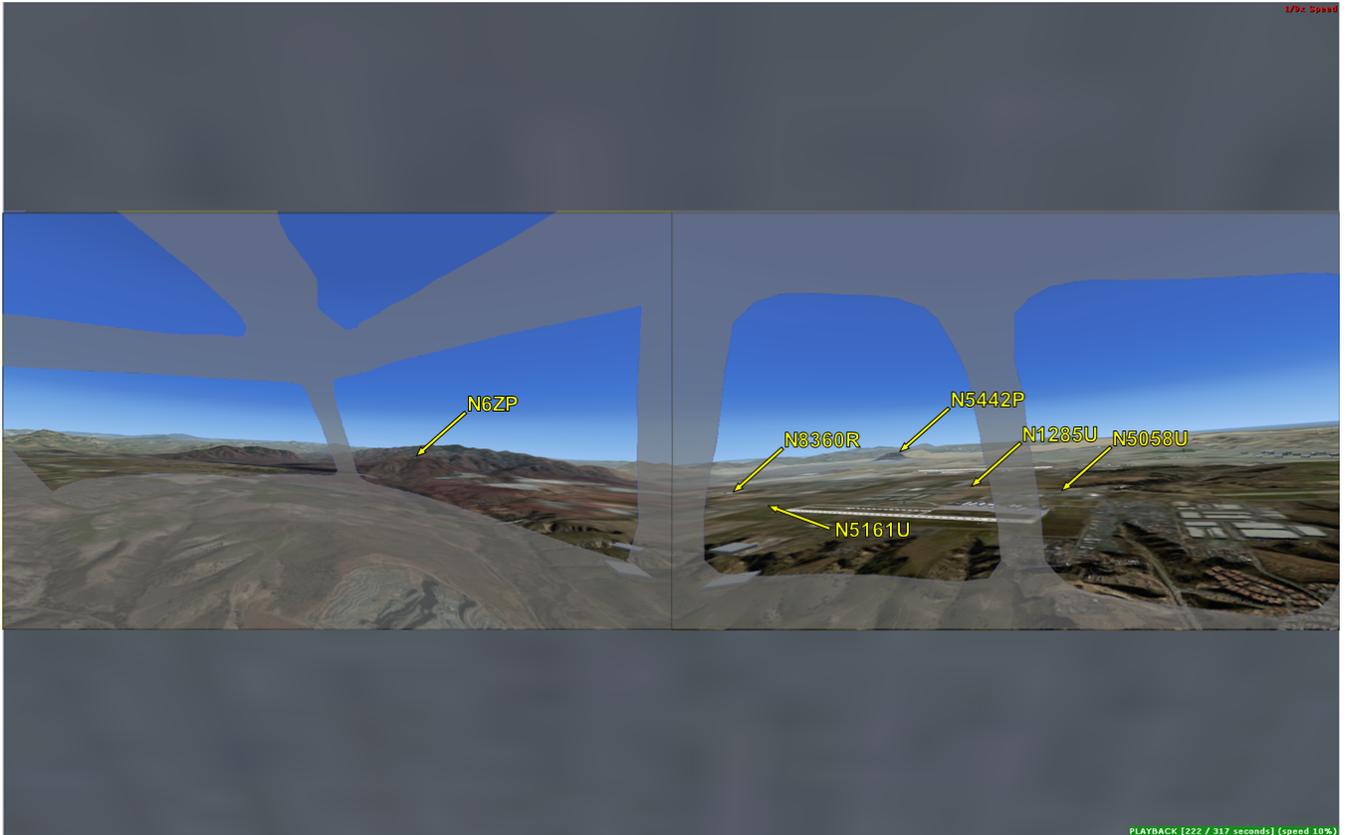
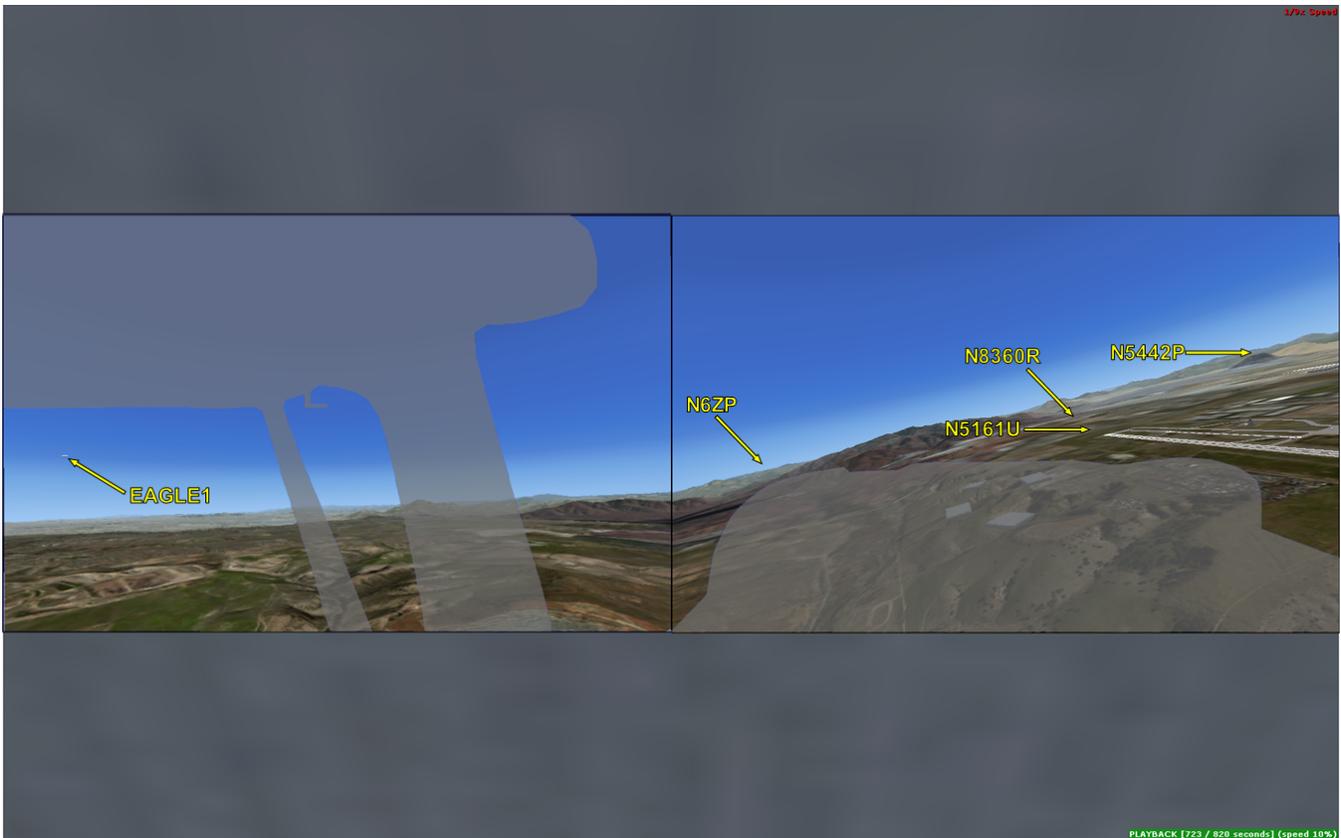
At 1101:43.1, N1285U would have been located just to the left of the window post separating Eagle1's R2 and R3 windows, and N5058U would have been just to the right of this post (see figure 7a). Eagle1 would have appeared in the left window of N1285U, just below the wingtip (see figure 7b). Eagle1 and N1285U were both on the right downwind leg for runway 26R, with Eagle1 about 0.4 nm north of N1285U.

Figure 7a. View from the copilot seat of Eagle1 at 1101:43.1, when the airplanes were 0.5 nm apart.

Figure 7b. View from the pilot seat of N1285U at 1101:43.1, when the airplanes were 0.5 nm apart.

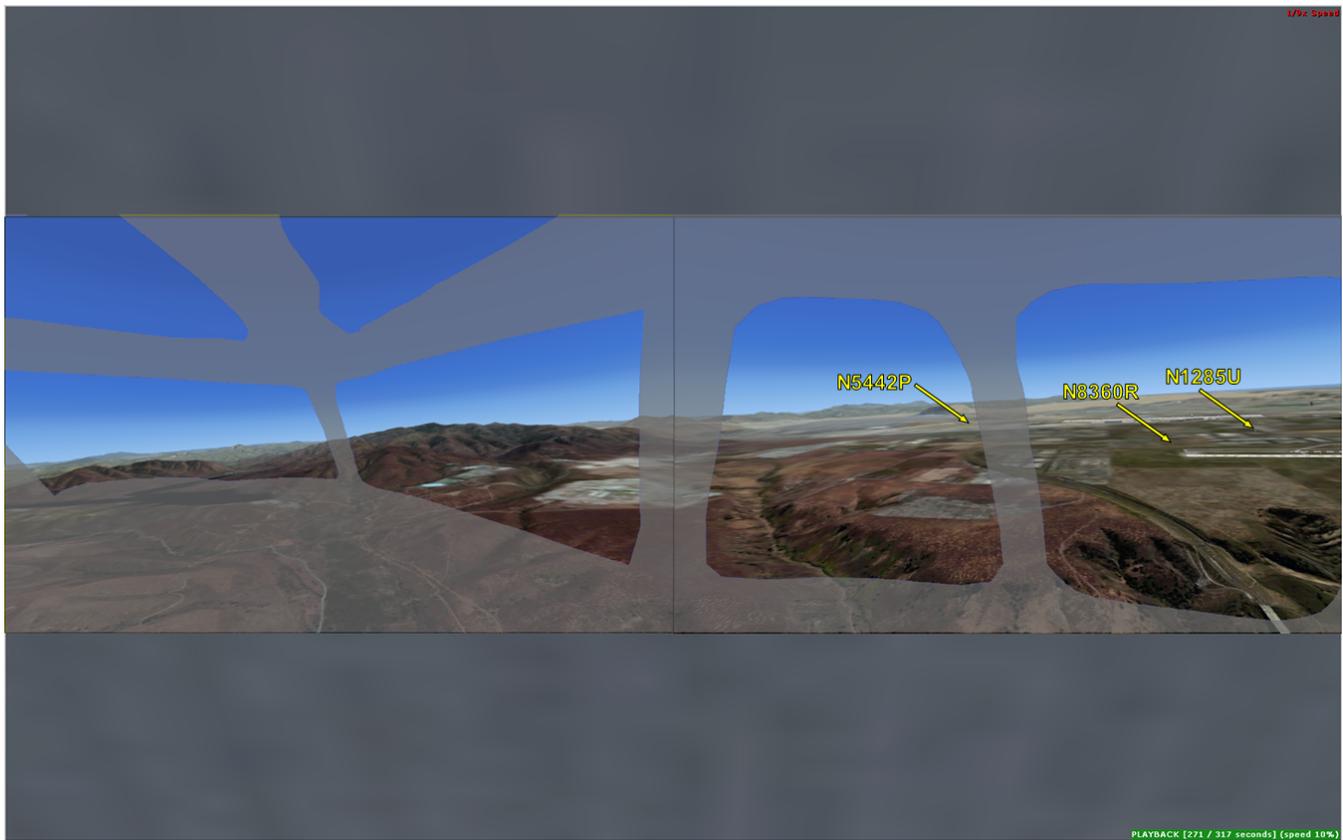
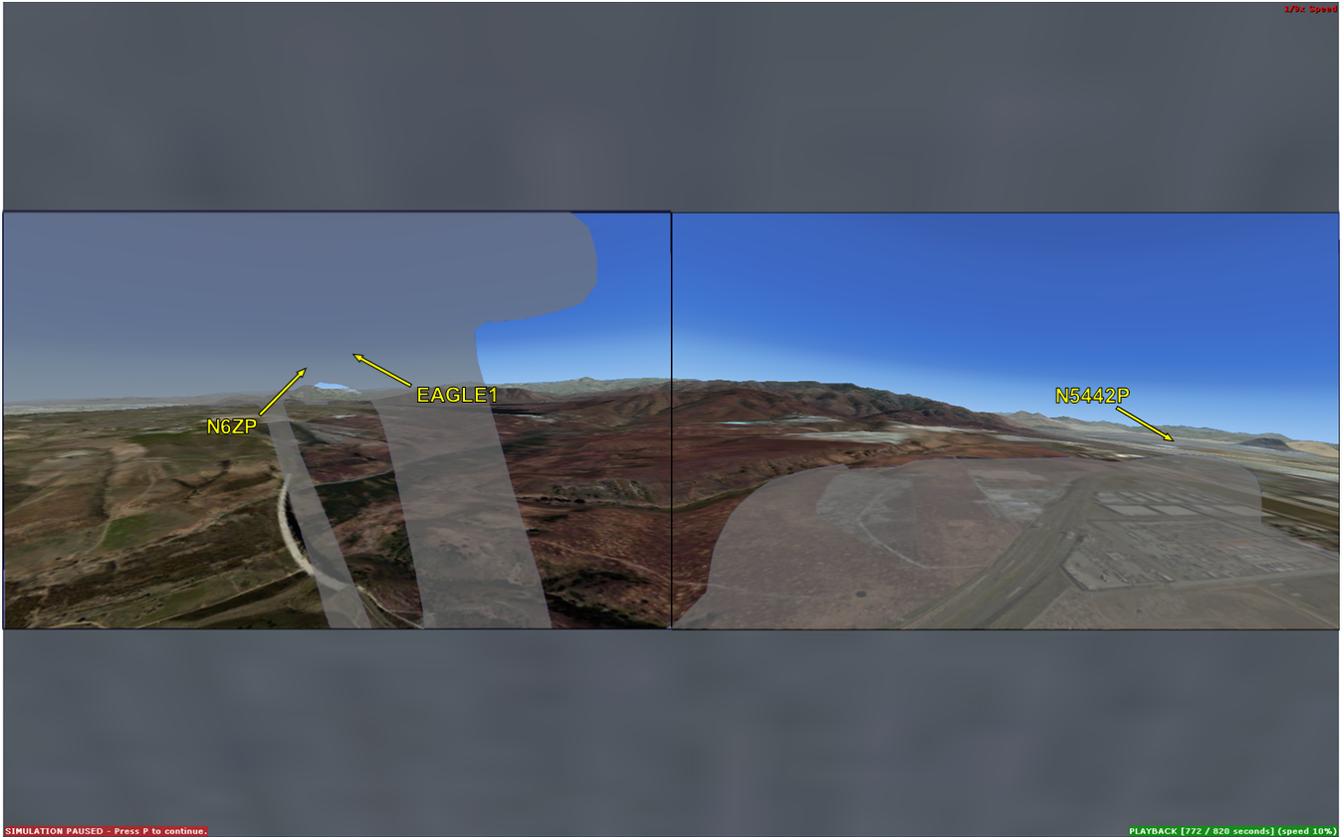
At 1102:32.0, when the LC mistakenly instructed N6ZP to make a right 360° turn, intending the instruction for N1285U, Eagle1's CVR recorded the pilot ask "you still got the guy on the right side?" N1285U was 0.8 nm away and would have appeared in Eagle1's R3 window (see figure 8a). Also to Eagle1's right were N8360R (on short final approach for runway 26L), N5442P (on a left base leg for runway 26L), and N5058U (which was climbing through 1,500 ft about 2.6 nm to the west of the

runway 26R threshold). Eagle1 would have been obscured from the N1285U pilot's field of view by the left wing and strut (see figure 8b). Eagle1 started banking to the right, turning toward right base, shortly after this time.

Figure 8a. View from the copilot seat of Eagle1 at 1102:32.4, when the airplanes were 0.8 nm apart.

Figure 8b. View from the pilot seat of N1285U at 1102:32.4, when the airplanes were 0.8 nm apart.

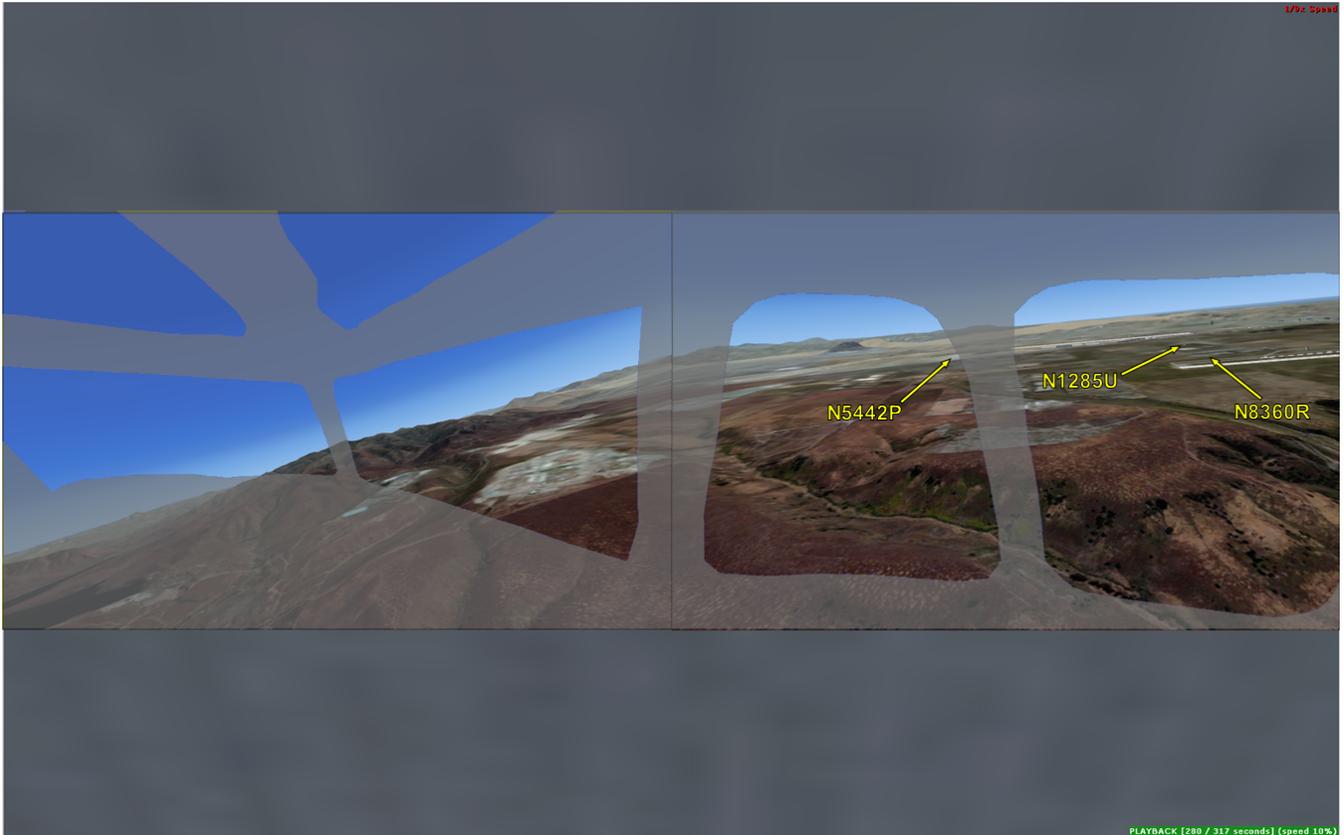
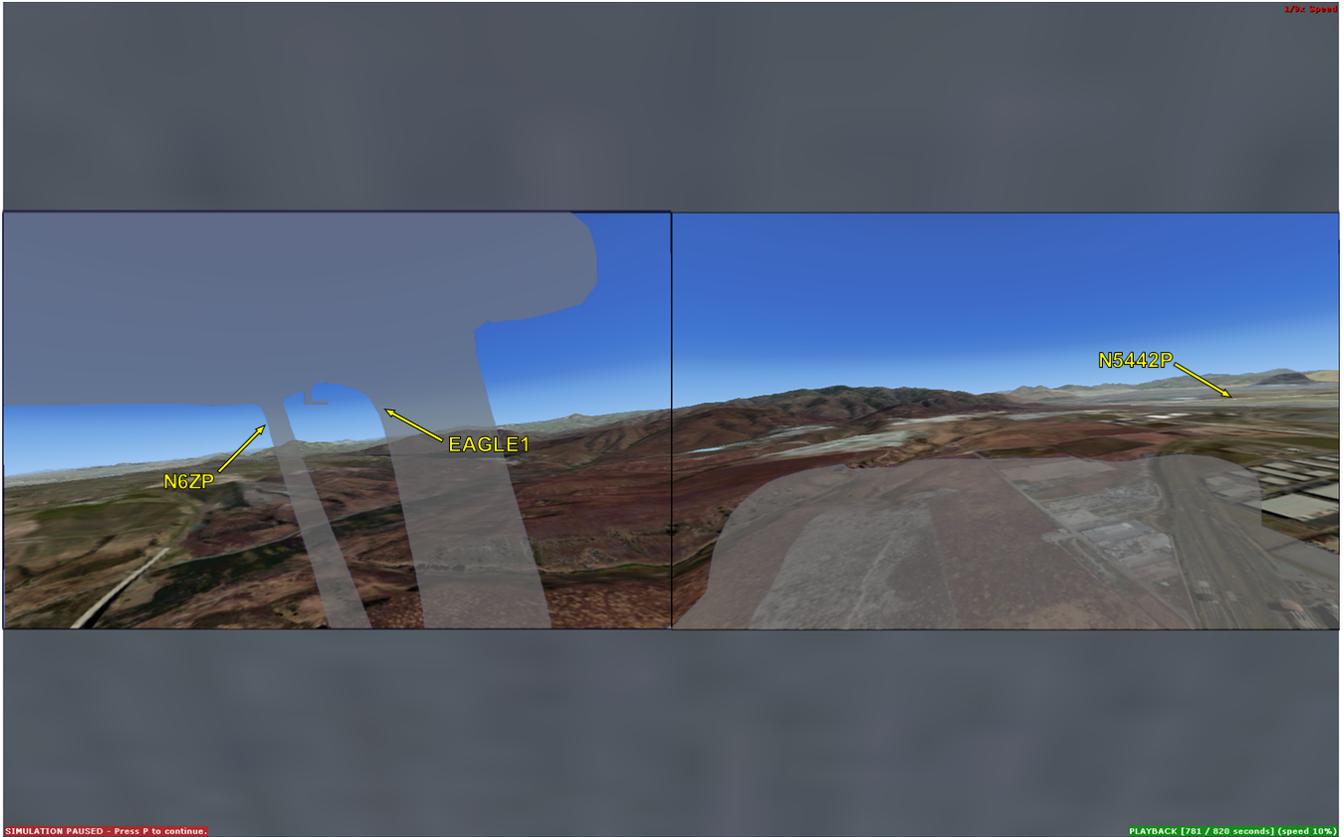
At 1102:42.0, when the LC instructed the pilot of Eagle1 to "turn base two six right cleared to land," Eagle1 was descending through 1,960 ft in a right bank, about 1.3 nm north and 0.7 nm east of the runway 26R threshold. N1285U was descending through 1,460 ft, about 0.6 nm north and 0.3 nm east of the threshold, and would have appeared in Eagle1's R3 window (see figure 9a). Eagle1 would have appeared in the N1285U pilot's field of view near the edge or slightly behind the window post separating the left window from the windshield (see figure 9b). The airplanes were still about 0.8 nm away from each other.

Figure 9a. View from the copilot seat of Eagle1 at 1102:42.0, when the airplanes were 0.8 nm apart.

Figure 9b. View from the pilot seat of N1285U at 1102:42.0, when the airplanes were 0.8 nm apart.

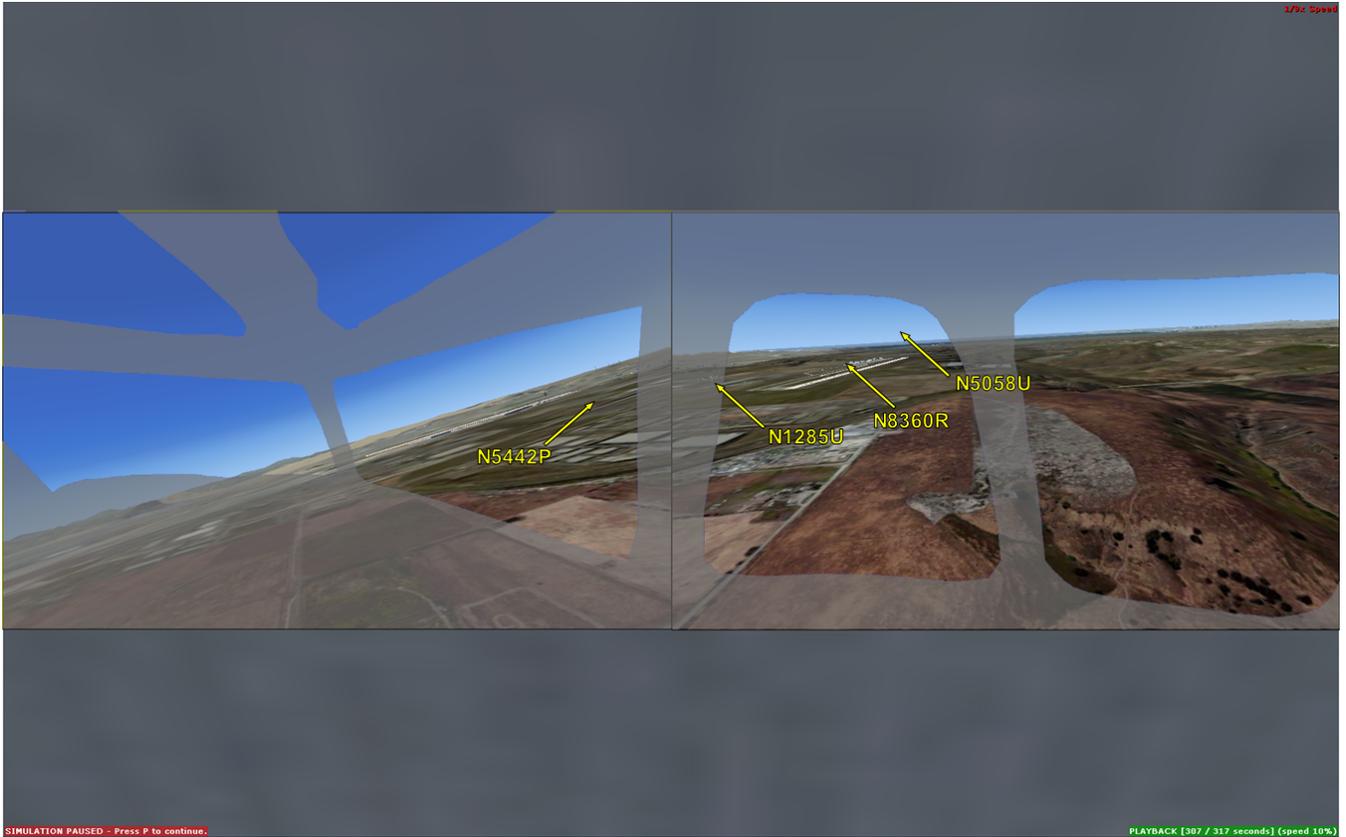
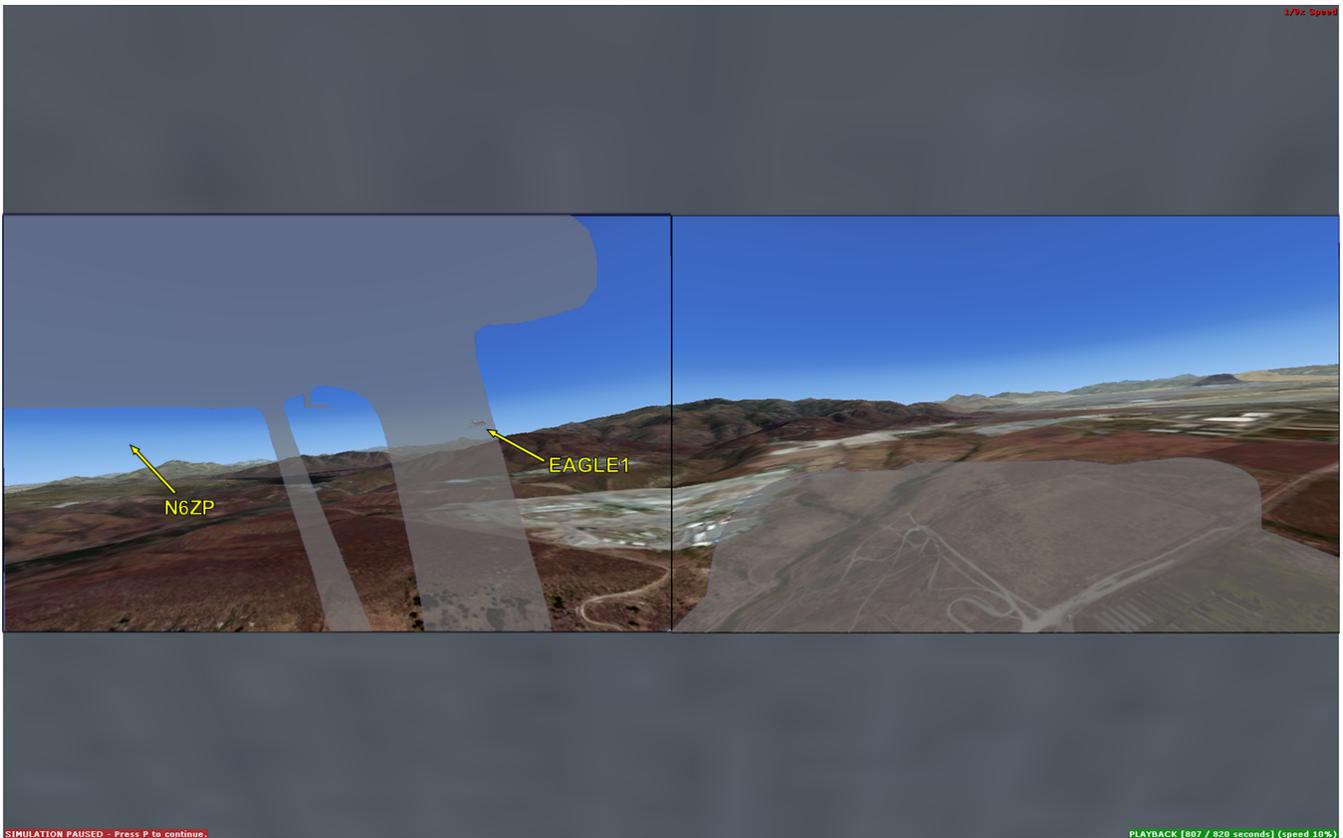
At 1103:08.0, when the controller asked the N1285U pilot if he was still on downwind, Eagle1 and N1285U were about 0.1 nm apart. N1285U may have been obscured by the post between Eagle1's R1 and R2 windows, and Eagle1 may have been obscured by N1285U's window post (see figures 10a and 10b).

Figure 10a. View from the copilot seat of Eagle1 at 1103:08.0, when the airplanes were 0.1 nm apart.

Figure 10b. View from the pilot seat of N1285U at 1103:08.0, when the airplanes were 0.1 nm apart.

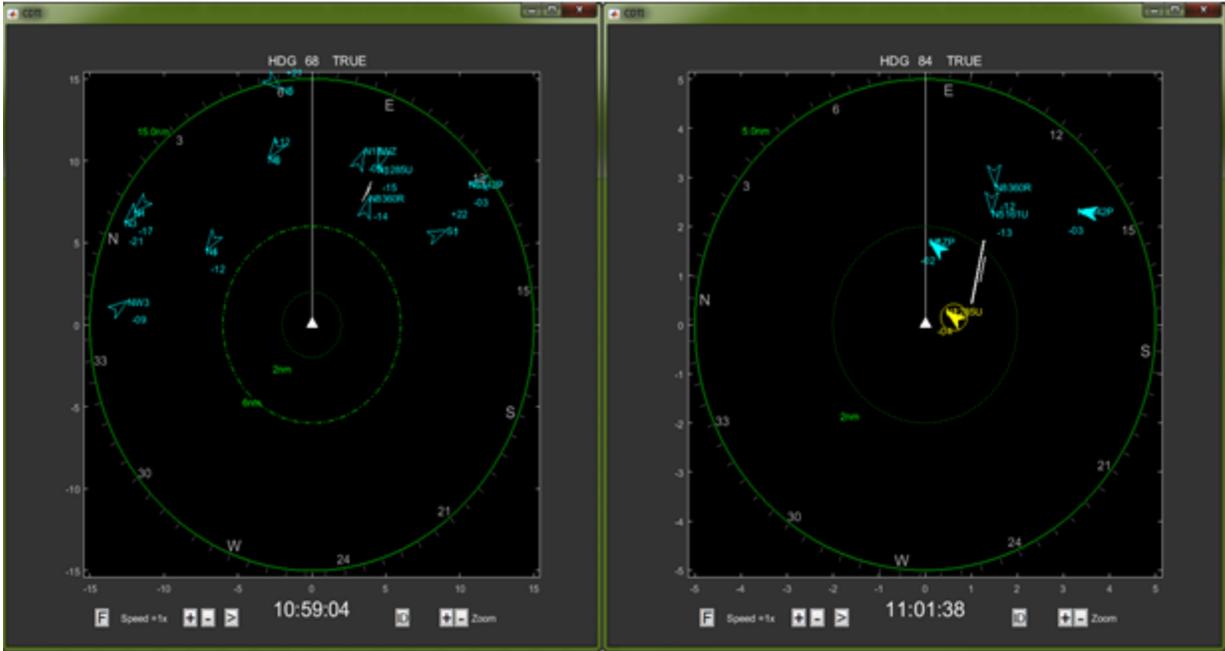
The NTSB's in-cockpit traffic display simulation for Eagle1 indicates that at 1059:04, open (outlined), cyan-colored, arrowhead-shaped targets representing the local traffic at SDM would have appeared at the 1 o'clock position, 8 nm from Eagle1, and traffic inbound for the San Diego area would have appeared at Eagle1's 9 to 11 o'clock position, 8 nm from Eagle1. N1285U would have been depicted 500 ft below Eagle1 east of the airport on a final approach leg. As Eagle1 continued its east-bound track toward SDM, N1285U would have disappeared from view (loss of radar contact). At 1059:48, as Eagle1 approached 6 nm from SDM, N6ZP would have appeared over SDM as an open arrowhead and turned right to remain in the traffic pattern for runway 26R. At 1100:16, N6ZP would have changed to a filled cyan-colored arrowhead before becoming established on the downwind leg at 1100:49. (N6ZP would eventually cross over the projected flightpath of Eagle1 at 1101:49, headed northeastbound.) At 1100:57, when Eagle1 was about 3.5 nm from the runway 26R threshold, N1285U would have reappeared on Eagle1's display as a filled, cyan-colored arrowhead at Eagle1's 1 o'clock position, about 2.5 nm from and 1,100 ft below Eagle1. At 1101:38, N1285U's symbol would have changed to alert status (a filled, yellow-colored arrowhead, enclosed by a yellow circle), and Eagle1 would have received an aural alert advising, "Traffic, 2 o'clock, low, less than 1 mile, climbing" (see figure 11).

Figure 11. Simulated in-cockpit traffic display for Eagle1 at 1059:04 (left) and 1101:38 (right).

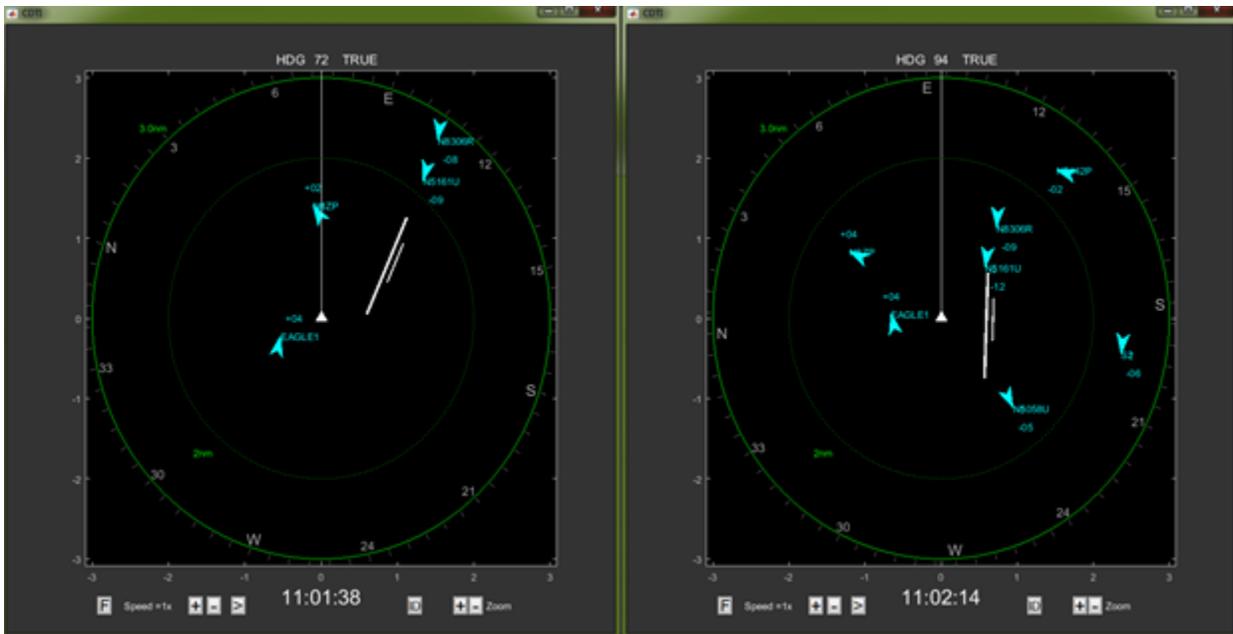
As shown in figure 12, at 1101:38, as N1285U turned onto the downwind leg and as Eagle1 was receiving its aural alert, N1285U's display would have depicted Eagle1 at N1285U's 8 o'clock position, 0.6 nm from and 400 ft above N1285U. At 1102:14, both Eagle1 and N1285U were positioned abeam the tower, and Eagle1 reported traffic to the left and right in sight. N6ZP would also have been shown on the displays departing the SDM area heading in a northeastern direction 400 ft above N1285U and at the same altitude as Eagle1.

Figure 12. Simulated in-cockpit traffic display for N1285U at 1101:38 (left) and 1102:14 (right).

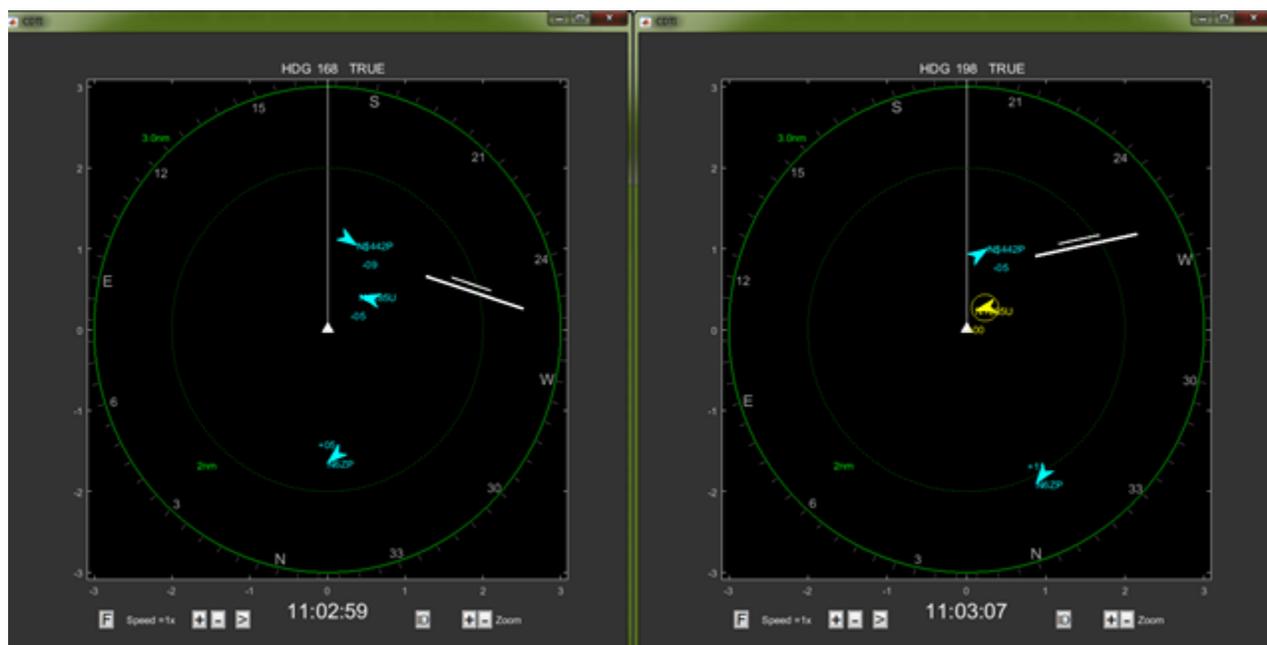
At 1102:59.3, during Eagle1's base turn, the pilot stated, "I see the shadow but I don't see him." At this time, N1285U would have been depicted on Eagle1's display at Eagle1's 2 o'clock position, between Eagle1 and the runway 26R threshold, 1 nm from and 500 ft below Eagle1. At 1103:07, about 3 seconds before the collision, N1285U would have again changed to alert status (yellow, circled arrowhead), and Eagle1 would have received a second aural alert advising, "Traffic, 1 o'clock, same altitude, zero miles" (see figure 13). At the same time, Eagle1 would have changed to alert status on N1285U's display, and N1285U would have received an aural alert advising, "Traffic, 11 o'clock, same altitude, zero miles, descending." Additional details about the traffic information that could have been displayed during the accident scenario can be found in the Aircraft Performance and Cockpit Visibility Study.

Figure 13. Simulated in-cockpit traffic display for Eagle1 at 1102:59 (left) and 1103:07 (right).
