AVIATION INVESTIGATION REPORT A15A0054

Hard landing and runway excursion

Maritime Air Charter Limited
Beechcraft King Air A100, C-FDOR
Margaree, Nova Scotia
16 August 2015

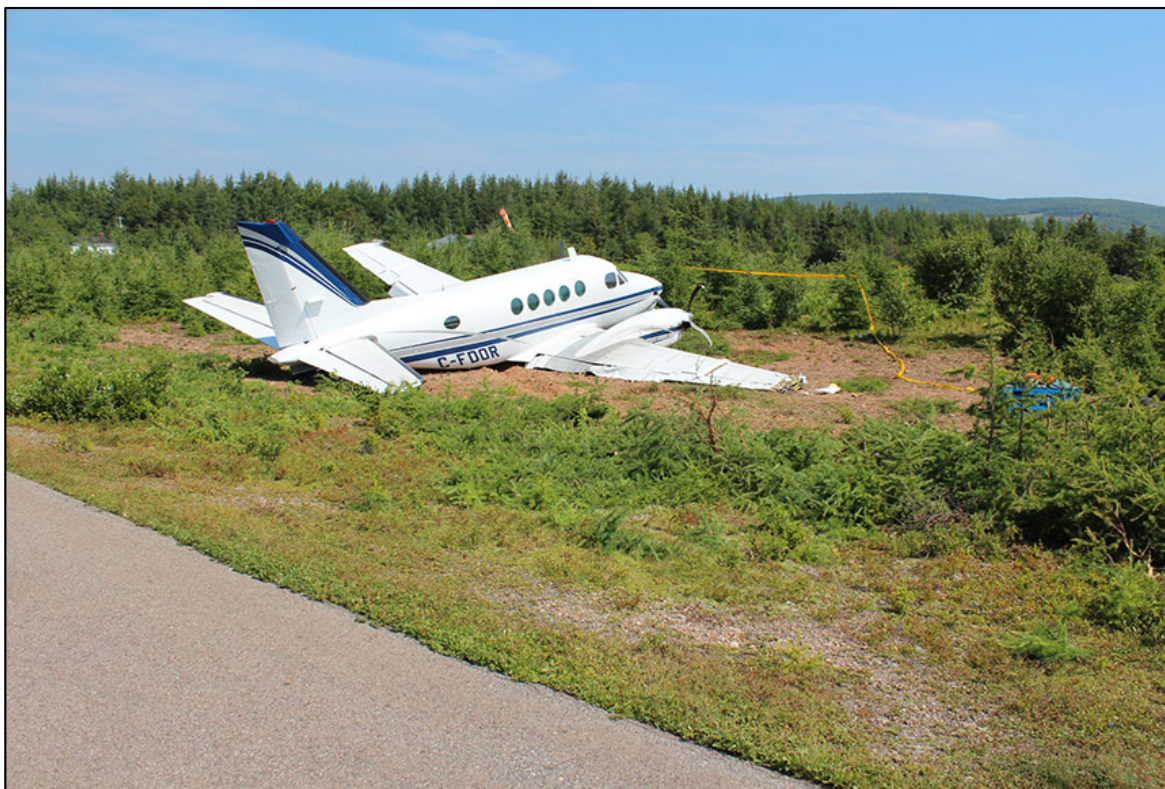
Figure 1. Occurrence aircraft

There were no injuries and there was no post-impact fire. The crew and passengers evacuated the aircraft through the cabin door.

The aircraft was substantially damaged.

The right propeller blades were bent and abraded. The right flaps were crushed, and the right wing sustained damage to the tip, the leading edge, and the upper and lower surfaces. The right engine oil cooler scoop sustained abrasion damage, and the right MLG doors were buckled and abraded. The right side of the fuselage adjacent to the propeller sustained several small dents.

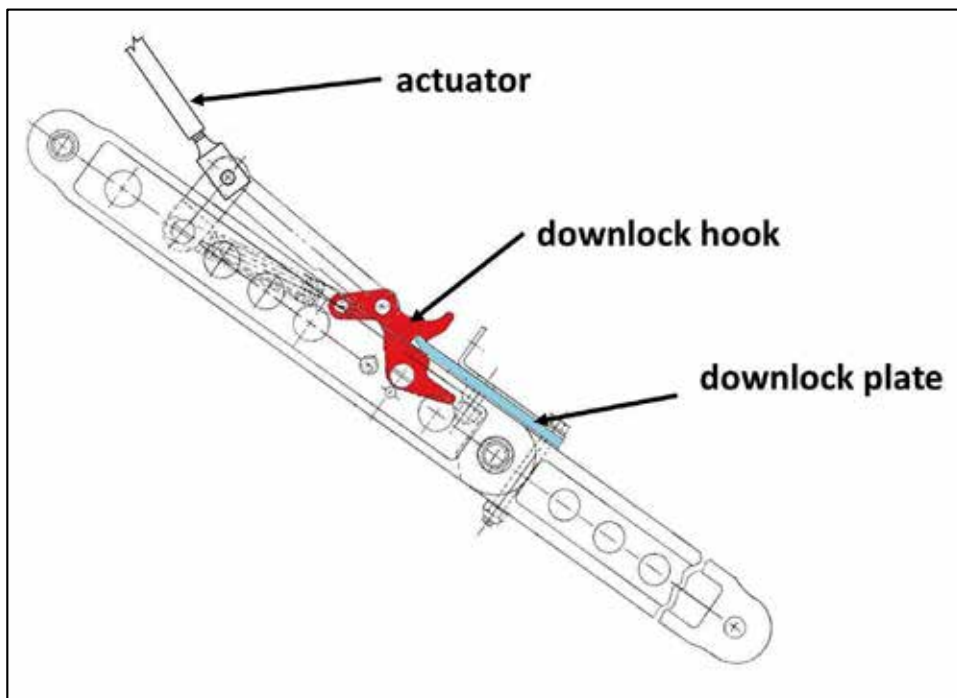
Figure 2. Main landing gear drag brace assembly (Source: Textron Aviation Inc., with TSB annotations)

positive down and locked position and allows the drag brace to act as a rigid component of the landing gear assembly (Figure 2).

The right MLG drag brace downlock plate was found bent. The plate had disengaged from the downlock hook, the drag brace assembly had folded up to the retracted position, and the right MLG actuator was found fully extended.

The aircraft crossed the runway threshold with insufficient energy to arrest the rate of descent in the landing flare, resulting in a hard landing that caused the right main landing gear to collapse.

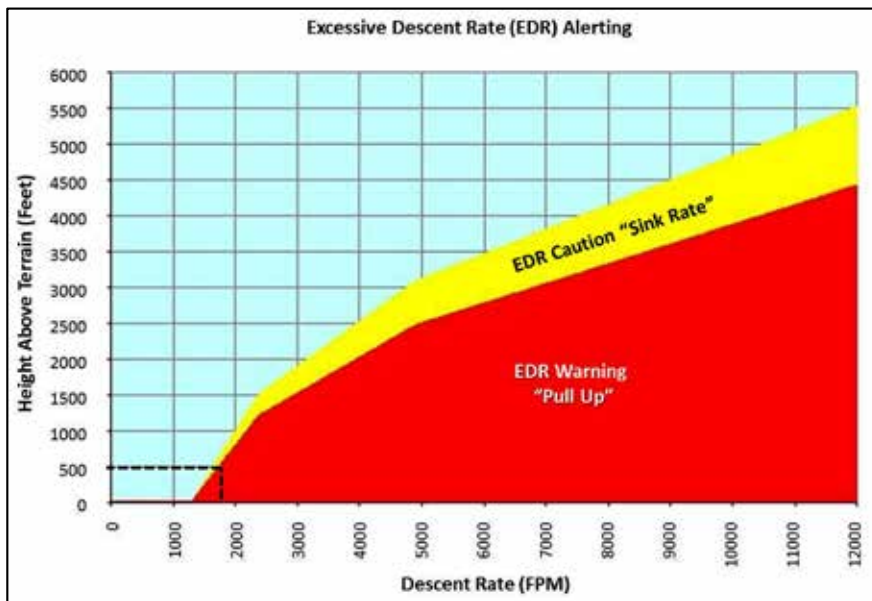
Figure 3. Excessive descent rate alert criteria chart (reproduced with permission from Garmin International, Inc., with TSB annotations)

Based on the excessive descent rate criteria, for the TAWS to call "SINK RATE" then "PULL UP, PULL UP" in very quick succession when the aircraft is about 500 feet above terrain, the descent rate would have had to be at least 1750 feet per minute (Figure 3).

Almost immediately after that correction was made, the aircraft was descending at about 1750 feet per minute, about 500 feet above the ground. The PF corrected for the excessive rate of descent by pitching up, which would have caused the airspeed to decrease.
