Report IN-031/2015

Incident involving an Airbus A-321-211, registration G-TCDX, operated by Thomas Cook Airlines, while on approach to the Menorca Airport (Balearic Islands, Spain) on 1 September 2015

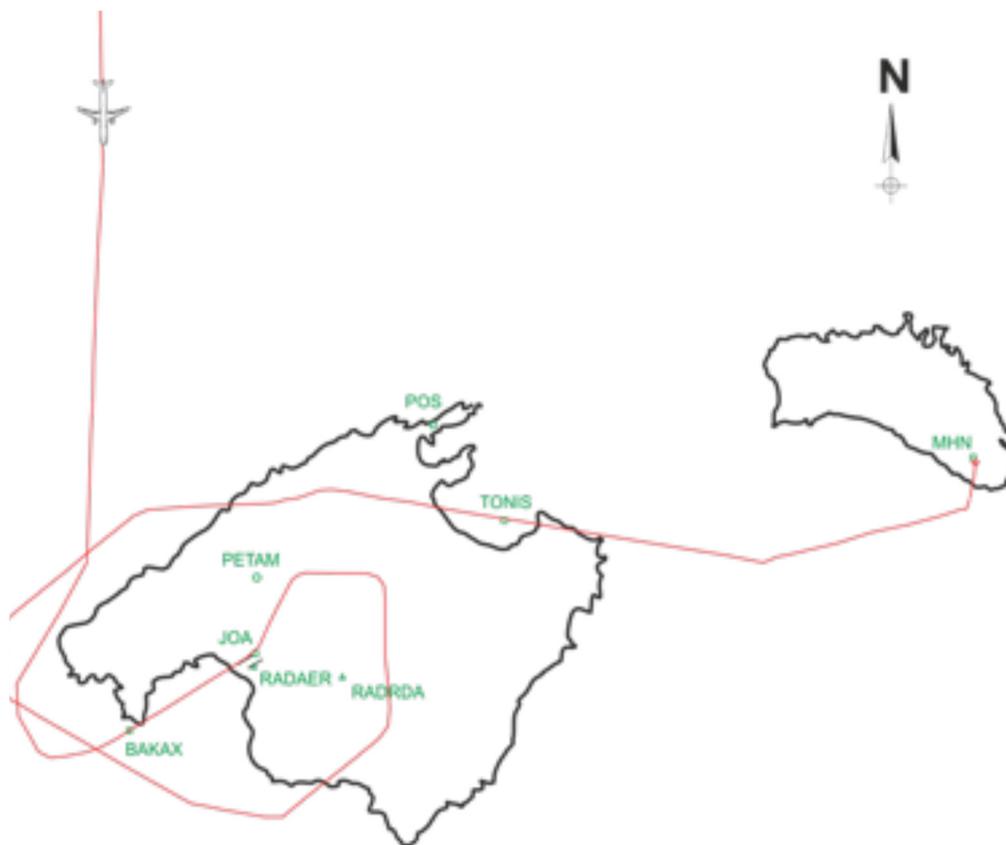
Figure 1. Aircraft's flight path

The flight path followed by the aircraft from its initial contact with the Palma de Mallorca Control Center (ACC) until it landed at the Menorca Airport is shown below.
