# Air Accident Investigation Sector

- Final Report -

AAIS Case N° AIFN/0011/2015

## Takeoff from Taxiway

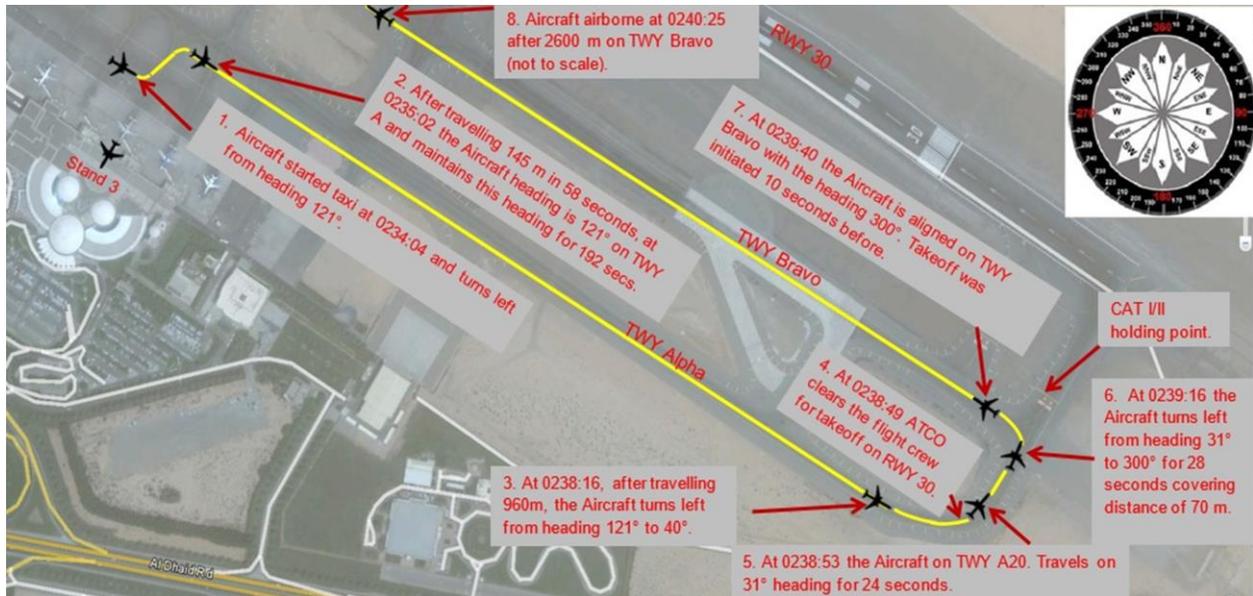
Figure 1. illustrates the Aircraft taxi route and eventual takeoff.

Figure 1. Aircraft taxi and take-off route

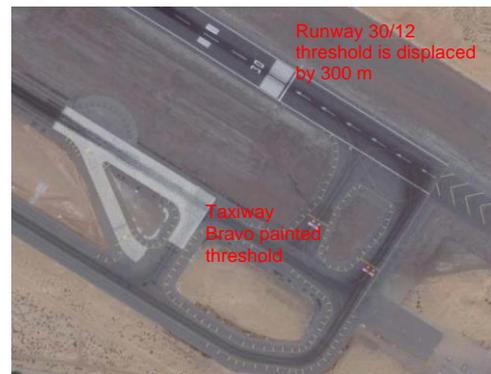
The Investigation noted that the displaced threshold stripes on taxiway Bravo are still faintly visible. As per the UAE AIP, aircraft high power engine runs are carried out at this location. The AIP states that the taxiway was 25 meter wide. This measurement was between the yellow painted edge lines. The Investigation noted that the width of the taxiway Bravo intersection with taxiway Alpha 20 was 45 meters. Signs of the previous runway imprint could be seen through the painted surface, and taxiway Bravo was extending beyond taxiway Alpha 2, at the west end, and taxiway Alpha 20, at the east end, into what was probably the previous runway end safety area (RESA).

Figure 2. Runway threshold and painted taxiway Bravo threshold

- Review and mitigate any risk associated with the use of similar designations for taxiways that lead to runway 12/30 that may cause taxiway confusion.
- Review and mitigate any risk associated with the green lead-on lights towards taxiway Bravo beyond taxiway Alpha 20 and taxiway Alpha 2.
- Determine whether the intersection of taxiway Alpha 20 with taxiway Bravo and taxiway Alpha 2 with taxiway Bravo should be designated as a hot spot, especially as there have been two incidents of taxiway confusion.
- As part of the Aerodrome Runway Safety program, review and mitigate any risk associated with the previous runway markings, color and width of taxiway Bravo.

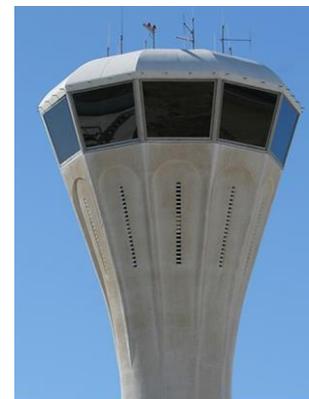
Figure 3. OMSJ Tower - visual control room

As the Investigation confirmed, especially during nighttime, the metallic structure within the visual control room hinders the controller’s view of a departing aircraft. The GCAA had raised several audit findings related to the condition of the visual control room prior to the Incident flight.

- (j) The Controller’s view of the Aircraft movement was degraded by the ergonomic design of the visual control room tower.
- (k) There were no hot spots identified on any of the Airport charts or current manuals.

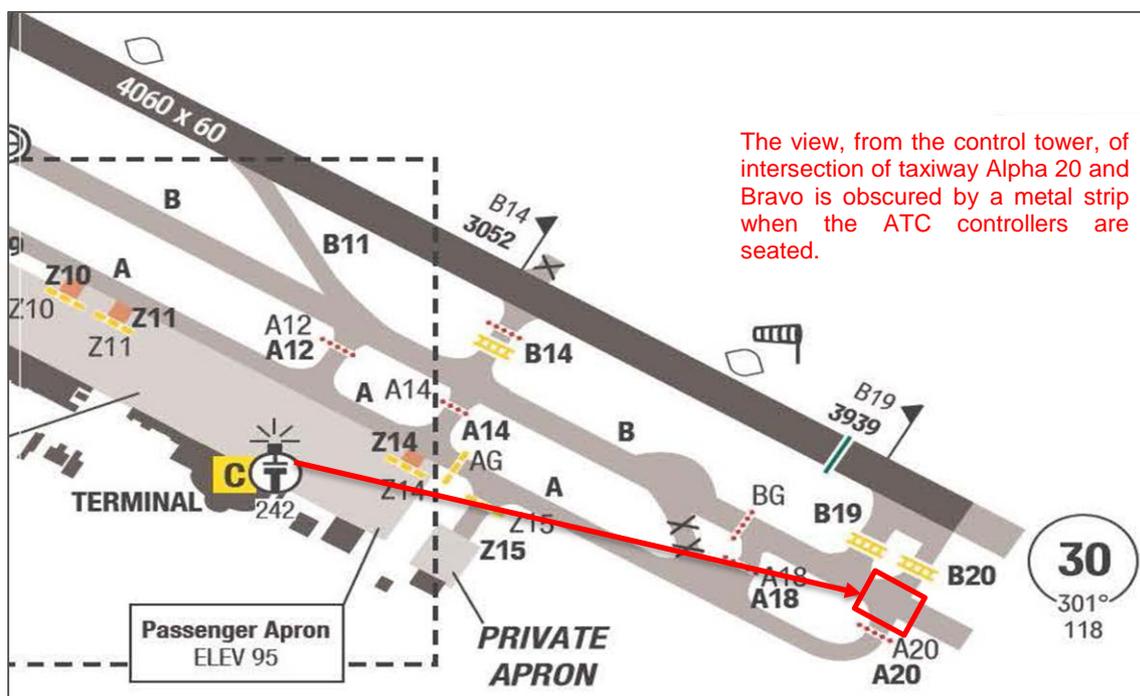
Figure 4. OMSJ Tower location in the Aerodrome

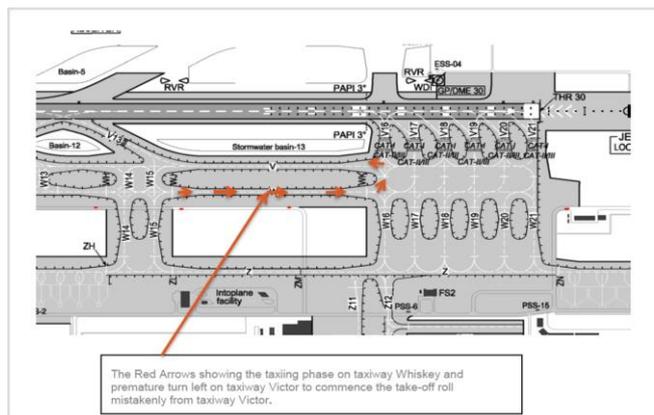
As the aircraft approached the end of taxiway Whiskey, it turned left at the intersection of Whiskey 16, and then, mistakenly, made a premature left turn and lined up on taxiway Victor instead of continuing straight ahead on taxiway Whiskey 16 to runway 30.

The air traffic controller did not observe that the aircraft was lined up on the taxiway when takeoff clearance was given. The aircraft commenced the takeoff roll on taxiway Victor and continued accelerating along the taxiway without any awareness of the situation on the part of the air traffic controller.

Figure 5. Taxiway attempted takeoff at OMDW

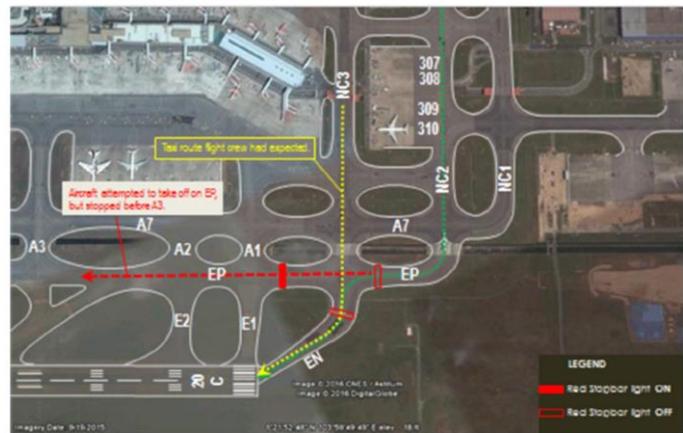
Figure 6. Attempted takeoff on taxiway – Singapore

During the turn onto the taxiway Echo Papa, the copilot, who was the pilot flying, did not see the lit red stop bar lights ahead of him. The stop bar lights was only noticed as the aircraft ground speed started to increase during the attempted takeoff on the taxiway.
