Investigation Report

Type of Occurrence:	Accident
Date:	30 September 2015
Location:	Saarbrücken
Aircraft:	Airplane
Manufacturer / Model:	Bombardier Inc./DHC-8-402
Injuries to Persons:	None
Damage:	Aircraft severely damaged
Other Damage:	None
State File Number:	BFU 15-1354-AX

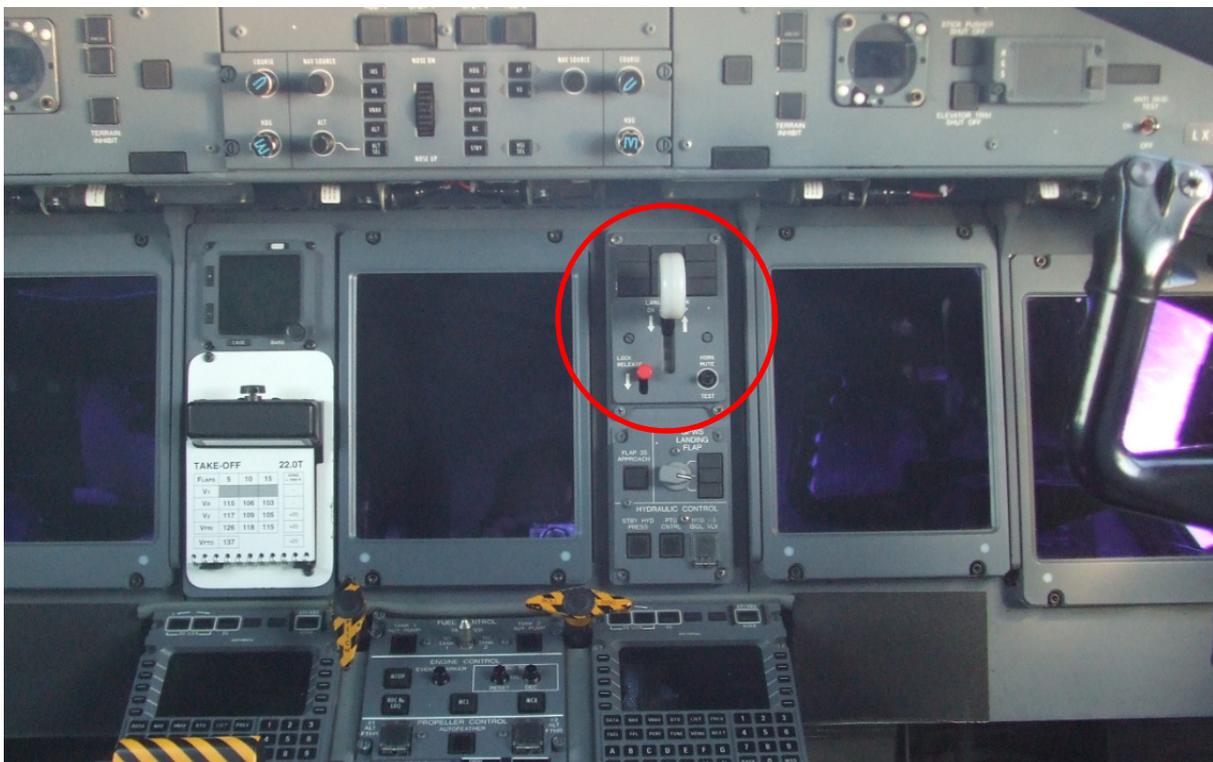
The design of the landing gear selector unit, the landing gear lever, the lock release button, and the indication dates from the '70s and was first used for the aircraft type de Havilland Canada DHC-7 (Dash 7).

Position landing gear lever, lock release and indication lights in the cockpit

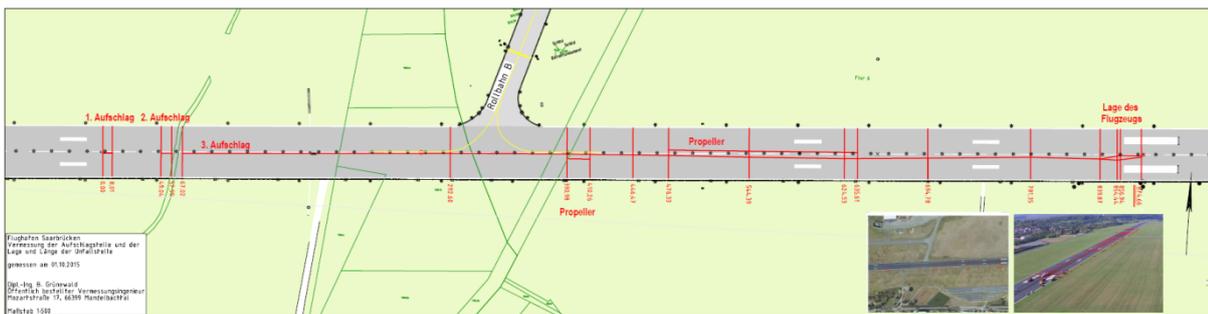
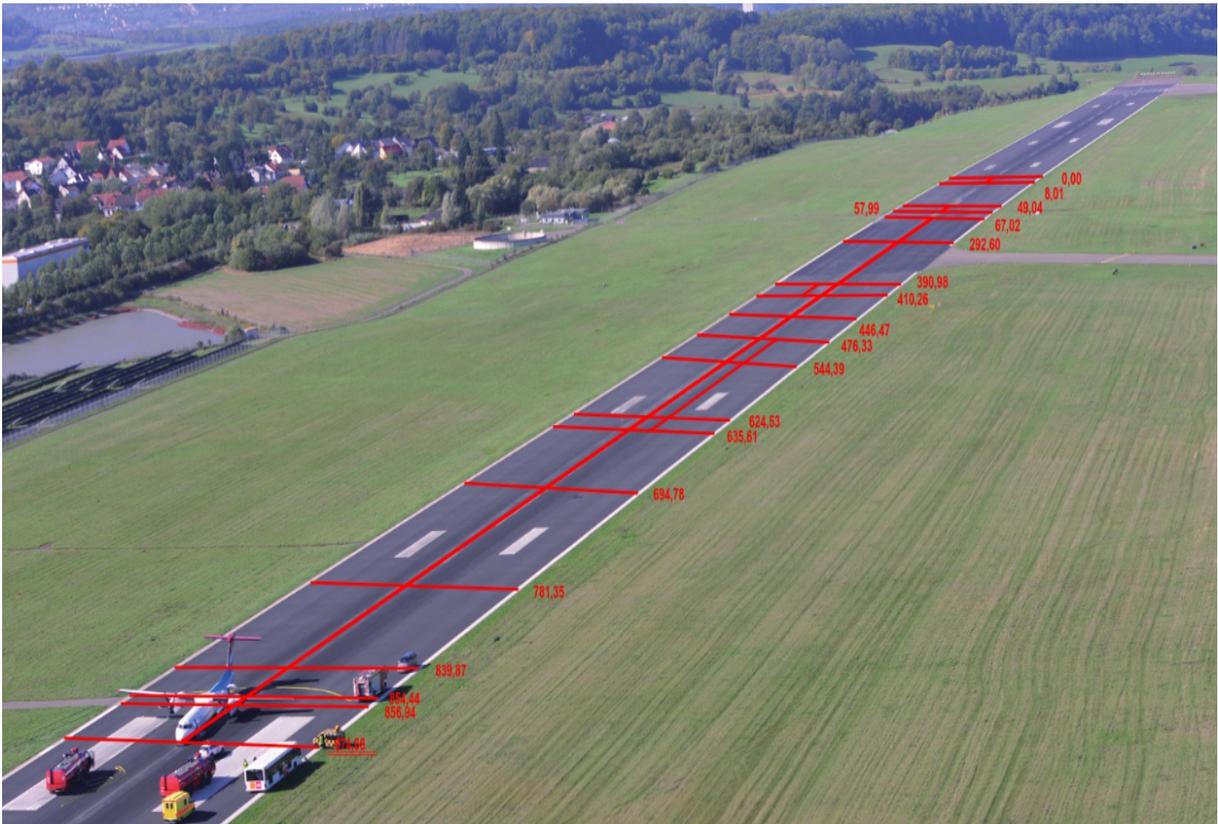
The airplane bounced three times and skidded for a distance of approximately 807 m. It then came to rest approximately in the centre of the runway, abreast the PAPI of runway 27.

Overview skid marks and final position of the airplane

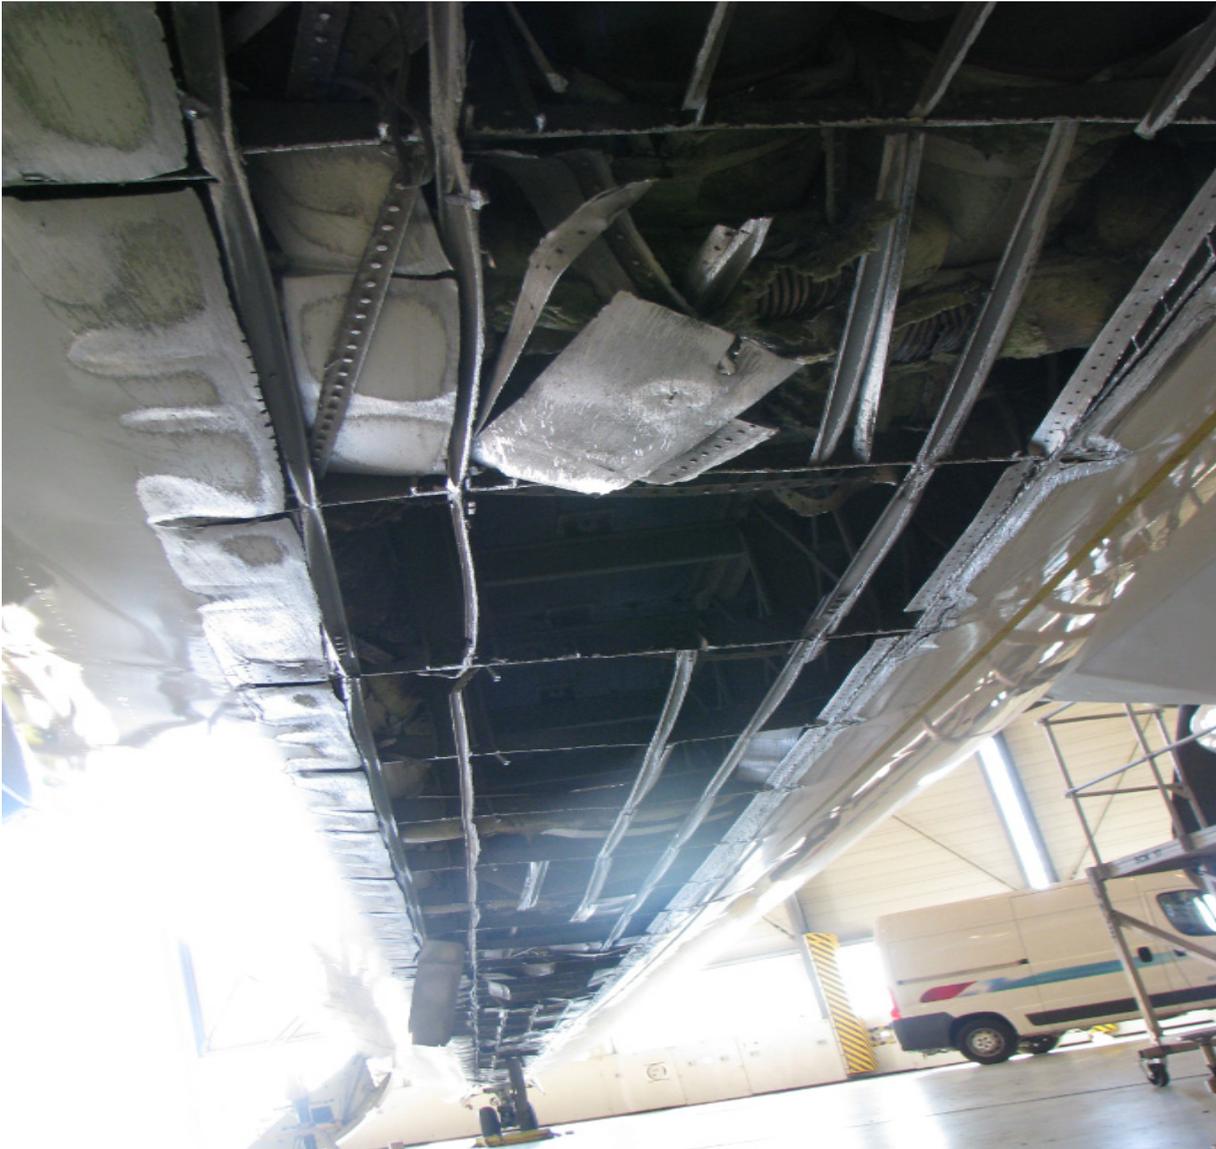
The airplane rested upright on the fuselage. The main landing gear was completely retracted and the wheel well doors at the engine cowlings closed. The nose landing gear was retracted. The front nose landing gear doors were open and damaged. The landing gear selector lever in the cockpit was in the position “UP”, i.e. retracted. The propeller blades of the left propeller were shortened by approximately 40 cm and the ones of the right by about 1 cm. Commensurate propeller impact marks were found on the runway. The entire length of the left lateral fin below the fuselage was abraded by about 3 cm. The fuselage’s bottom surface was scratched, dented and completely abraded, respectively, from about 2 m aft of the nose landing gear until the aft baggage compartment.

Damage on the fuselage's bottom surface (in flight direction)

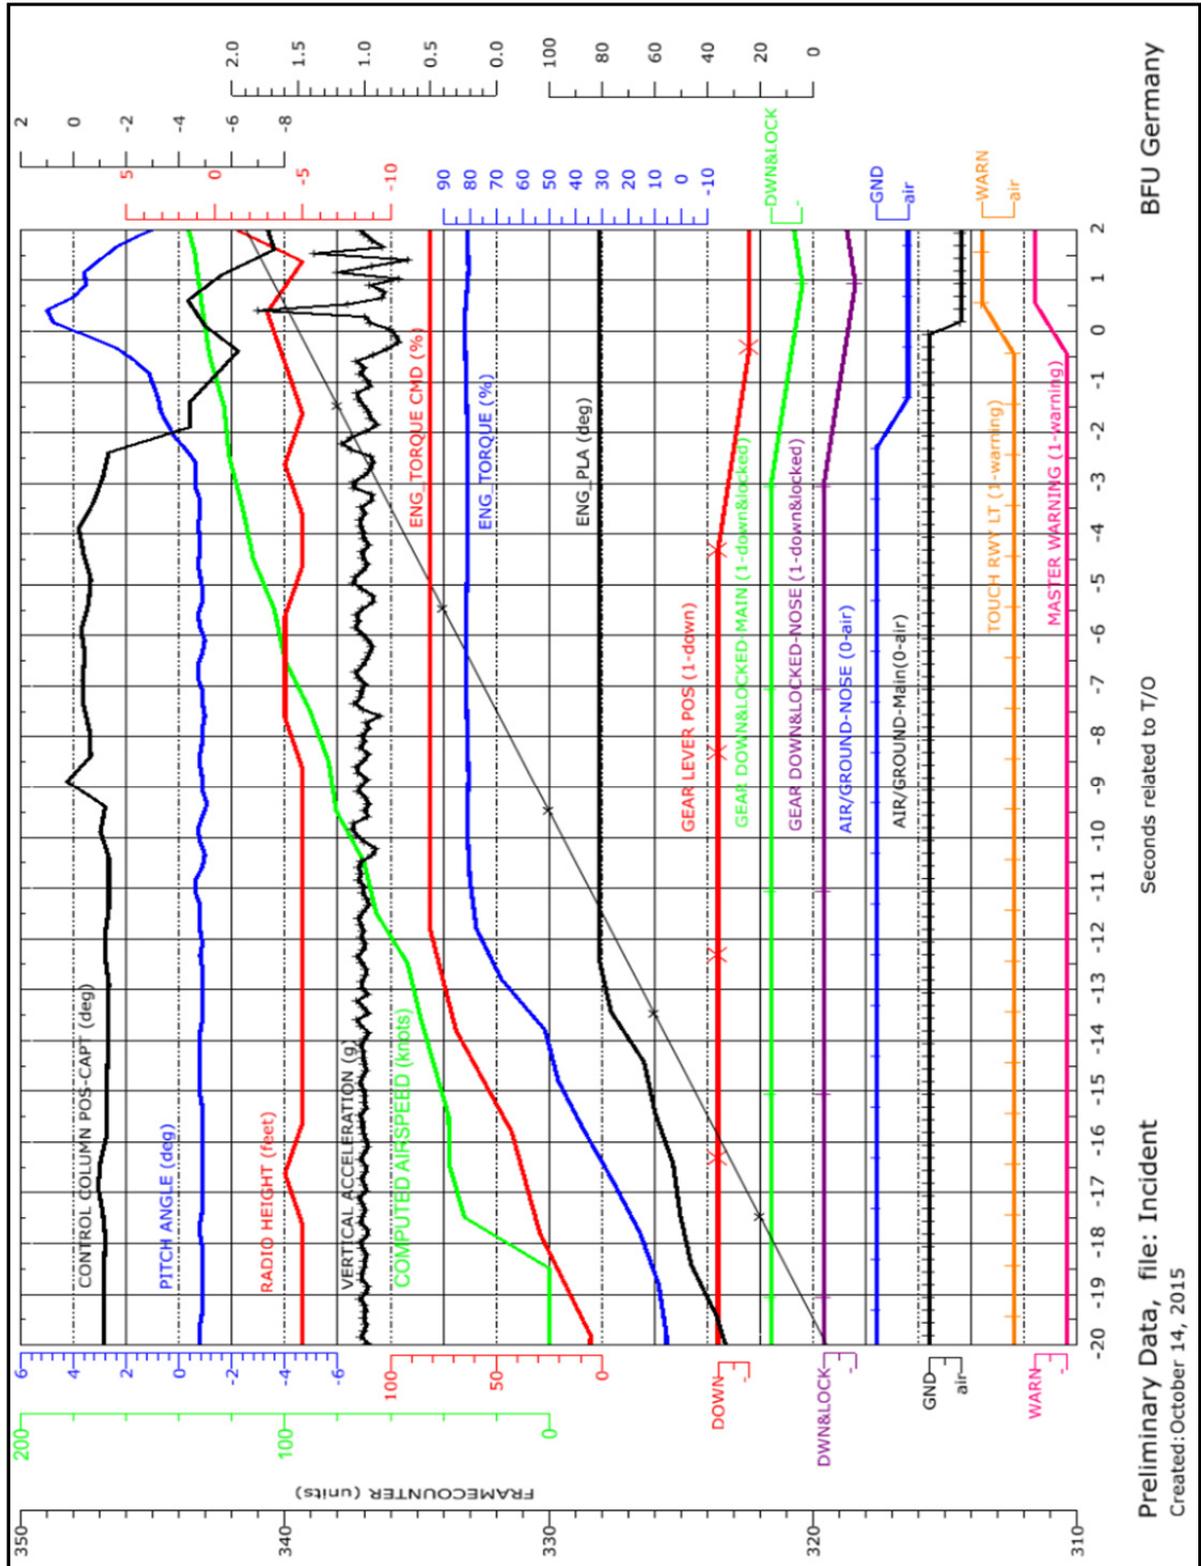
FDR data of the take-off run

During the rotation phase with approximately 127 KIAS and a nose-up attitude of approximately 5°, the landing gear retracted. At 1016:44 hrs the airplane's tail had the first ground contact (tailstrike). The tailstrike warning light illuminated. Approximately 875 m after the initial ground contact the airplane came to a stop after it had bounced three times and skidded on the fuselage.
