FINAL REPORT

ACCIDENT OF M/S SHAHEEN AIR INTERNATIONAL FLIGHT NL-142 B-737-400 AIRCRAFT REG # AP-BJO AT AIIAP, LAHORE ON 03RD NOVEMBER, 2015

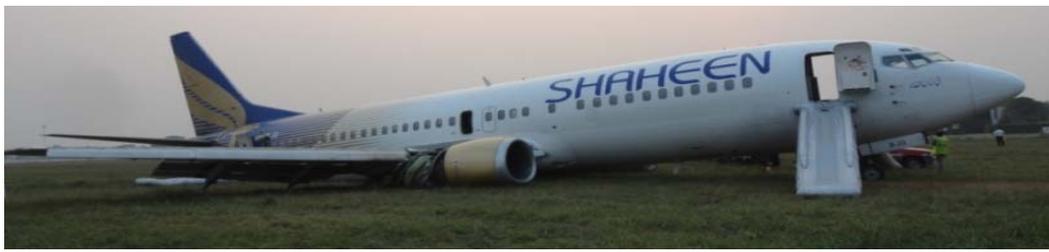
- 1.3. **Damage to Aircraft.** The fuselage of the aircraft remained intact. Both main landing gears got dislodged from the aircraft. The wing structure adjacent to the main landing gear attachment points was extensively damaged. Both engines sustained extensive damage because of dragging after landing gears collapse. The fuselage sustained damaged at right side in the tail section. The seats adjacent to the fuselage damage location were not occupied; therefore, there were no injuries.

Overview of damage to aircraft

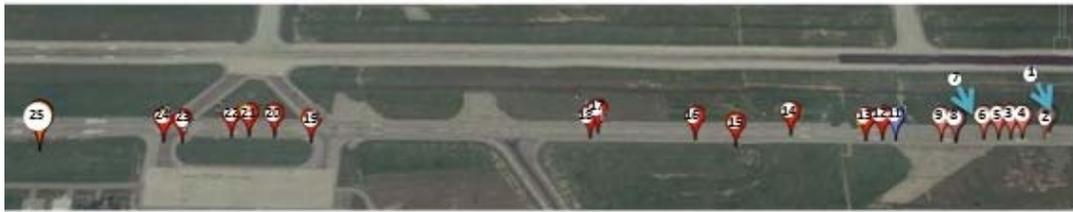
Aircraft ground track and location of dislodged parts

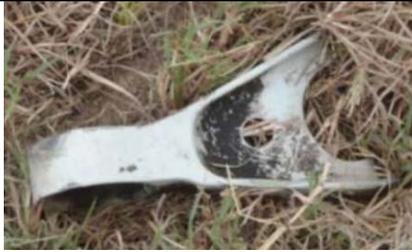
<p>15. Upper torsion link forward piece (3556 ft from RWT, 105 ft left of CL).</p>

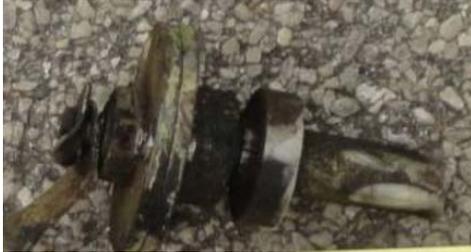
<p>16. Shimmy damper piston rod end piece (3818 ft from RWT, 62 ft left of CL).</p>

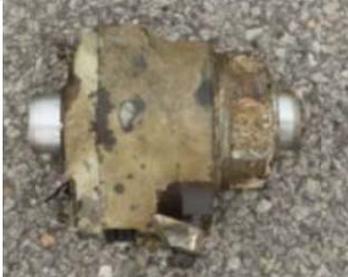
<p>17. Shimmy damper was found (4474 ft from RWT, 16 ft right of CL).</p>

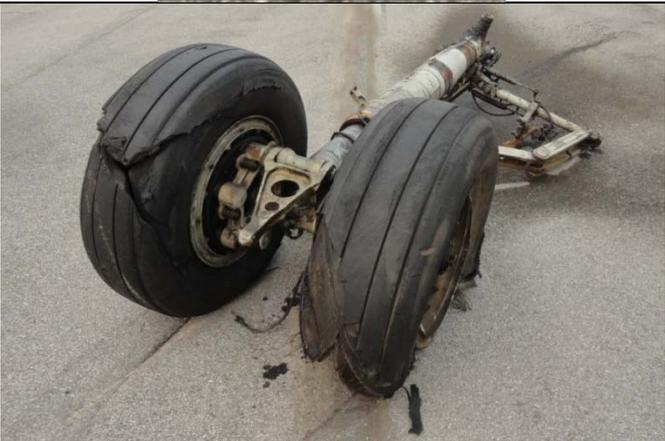
<p>18. Left main landing gear (4540 ft from RWT, 52 ft left of CL).</p>

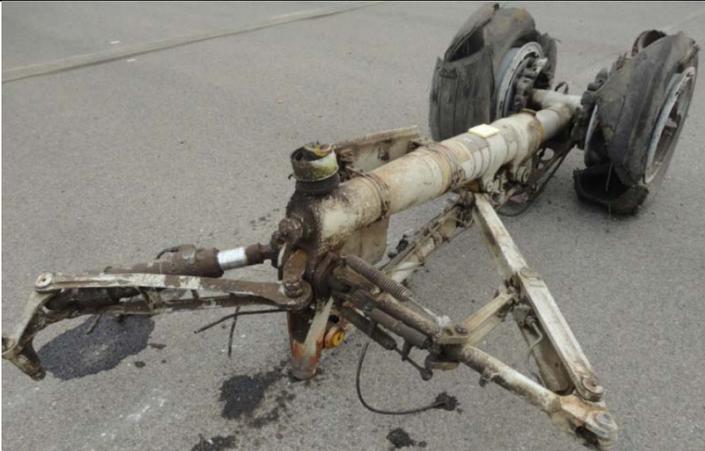
<p>24. Right main landing gear (7452 ft from RWT, 128 ft left of CL)</p>

- 2.2.10 The FDR record shows that right roll angle decreased between 5352 to 5355 seconds, and then remained very close to zero degree. A local peak of vertical acceleration was also noted in this time interval. This time interval corresponds to RMLG collapse and is corroborated by ground contact of right engine cowling. The right engine cowling ground contact was evident by drag marks and presence of right engine cowling parts, miscellaneous hardware items and thrust reverser parts in the area centred at a distance of 7390 ft from RWT (Para 1.12.3, Picture #23). The RMLG was located at approximate distance of 7452 ft on the paved link from RWT along the aircraft path (Para 1.12.3, Picture #24).

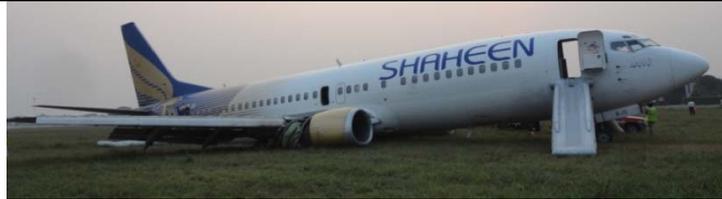
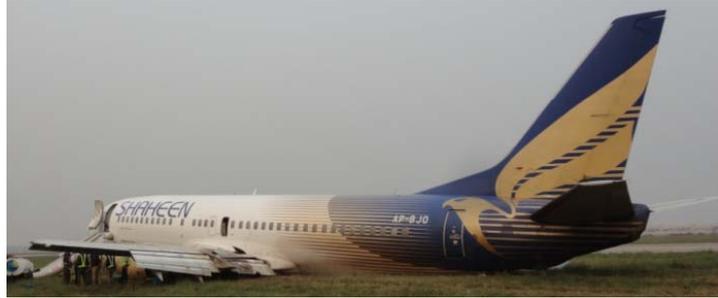
25. Aircraft final position on left side of the runway (8302 ft from RWT, 197 ft left of CL).

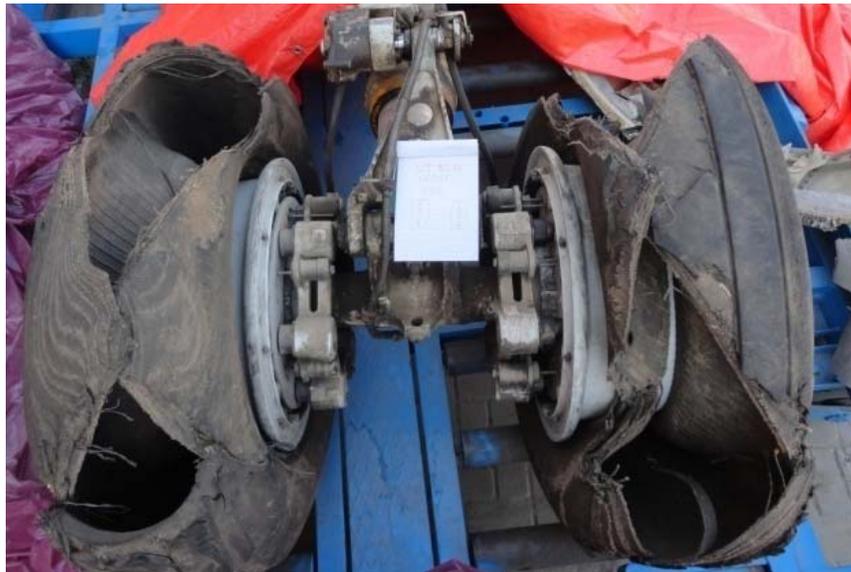
- 2.2.9 One piece of RMLG tyre (Para 1.12.3, Picture #14) was located on the path of the aircraft after it left the runway and was moving forward on unprepared surface. It appeared that tyre piece separated after it encountered a brick lining on the soft ground along the runway edge. The distance was 6996 ft from RWT and 10 ft away from runway left edge. Most probably the RMLG tyres failed due to cumulative effect of braking and encountering uneven load off the unprepared surface.

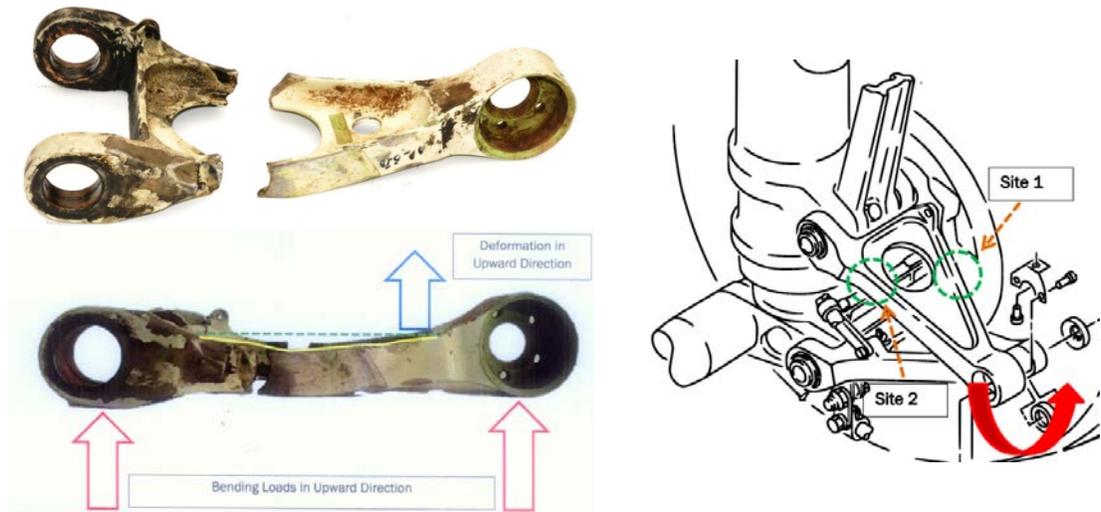
2.2.16.1 The UTL failed due to bending and torsional overload at locations marked site 1 and 2 as shown below. Both the sites exhibited identical deflection pattern, however site 2 exhibited deformations in multiple directions, indicating that bending forces on site 2 were not unidirectional. The bending overload caused the UTL to bend in upward direction as shown in picture below and site 1 breakage took place first. After breakage of site 1 the entire load transferred to site 2 resulting into its twisting, bending and breakage. The twist due to torsional load was evident on site 2.

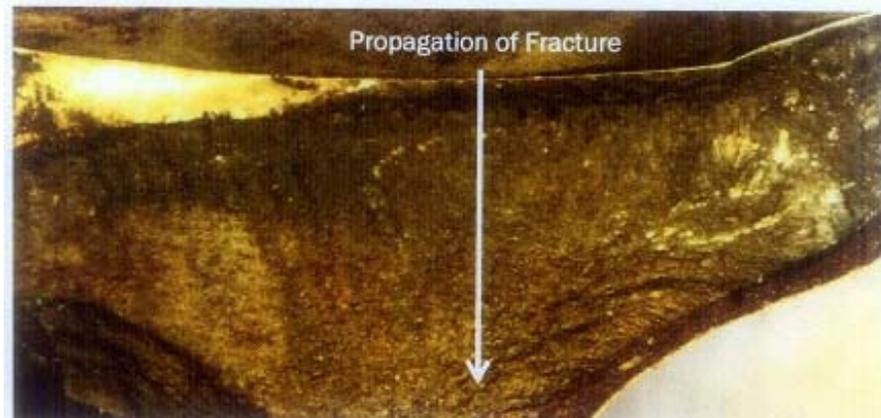
2.2.16.3 The fracture surface of site 2 contained radial marks, which were indicative of direction of propagation of fracture.

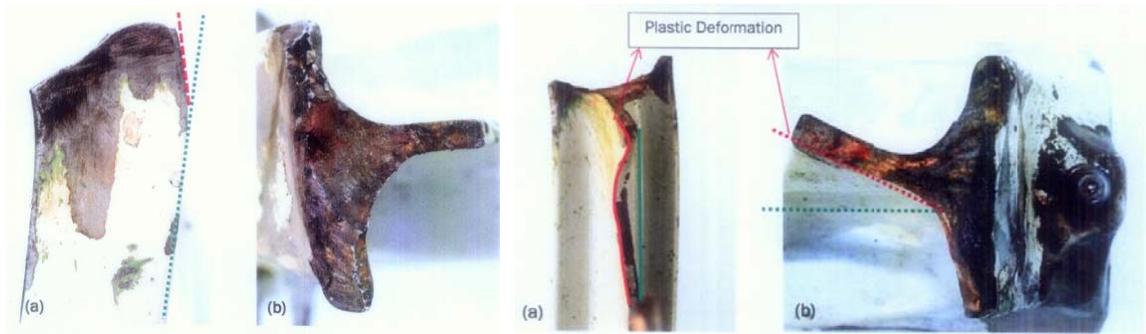
2.2.16.4 The visual examination of the UTL clearly indicated plastic deformation. The electron microscopy of fracture surface showed micro-void coalescence thus indicating a fracture due ductile overload.

Plastic deformation of site 1

Plastic deformation of site 2
(a) Bending in multiple directions (b) Twist

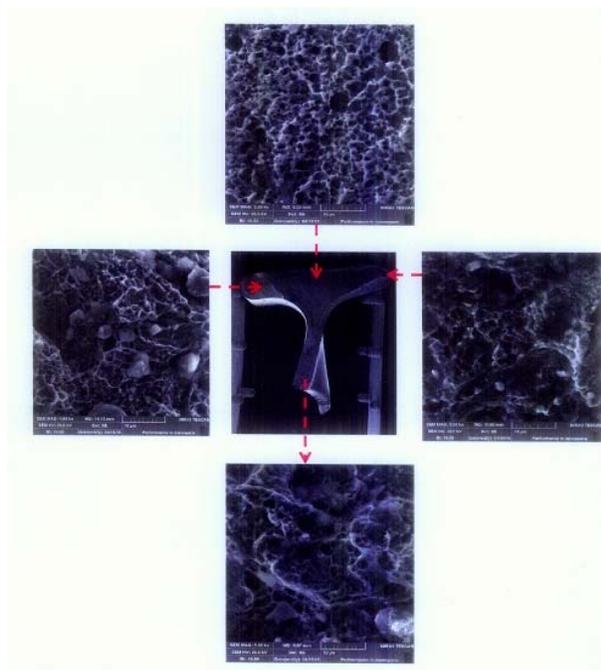
Micro-void Coalescence of UTL fracture surface

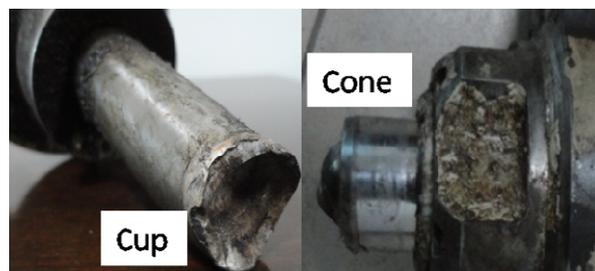
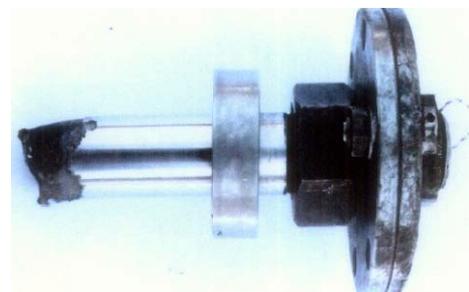
2.2.16.6 The failed Shimmy Damper Piston Rod (SDPR) exhibited plastic deformation and cup-cone fracture feature which is a typical of tensile overload failure in ductile materials.

Necking / Plastic Deformation

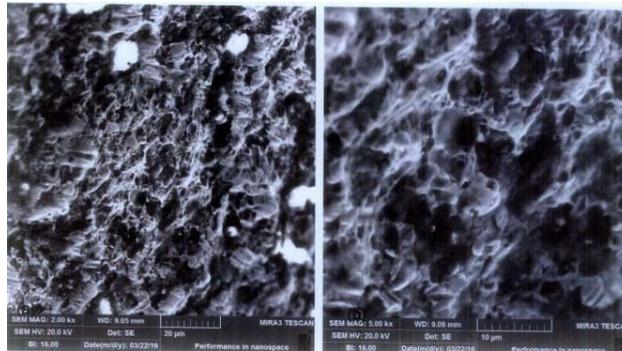
- 2.2.16.7 The electron microscopy of SDPR fracture surface showed micro-void coalescence on the thus further confirming the ductile overload failure. Secondary damage was also observed on the fracture surface.

Micro-void coalescence of SDPR fracture surface

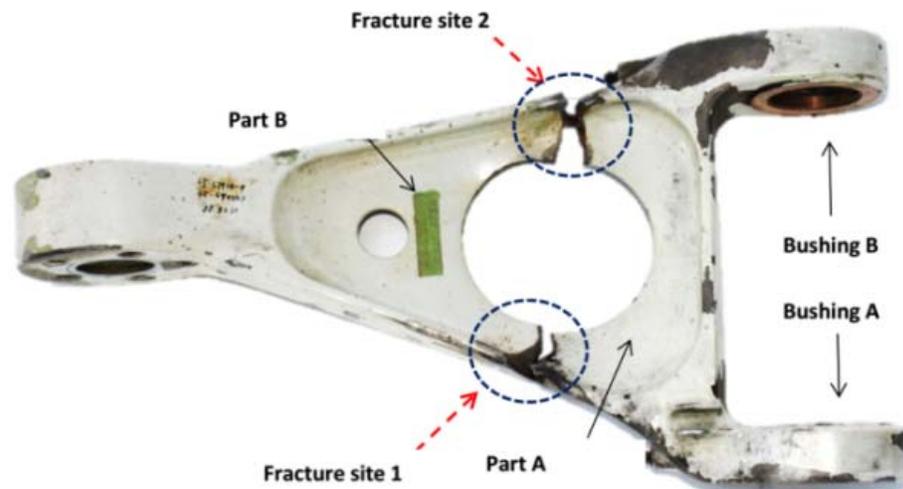
- 2.2.21 The dimensional check of the distance between the inner faces of the bushings of upper and lower torsion links of both main landing gears was carried out and found more than AMM specified wear limits (up to 6.394” as compared to maximum permitted 6.382” as per AMM 32-11-51/603).

More than specified distance between bushings A and B results in excessive play in the assembly

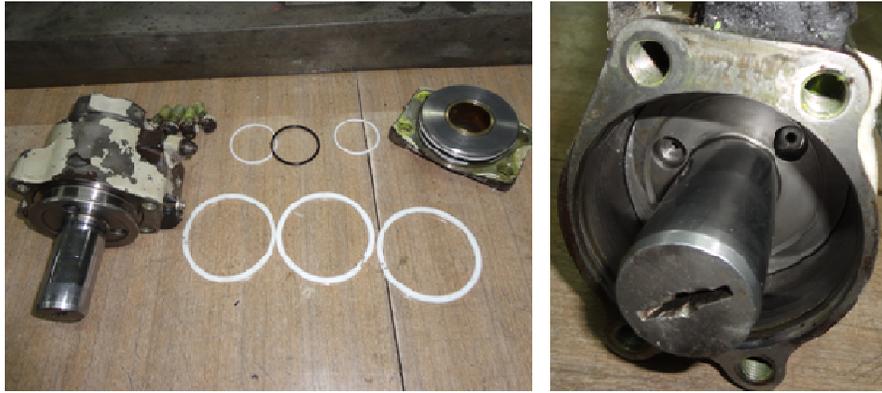
- 2.2.23 The internal hydraulic leaks/damaged of shimmy damper can also adversely affect the damping efficiency. The shimmy damper bench check was not possible because of damage to hydraulic ports and piston rod. The tear down examination was carried out and internal seals and piston was verified to be intact.

Shimmy damper internal seals and parts were found intact
