**KOMITE NASIONAL KESELAMATAN TRANSPORTASI  
REPUBLIC OF INDONESIA**

**Aircraft Serious Incident Investigation Report**

**PT. Batik Air Indonesia**

**Boeing 737-900 ER; PK-LBO**

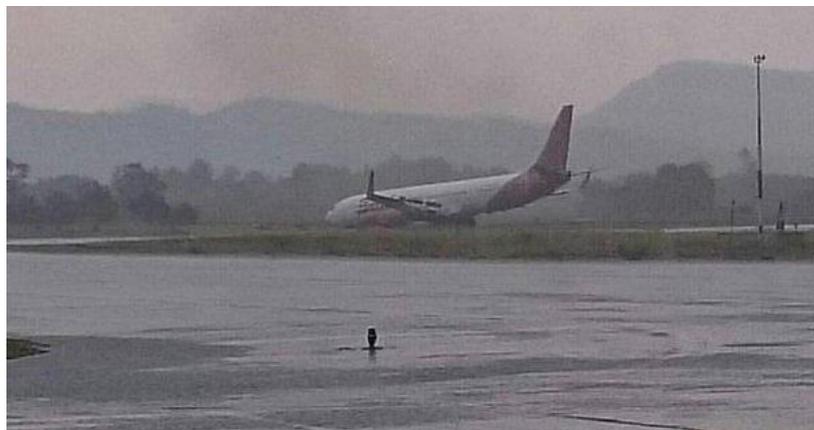
**Figure 2: The aircraft condition just after stopped**

After the aircraft stopped, the SIC requested the Adi Tower whether there was fire seen from the tower and replied that there was no sign of fire around the aircraft. The PIC then commanded to perform slow evacuation using the escape slides.

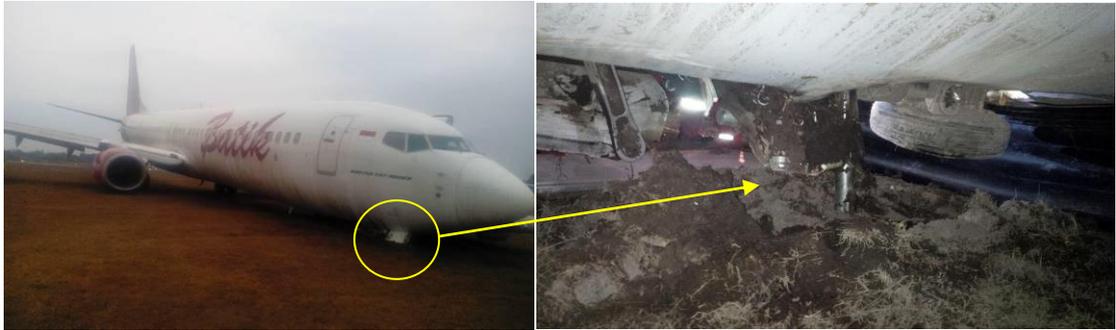
**Figure 3: The aircraft after the impact with the nose wheel folded backward**

The aircraft damaged on its belly. The observation found that the lock pin of the nose gear that provides structural support for the nose gear broken into three pieces and caused the nose wheel folded backward then damaged the forward belly.

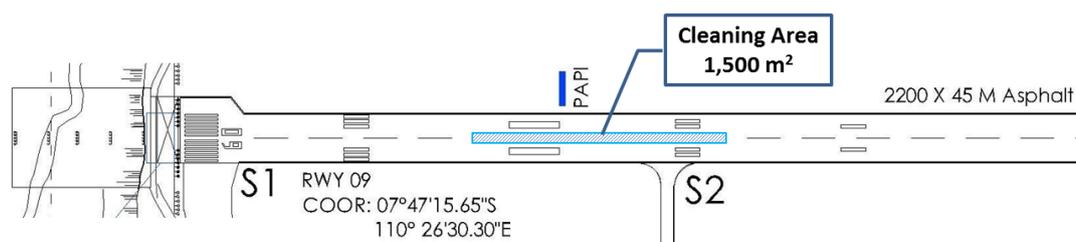
**Figure 6: The last rubber deposit cleaning location**

The last rubber deposit cleaning was performed on 29 October 2015 by using chemical liquid (Magnus 758) on touchdown runway 09 area of 1,500 m<sup>2</sup> (figure 6).

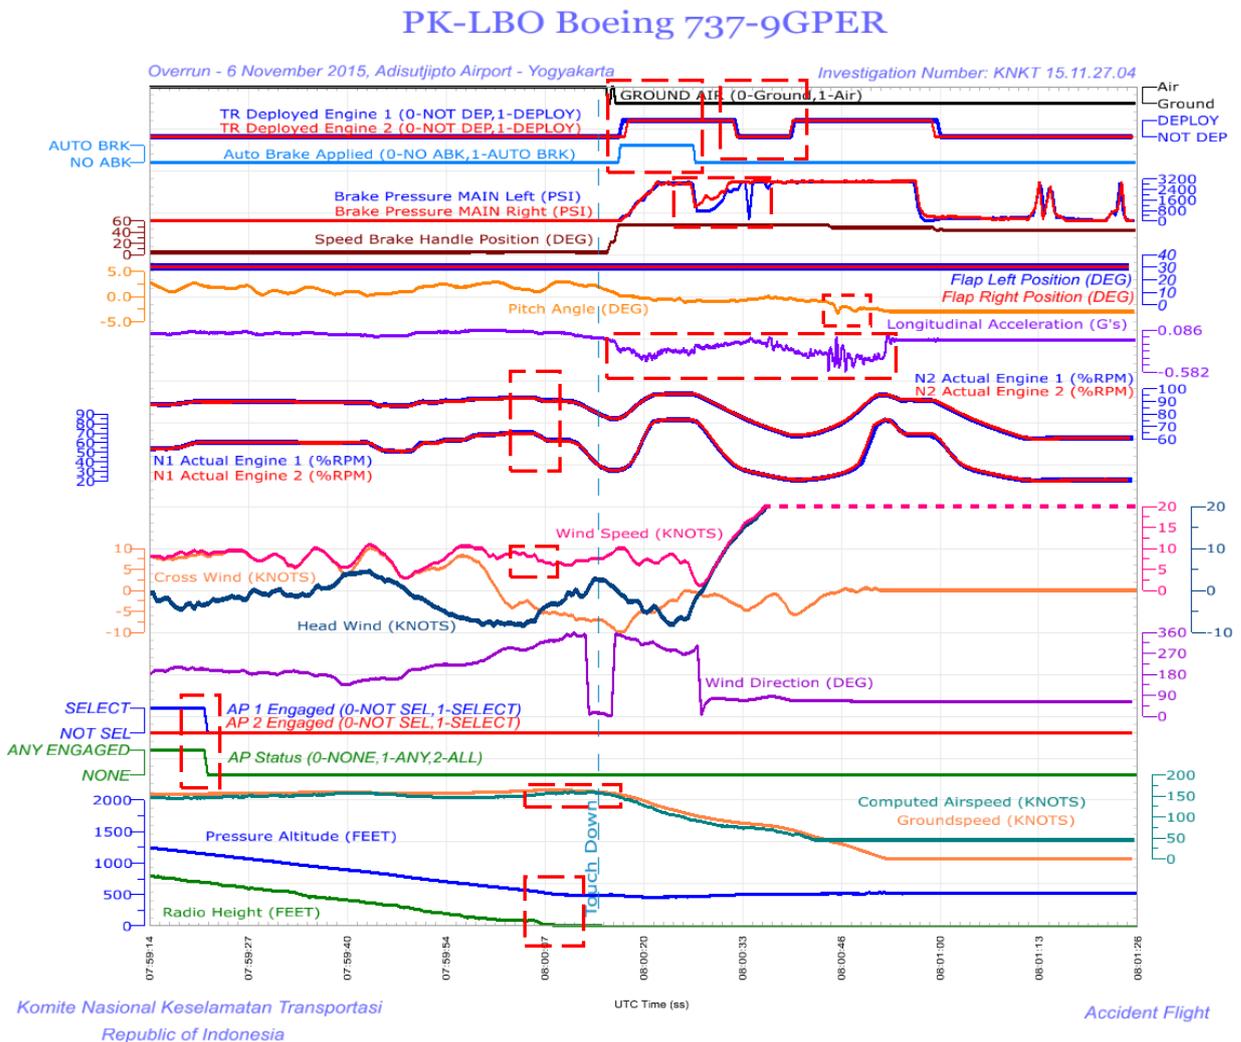
**Figure 9: The significant FDR parameters**

The red boxes on figure 9 showed significant event that will be described on chapter 1.11.3 (Recorders Significant Events).

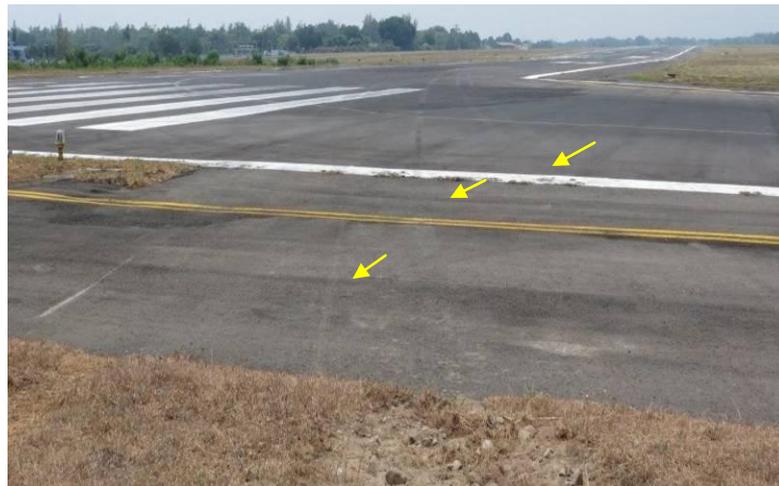
**Figure 11: The main and nose wheel marks (indicated by arrows)**

After the aircraft leaving the pavement, there were no sign of nose wheel mark on the gravel instead of an indentation the gravel with the dimension approximately 50 cm in width and 150 cm in length. Subsequently, after the indentation, there was a long single scratch mark on the gravel until the aircraft final position.

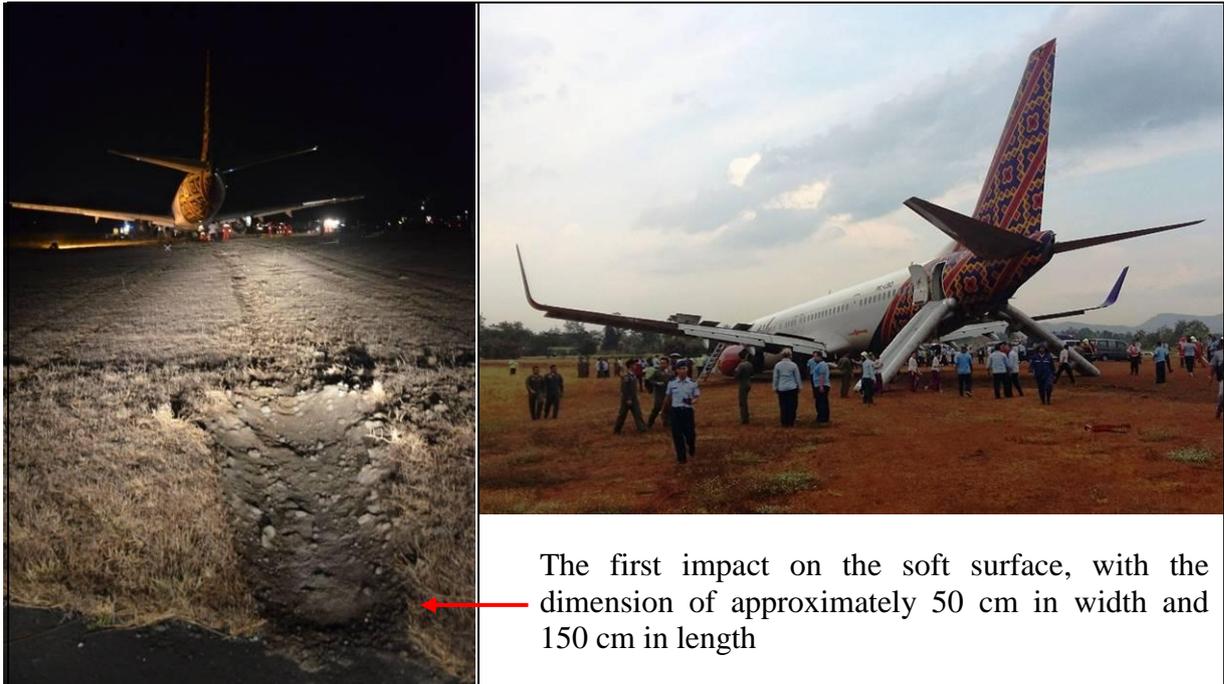
**Figure 12: Nose wheel mark on the grass (left) and the Aircraft last position after passenger evacuated (right)**

The aircraft stopped at about 80 meters on the left of runway 09 centerline extension and about 84 meters from end of runway 09 with the nose landing gear collapsed.

The first impact on the soft surface, with the dimension of approximately 50 cm in width and 150 cm in length
