- Investigation Summary Report -

AAIS Case N°: AIFN/0012/2015

Aircraft Struck by Ground Vehicle

Operator:	Etihad Airways
Make and Model:	Airbus A320 - 232
Nationality and Registration:	The United Arab Emirates, A6-EIY
Place of Occurrence:	Abu Dhabi International Airport
State of Occurrence:	The United Arab Emirates
Date of Occurrence:	25 November 2015

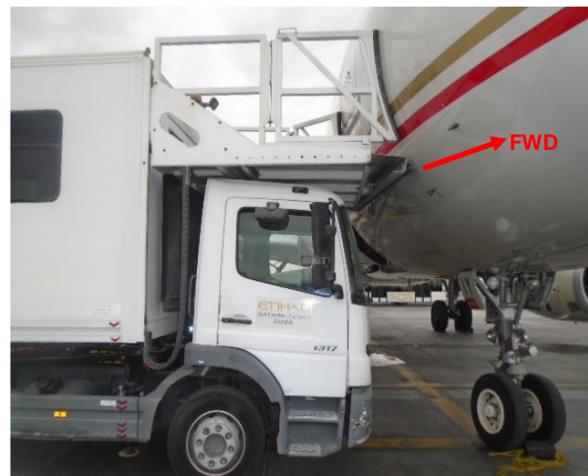
During passenger disembarkation, a Medical Hi Loader (MHL) was being positioned to the Aircraft R1 door to disembark a sick passenger. The MHL struck the Aircraft in the area of the R1 door causing significant damage to the fuselage (figures 1 to 4).

The MHL Operator stopped the MHL approximately 1.5 meters from the Aircraft. The MHL Operator continued the slow movement towards the Aircraft. As the MHL came close to the Aircraft, the Operator mistakenly depressed the accelerator pedal instead of the brake pedal. This resulted in a sudden acceleration causing the MHL to impact the Aircraft. The aircraft sustained damage (figures 1 to 4).

Figure 1. MHL collided with the Aircraft at R1 door

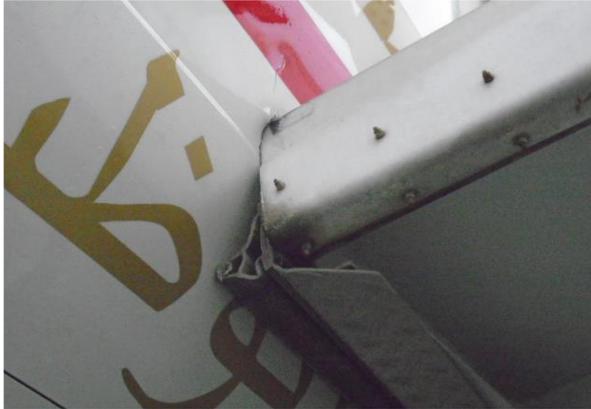
Figure 2. MHL left hand side

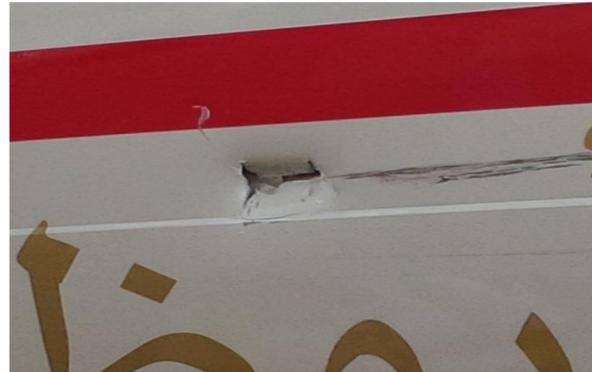
The damage to the Aircraft is shown in figures 1 to 4. The MHL collided with the aircraft resulting in one significant skin puncture (figure 3), as well as several dents below the R1 door (figure 4).

Figure 3. Damage to fuselage – skin puncture

The Aircraft was towed to the hangar for repair as the damage was beyond the *Structure Repair Manual (SRM)* limits. The MHL was withdrawn from service.

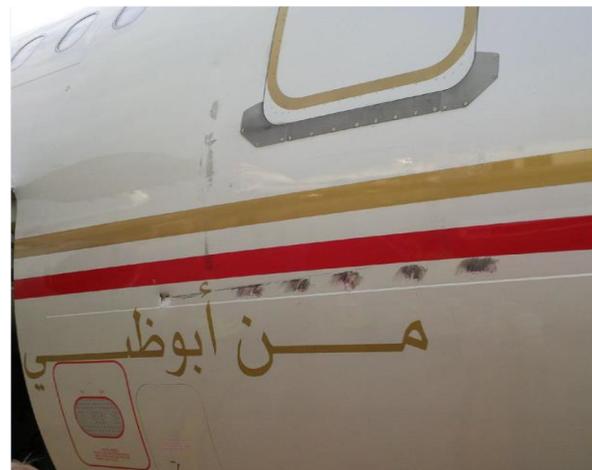
Figure 4. Damage to fuselage – dents

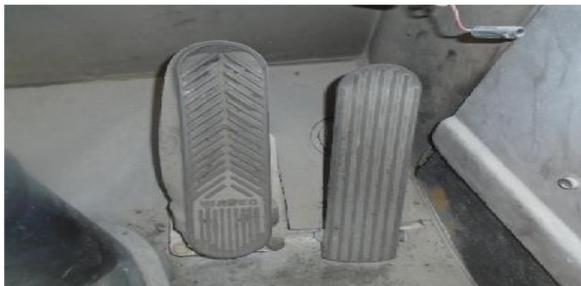
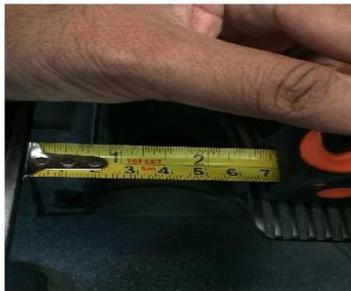
The MHL operator had limited experience in positioning the MHL to the aircraft in comparison with his experience in driving passenger buses. Comparing the two equipment, the distance between the brake and accelerator pedals of the Cobus 3000 buses was much less than the MHL 17-07 (figures 5 and 6). This difference between the bus and the MHL contributed to the MHL operator depressing the accelerator pedal instead of the brake pedal.

New Cobus 3000 Pedals.

Figure 5. Distance between the brake pedal and accelerator on the Cobus bus

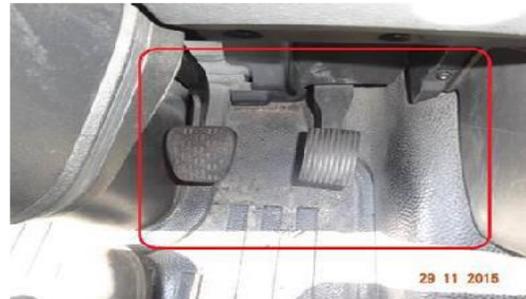
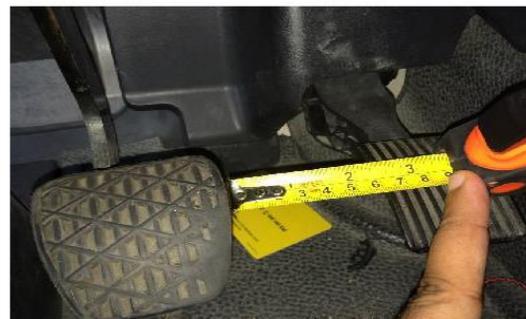
Figure 6. Distance between the brake pedal and accelerator on the MHL
