ACCIDENT

Aircraft Type and Registration:	Cessna Citation 560XL, SE-RHJ
No & Type of Engines:	2 Pratt & Whitney PW545A turbofan engines
Year of Manufacture:	2000
Date & Time (UTC):	29 November 2015 at 1350 hrs
Location:	On descent into Farnborough Airport, Hampshire
Type of Flight:	Commercial Air Transport (Passenger)
Persons on Board:	Crew - 2 Passengers - 9
Injuries:	Crew - None Passengers - None
Nature of Damage:	Right engine upper cowling detached in flight, impact damage to horizontal and vertical stabilisers
Commander's Licence:	Airline Transport Pilot's Licence
Commander's Age:	41 years
Commander's Flying Experience:	3,700 hours (of which 2,200 were on type) Last 90 days - 4 hours Last 28 days - 4 hours
Information Source:	AAIB Field Investigation

Synopsis

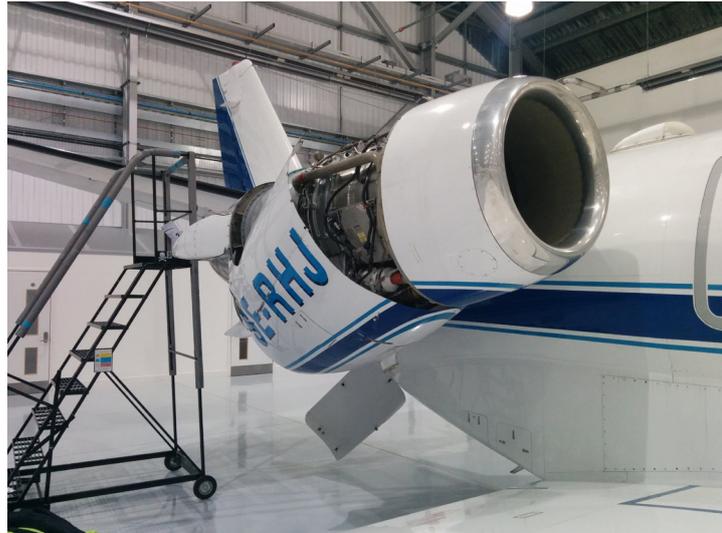
Figure 1

The aircraft was recovered to a local maintenance organisation where the majority of the right engine upper cowling was observed to be missing, Figure 1. Damage on the leading edges of the vertical and horizontal stabilisers was consistent with them being struck by debris.

Right engine cowlings following recovery of the aircraft to the hangar

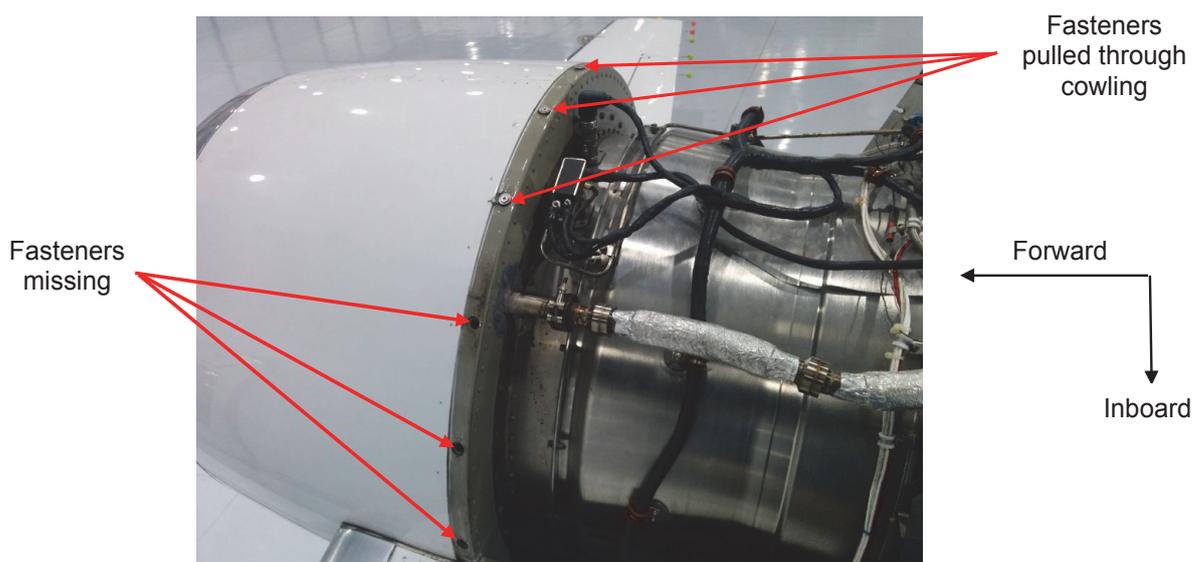
Figure 2

The remnants of the upper cowling that remained with the aircraft had been pulled from the fasteners, which, with the exception of four, remained securely locked, Figure 2. Three fasteners were missing from the inboard leading edge and one was missing from the inboard trailing edge. The empty locking receptacles were confirmed to be serviceable using a representative fastener and the surrounding structure showed no evidence of damage.

Upper cowling inboard leading edge attachment fasteners

It is unlikely that the fasteners were the wrong size or had failed in flight and investigation concluded that the cowling probably detached because a number of fasteners had not been securely fastened during maintenance.

The maintenance organisation has changed their inspection procedures to ensure that, following installation, the security of engine cowlings is checked by an independent mechanic.
