FINAL INVESTIGATION REPORT ON
ACCIDENT TO SPICEJET LTD.
BOMBARDIER Q-400 AIRCRAFT VT-SUC
AT JABALPUR ON 04.12.2015

**INVESTIGATION REPORT ON ACCIDENT TO M/S SPICE JET
BOMBARDIER Q400 AIRCRAFT VT-SUC AT JABALPUR ON
04.12.2015.**

| 12. Type of accident | Wildlife Strike during landing roll |

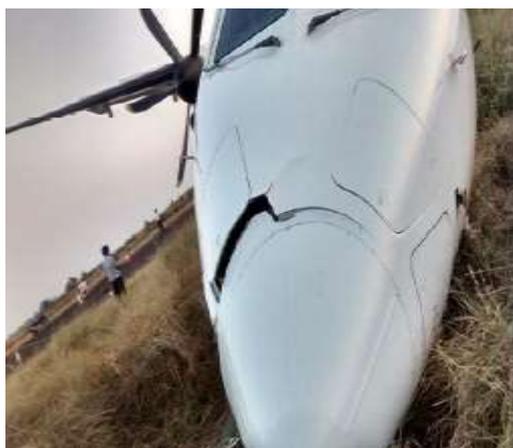
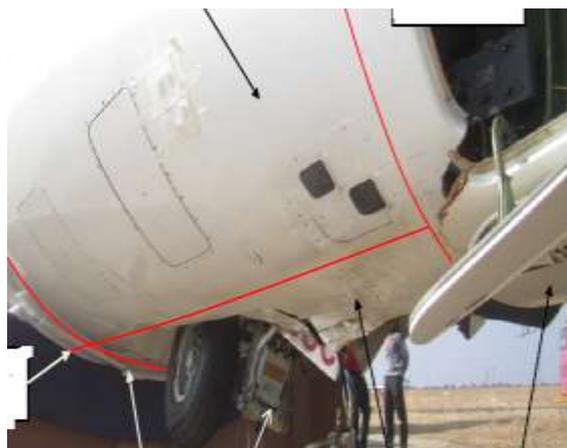
- Nose landing gear found collapsed.

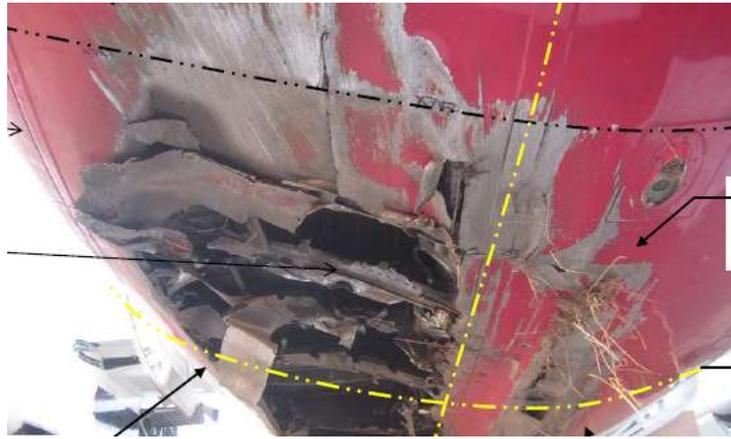
- Forward unpresurized compartment severely punctured and portion sheared off.

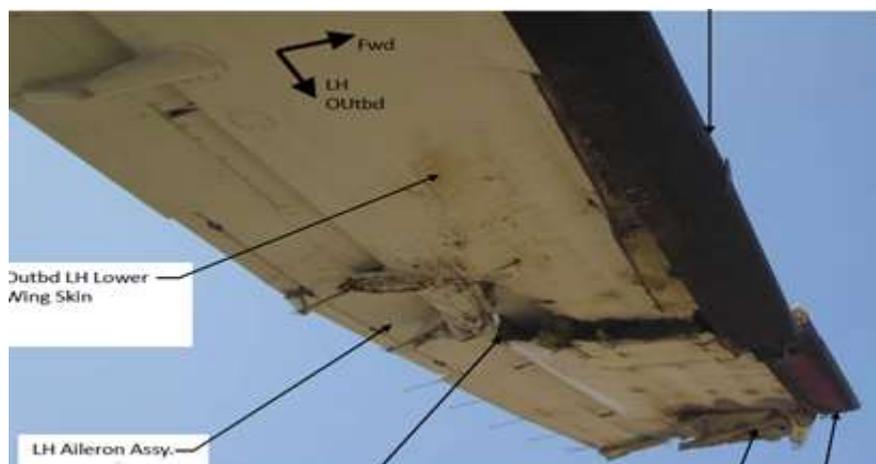
- Left wing tip found sheared.

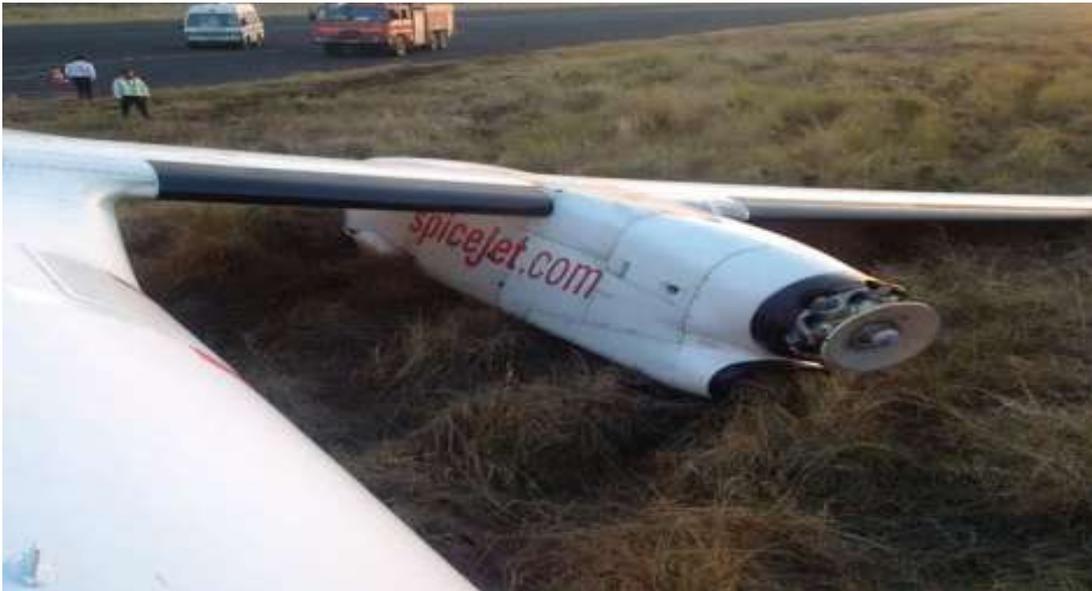
- Left aileron found bent and cracked including tab.
- Left side wing from extreme outboard upper access panel found bent.
- Left extreme outboard leading edge found cracked.
- Front wing spar (left wing) found cracked and bent.
- Left engine all six propeller blades found sheared off completely till the root and left main landing gear was collapsed into the engine nacelle. The lower portion of the nacelle found sheared off.

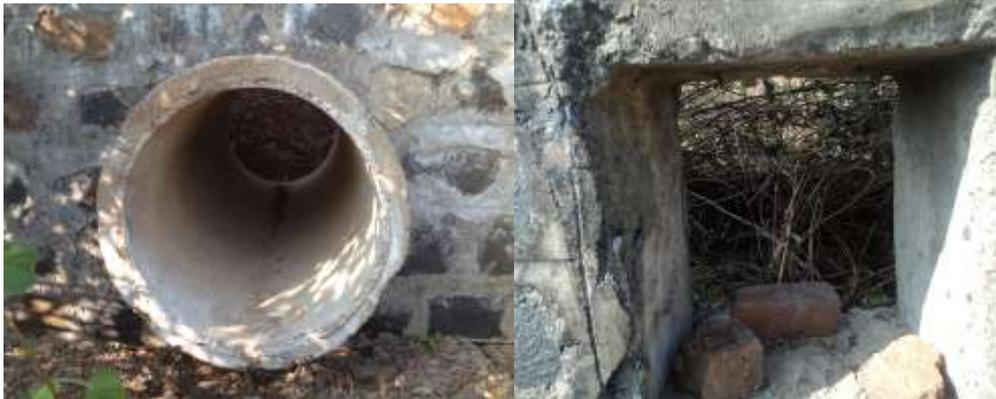
1. There were around 20 breaches found in the perimeter wall of the aerodrome which includes several 18 inch (diameter) open circular drainage pipes and 18"x 18" square opening in the perimeter wall. There were several openings at the bottom of the perimeter walls of 15x20 inch. They were adequate for the wild life animals to enter the aerodrome premises at any time of the day.

- r) There was no post-accident fire.
- s) The cockpit crew did not wear headsets during the flight.
- t) During, aerodrome inspection there were several breaches of 18 inch (diameter) open circular drainage pipes and 18"x 18" square opening in the perimeter wall.

- u) There were several openings of 15x20 inch at the bottom of the perimeter walls.
- v) Further the height of the perimeter wall was found to be as low as 5 feet at certain places.

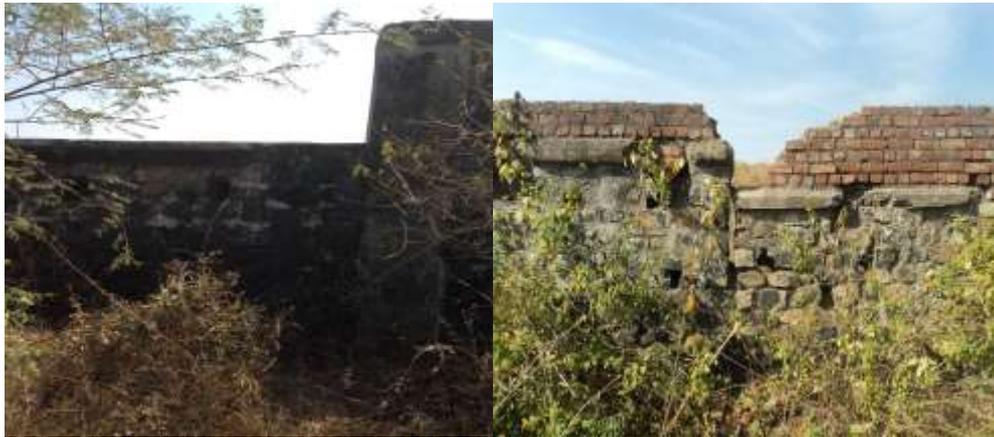
2. At certain places the height of the perimeter wall was found to be 5 feet 6 inches.

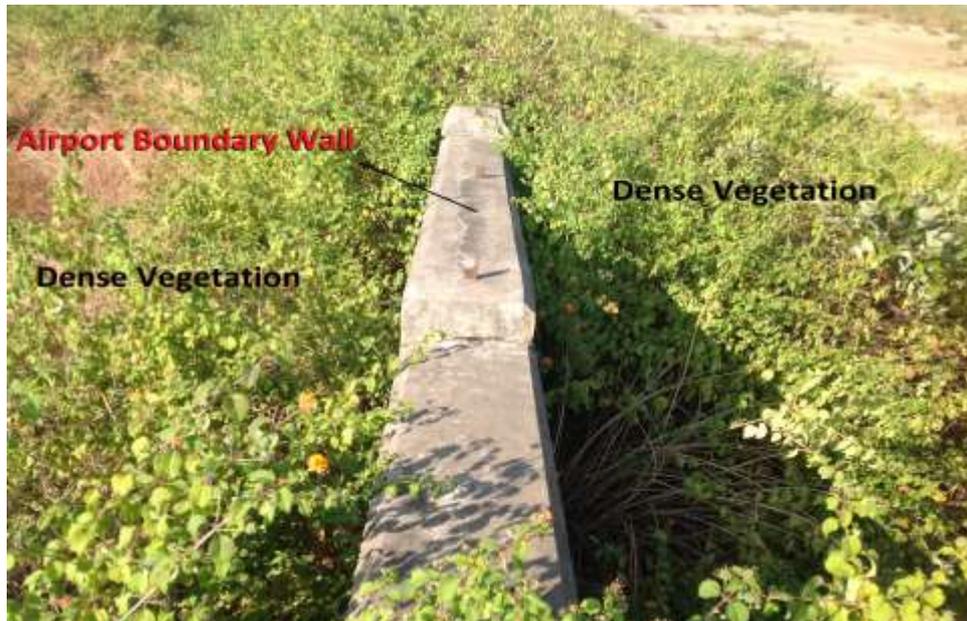
3. In some places the boundary wall was found to be broken from top.
4. The overhung fence is missing at most of the places.
5. The perimeter road was not available.
6. There are no perimeter lights available.

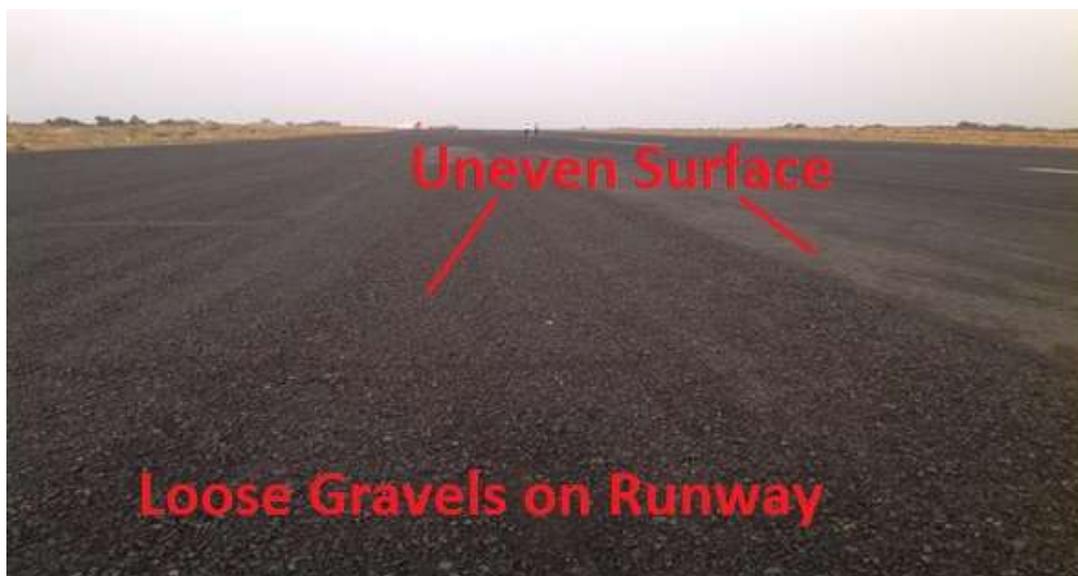
1. The runway surface condition was very poor with visible patches and uneven pavement. Loose gravel/ Foreign objects on the runway and taxiway.

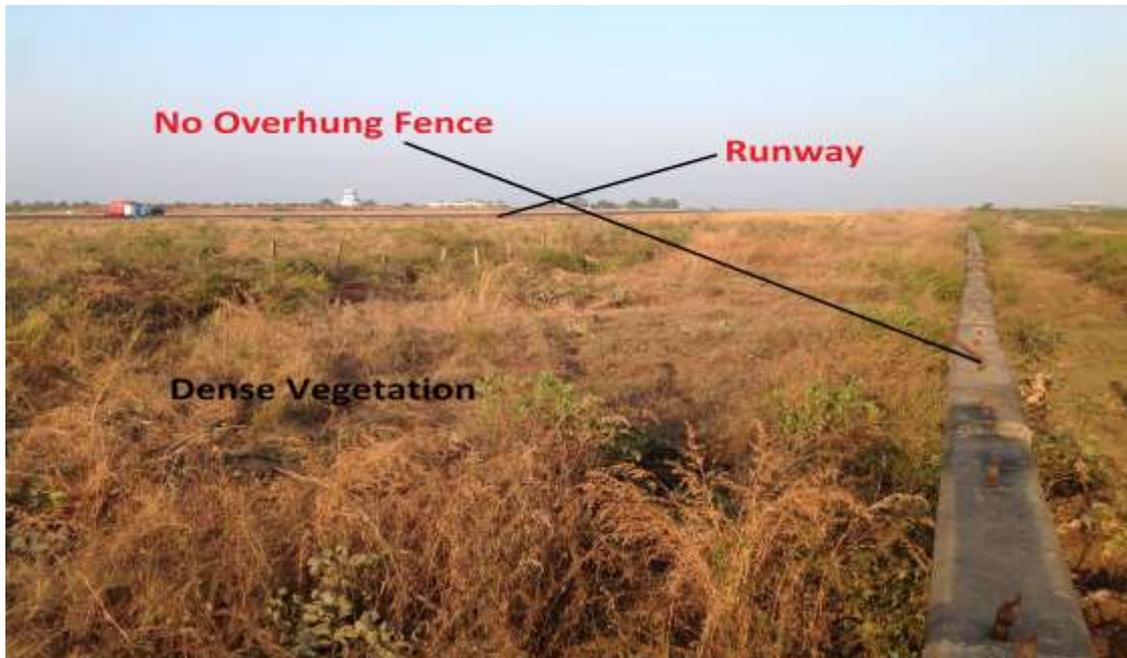
1. Dense vegetation/shrubs/tall grass were observed between the runway and the perimeter wall.

No perimeter road available on either side of the airport boundary wall

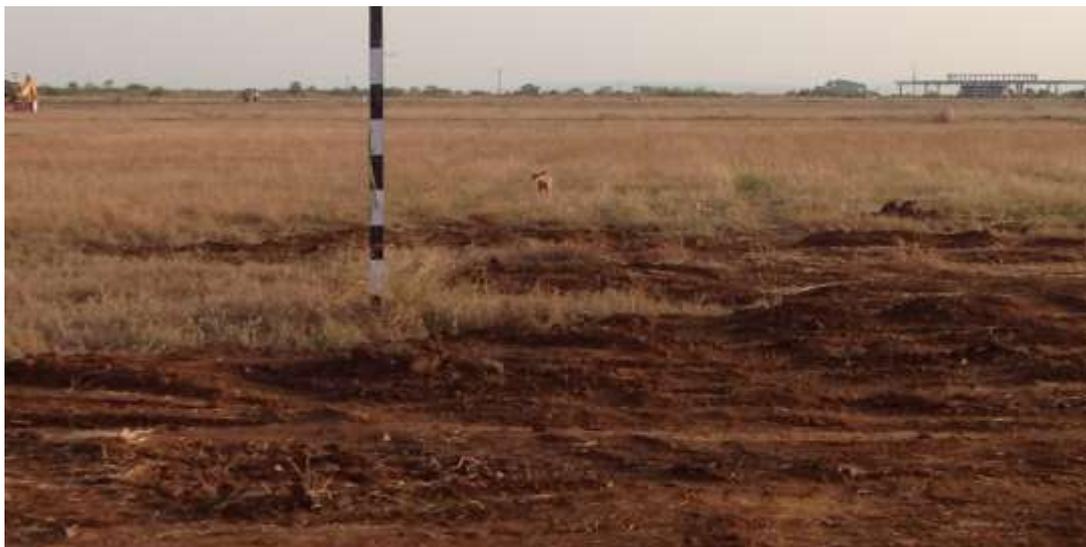
2. Dense vegetation/shrubs/tall grass was also observed outside the perimeter wall and of approximately 12 feet high at certain places.

While carrying out onsite investigation jackals and dogs were found moving around the operational area.

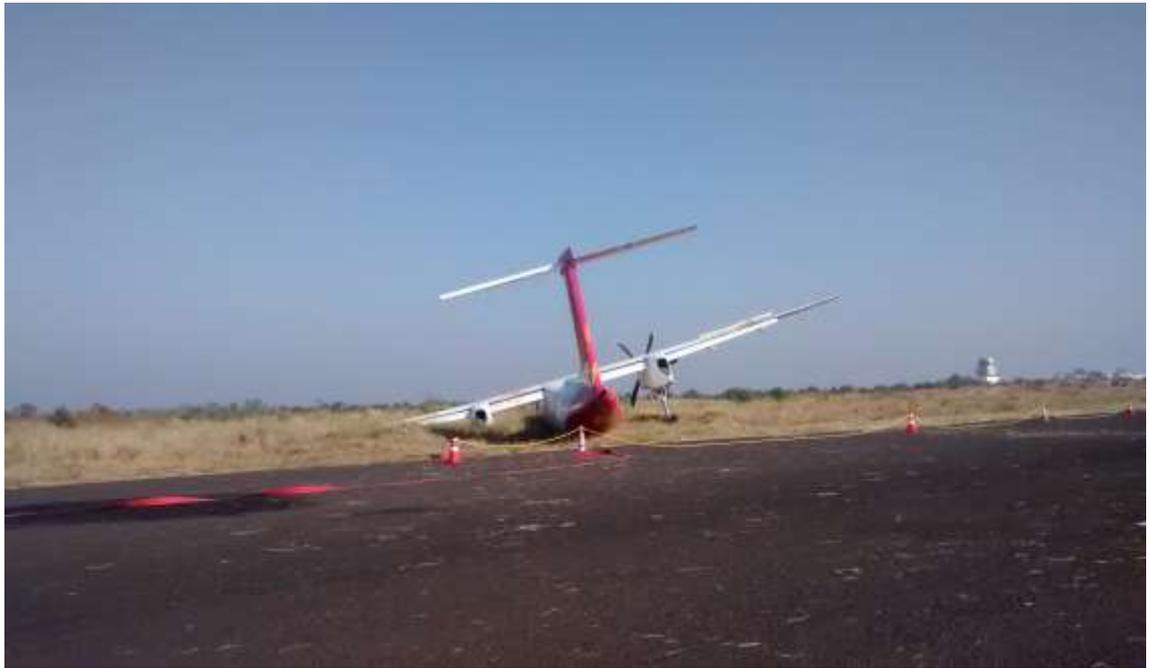
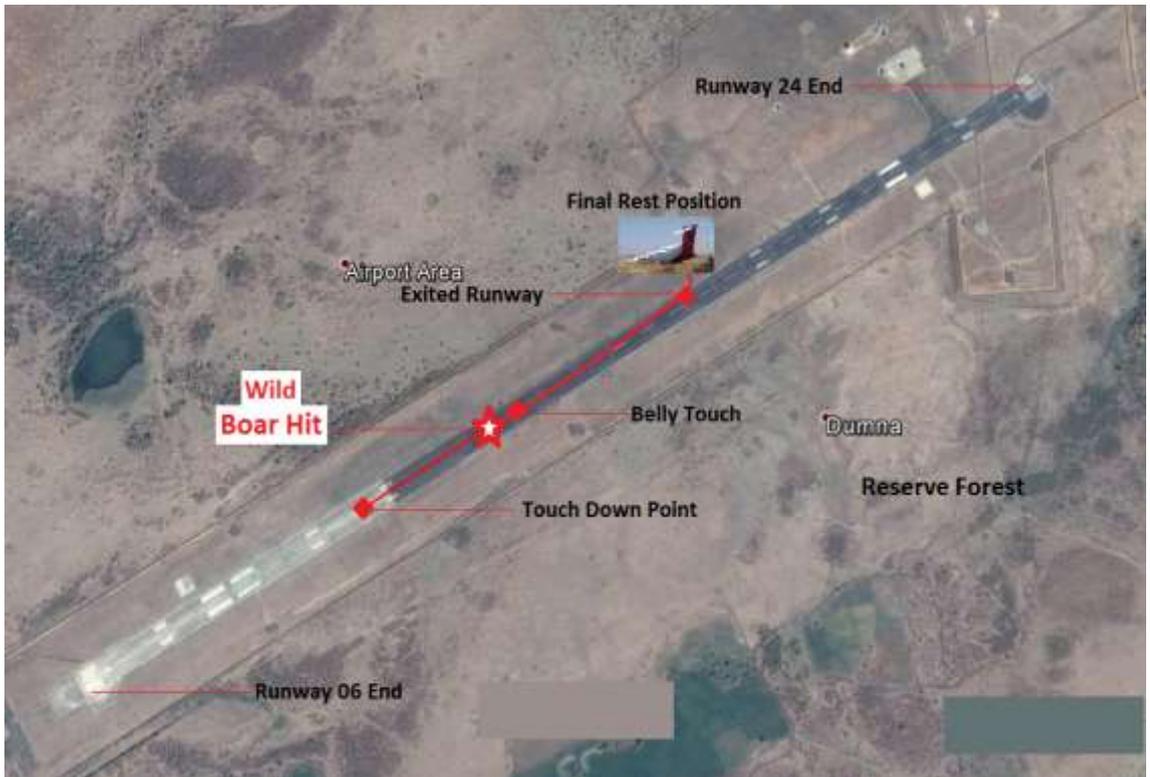
During examination of the wreckage at the accident site, it was observed that the aircraft had sustained substantial damage after the accident. The aircraft exited the runway on the left and was resting on the soft ground in a banked condition on its belly and left wing tip.

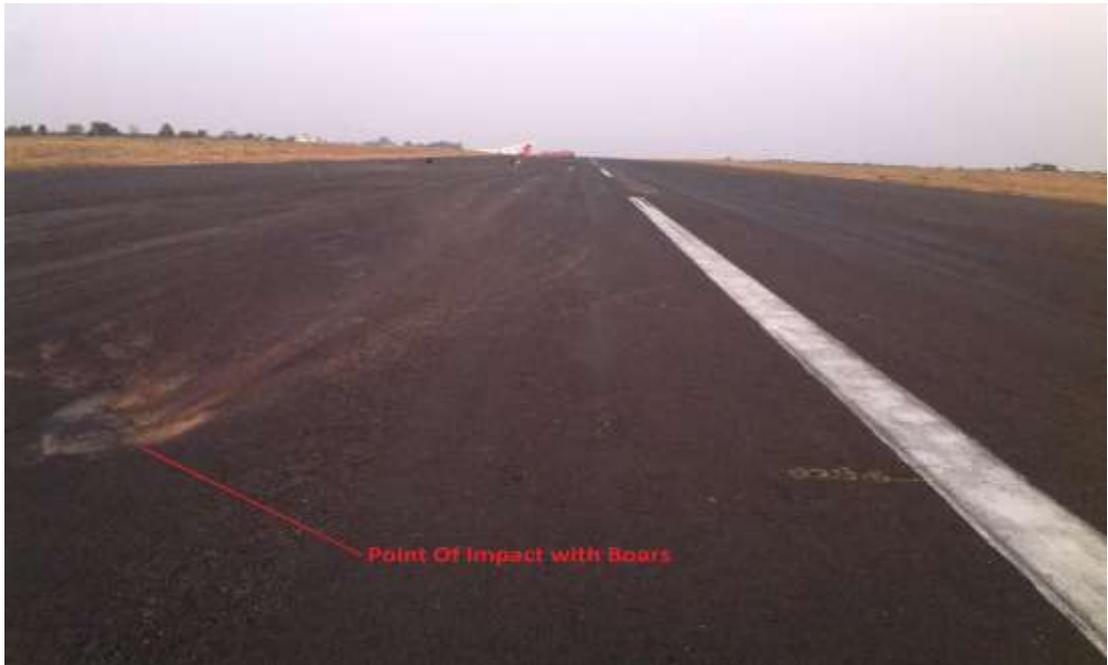
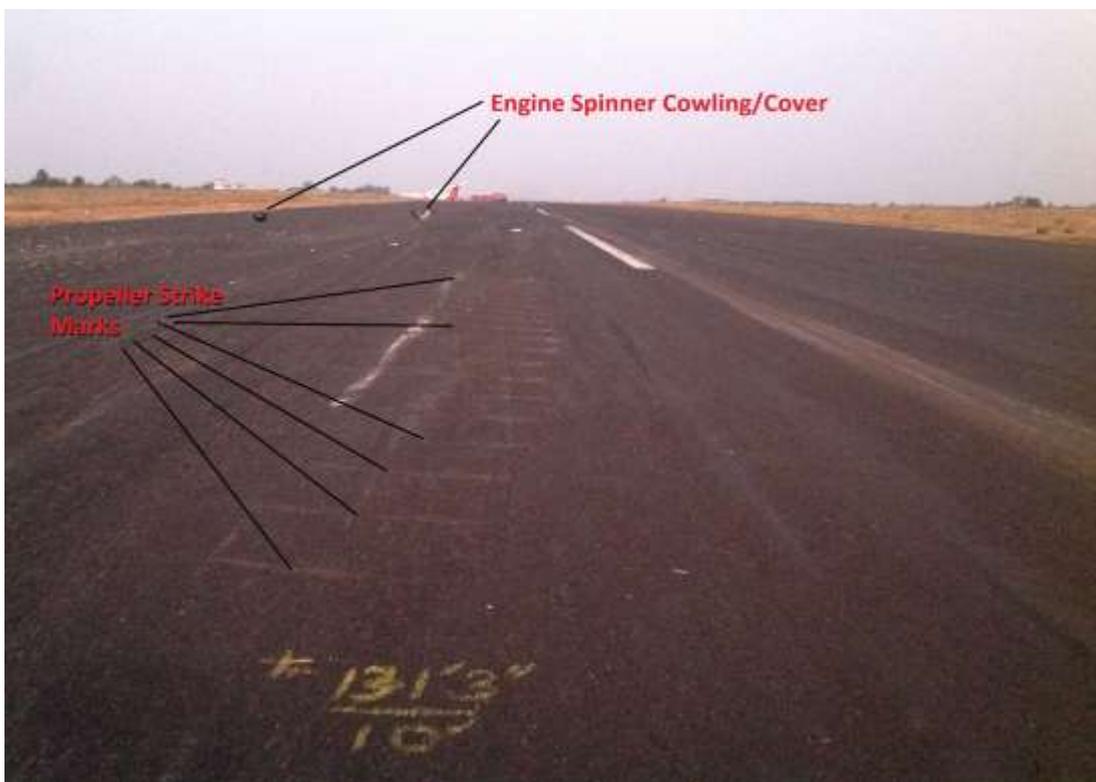
As per the evidences collected at the accident site, the aircraft made touch down at a distance of 595 meters from the runway 06 end. After about 254 meters of landing roll the left main landing gear of the aircraft hit the wild boars on runway. Due impact with the boars the left main landing gear collapsed. Continuous marks of propeller blade strike were observed on the

runway surface at about 300 meters from touch down point. The damaged left main landing gear tyre was found on the runway.

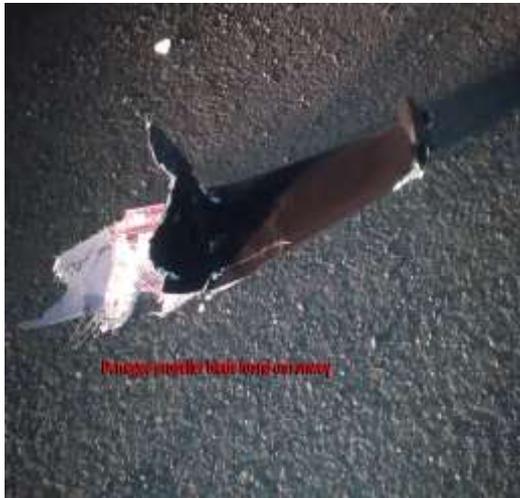
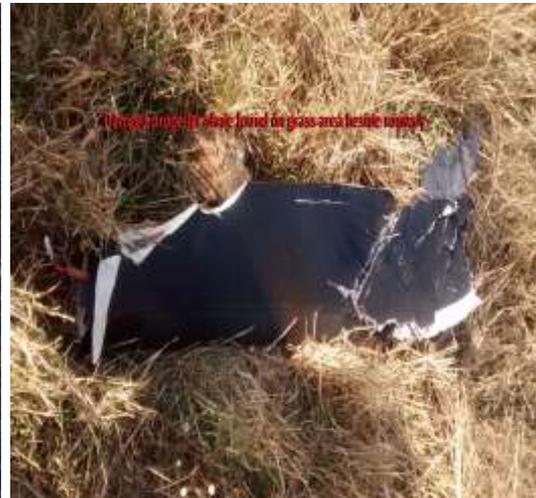
Damaged Propeller on the runway and shoulder area

Subsequently the aircraft belly came in contact with the runway surface and belly scraping marks were observed on runway for about 168 meters. All the five propeller blades were sheared off from the root attachment. The damaged propeller blades were found on runway and on the basic strip.

- j) After the left landing gear collapsed the left propeller blades hit the runway surface and sheared off from the root attachment.
- k) The nose wheel tyre failed under over load conditions and the nose landing gear collapsed and the aircraft belly came in contact with the runway surface.
