Report IN-033/2015

Incident involving an Airbus A-330-300, registration EC-LZX, operated by Iberia, and a Boeing B-777-200, registration N758AN, operated by American Airlines, at the Adolfo Suárez Madrid-Barajas Airport (Spain) on 6 December 2015

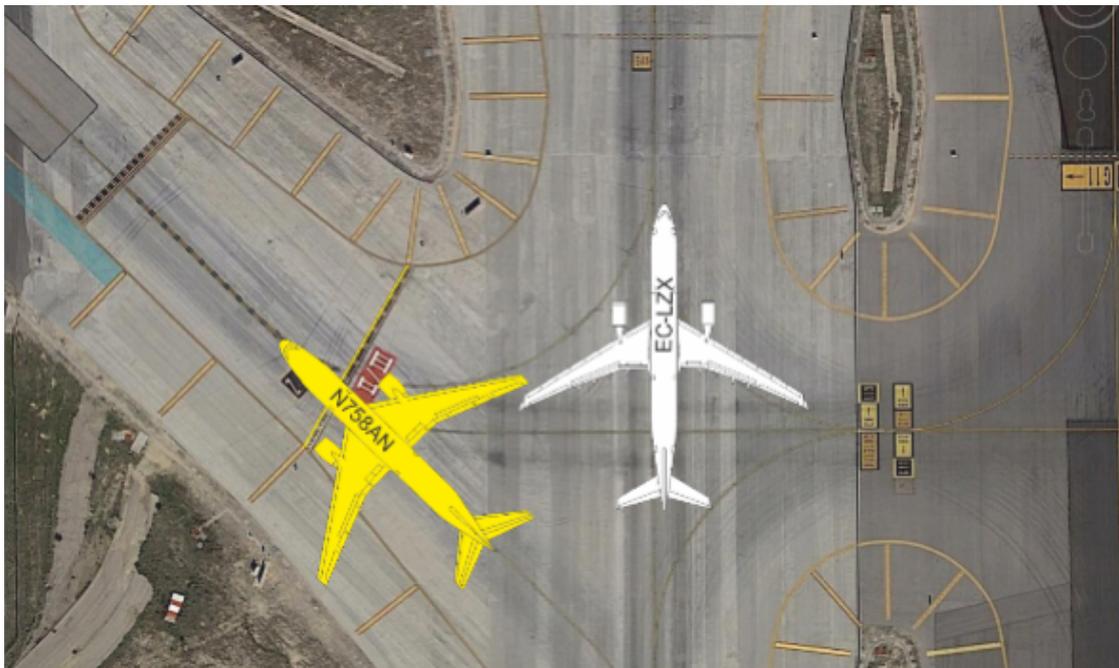
The Airbus A-330-300, registration EC-LZX, operated by Iberia, had landed on runway 32L inbound from the Miami Airport (United States) on flight IBE6118. Its crew had been instructed to taxi on standard route B to gate 12. As it reached the intersection of taxiways B2, B3 and Z1, the left wing on the A-330 struck the right elevator on the B-777, registration N758AN, which was stopped at Z1, causing a crack on its lower surface. The A-330 continued taxiing and moments later a second impact took place, as the left winglet on the A-330 struck the trailing edge of the right wing on the B-777. The winglet penetrated about halfway into the wing until it broke off, with the detached winglet component becoming embedded in the wing of the B-777.

Figure 1. Diagram of the aircraft positions at the time of the impact

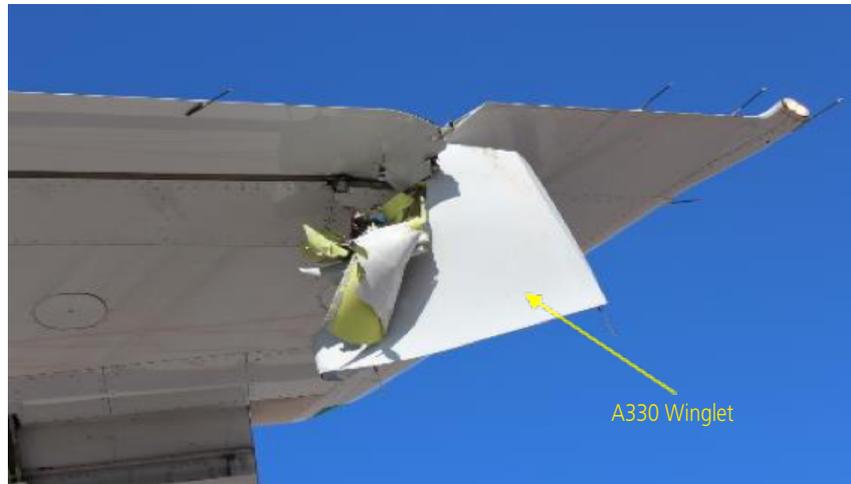
The A330 continued taxiing to its assigned stand. The crew of the B-777 requested assistance from the airport's firefighting service to evaluate the damage to the aircraft. It was concluded that it was safe for the aircraft to move under its own

Figure 2. Right wingtip of the B777 with part of the embedded A330 winglet

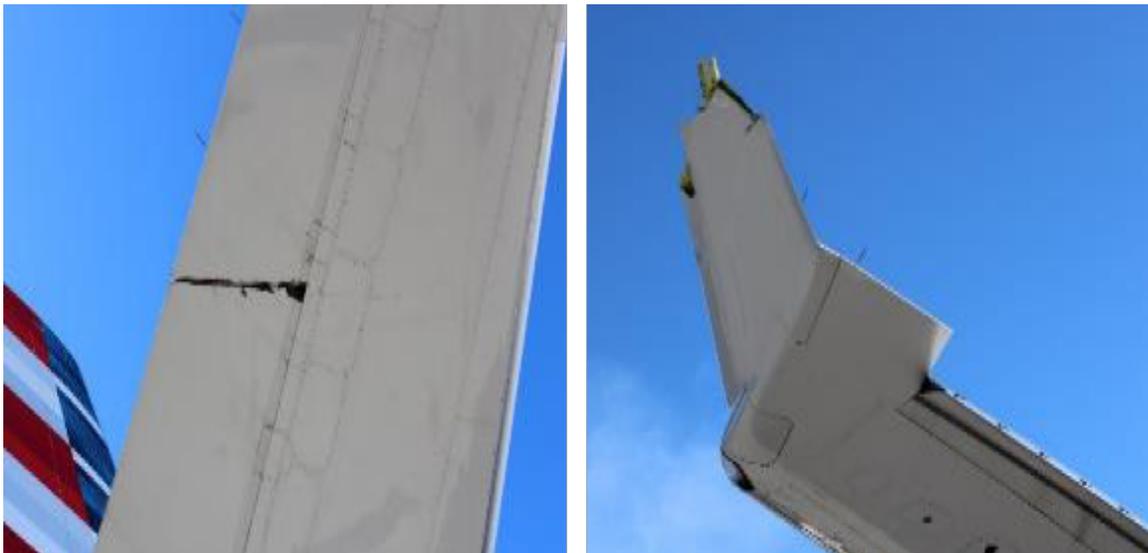
The aircraft's left winglet was broken by the impact against the right elevator and wing of aircraft N758AN.

When the winglet was removed from the left wing, it was noted that the wing's support structure had sustained minor damage which required repairs.

Figure 3. Photograph of the cut in the right elevator of aircraft N758AN (left) and of the left wingtip of aircraft EC-LZX (right)

The B777 aircraft, registration N758AN, sustained minor damage to its horizontal stabilizer and right elevator, as well as to its right wing.

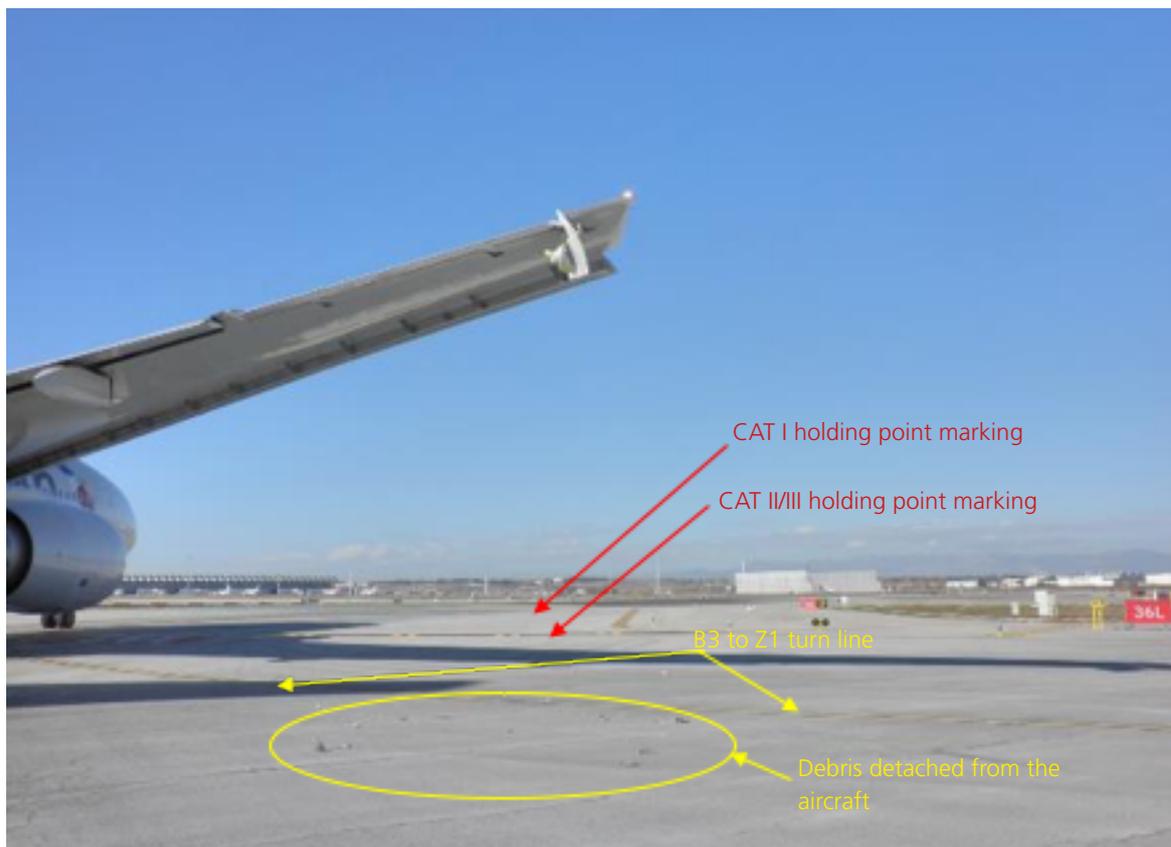
Figure 14. Photograph of aircraft N758AN on taxiway Z1, taken before it was moved and after being impacted by aircraft EC-LZX

Figure 14 shows a photograph of aircraft N758AN, taken at the site where the impact occurred before it was moved after the incident.

The fragments that detached during the event were found on the pavement in the vicinity of where the B3 to Z1 turn line and the line indicating the right edge of taxiway Z1 intersect.

As noted in point 1.12, the photograph of the aircraft taken before it moved reveals that its nosewheel was a few meters beyond the category II/III holding point marking. The fragments that detached during the event were found on the pavement in the vicinity of the place where the B3 to Z1 turn line and the extended right edge line for taxiway Z1 would intersect.

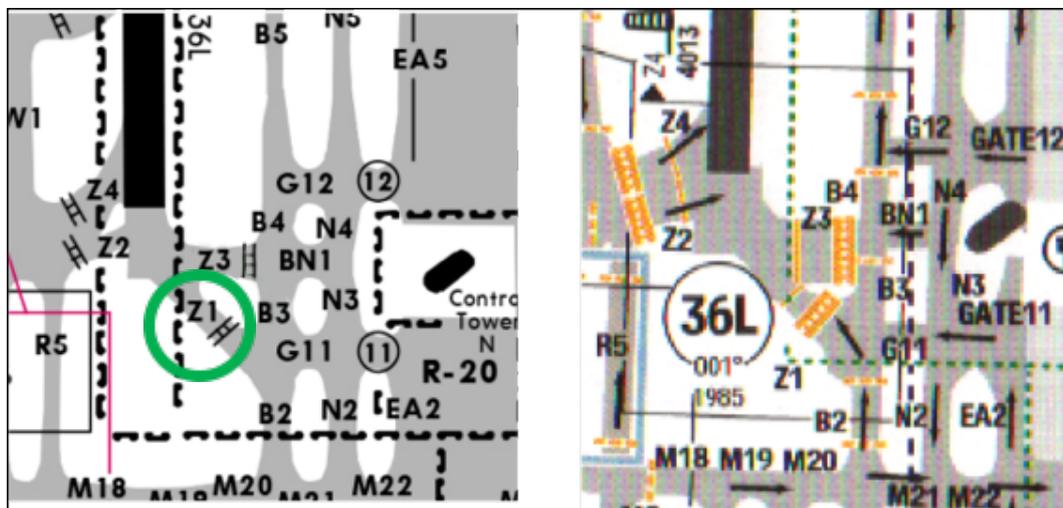
The documentation available to the crew of the incident aircraft was inspected. It was noted that on pages, 10-9C, "taxi routings", and 10-9E, the Z1 holding point is shown with a single holding point marking, as the crew of the American Airlines aircraft had stated (see 1.16.1.2).

Figure 16. Portion of page 10-9C of the Jeppesen documentation (left) and of the AGC North chart from the LIDO documentation LIDO (right)

REC. 15/16. It is recommended that Jeppesen review the information published in the AIP-Spain that is not included in its documentation, and that it incorporate which could be operationally important, such as the note in the airport chart indicated in this report.

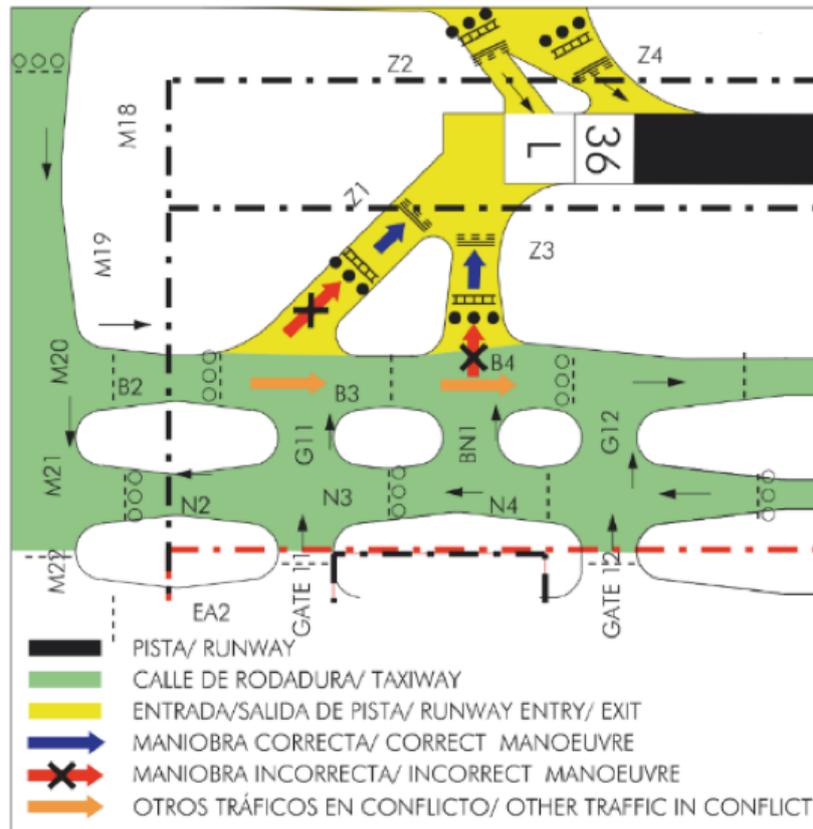
- Measures adopted:
 - o Modification to holding points (approved in October 2015). The existing CAT I/III holding points on the four runways will be removed, due to their

exclusive use. The CAT II/III holding points for runway 18L-36R will be removed in the spring of 2017. The actions involving the remaining points to be removed will be carried out in subsequent years. There are no detailed plans as of the writing of this report.

Figure 19. Information on the hotspot for holding points Z1 and Z3 published in AIP-Spain

- o Until the holding points are modified, the holding points LA, LB, Z1 and Z3 will be included in the listing of hotspots in the AIP.

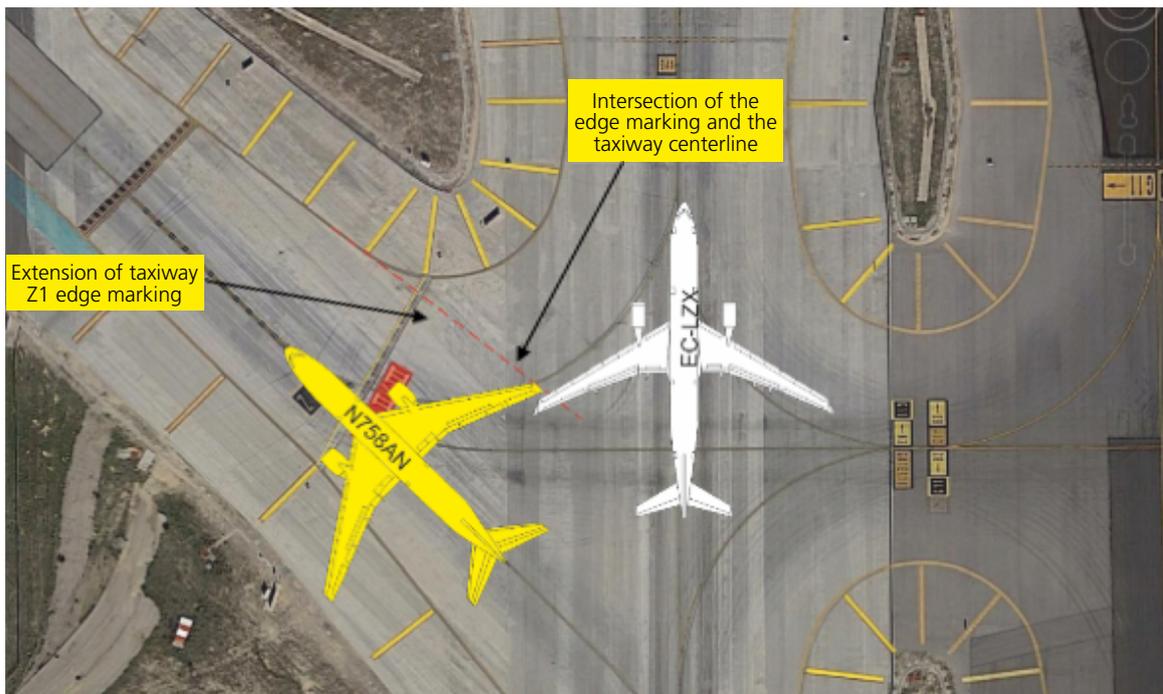
This same figure shows aircraft N758AN such that its right wingtip is over the intersection of the markings specified in the above paragraph. In this position, the front part of the aircraft would be some 40 m away from the holding point marking.

Since the CAT I and CAT II/III markings are 60 m apart, it follows that under these conditions, the front of the airplane was 20 m forward of the CAT II/III marking.

Figure 20. Diagram of the probable positions of the two aircraft at the time of the collision

The nosewheel is 5.89 m behind the front tip of the aircraft, meaning that under the conditions in question it would have been 14 m forward of the CAT II/III marking.
