AIRCRAFT ACCIDENT REPORT AND EXECUTIVE SUMMARY

Reference:	CA18/2/3/9505	
Aircraft registration	ZS-DKS	Date of accident	7 December 2015		Time of accident	0857Z
Type of aircraft	Eclipse EA500 (Aeroplane)		Type of operation	Private (Part 91)		
Pilot-in-command licence type		Private	Age	57	Licence valid	Yes
Pilot-in-command flying experience		Total hours	2 977.0		Hours on type	506.15
Last point of departure		Lanseria International Airport (FALA), Gauteng				
Next point of intended landing		Cape Town International Airport (FACT), Western Cape				
Location of the accident site with reference to easily defined geographical points (GPS readings if possible)						
On the farm Spioenkop, Overberg district, (GPS position: 34°10.31' South 020°08.15' East)						
Meteorological information		Surface wind: 160°/5kt, Temperature: 24°C, CAVOK				
Number of people on board	1 + 0	No. of people injured	0	No. of people killed	1	
Synopsis						
<p>The aircraft had taken off on a private flight with the pilot being the sole occupant on board. The pilot had filed an IFR flight plan and had informed air traffic control (ATC) at FALA that the aircraft had a fuel endurance of 4 hours and his estimated flying

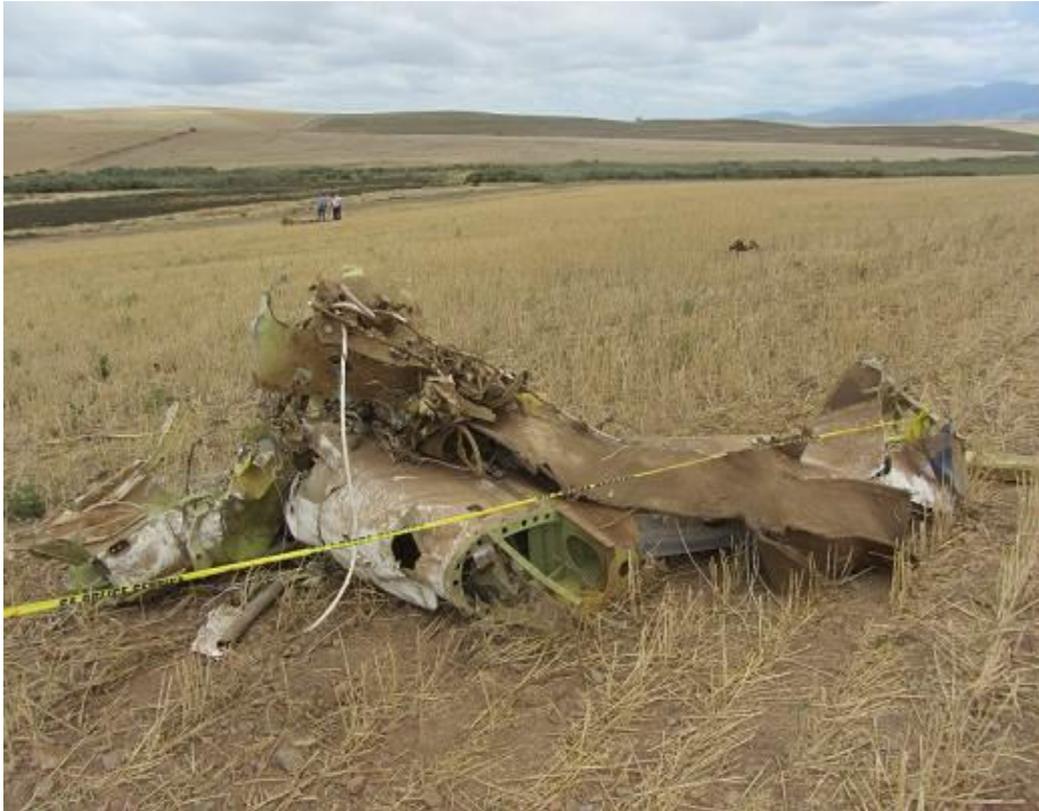
1.3.1 The aircraft was destroyed during the impact sequence.

Figure 2: The empennage section of the aircraft

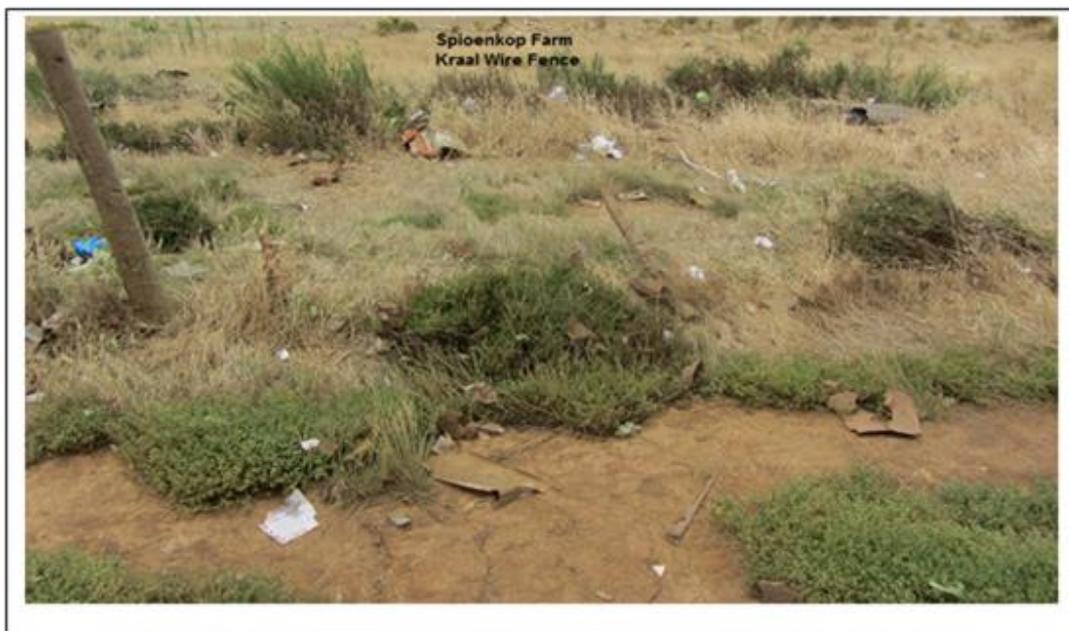
1.4.1 Other damage was limited to a barbed wired fence and vegetation.

Figure 3: Damage to the fence

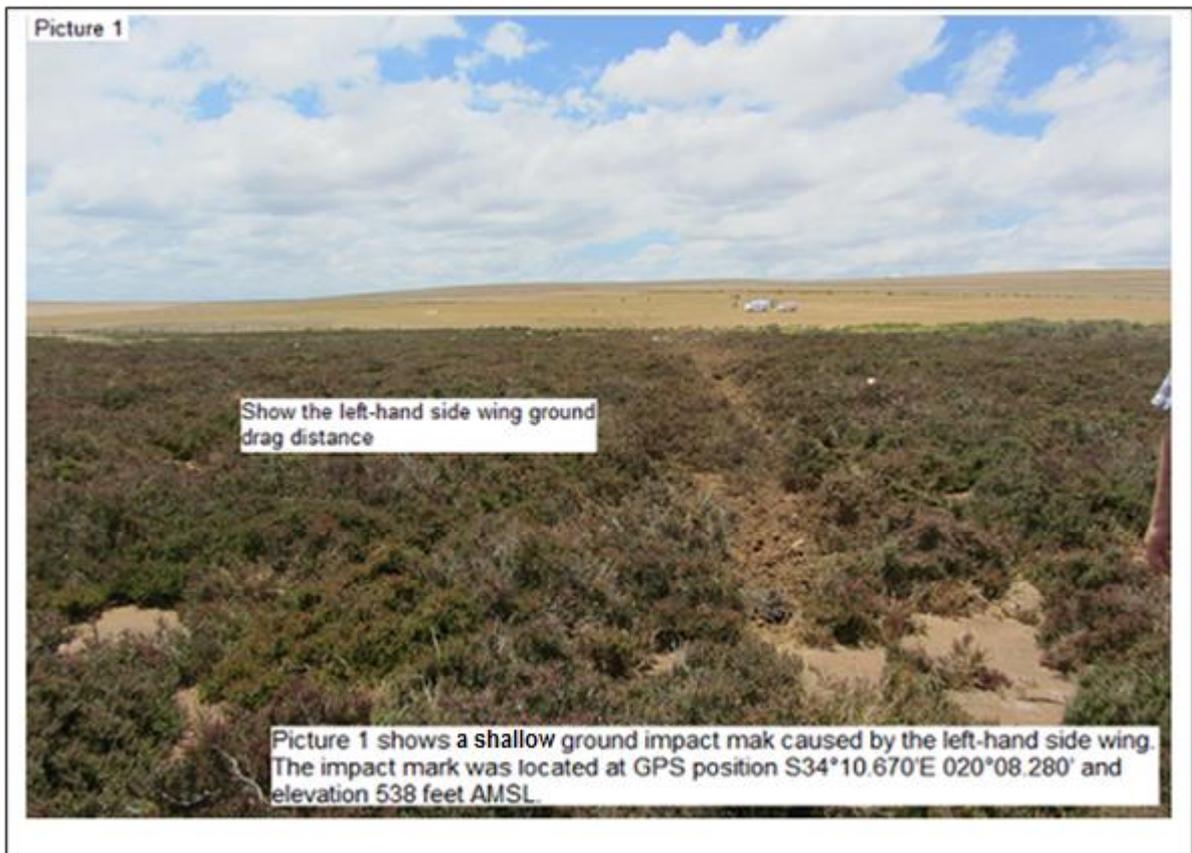
- 1.12.4 Information from the accident site was used to draw an impact sequence diagram. The ground marks indicate that the wing of the aircraft impacted the ground first, and the wing structure displayed evidence of severe deformation. The impact sequence was found to follow a relatively straight line.

Figure 6: The first ground impact mark

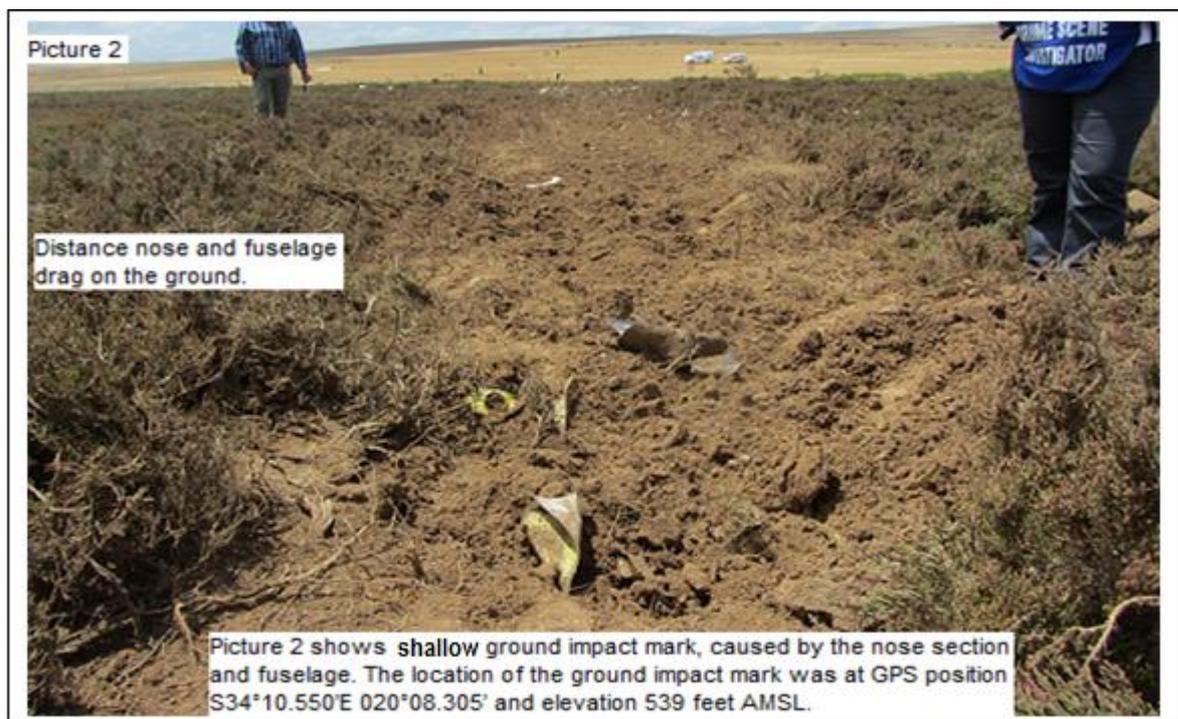
- 1.12.5 Following the left wing impact mark, the subsequent ground marks indicate that the nose section of the aircraft then impacted the ground. Due to the high impact forces the fuselage structure then started to break up.

Figure 7: The ground impact mark of the nose and fuselage

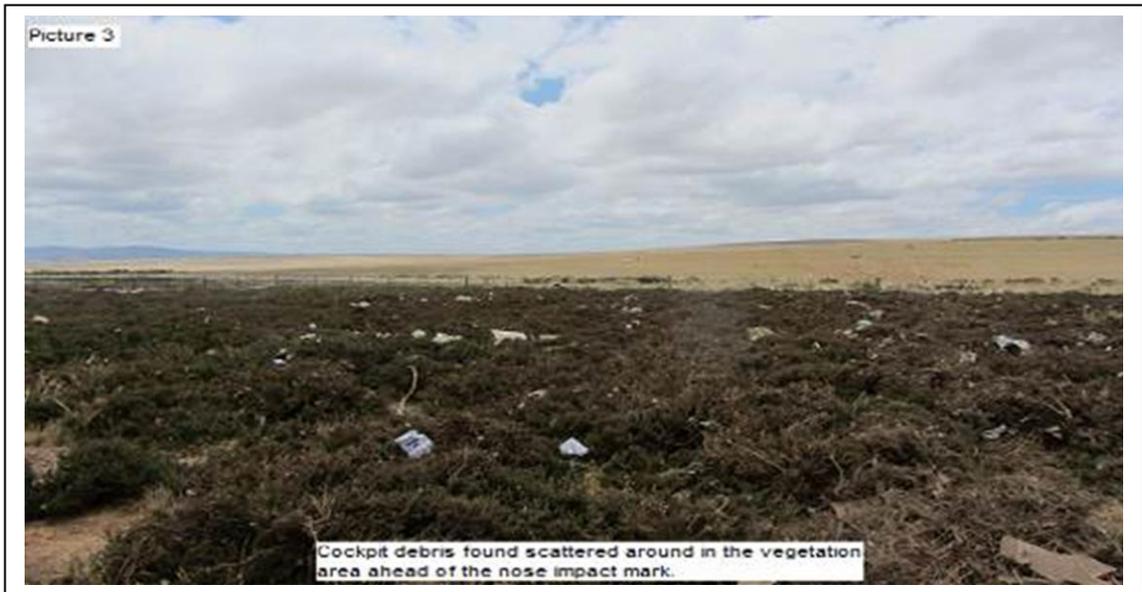
1.12.6 After the nose impacted the ground it disintegrated; as a result, the cockpit debris (i.e. navigation aids, radio communication equipment, furnishings and loose pages of documentation that was on board the aircraft were found scattered over

Figure 8: Scattered debris from the cockpit and cabin area ahead of the nose impact mark

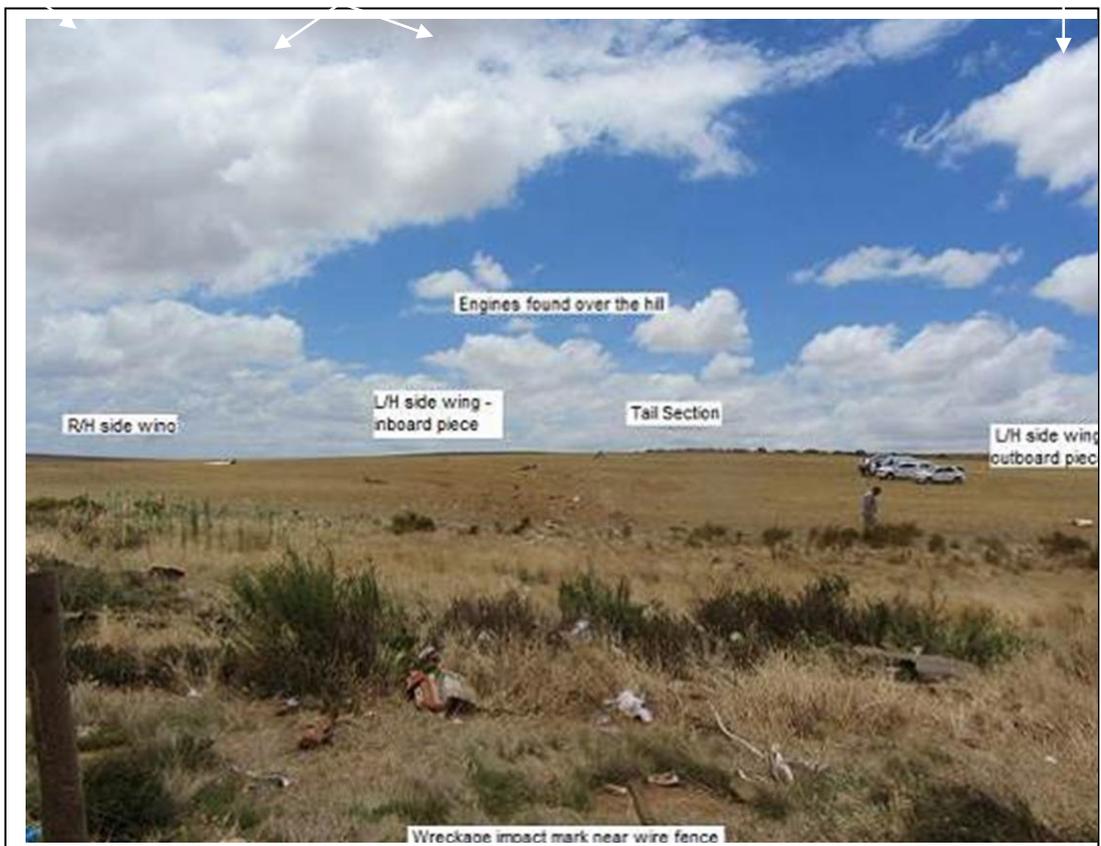
Figure 8: The wreckage distribution beyond the first point of impact

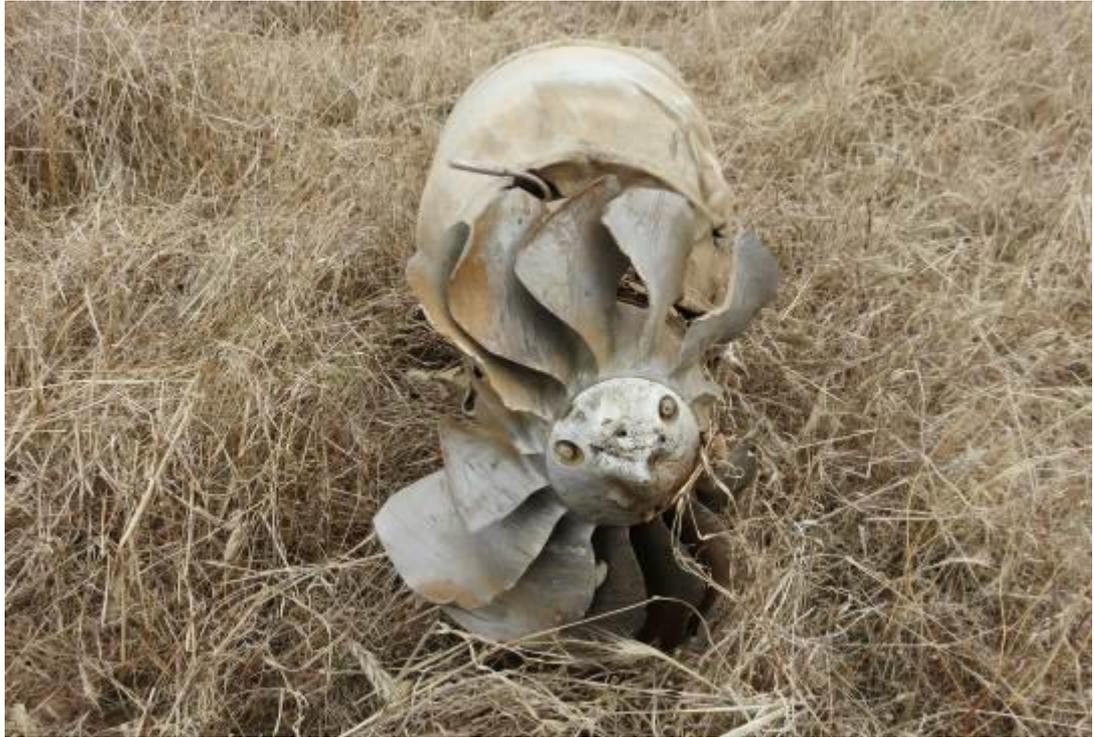
1.12.7 The two engines were located more than 1 km from the point of impact, which was at the end of the wreckage path. The number 1 engine (left side) displayed substantially more impact damage than the number 2 engine (right side).

Figure 9: Front view of No. 1 engine

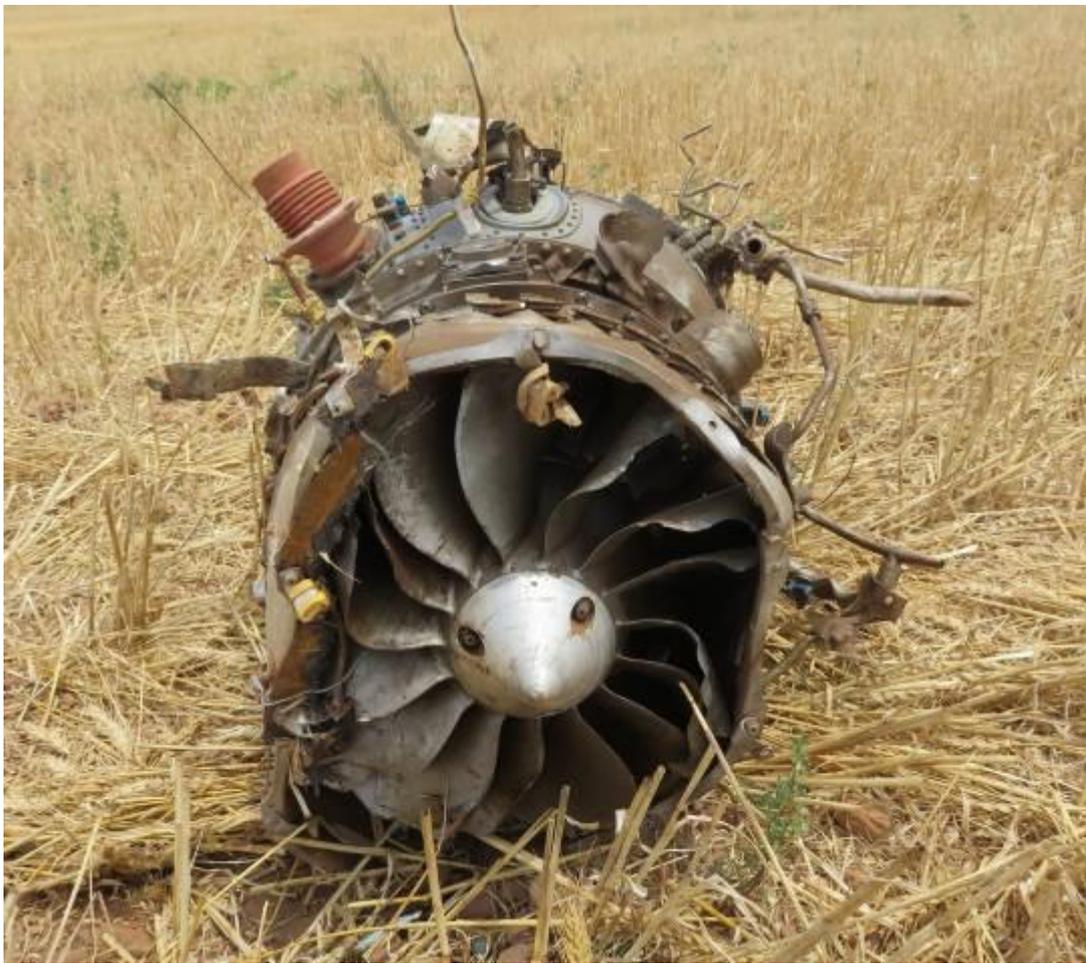
Figure 10: Front view of No. 2 engine

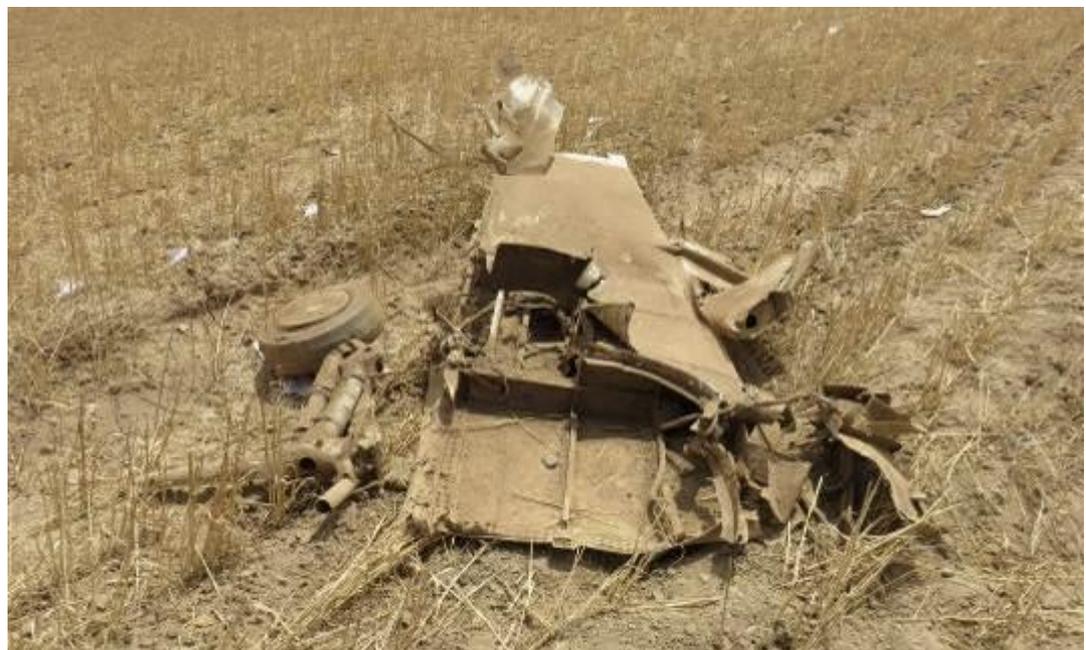
Figure 11: The inner section of the left wing and the left main gear

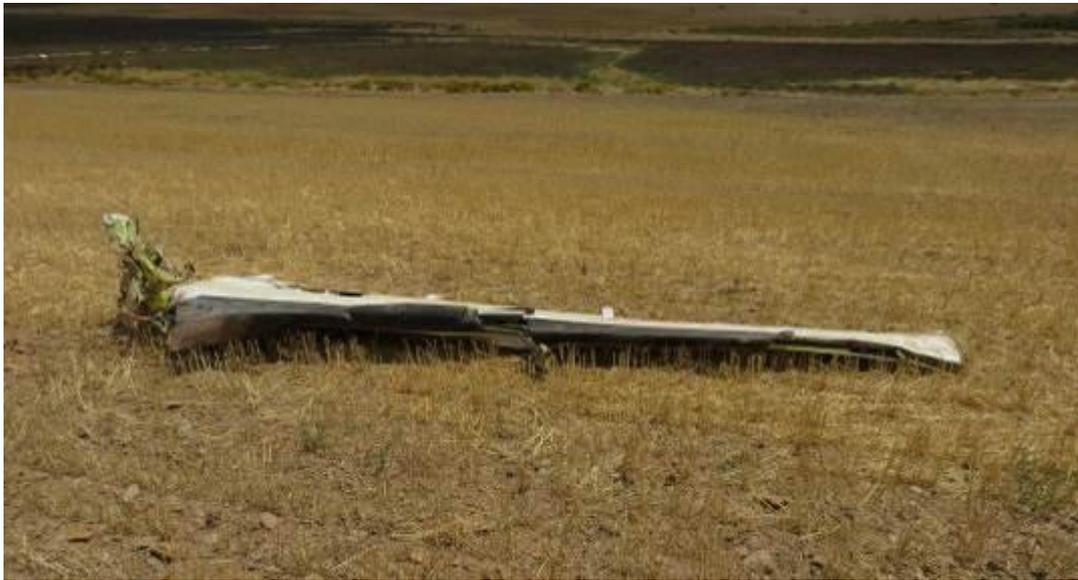
Figure 12: The right wing

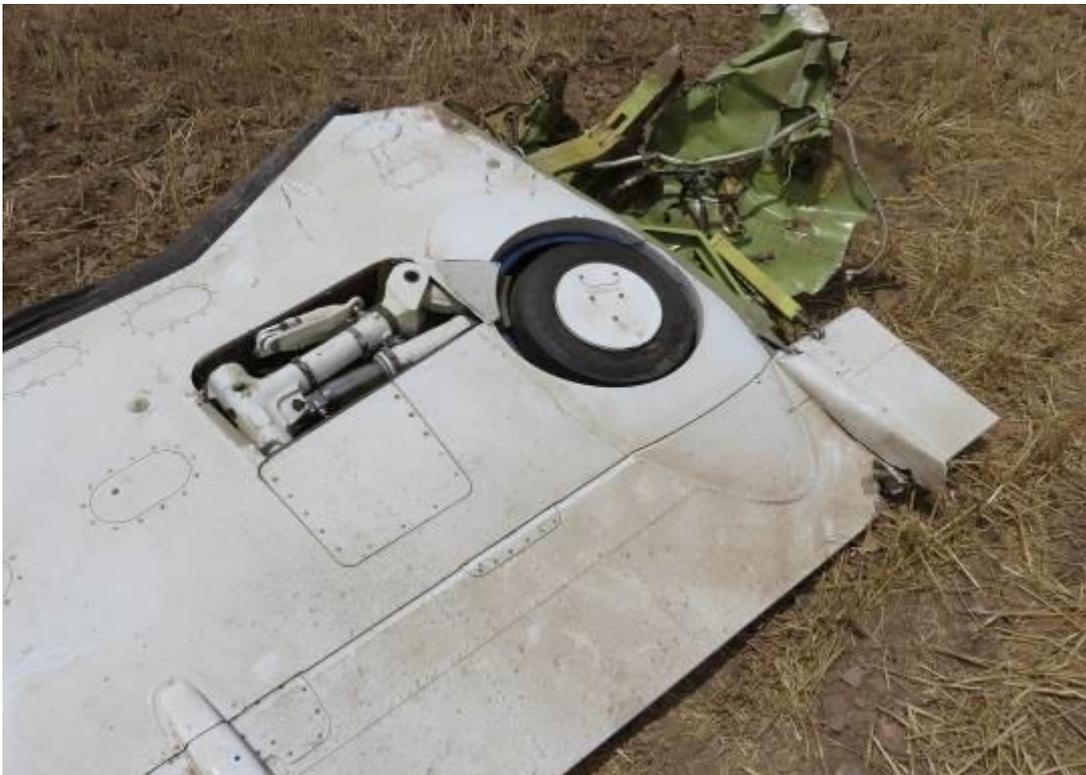
Figure 13: The right wing with the main gear still in the retracted position

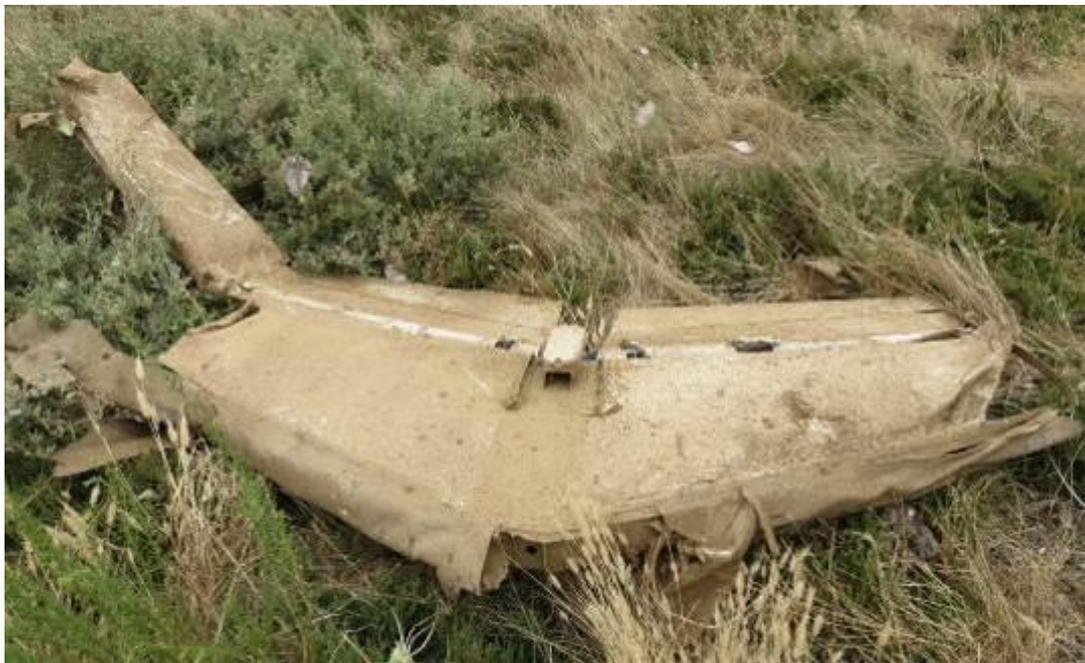
Figure 14: The vertical stabiliser with both elevators attached

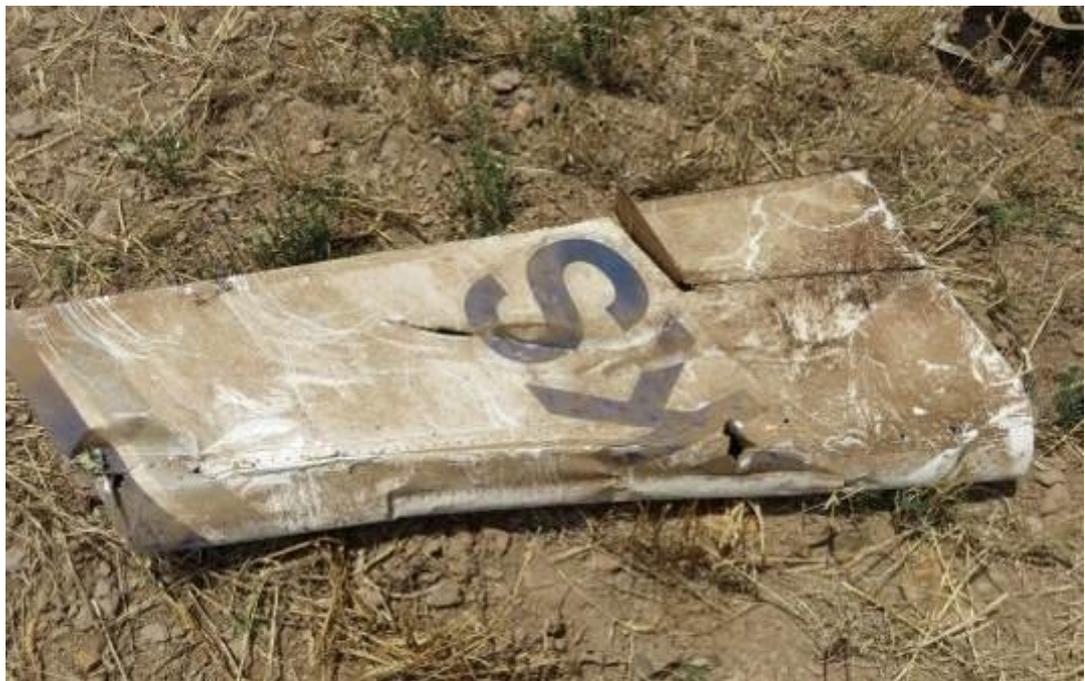
Figure 15: The rudder

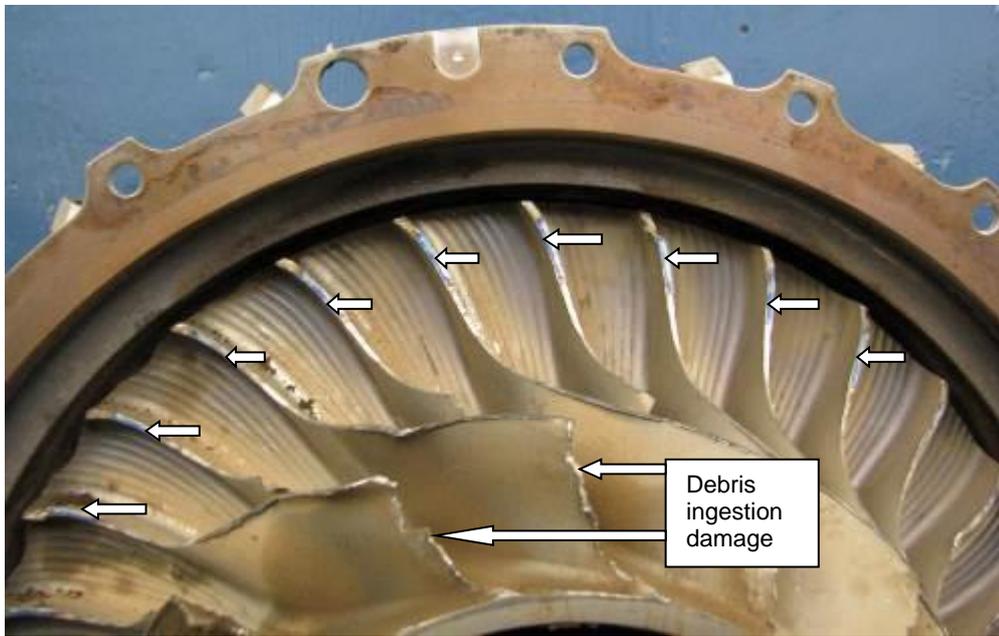
Figure 23: Close-up of the No. 1 engine high-pressure (HP) centrifugal compressor airfoils

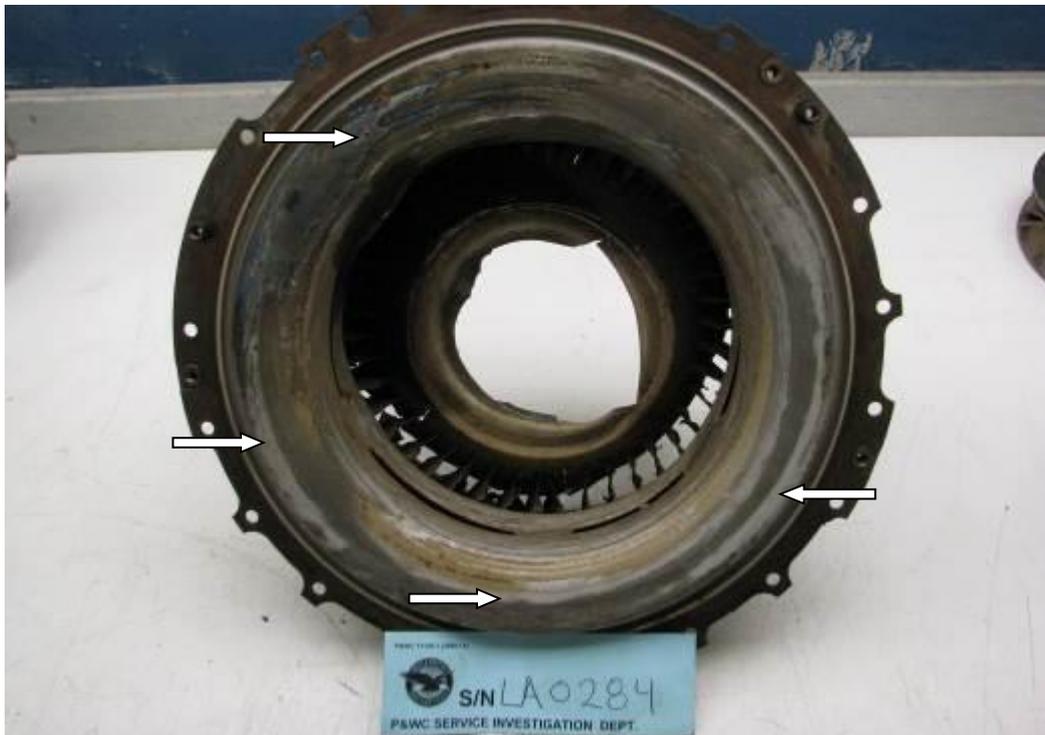
Figure 24: Rub marks on the No. 1 engine centrifugal compressor shroud

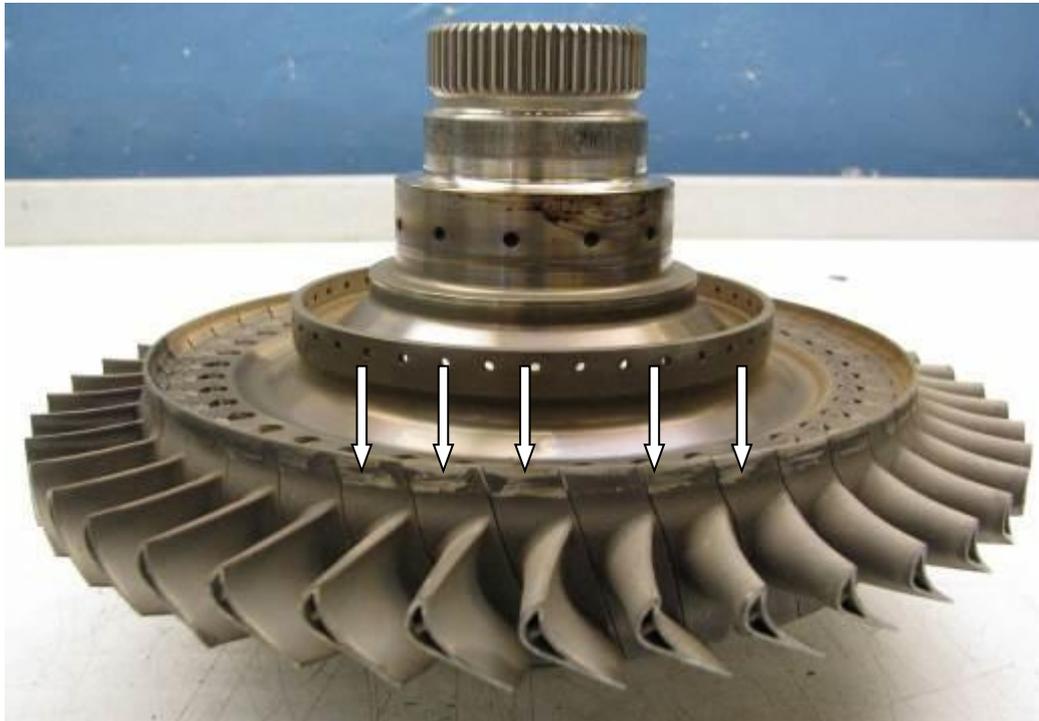
Figure 25: Rub marks on the high-pressure (HP) turbine leading edge, with no distress to the blades

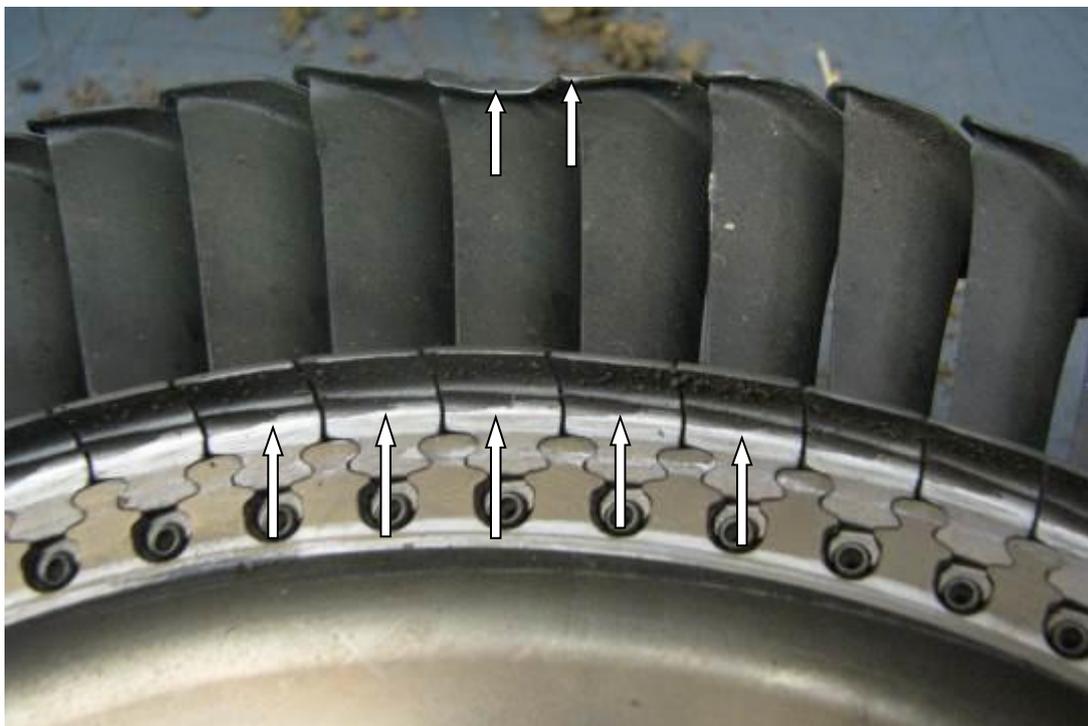
Figure 26: Rub marks on the low-pressure (LP) turbine disk and blades

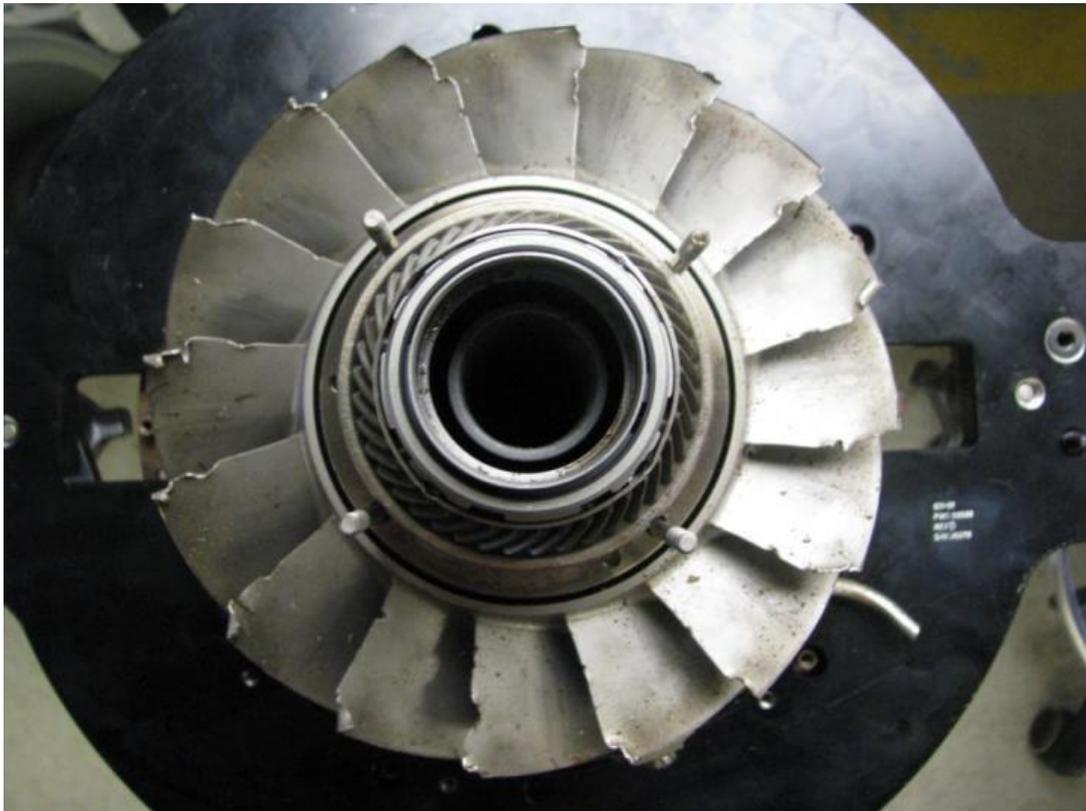
The photographs following below refer to the No. 2 engine. The engine displays slightly less evidence of rotation than the No. 1 engine, which was attributed to the angle of impact.

Figure 27: Damage to the axial compressor (No. 2 engine) associated with debris impact during rotation

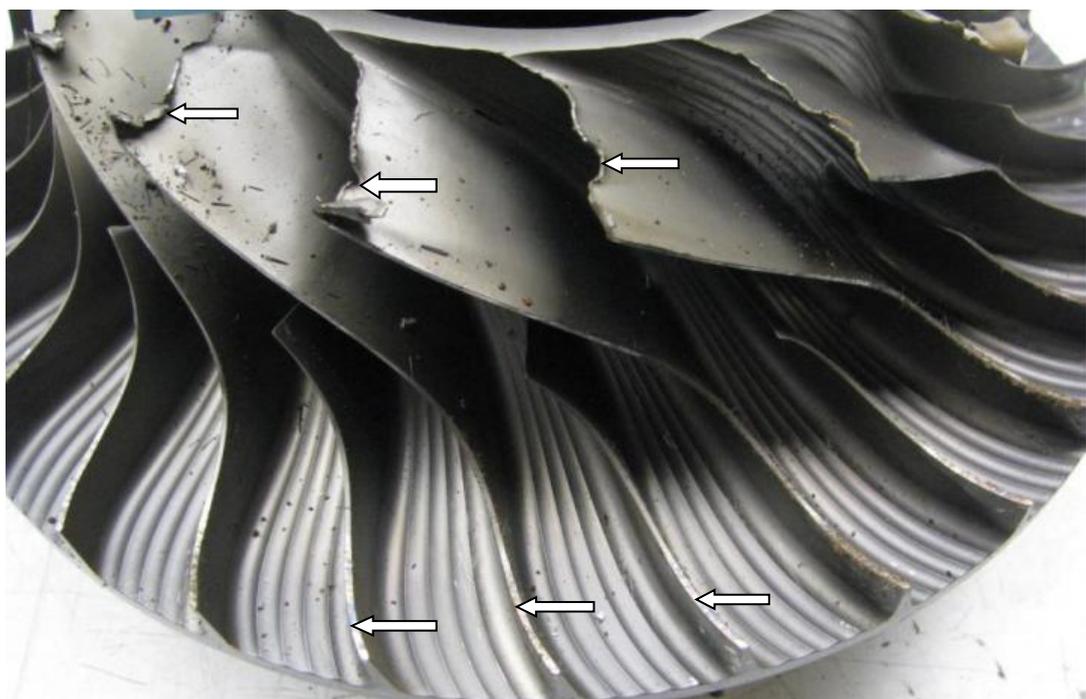
Figure 28: Close-up of the centrifugal compressor with damage visible to the airfoils

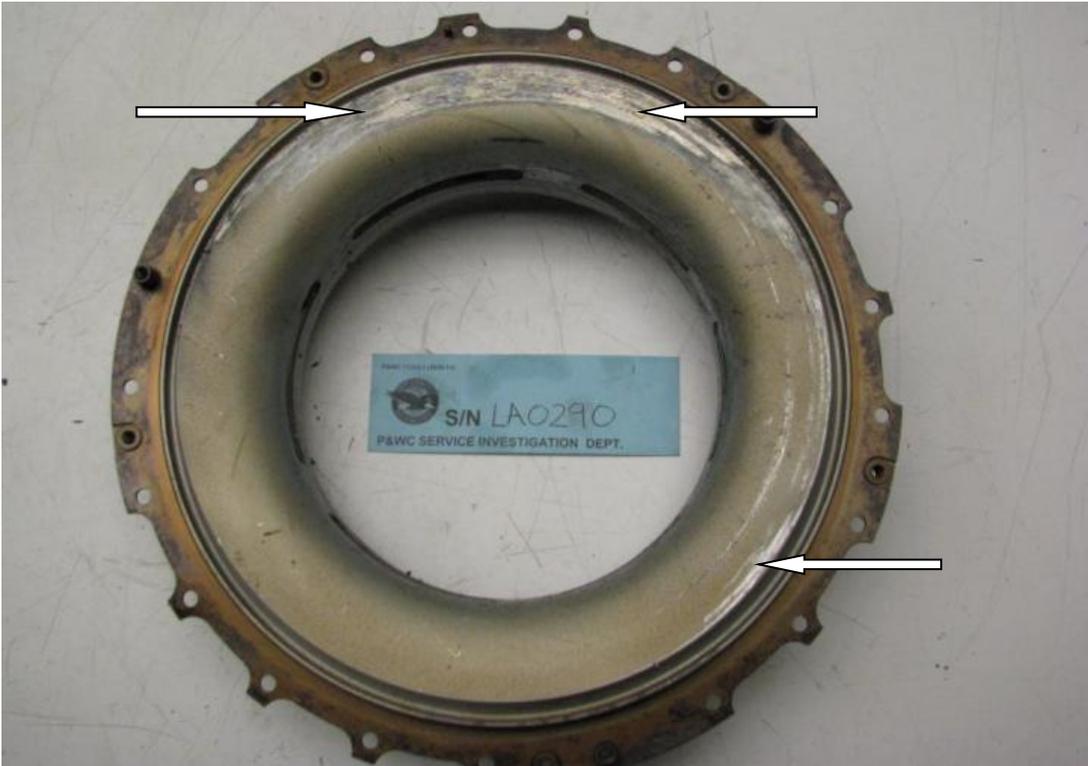
Figure 29: Rub marks visible on the centrifugal compressor shroud

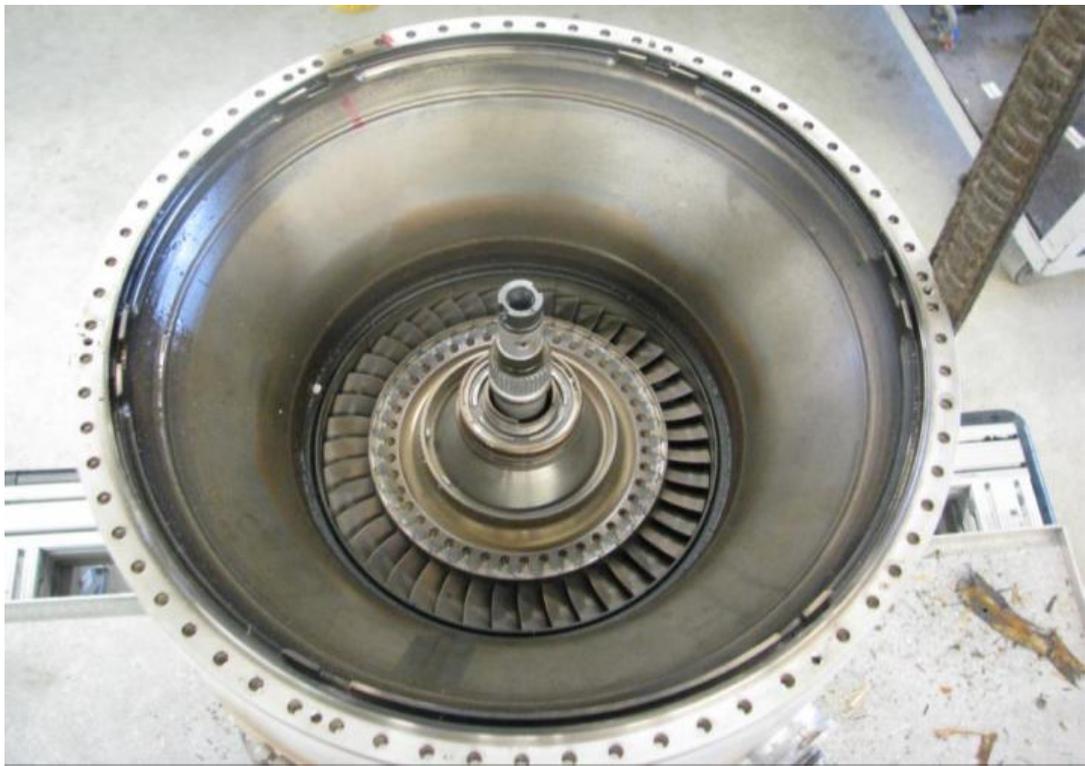
Figure 30: The high-pressure (HP) turbine support case; no damage was visible

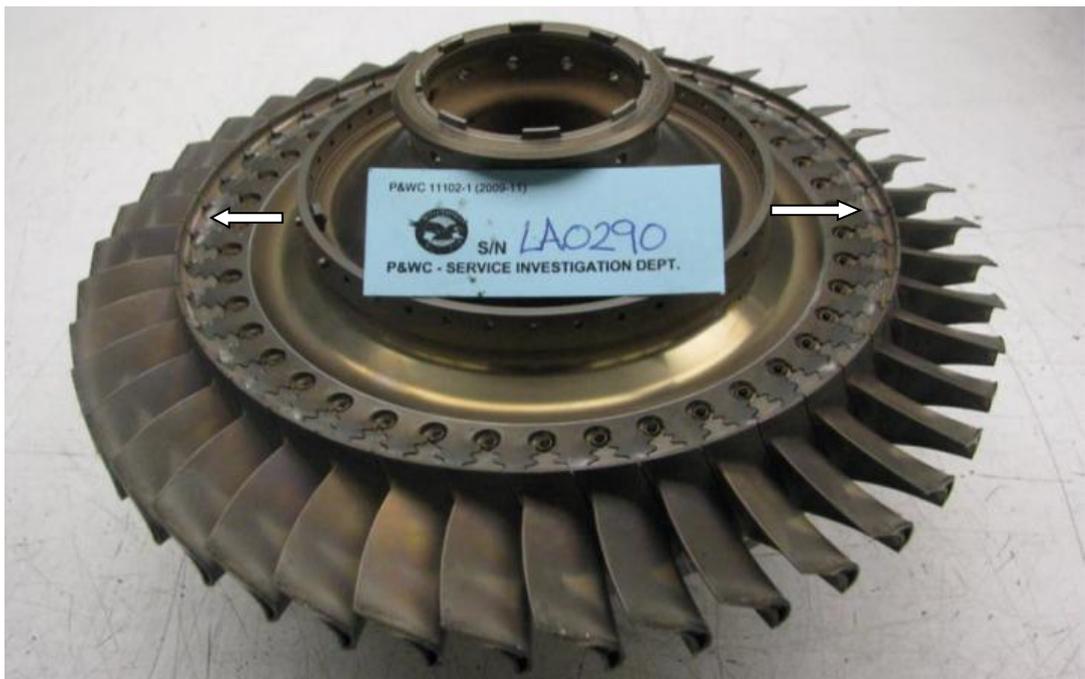
Figure 31: The high-pressure turbine disk (trailing edge view), with some rub marks visible

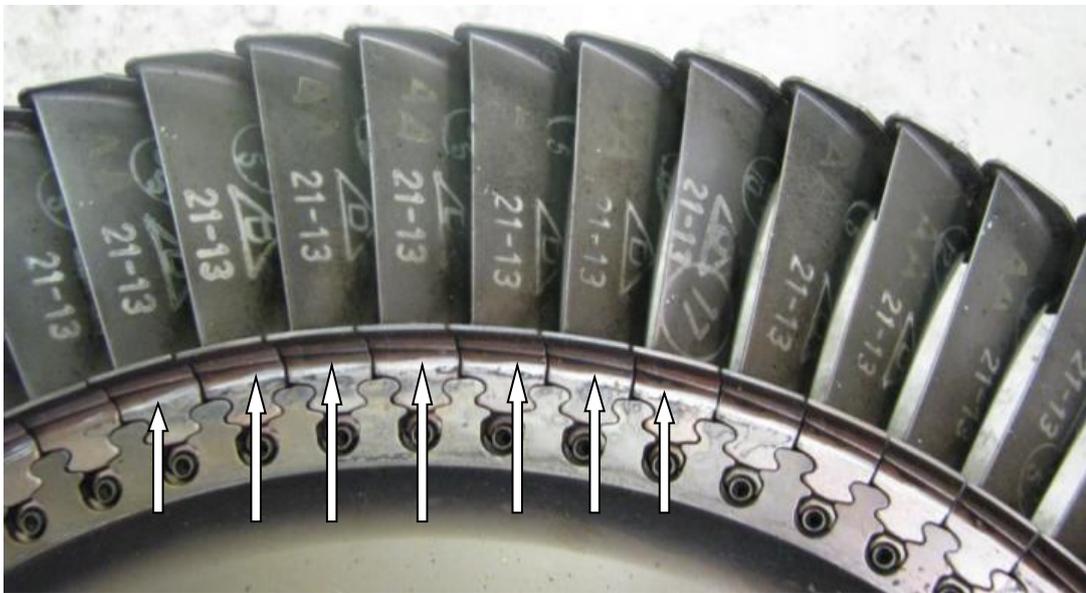
Figure 32: The low-pressure turbine disk with rub marks visible

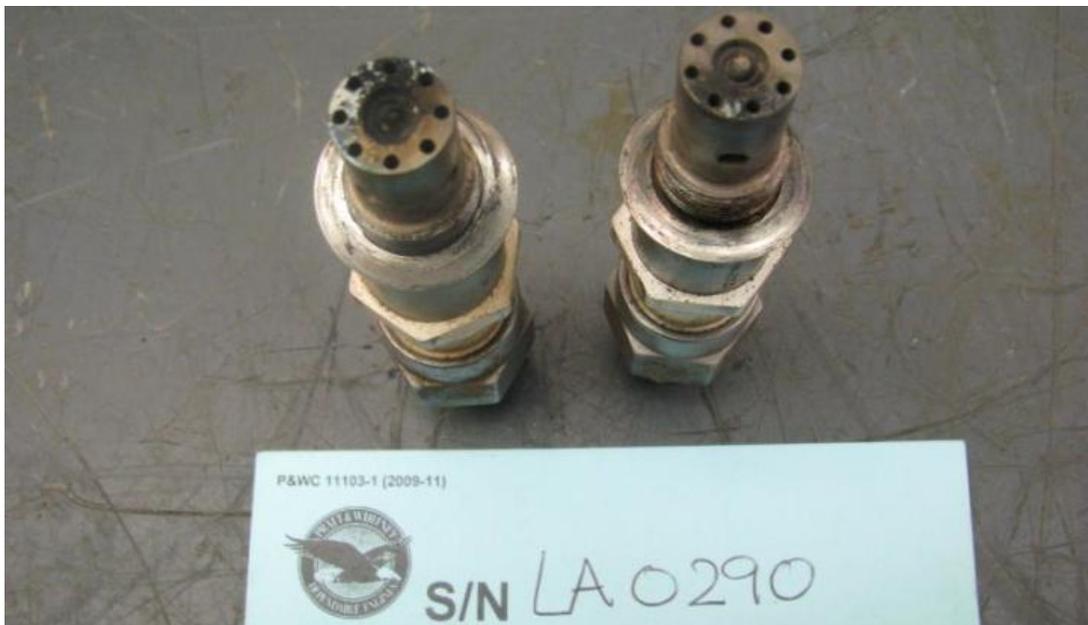
Figure 33: The ignitor plug faces were not damaged, but they display some carbon accumulation

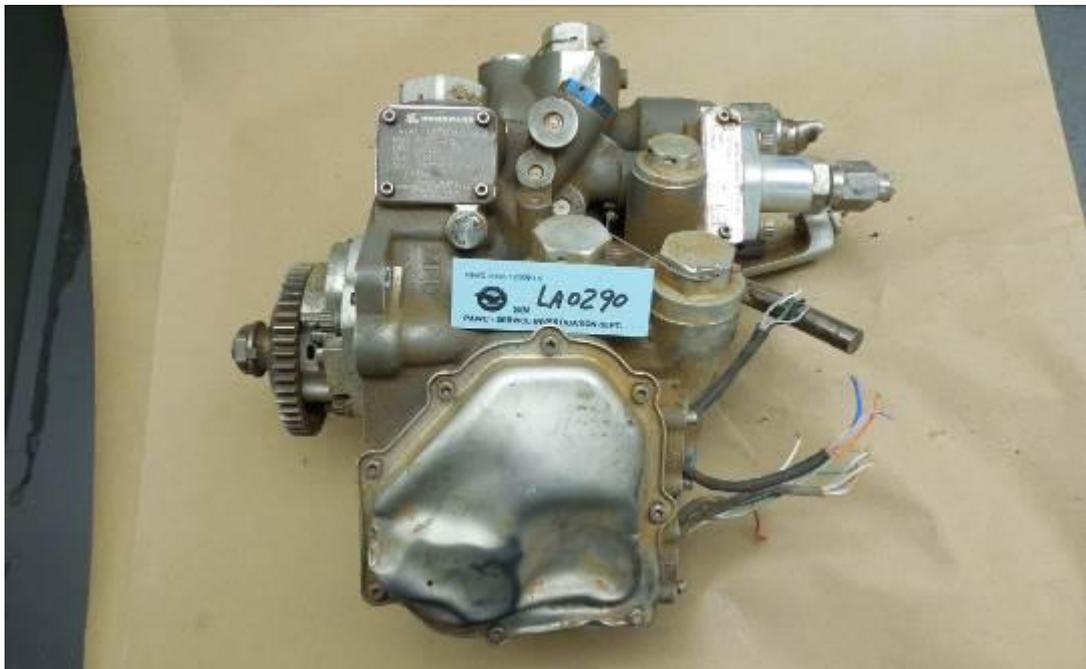
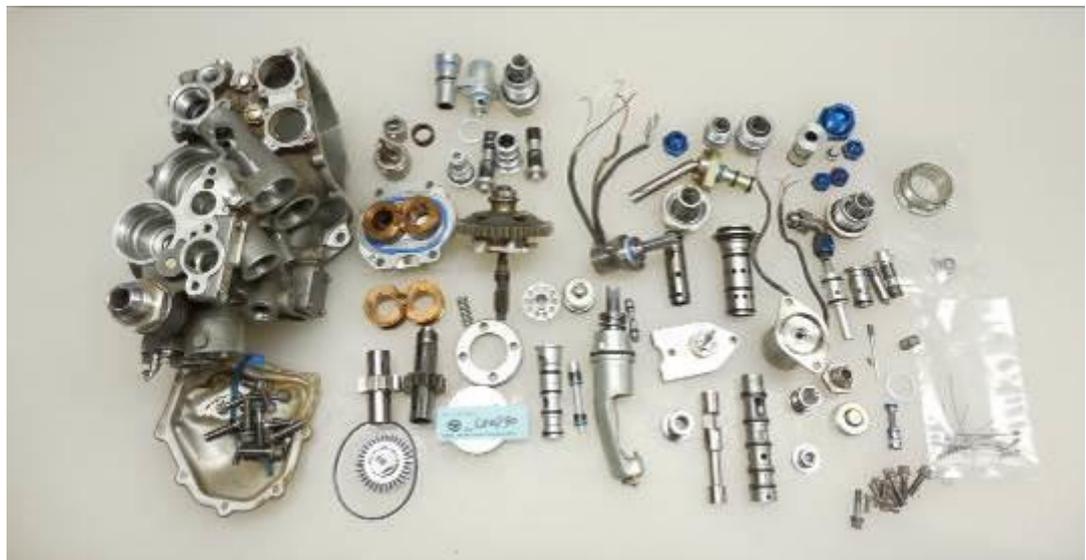
1.16.12 None of the parts from the accessory gearboxes were recovered, and only one fuel metering unit (No. 2 engine) was recovered. The unit was found on the accident site as it became detached from the engine during the impact sequence. A visual inspection of the unit displayed multiple severe impact damage. The unit, manufactured by Woodward, with part number 35C2496-04 and serial number 15042650, was dismantled in the P&WC accessories department (fuel component shop). The visual inspection of the internal components did not reveal any damage or abnormal conditions that would have prevented normal operation prior to the accident.
