AVIATION INVESTIGATION REPORT A15C0163

Icing encounter, loss of control, and collision with terrain

Wasaya Airways Limited Partnership
Cessna 208B, C-FKDL
Pickle Lake, Ontario, 10 nm N
11 December 2015

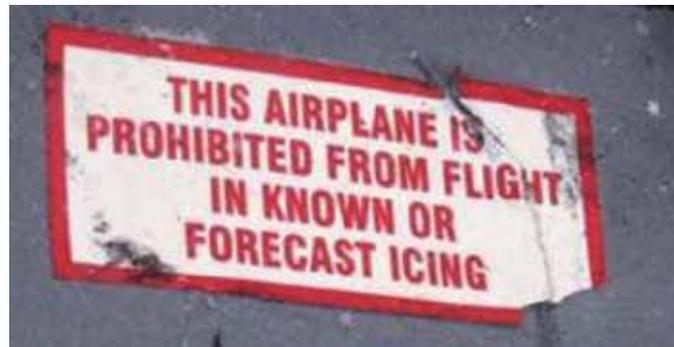
Figure 1. C-FKDL cockpit placard

C-FKDL was fitted with a McCauley aluminum 3-bladed, constant-speed, full-feathering, and reversible propeller. The aircraft was certified for day and night VFR as well as instrument flight rules (IFR) flight, and it was prohibited from flight in known or forecast icing conditions. The prohibition was prominently placarded in the cockpit in view of the pilot (Figure 1).

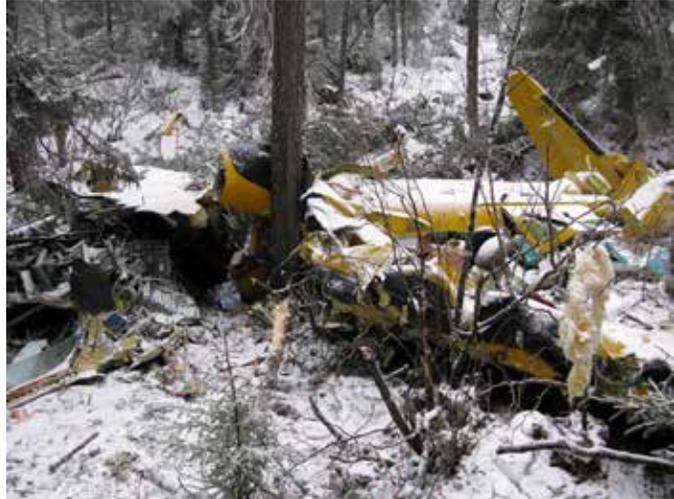
All of the damage to the aircraft was attributable to impact forces. All of the flight control surfaces and major structural components were found with the wreckage.

Figure 3. Left front view of wreckage

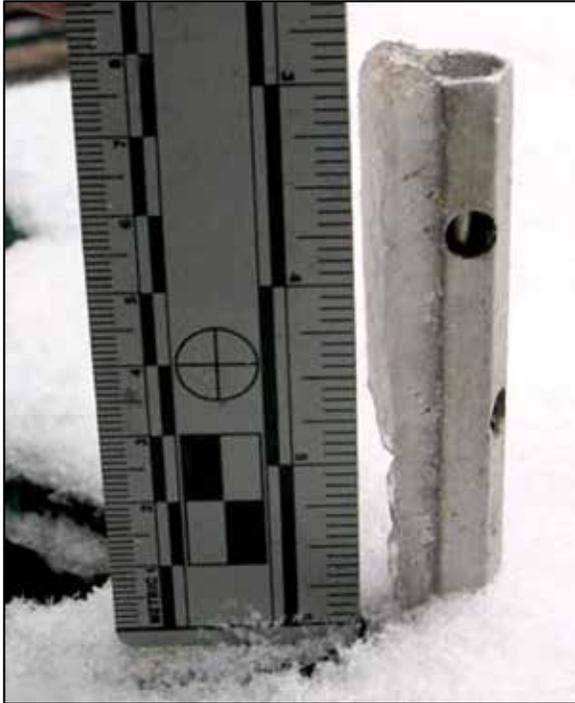
Examination of the airframe wreckage at the crash site revealed accretion of ice about five sixteenths of an inch thick on the outside air temperature probe (Figure 4), antennas (Figure 5), and other protruding components. There was residual ice on the de-icing boots on the vertical stabilizer (Figure 6), horizontal stabilizer (Figure 7), and right wing (Figure 8), indicating that the boots had been operated after in-flight accretion of ice.

Figure 4. Ice on the outside air temperature probe

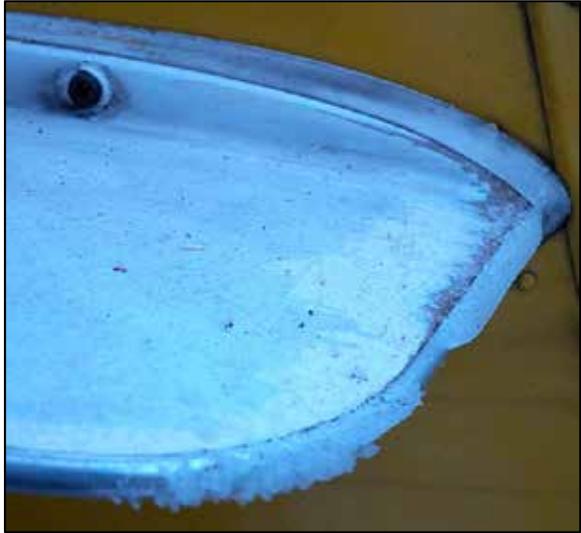
Figure 5. Ice on an antenna on the right side of the vertical stabilizer

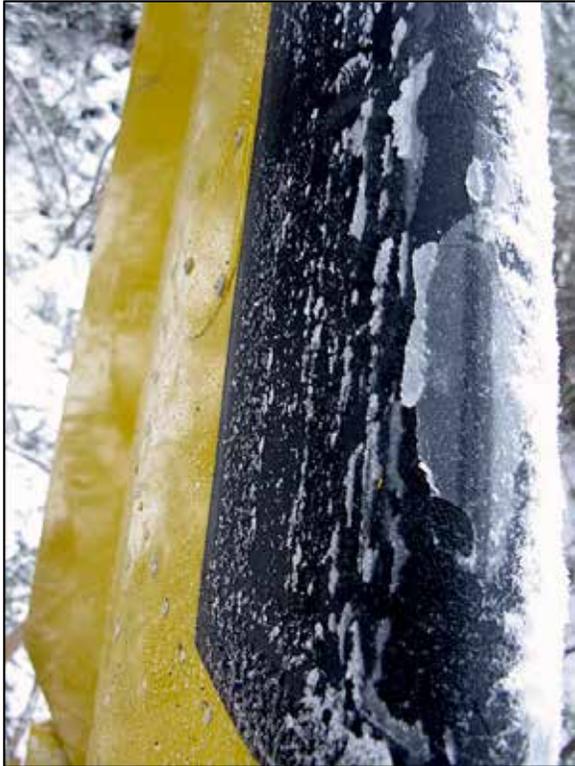
Figure 6. Ice on the right side of the vertical stabilizer

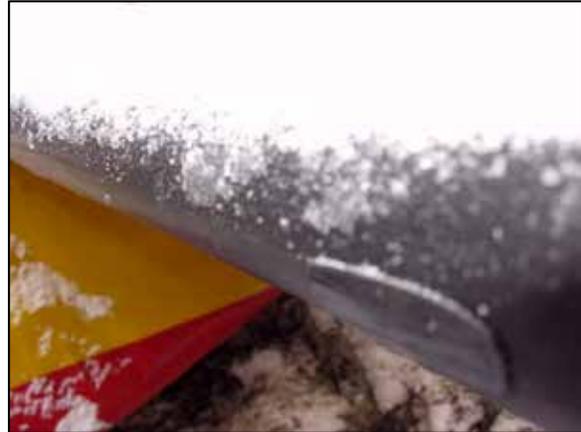
Figure 7. Ice on the leading edge of the left horizontal stabilizer

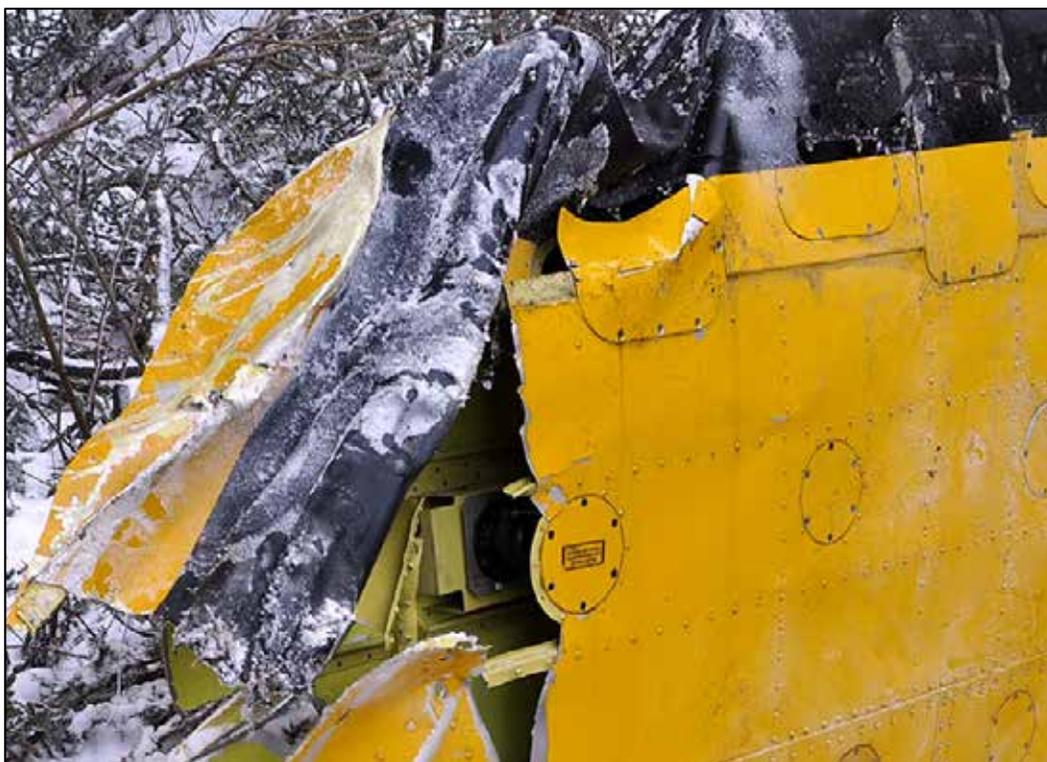
Figure 8. Ice on the leading edge of the right wing outboard section

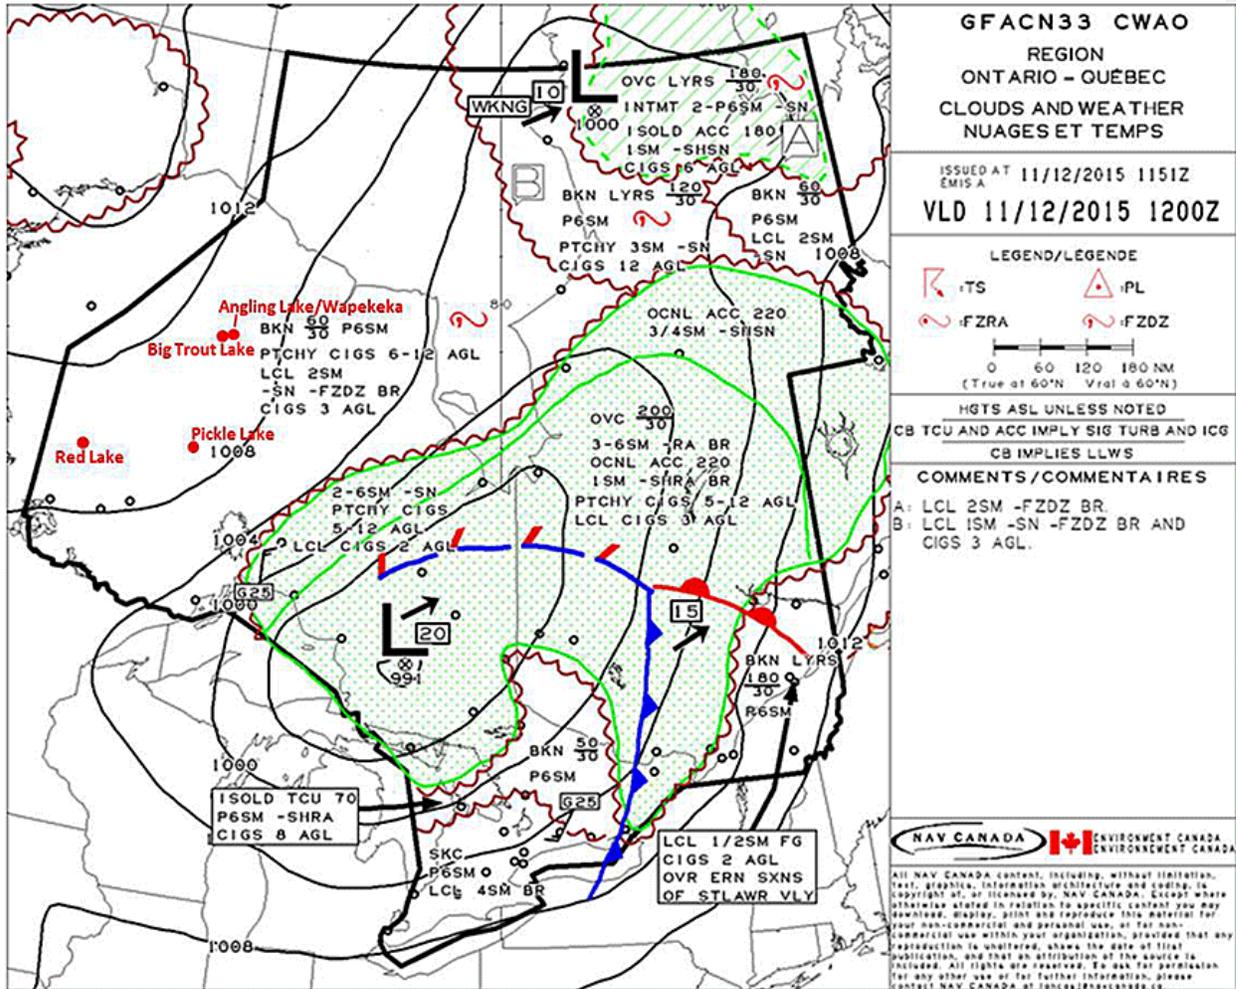
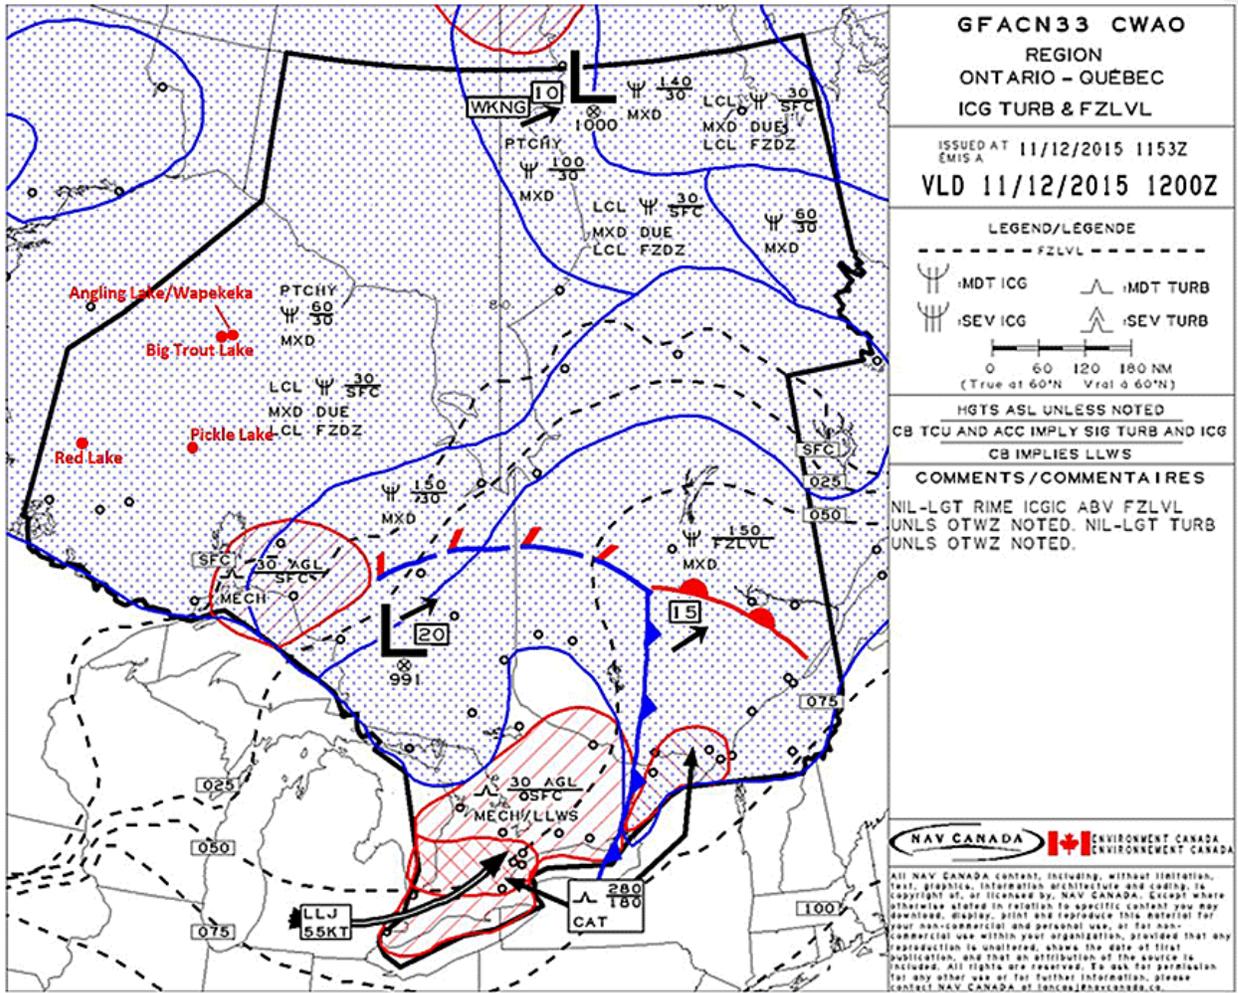
Appendix B – Graphical area forecast CN33 valid at 0700 EST (1200 UTC) 11 December 2015

- Clouds and weather (issued at 0651): broken clouds based at 3000 feet ASL topped at 6000 feet ASL; patchy ceilings based at 600 to 1200 feet AGL; and local visibility 2 sm with light snow, light freezing drizzle, mist, and ceilings at 300 feet AGL.
- Icing, turbulence, and freezing level (issued at 0653): Freezing level at the surface; no moderate or severe turbulence; patchy moderate mixed icing between 3000 and 6000 feet ASL; and local moderate mixed icing from the surface to 3000 feet ASL due to freezing drizzle.
- No SIGMET or AIRMET was issued following the GFA.

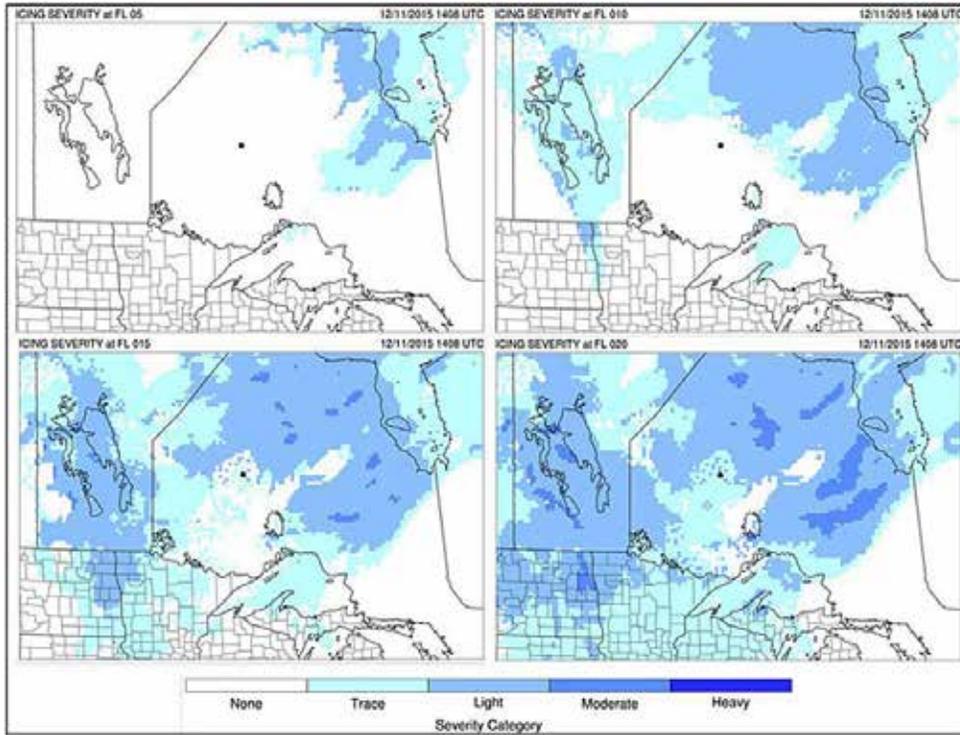
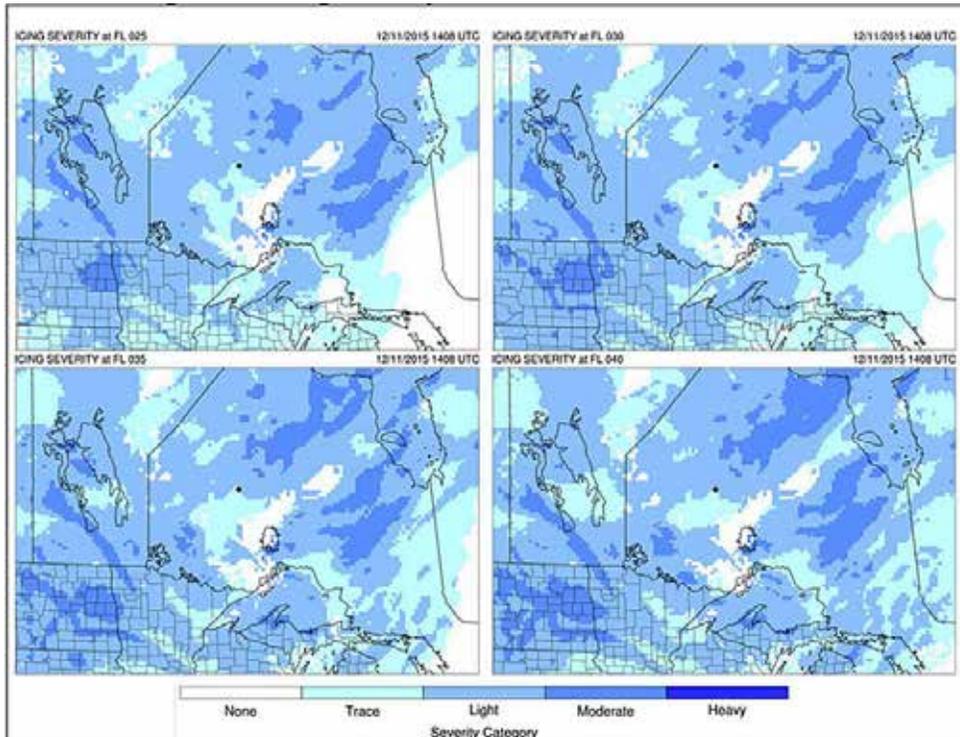
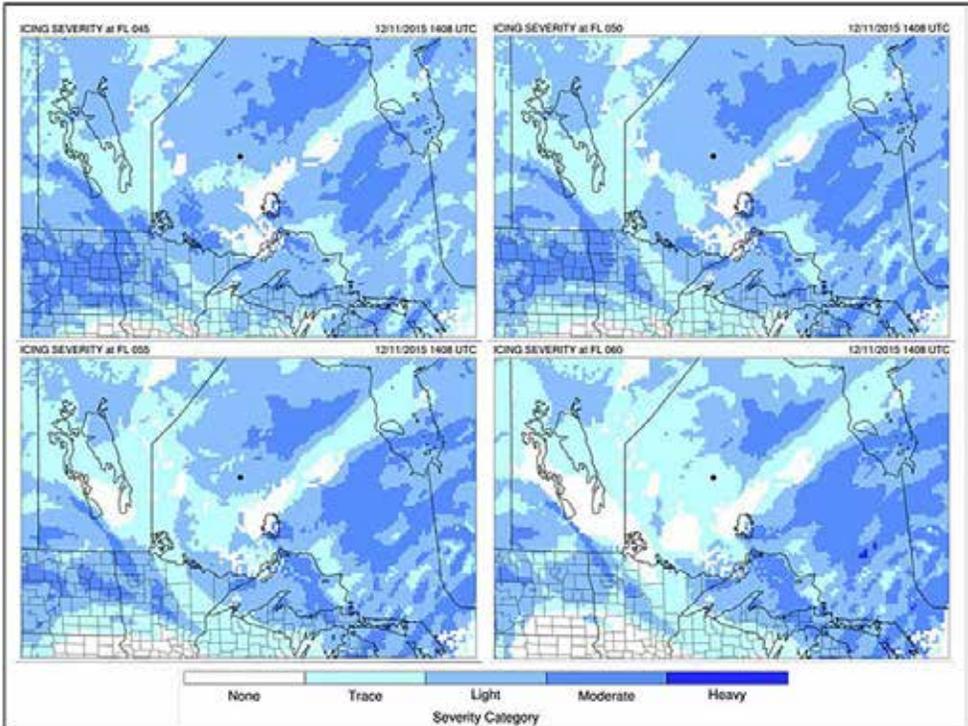
*Appendix D – Current Icing Product showing severity of icing:
11 December 2015 at 0908 (1408 UTC)*

The CIP icing severity graphics (Appendix D) depict the icing severity potential in the CYPL area as trace to light icing conditions from 1500 to 2500 feet ASL and as light icing conditions from 2500 to 5000 feet ASL.

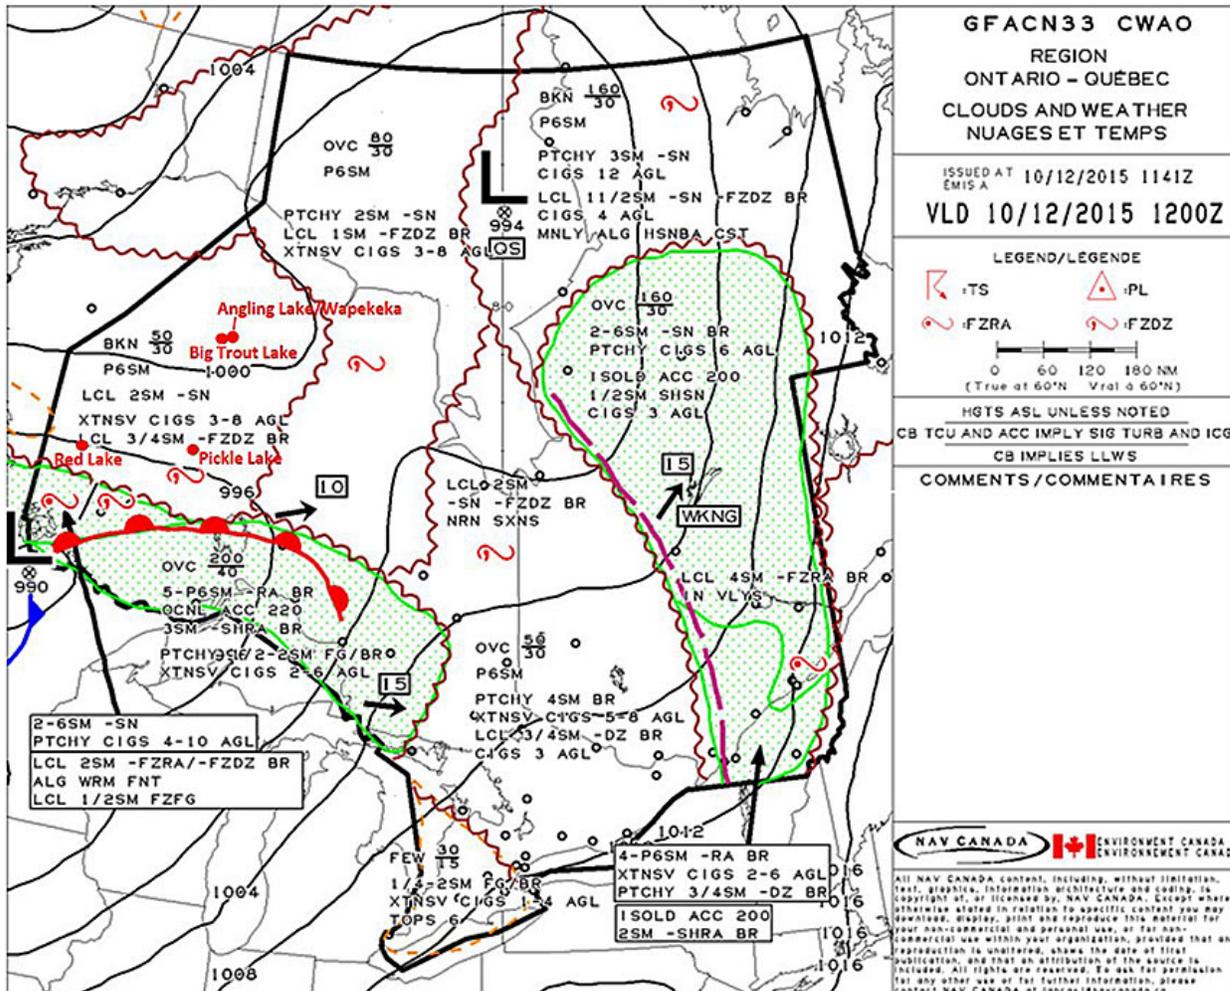
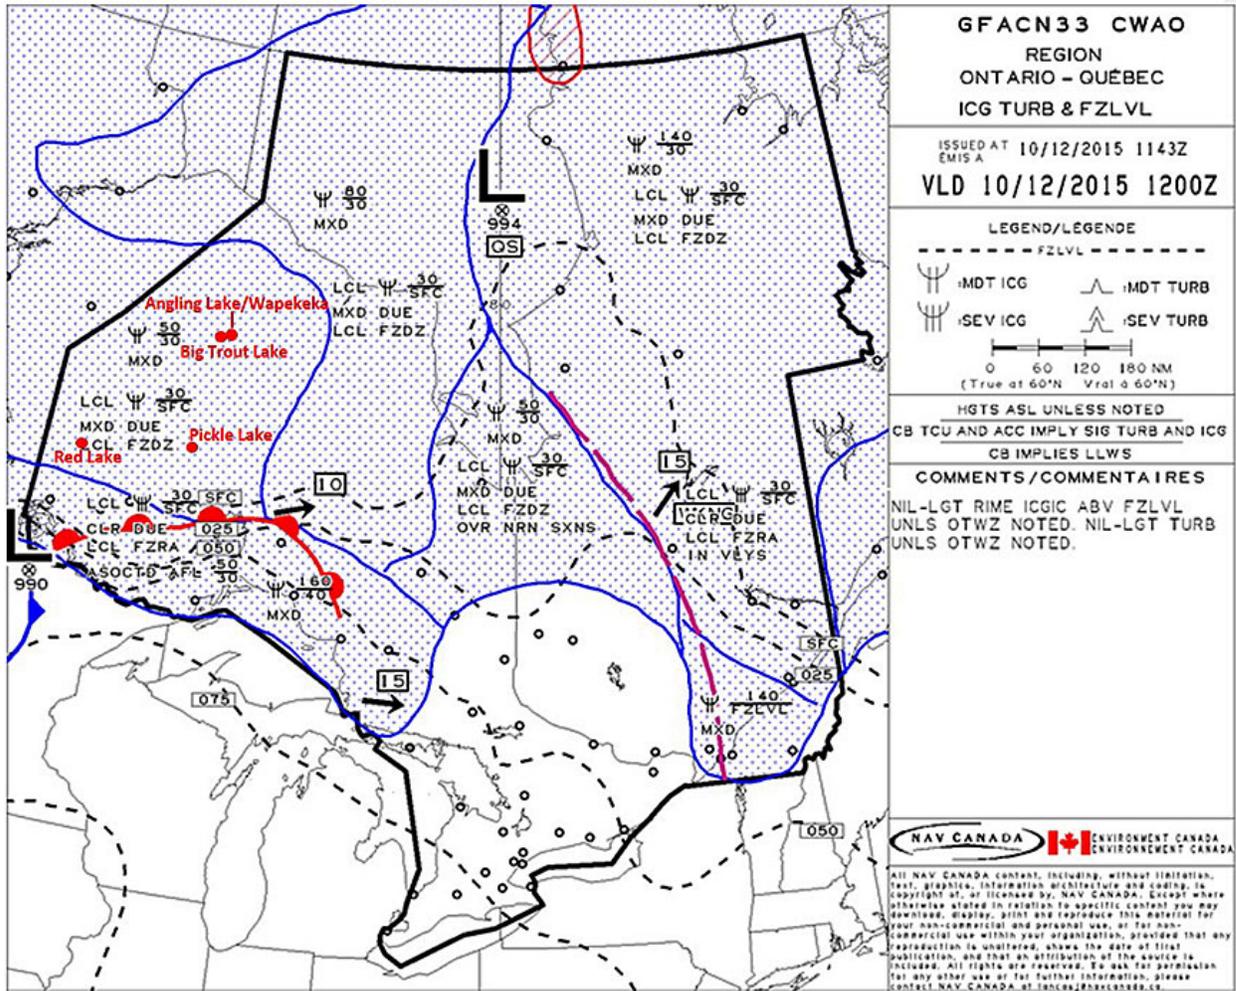
Appendix G – Graphical area forecast CN33 valid at 0700 EST (1200 UTC) 10 December 2015

- Clouds and weather (issued at 0641): broken clouds based at 3000 feet ASL and topped at 5000 feet ASL with visibility greater than 6 sm; local visibility 2 sm with light snow; extensive ceilings at 300 to 800 feet AGL with local visibility ¾ sm in mist and light freezing drizzle.
- Icing, turbulence, and freezing level (issued at 0643): freezing level at the surface; no moderate or severe turbulence; moderate mixed icing from 3000 to 5000 feet ASL, with local moderate mixed icing from the surface to 3000 feet ASL due to freezing drizzle.
