ACCIDENT

Aircraft Type and Registration:	Embraer EMB-145MP, G-CGWW	
No & Type of Engines:	2 Allison AE 3007A1 turbofan engines	
Year of Manufacture:	2000 (Serial no: 145362)	
Date & Time (UTC):	5 December 2015 at 2019 hrs	
Location:	Newcastle Airport	
Type of Flight:	Commercial Air Transport (Passenger)	
Persons on Board:	Crew - 4	Passengers - 19
Injuries:	Crew - None	Passengers - None
Nature of Damage:	Left wingtip and aileron scraped	
Commander's Licence:	Airline Transport Pilot's Licence	
Commander's Age:	36 years	
Commander's Flying Experience:	5,002 hours (of which 1,234 were on type) Last 90 days - 96 hours Last 28 days - 34 hours	
Information Source:	Aircraft Accident Report Form submitted by the pilot and further enquiries by the AAIB

Synopsis

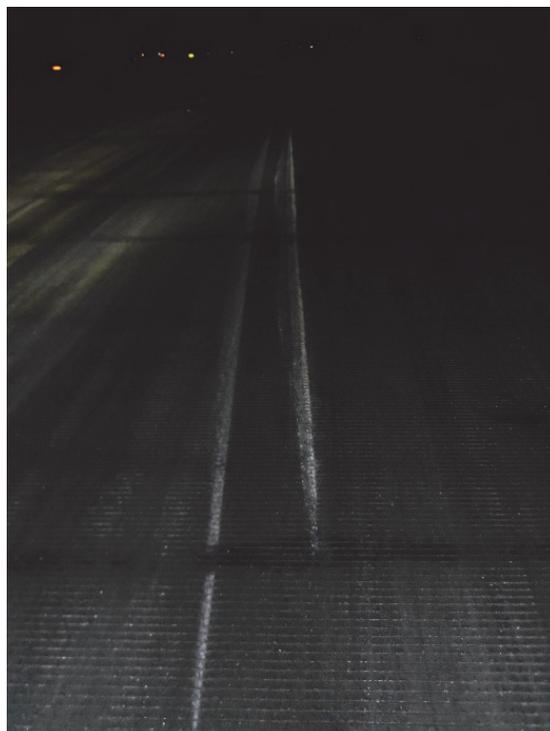
Figure 1

Witness marks on Runway 25, viewed looking east towards the landing threshold

The aircraft touched down to the right of the centreline, on a runway which slopes away from the centreline for drainage purposes. The wingtip touched the runway 1 m left of the centreline in a position where the elevation was higher than that at which the left wheel made contact. Therefore, it was possible for ground contact to be made by the wingtip with an angle of bank of less than 16.4° .

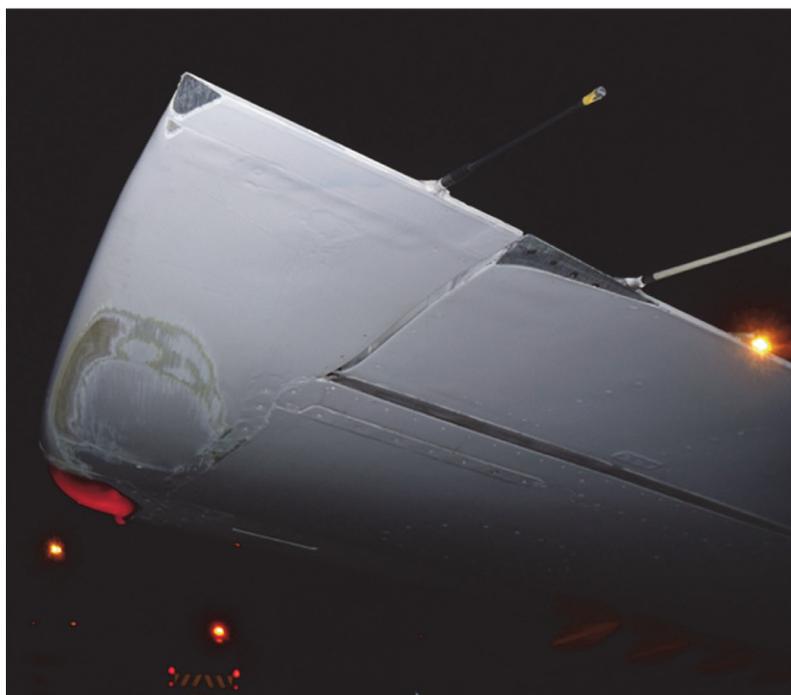
Figure 2

Following the accident, surface abrasions were noted to the left wingtip fairing and the left aileron (Figure 2). Subsequent examination proved that the wingtip fairing could be repaired but the aileron was damaged beyond acceptable limits and was replaced.

Damage to the left wingtip and aileron of G-CGWW
(photographs courtesy of Newcastle Airport)

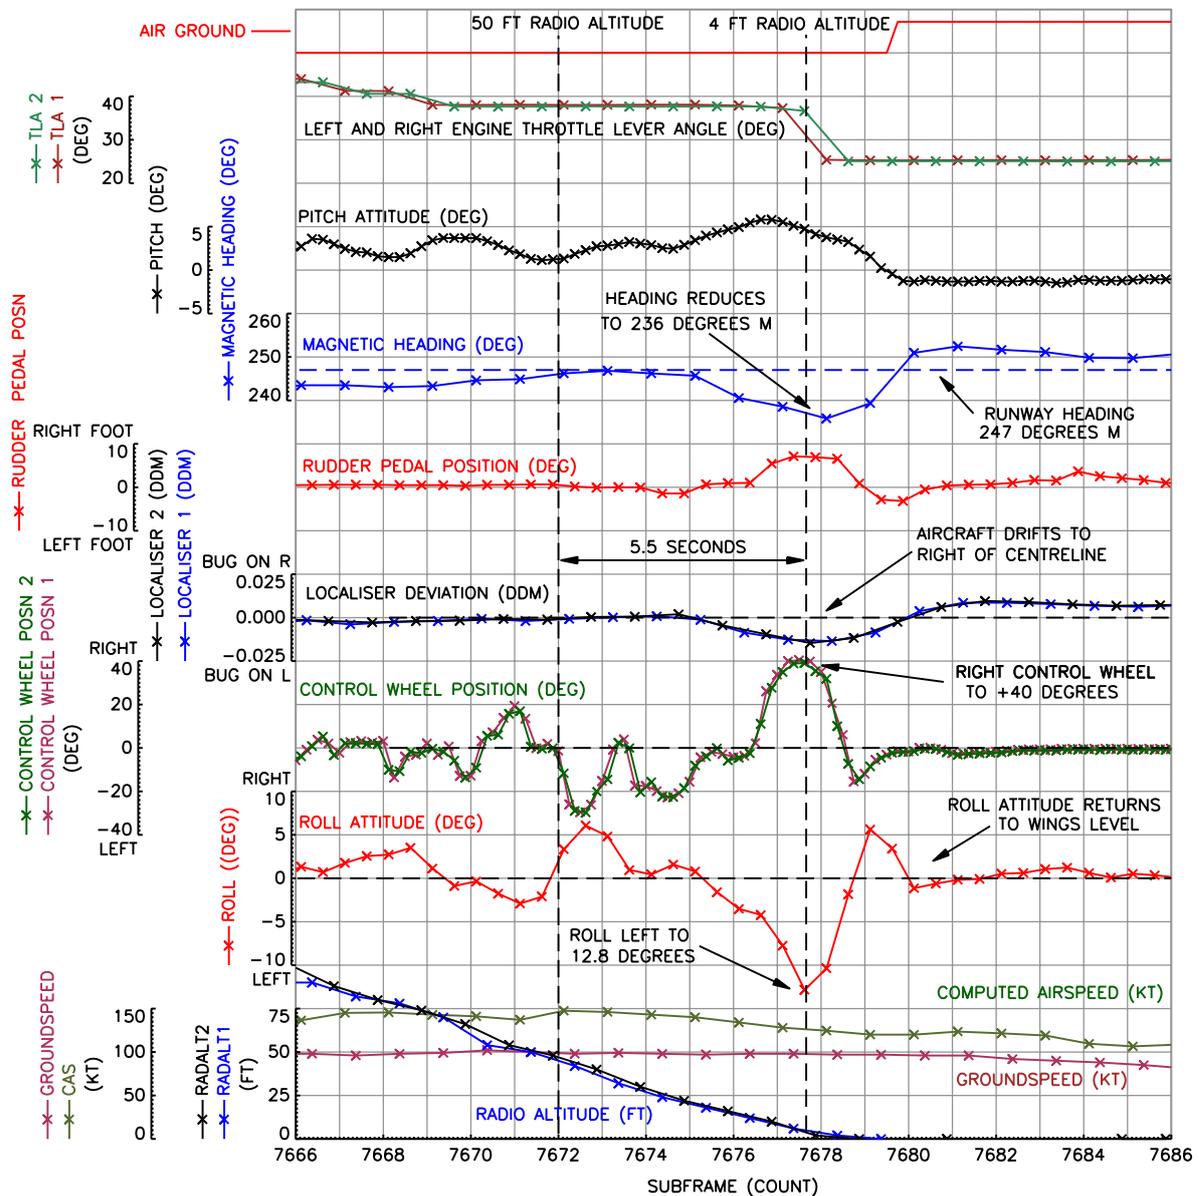
Figure 3
G-CGWV FDM data

As the aircraft descended through 50 ft agl, the Computed Airspeed (CAS), which was sampled every second, was increasing between 137 and 148 kt. At the same time, the recorded groundspeed was 100 kt, magnetic heading was 244° and the roll attitude was (-)2.9°¹ to the left. Left and right aileron and rudder surface positions were not recorded, nor were they required to be. The exact touchdown point could not be established but at a radio altitude of 4 ft, the recorded localiser deviation showed the aircraft deviating to the right of the runway centreline, with its heading decreasing to 236°M. It rolled to a

maximum of (-)12.8° to the left, with a nose-up pitch attitude of approximately 5°. At the same time, the CAS reduced to 126 kt and the groundspeed to 97 kt. Full control wheel (40°) was applied to the right to counter the roll to the left, together with 7° of right rudder pedal².

$\pm 10^\circ$ initiates the warning but it is de-activated below 5 ft agl. Due to the sampling rate, the exact roll attitude at 5 ft agl could not be established but the recorded roll to the left was increasing from $(-)7.7^\circ$ to $(-)12.8^\circ$.
