FINAL
KNKT.15.12.28.04

Aircraft Accident Investigation Report

**PT. Kalstar Aviation
Embraer 190-200LR; PK-KDC
El Tari International Airport
Kupang, Nusa Tenggara Timur
Republic of Indonesia
21 December 2015**

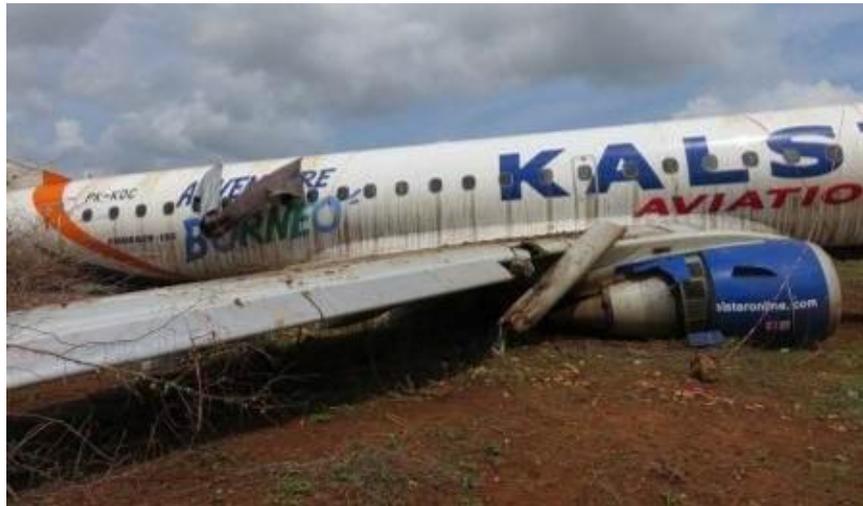
Figure 1: The damaged right wing

- Both nose wheels were minor damage. Reverted rubber marks found on both nose wheels.
- The right wing had severe damage with the details:
 - The navigation light broken,
 - The inner flap damaged,
 - The inboard slat detached from its mounting,
 - The wing leading edge behind the detached slat damaged by impact and torn (Figure 2).

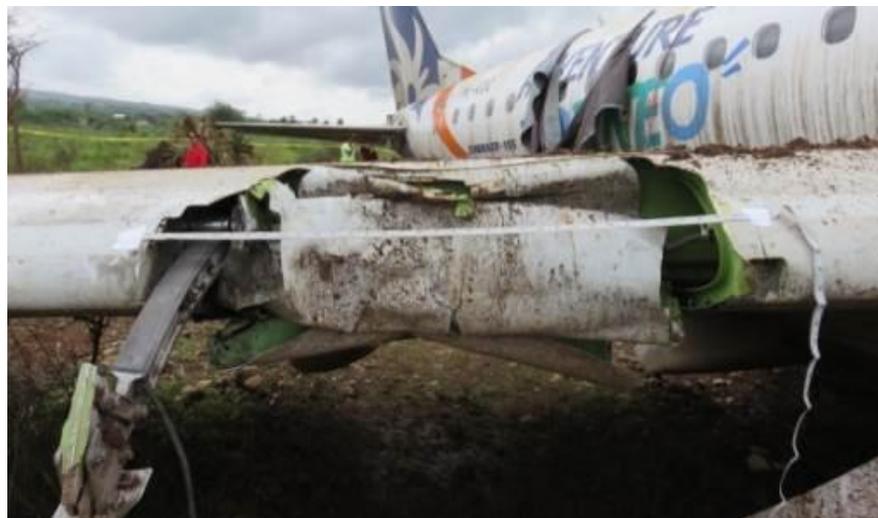
Figure 2: The impact damage on the right wing

Approximately 185 meters from end of runway 07, investigators found a collapsed palm tree. The dimension of the tree was approximately 40 cm in diameter with 5 m height. It is most likely that the right wing hit this tree damaging the leading edge of the right wing.

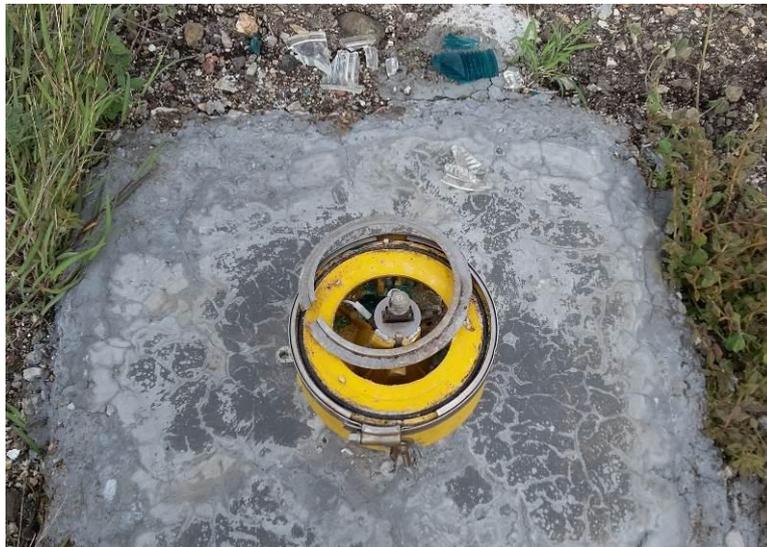
Figure 3: Broken runway light

There was a broken runway light at the end of runway 07.

A broken runway light was found at the end of runway 07 on the path of the aircraft movement.

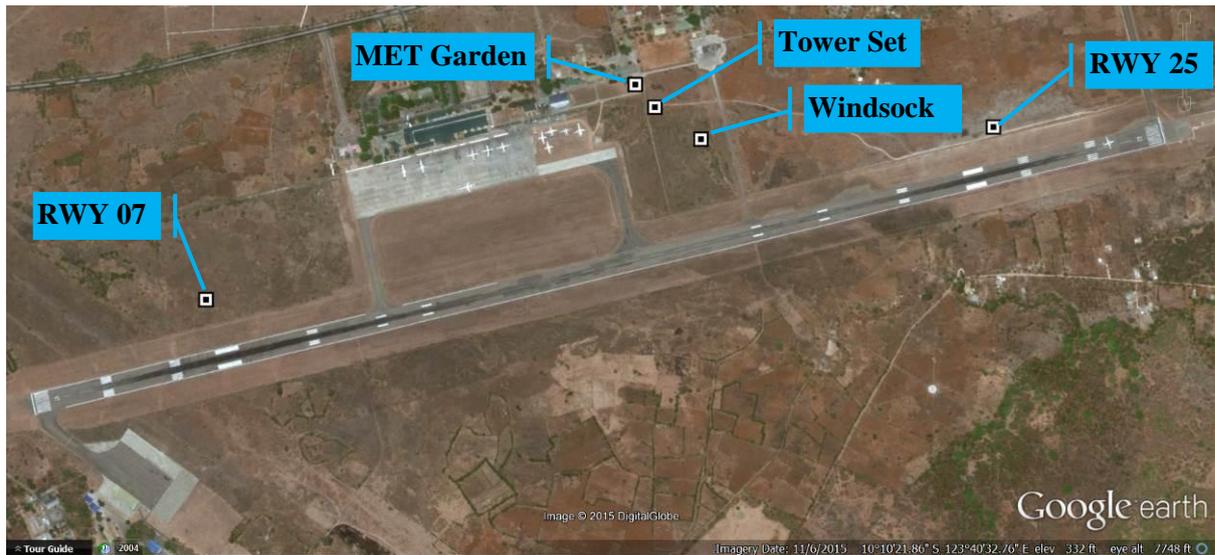
Figure 7: Meteorological sensor and windsock locations

There were three different sources that provided the latest wind information to air traffic controller which were the AWOS display, the Tower Set display and a windsock. Based on the interview, the air traffic controller stated that they used the information from AWOS display of runway 07 and the windsock near the tower building as comparison before providing the latest wind condition to the pilot of the accident flight.

The investigation could not find the standard procedure to determine the wind information from the three different sources (Figure 7).

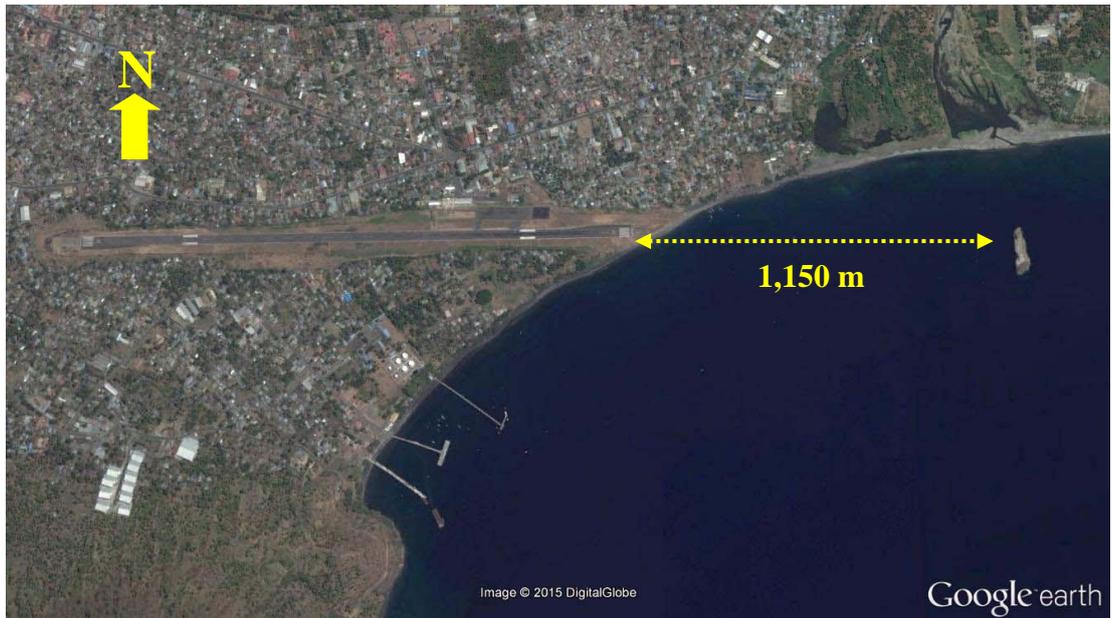
Figure 10: Atoll in final path runway 27

There was an atoll on final path runway 27 located at about 1,150 meters (0.62 Nm) from beginning of runway 27 and the height of atoll was approximately 180 feet.

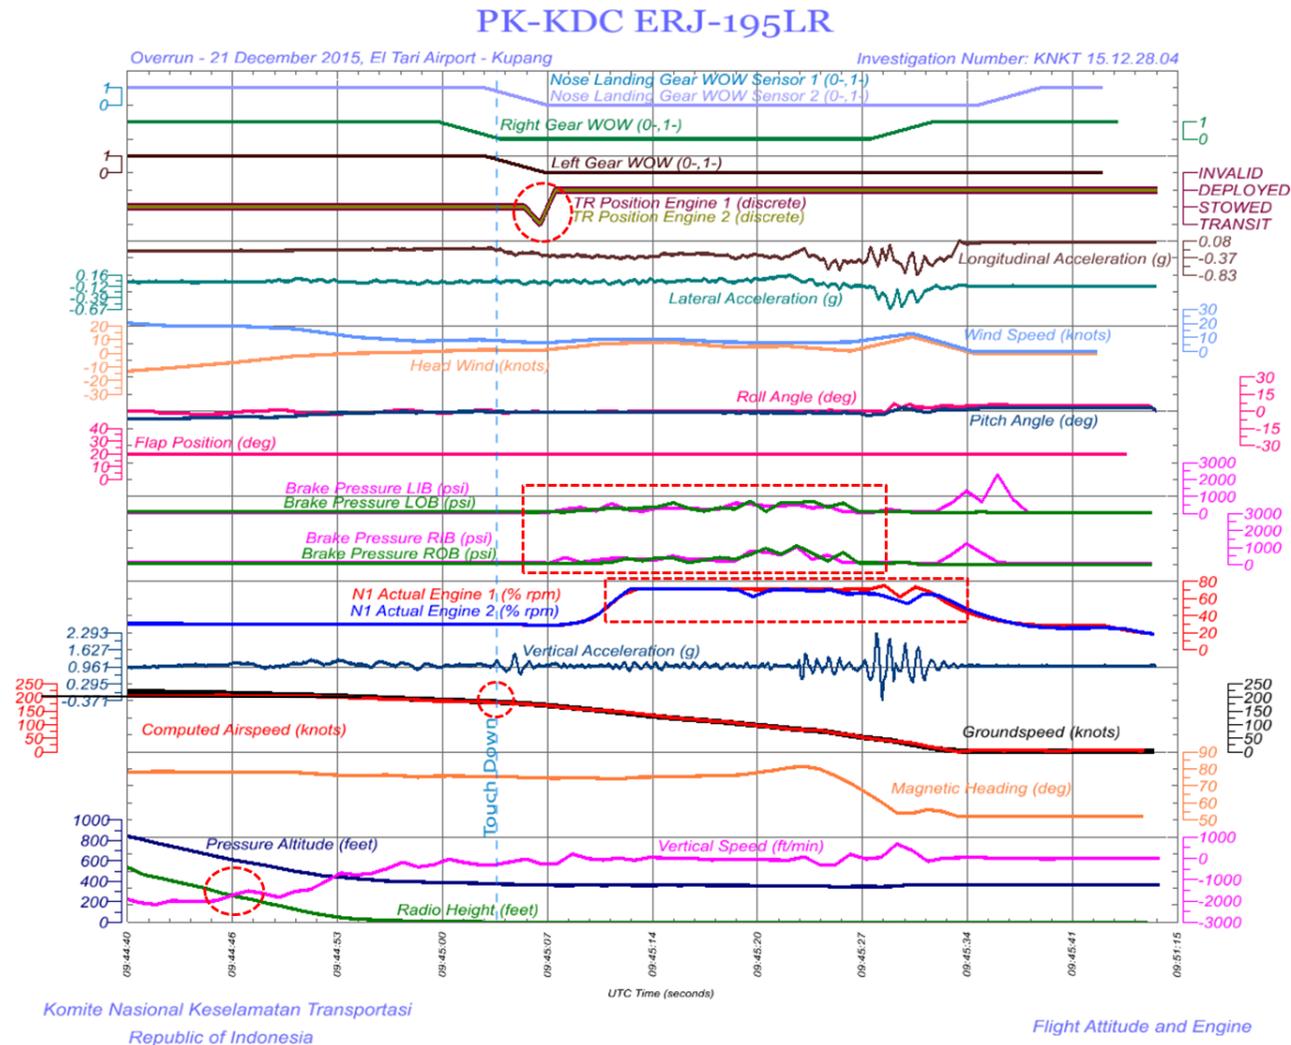
Figure 12: The graph of several flight data parameters of the accident flight

- When approach passed altitude 500 feet AGL, the rate of descent was more than 2,000 feet/minute and while passed altitude 200 feet AGL, the rate of descent was more than 1,500 feet/minute.
- Aircraft speed at 50 feet above runway was approximately 200 knots and 180 knots on touchdown.
- The thrust reversers deployed immediately after touch down.
- Brake pressures of both inboard and outboard were below 1,000 psi until the aircraft commenced to stop.
- The engine N1 rotation increased after the thrust reversers deployed.

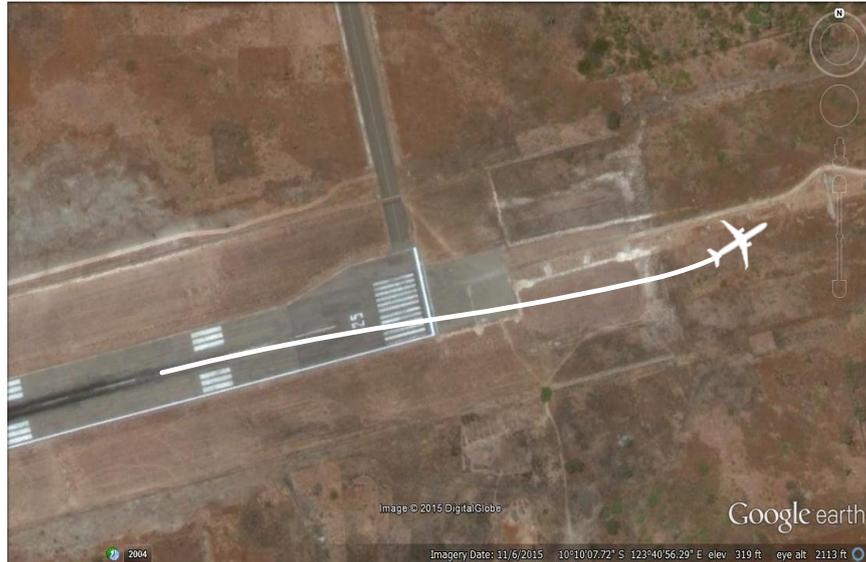
Figure 15: Illustration of tire mark when the aircraft started to veer from runway centerline (white line)

The investigation found tire marks began at 220 meters before end of runway 07 and indicated the aircraft started to veer to the right (Figure 15).

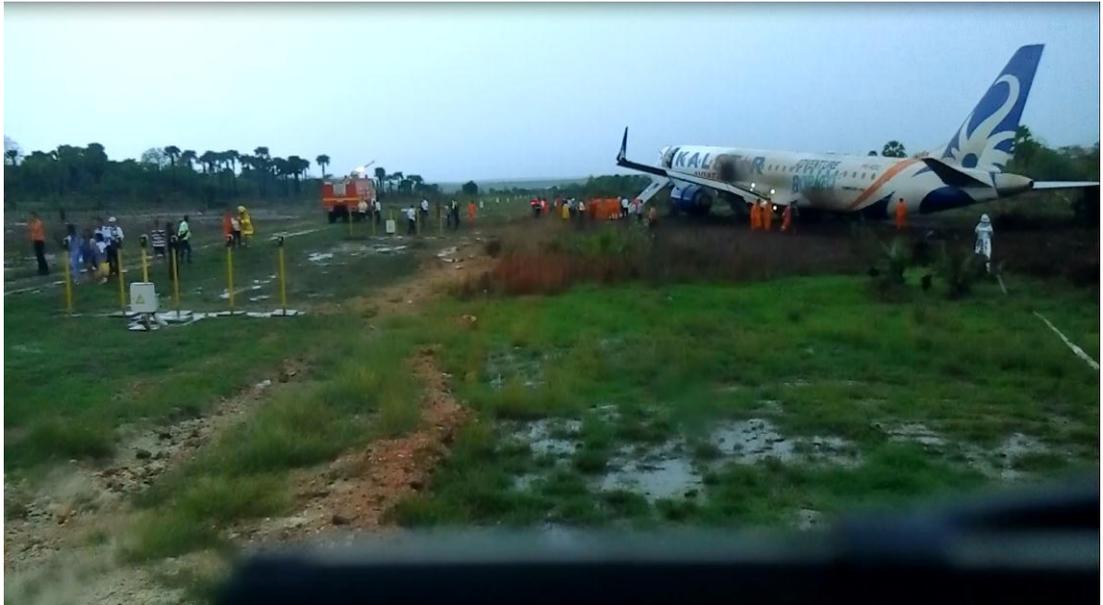
Figure 17: The aircraft final position

The aircraft stopped approximately 200 meters from the end of runway 07 on a heading of 060° . The relative angle of the aircraft and the ground was approximately 7° and the nose wheel was lifted about 50 centimeters from ground. The wings were tilted about 4° to the right (Figure 17).

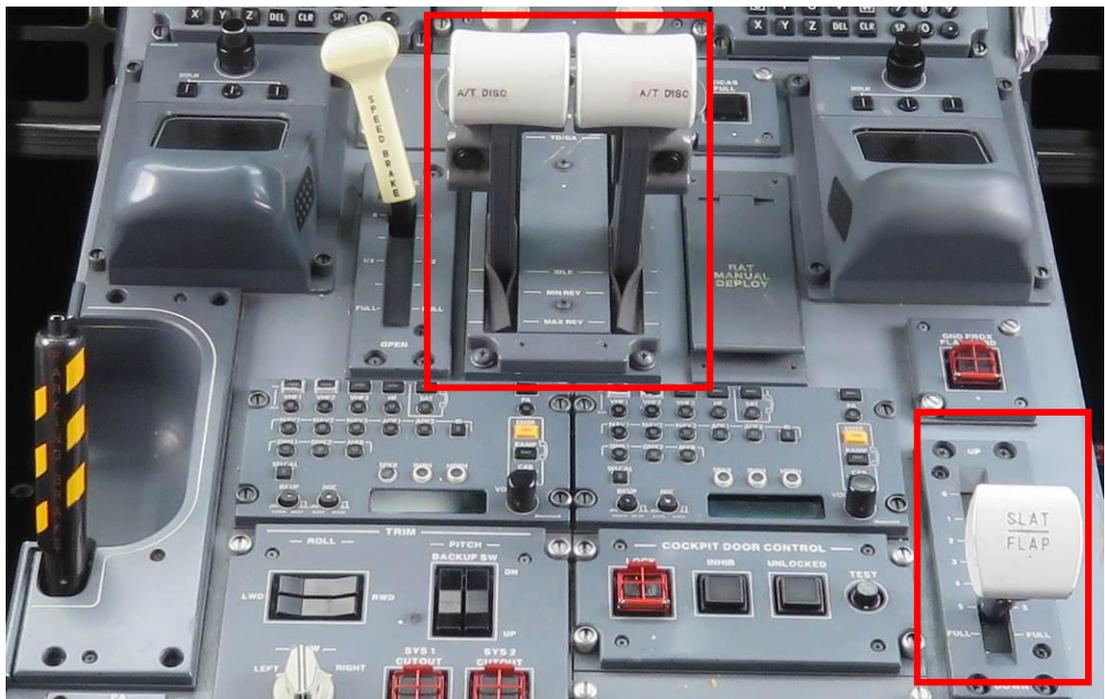
Figure 18: The thrust levers and flap selector observed after the aircraft stopped

The right main landing gear collapsed and contacted with the right inner flap. The flap selector was found at the Flap 5 detent (20 degrees wing flaps - Figure 18).

All wing flaps were extended to approximately 20 degrees.

The entire engine thrust reversers doors opened. The right engine thrust reverser doors detached and were found about 35 meters behind the aircraft.
