FINAL INVESTIGATION REPORT ON
ACCIDENT TO BORDER SECURITY
FORCE SKA B-200 AIRCRAFT VT-BSA
NEAR IGI AIRPORT, DELHI ON
22.12.2015

COMMITTEE OF INQUIRY VT-BSA

FINAL INVESTIGATION REPORT ON ACCIDENT TO BORDER SECURITY FORCE
BEECHCRAFT SKA B-200 AIRCRAFT VT-BSA NEAR IGI AIRPORT, DELHI ON
22.12.2015

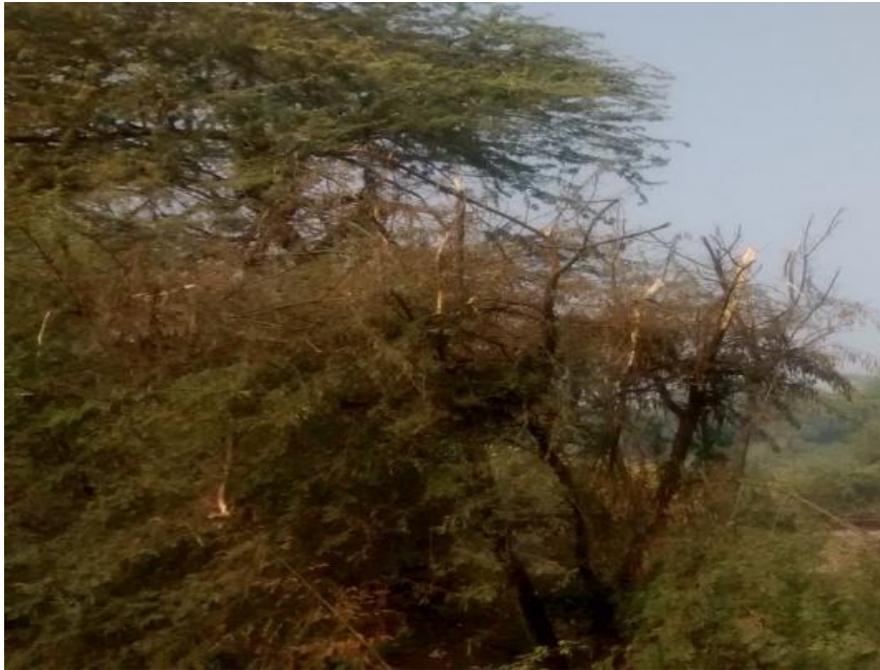
As per the evidences collected and inspection of the accident site the aircraft primarily impacted the trees as was evident from the chopping off the trees in the final phases of the path followed by the accident aircraft. The trees were probably chopped off by the aircraft wings as the aircraft was at a high roll attitude.

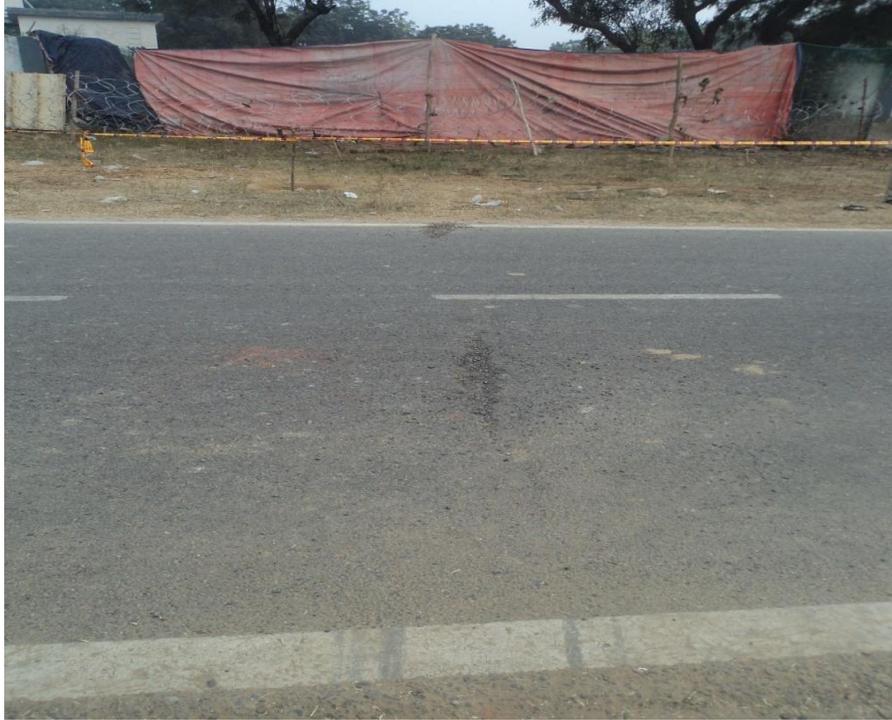
There were rubbing marks observed on the outside perimeter road of the airport and a part of wing tip was recovered beside the road indicating the rubbing marks were of the aircraft wing tip.

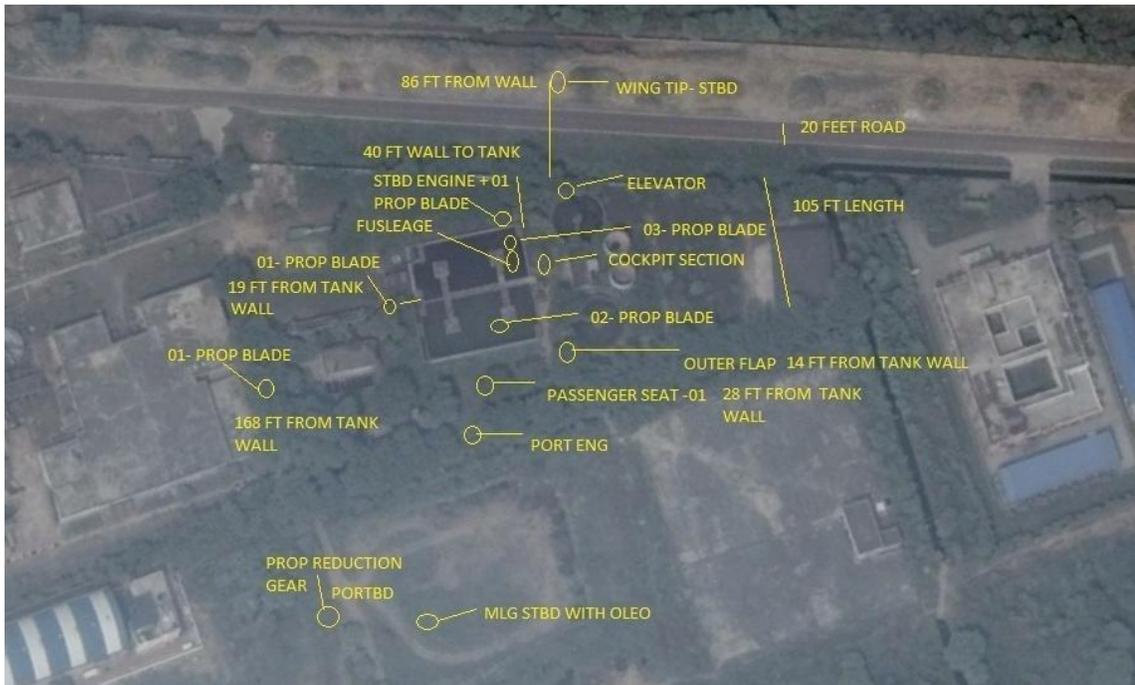
The wreckage distribution

1. Propeller Blades of both the propellers are broken from the Hub. Since the Blades were separated from the Hub the Pitch of the blades could not be ascertained.
2. RH Engine was found completely burnt with Reduction Gear Box separated from the engine and broken. However LH engine was comparatively less burnt but Reduction Gear box of LH engine was also broken.
3. Both the engines were separated from main structure.
4. All the instruments were completely burnt and damaged. The readings/indications cannot be ascertained.
5. Condition of the Engine before the event could not be ascertained by the control levers in the cockpit as all the six levers were found burnt and friction lock completely damaged. All the six levers (Power, Prop RPM and Condition) were found loose.

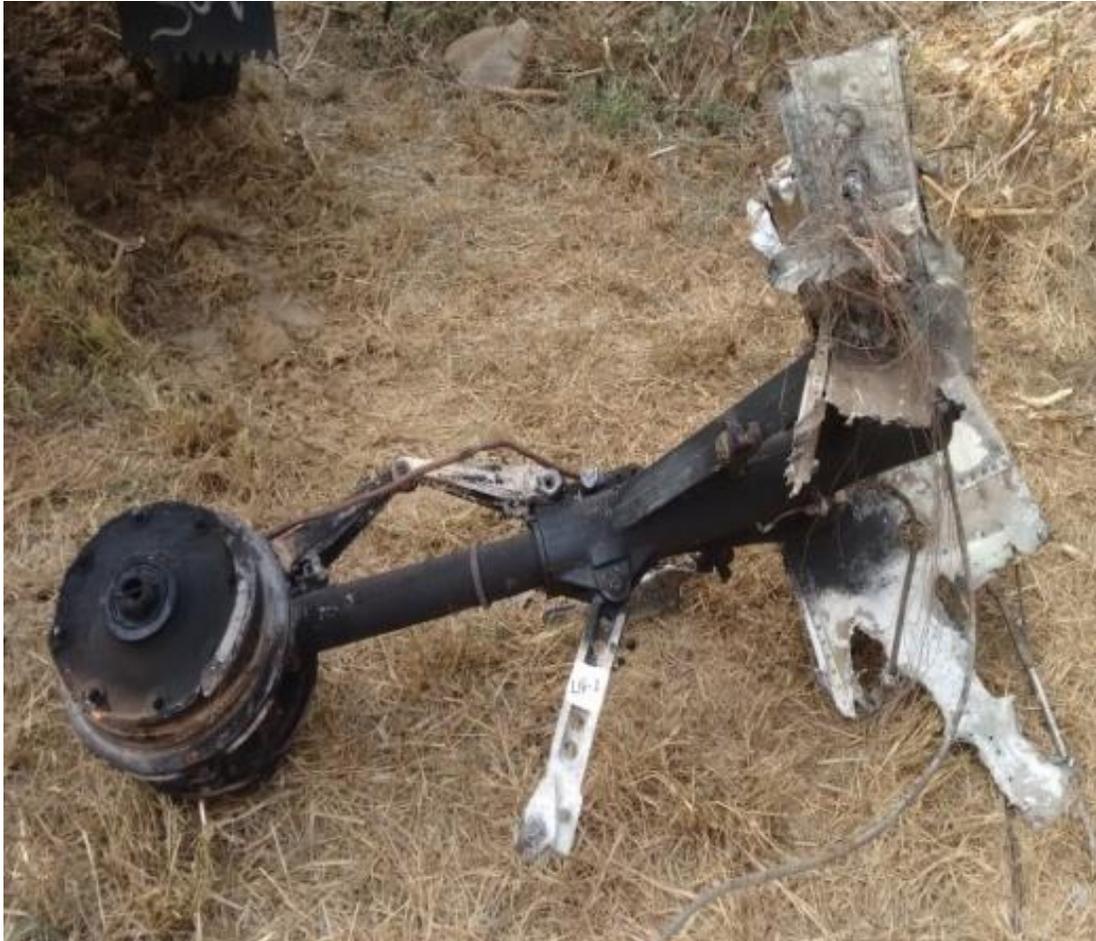
6. Landing Gears were found in extended condition. RH Ldg Down lock was in place but LH Ldg down Lock was free but the actuator of both the Ldg gears were in extended condition.

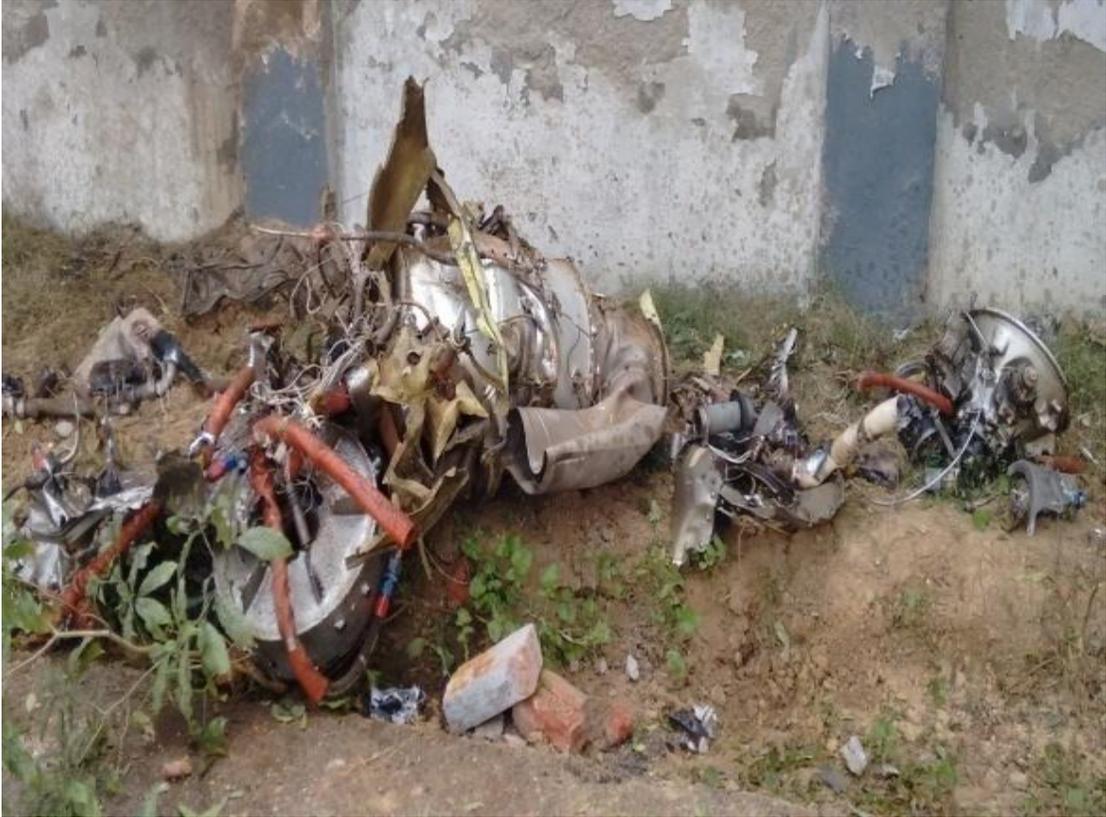
***Though wreckage was self-contained
but was disturbed to carry out rescue operation***

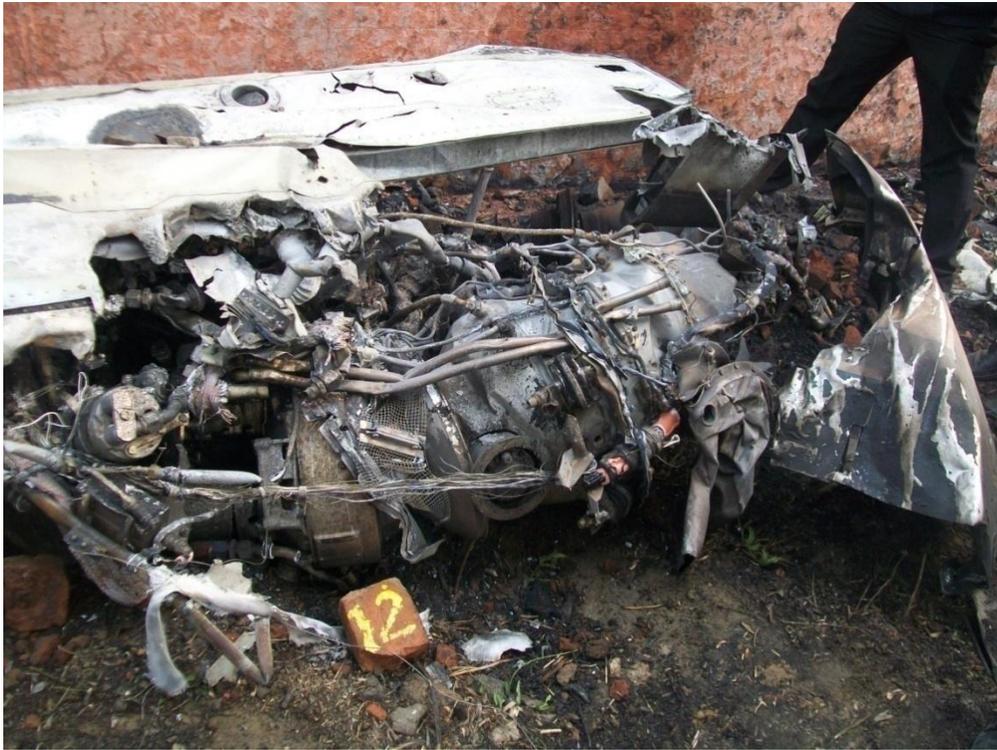
Damaged Engine

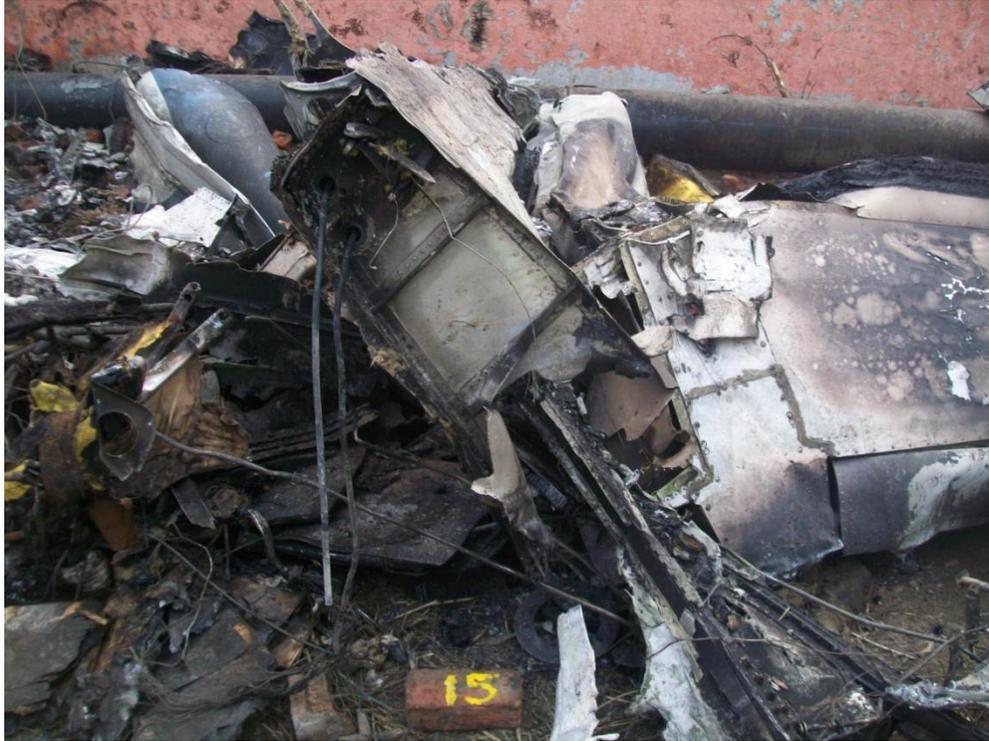
Horizontal & Vertical Stabilizer

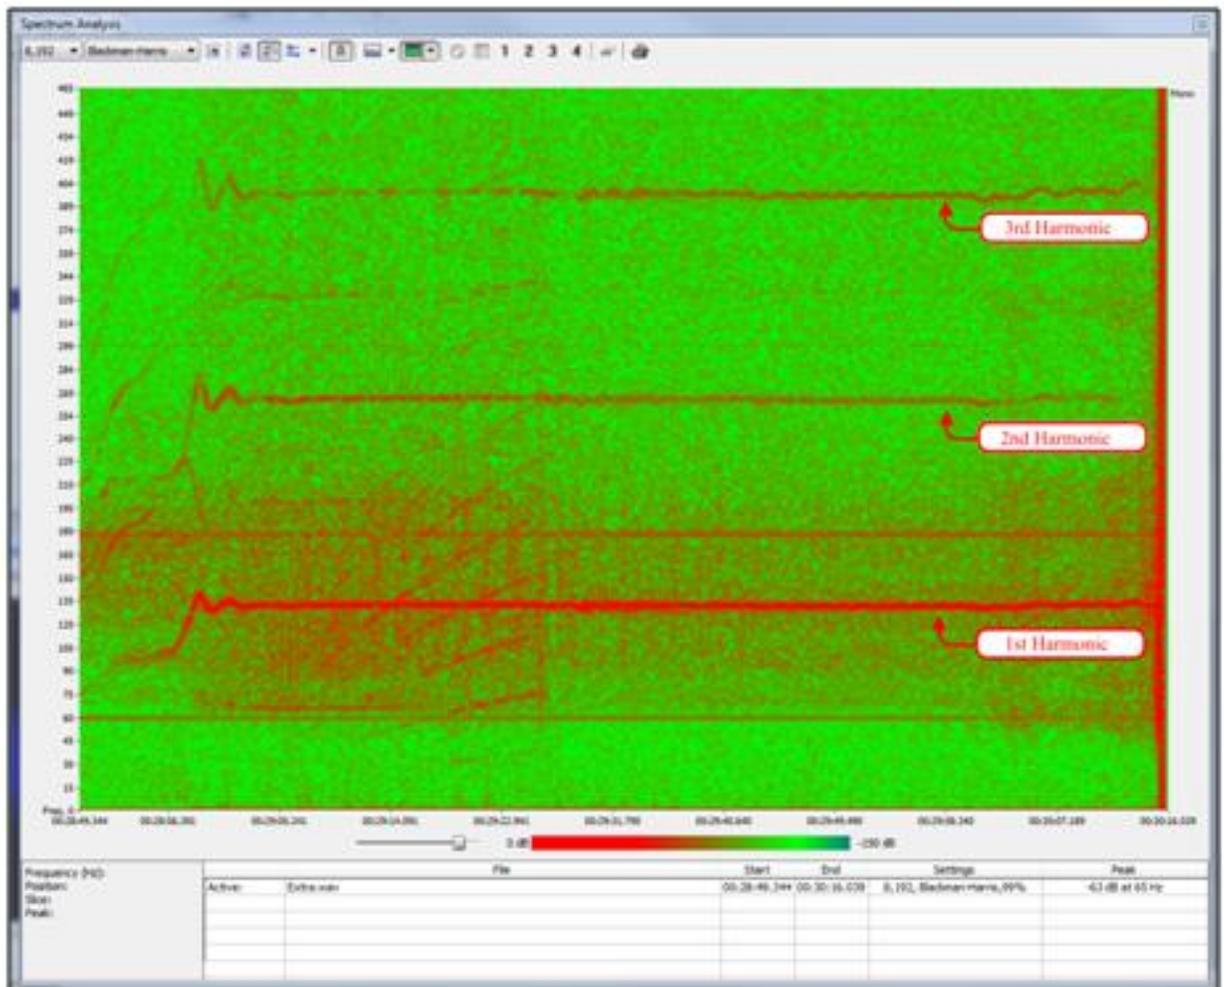
Spectrum analysis of takeoff portion of occurrence flight using data from the recovered extra channel

The first three harmonics of the propeller sounds were visible. A strong, consistent signal at approximately 133 Hz was visible in the first harmonic signature.
