Havarikommisjonen
Accident Investigation Board Denmark

FINAL REPORT

Serious incident

OY-LHA

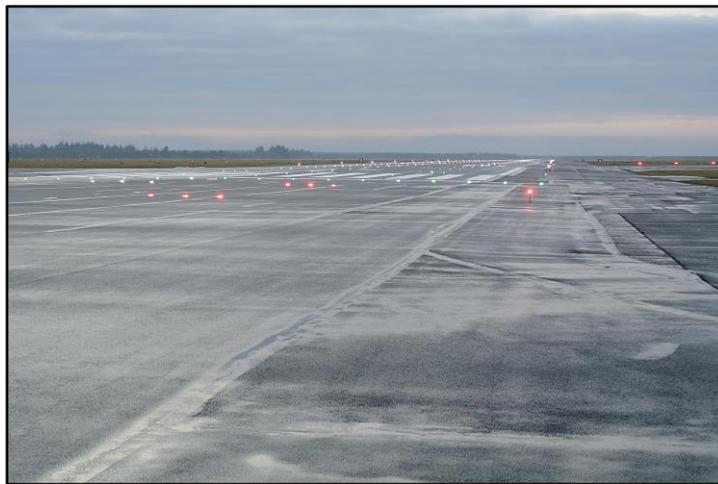
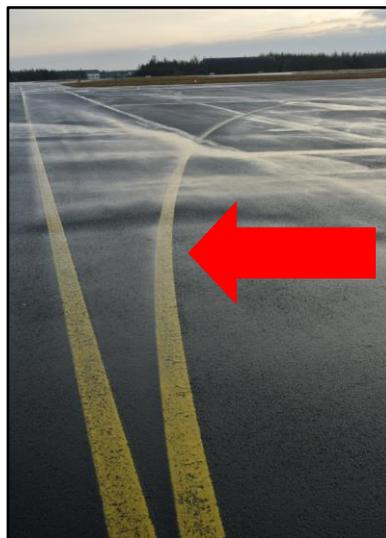
1.10.6 Intersection E at runway 27L

Runway 27L had an extra tarmac width (paved runway shoulder area) at intersection E, where the aircraft entered the runway. At the time of the serious incident, the area directly north of runway 27L was in darkness. The paved runway shoulder areas were not marked.

A taxiway lead-in line painted yellow lead from taxiway E to the center of the underrun of runway 27L.

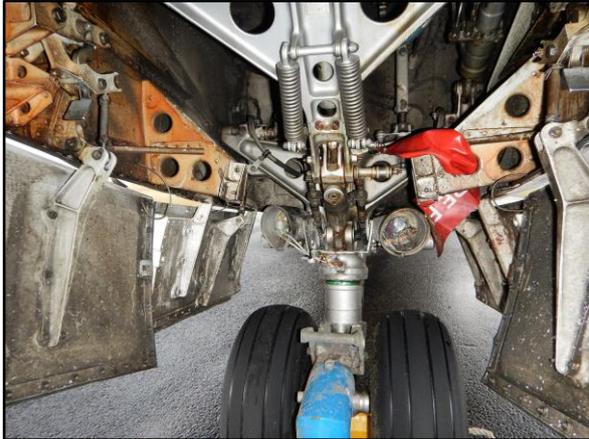
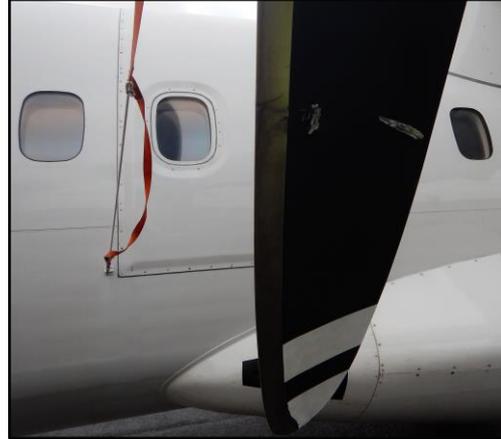
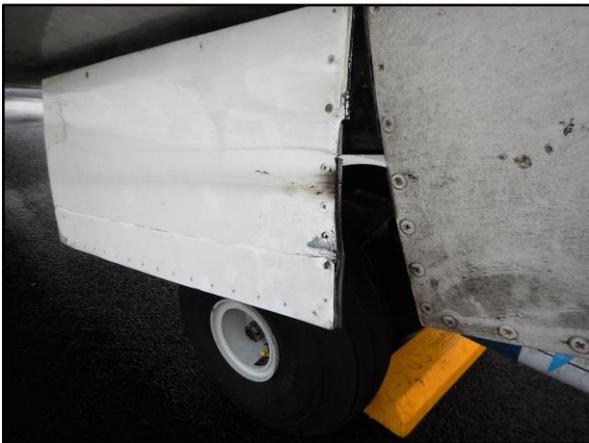
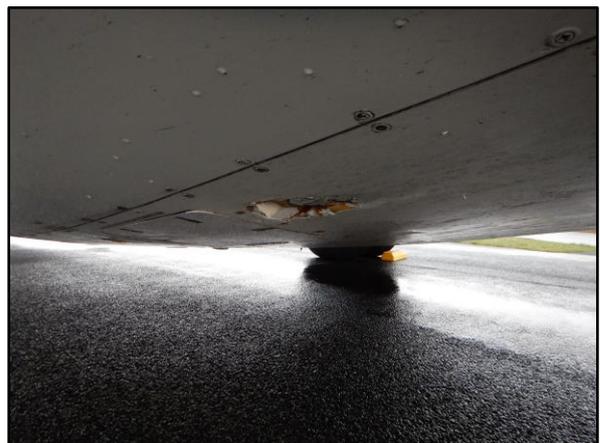
1.12.1 Damages to the aircraft

There were damages to and several cuts on:

- The nose landing gear taxi lights
- Both right hand nose landing gear doors
- Two of the propeller blades on the left hand propeller
- The lower fuselage skin in front of the air conditioning ground connection panel
- The tyres of the nose landing gear and the right main landing gear

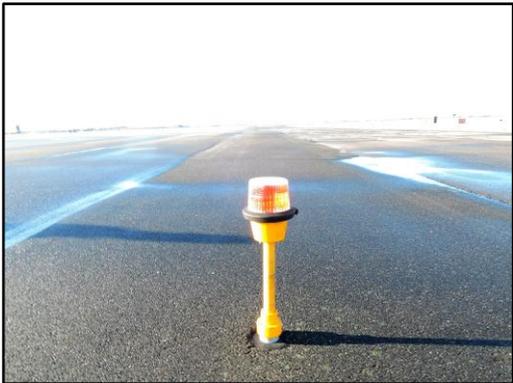
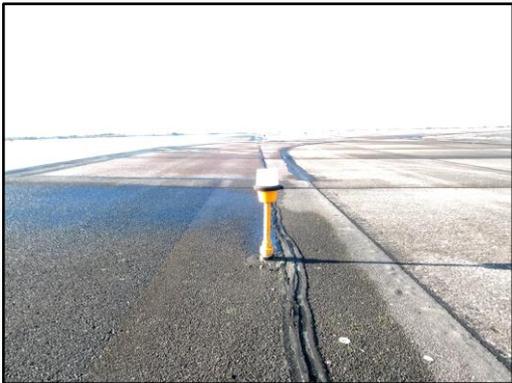
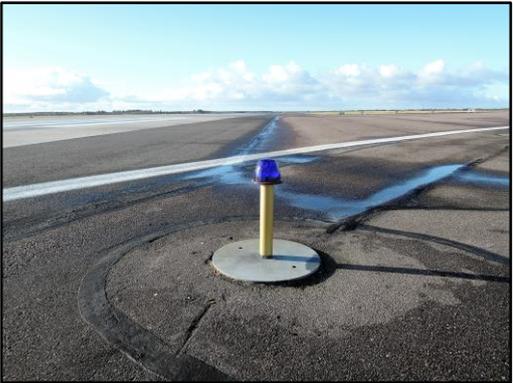
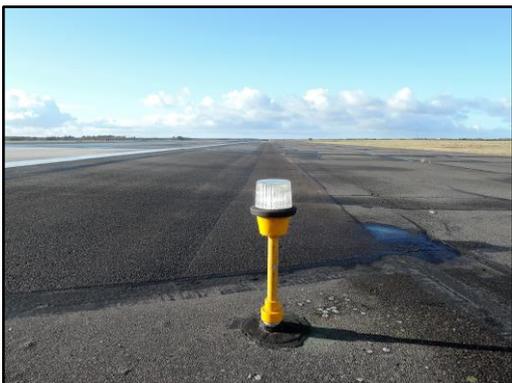
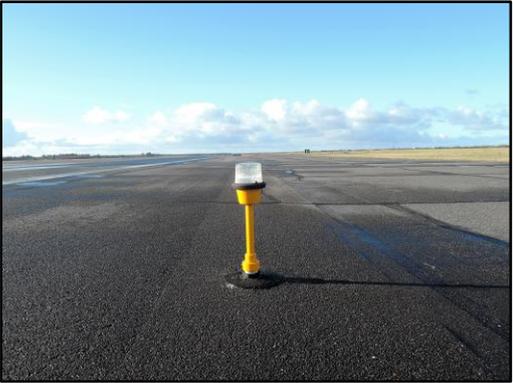
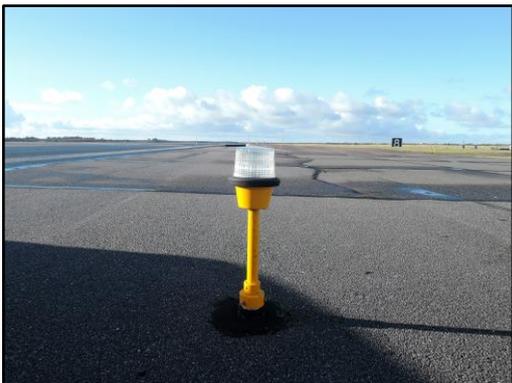
5.12 Runway edge lighting system

During the sequence of events, the aircraft hit six elevated runway edge lights and two obstacle lights on top of the military arrester cable mechanism along the right-hand side of runway 27L.
