**KOMITE NASIONAL KESELAMATAN TRANSPORTASI
REPUBLIC OF INDONESIA**

KNKT.16.02.05.04

Aircraft Serious Incident Investigation Report

Boeing 737-900ER; PK-LFG

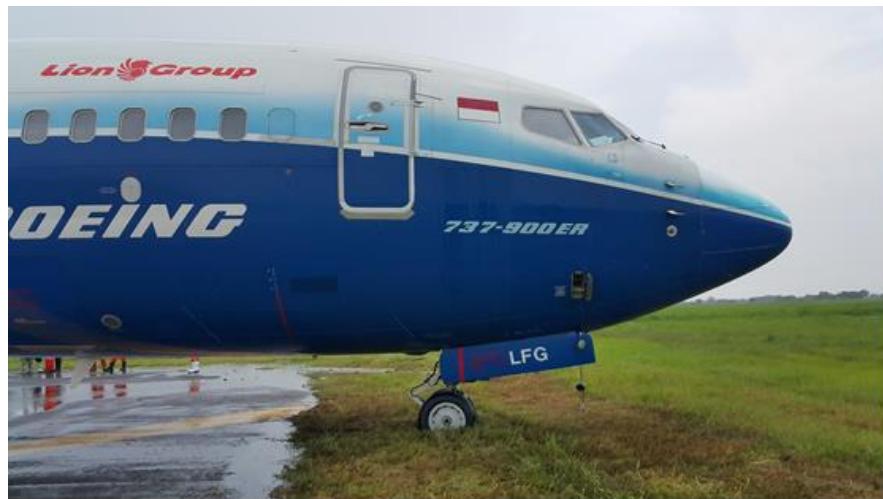
Figure 2: The aircraft last position

The aircraft overrun and stopped with the nose wheel position at approximately one meter out of the pavement. No one injured on this occurrence. There was no damage to the aircraft or to property and environment.

The aircraft overrun and stopped with the nose wheel position at approximately one meter out of the pavement. The pilot contacted Juanda Tower controller informed that the aircraft could not continue taxi.

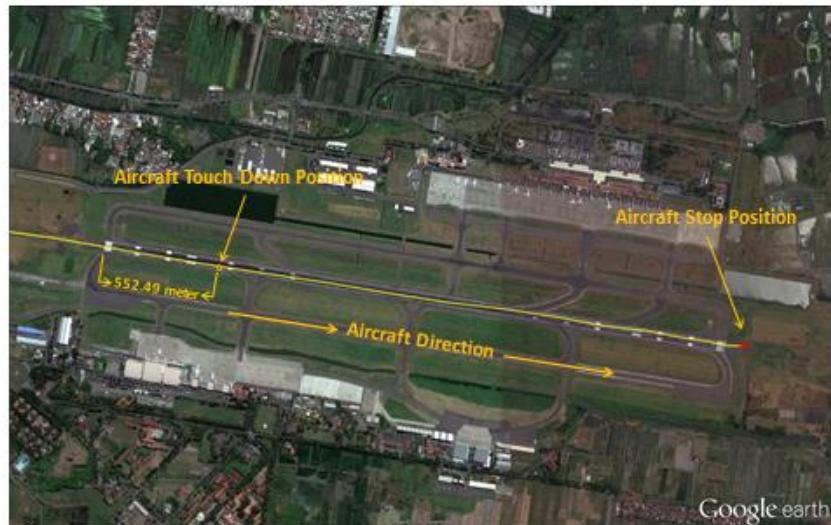
Figure 5: The landing trajectory processed from the FDR

Based on the FDR data, the aircraft touched down at approximately 552 meters from the beginning of the runway 10.

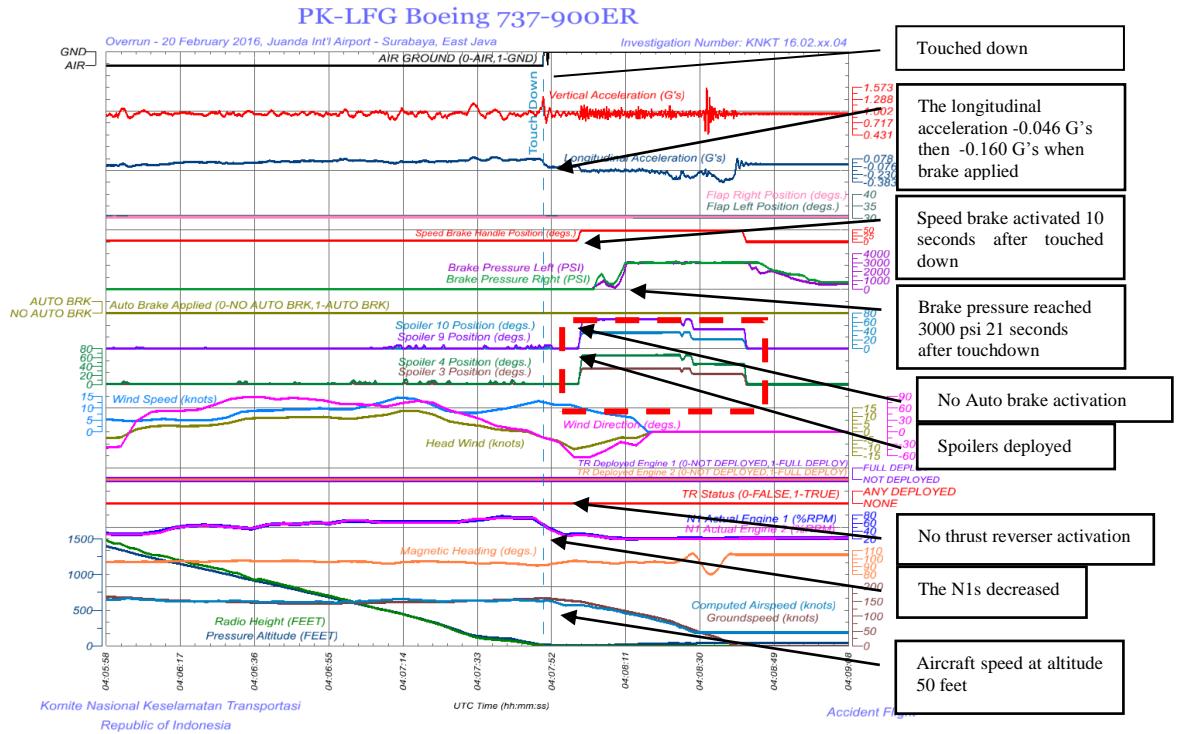
Figure 6: The FDR information started from aircraft altitude 1,500 feet to end of the flight

- 04:08:00 UTC, the speed brake handle position moved to 47° and the spoilers deployed.
