COMANDO DA AERONÁUTICA
CENTRO DE INVESTIGAÇÃO E PREVENÇÃO DE
ACIDENTES AERONÁUTICOS

FINAL REPORT
A-061/CENIPA/2016

OCCURRENCE:	ACCIDENT
AIRCRAFT:	PR-CRF
MODEL:	208B
DATE:	04APR2016

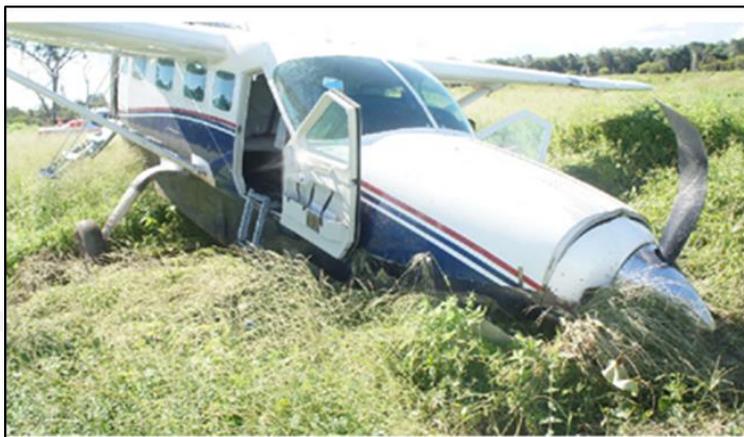
The aircraft had substantial damage to the propeller, engine, nose landing gear, and right wing.

Figure 1 - Aircraft with broken nose landing gear and propeller blade damage.

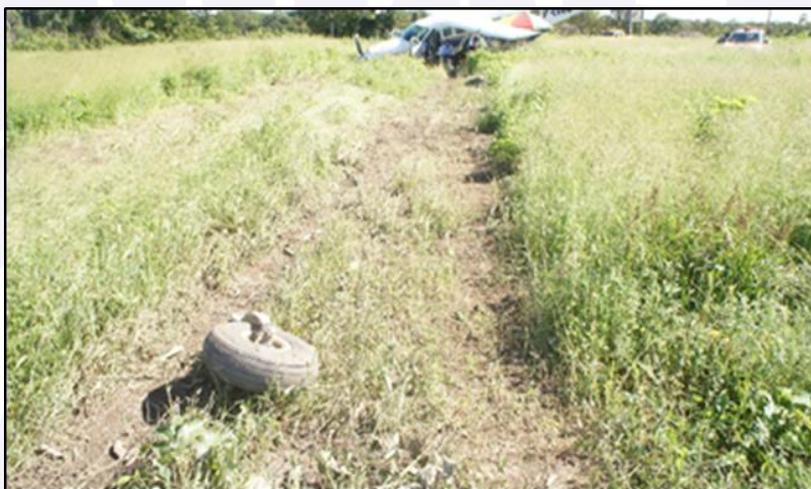
Figure 2 - Marks on the ground and wheel of the nose landing gear.

During this trajectory, the nose landing gear broke, whose wheel was separated from the aircraft, as shown in Figure 2.

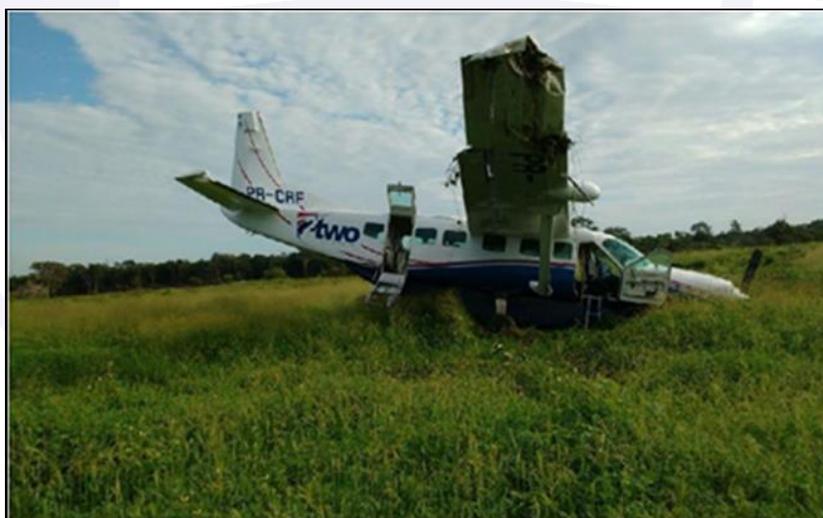
Figure 3 - Damage to the right wing.

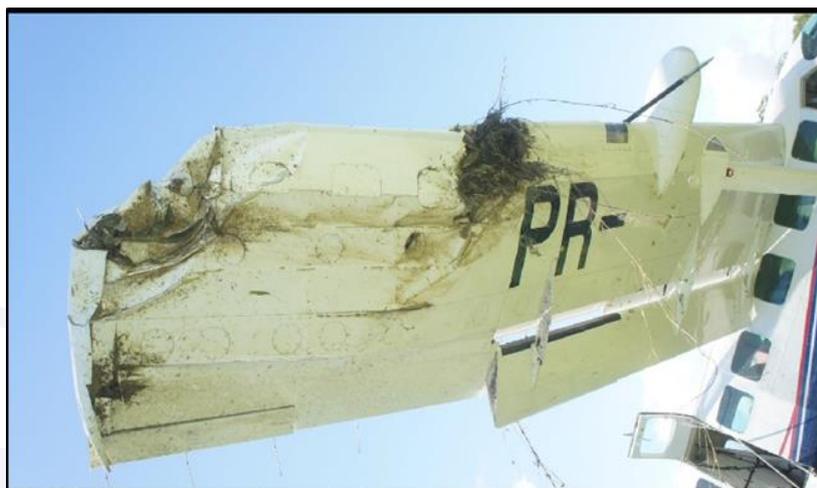
Figure 4 - Detail of damage to the right wing.

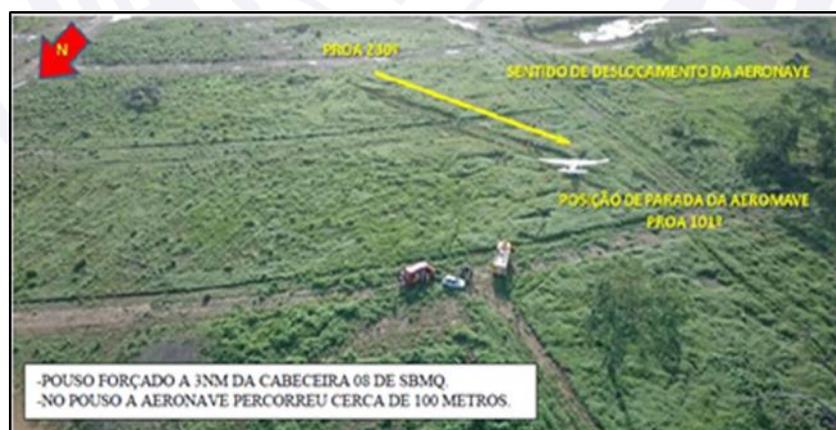
After touching the ground, the aircraft traveled approximately 100 meters and went left.

Figure 5 - Aerial view of the occurrence site.

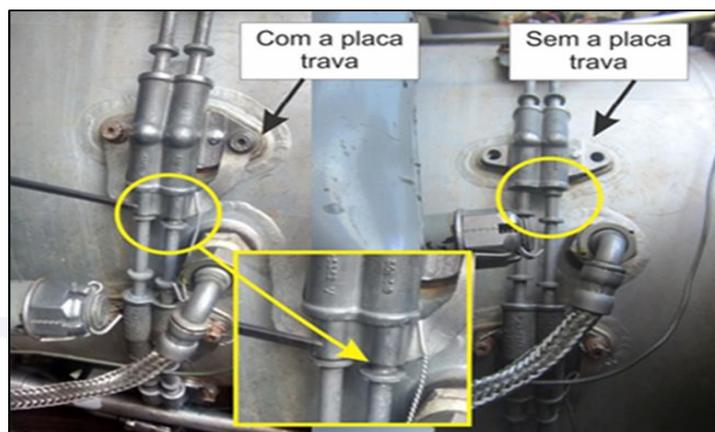
However, during this inspection, it was observed that one of the transfer tubes of the fuel injection nozzle, near the igniter, located at the 4 o'clock position of the external area of the engine at the combustion chamber level, appeared to have moved from its position (Figure 6).

Figure 6 - Evidence of displacement of the fuel transfer tube to the injector nozzle.

Under these conditions, the high working pressure of the fuel in that region caused the fuel transfer tube to recede and move from its original working position. This resulted in a fuel leak that resulted in loss of power and subsequent engine shutdown.

On the other hand, the fuel transfer tube away from its housing could explain the loss of engine power.

The displacement of the transfer tube was possible because the igniter cable wire, at the 4 o'clock position, had been anchored on its latch plate. When the wire was pulled too far, it lifted and deformed this plate, as shown in Figure 6 of this report.

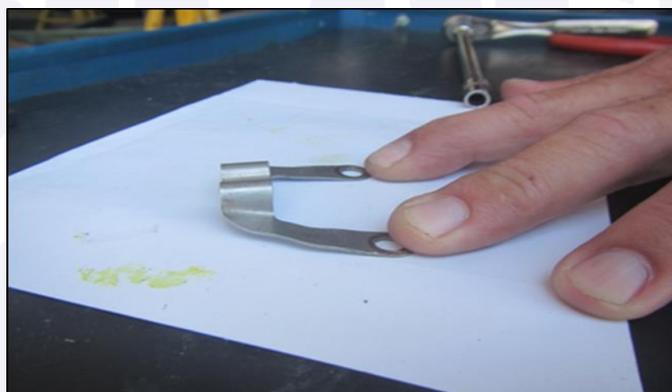
A deformation in the latch plate of these transfer tubes was also observed (Figure 7).

Figure 7 - The latch plate of the transfer tubes with deformation.

On the deformation in the latch plate of the transfer tubes, it was concluded that it occurred because the safety wire of the spark plug cable, at the 4 o'clock position, was anchored therein.

This wire, when pulled excessively, deformed the latch plate and pushed it away from the transfer tubes, leaving them free to move.

Thus, the deformation of the latch plate of the transfer tubes, which allowed its displacement, probably occurred during the execution of this safety wired.

Act with TWO Air Taxi Ltd. in order to ensure that the performance and supervision of the services performed on the Cessna 208B aircraft engines by this company are in accordance with that established by the engine manufacturer, in particular with regard to the CAP 70- 00-00 (Standard Practices - Maintenance Practices) of the Pratt & Whitney Canada Maintenance Manual.

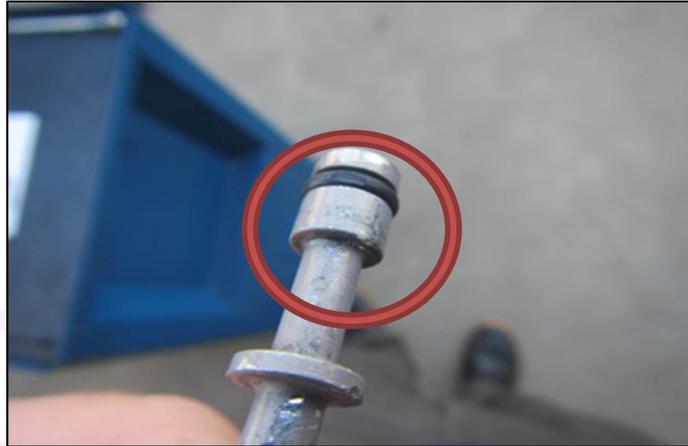
It was found that the sealing rings exhibited tearing, cracking and uneven wear on the sealing surfaces.

Figure 9 - Worn transfer tube sealing ring (packing).

The tearings on the transfer tube's sealing rings may have been caused by the action of the fuel on it, since, due to the high working pressure in that region, occurring a leak, the fluid would produce damages equivalent to those of a cutting object.

The cracks and wear indicated that they were no longer fit for use.

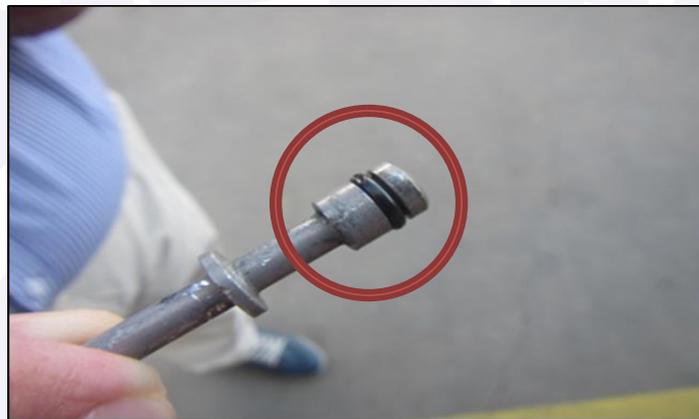
Figure 10 - Worn transfer tube sealing ring (packing).
