## *Final report RL 2017:03e*

**Serious incident at Gällivare Airport on 6 April 2016 involving the aeroplane YR-FZA of the model F28 Mark 0100, operated by Carpatair.**

File no. L-33/16

9 March 2017

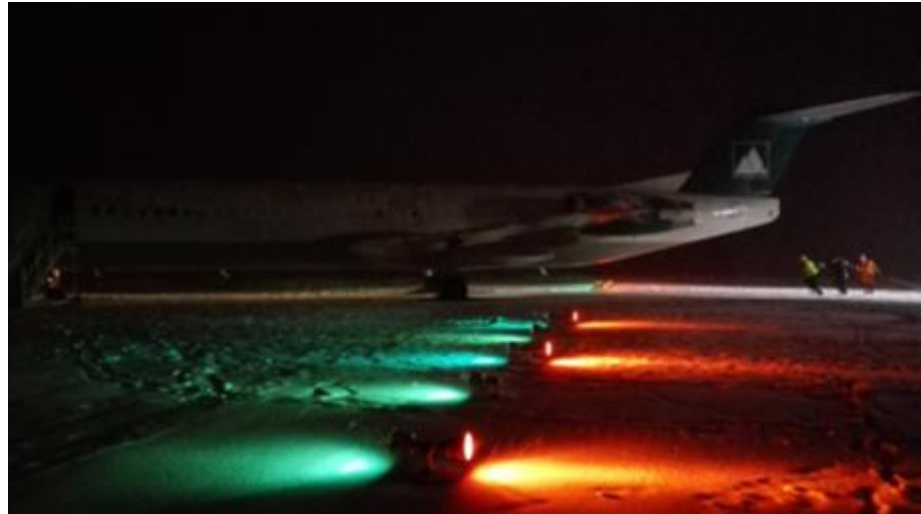
The aeroplane overran the paved runway and stopped on the runway strip with the main wheels just over six meters after the runway end (see figure 1).

Figure 1. The aeroplane after the overrun (Photo: Lapland Airport).

The damages, which were limited, consisted of damaged tires and engines' fan blades due to the reverse time within a restricted rpm range exceeded the maximum allowed time span.

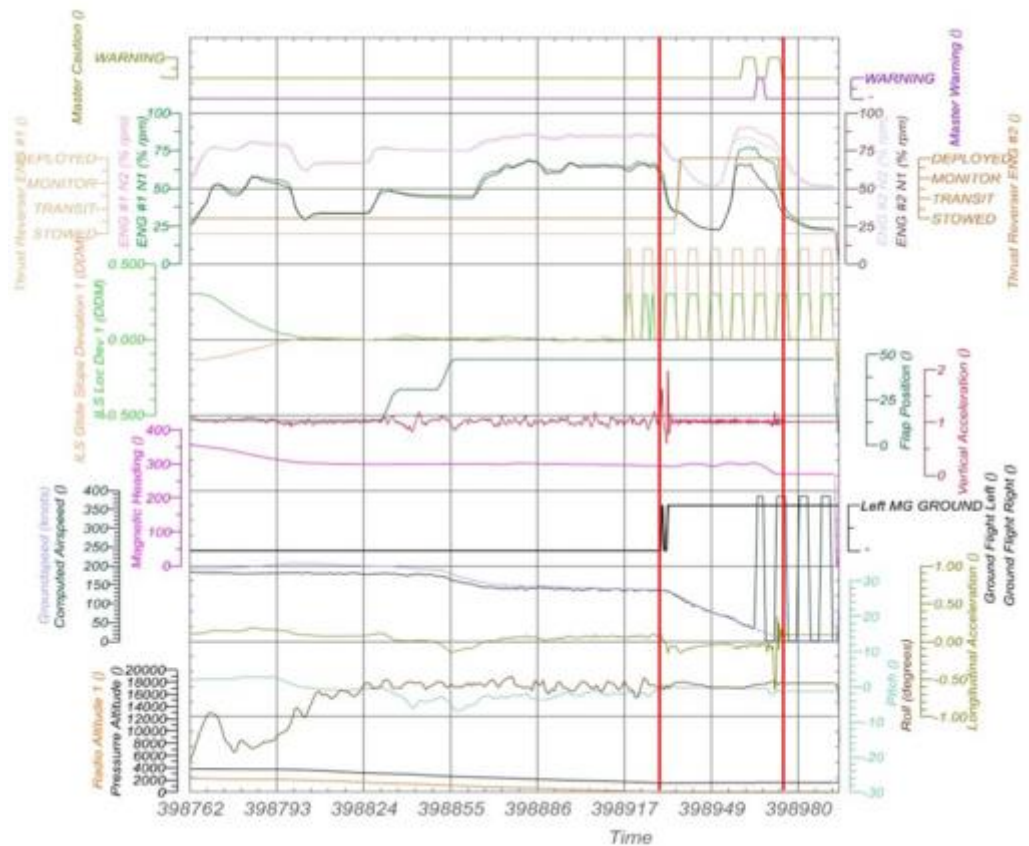
However, DFDR-data indicates that the reverse thrust increased from low idle only 20 seconds after touch down at a speed of about 50 knots. Thereafter the reverse rpm increased to about 75 % on the left engine and 65 % on the right engine.

The left red vertical line corresponds to the first touchdown while the other line indicates the time of the complete stop. The time span between the lines is about just over 40 seconds.

Figure 6. DFDR-data printout.

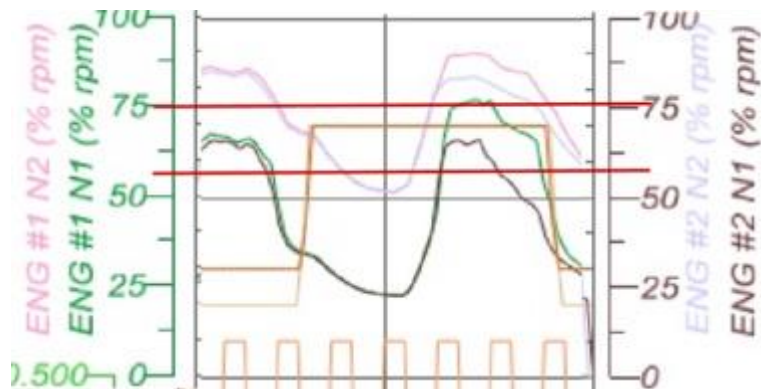
Figure 7 below is a partial enlargement of figure 6 and displays rpm in % N1 for left and right engine respectively (ENG #1, ENG #2), in green and brown colour. The red horizontal lines indicate the restricted area as described in section 1.6.2.

Figure 7. Detail of DFDR-data printout for engine parameters.

DFDR-data indicate that the longitudinal acceleration during the rollout averaged -0.07 G until the reverse rpm started to increase. This indicates that the wheel brakes had no effect during period, which either might be caused by the absence of brake application, or by a very low friction coefficient. The pilot's statement that the brake temperature indicated low values after landing is also indicates that the wheel brakes had no effect.

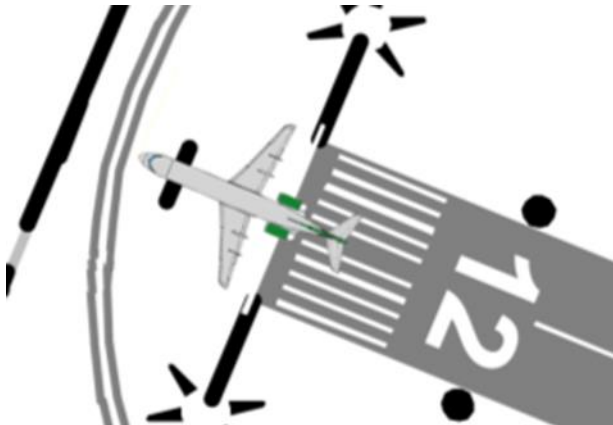
The occurrence took place at the end of runway 30 at Gällivare airport. The aeroplane came to a complete stop on the runway strip. The area was covered by snow.

Figure 8. The aeroplane's position after the excursion.

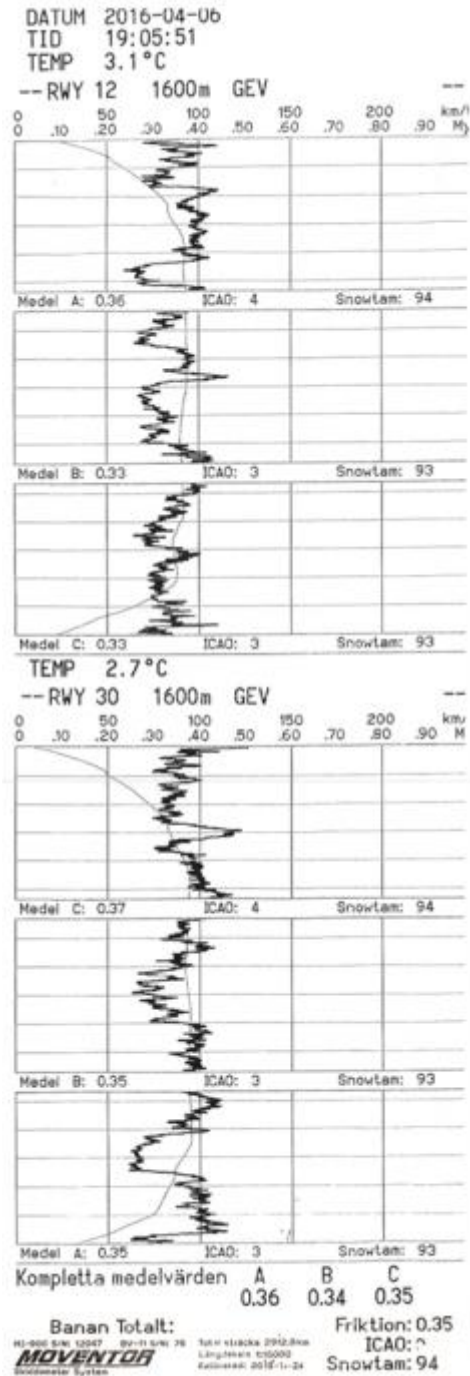
The measurement protocol below (figure 15) shows the last measurement prior to the event. The bold line shows the friction values for both runway directions.

The thin line shows the vehicle speed in km/h. The best possible reliability is achieved at a speed of 95 km/h. As the vehicle needs acceleration and braking distance at each runway threshold, the entire runway cannot be measured with a speed of 95 km/h, which results in a deterioration of the measurement accuracy. As the touchdown zone starts about 300 meters after the threshold, less than half of the first third of the measurement is usable.

Figure 15. Measurement protocol with friction coefficients from Lapland Airport.

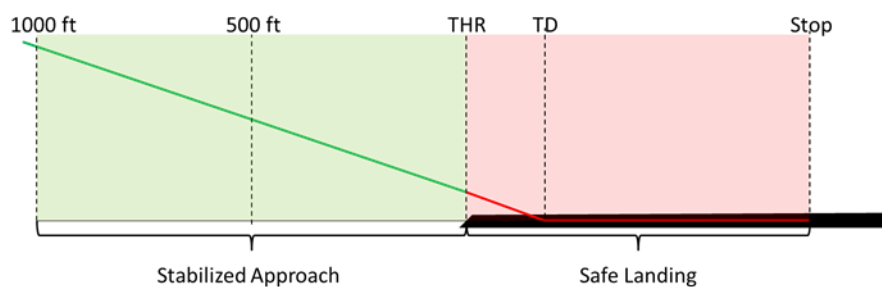
Figure 16- Safe Landing concept.

Figure 16 shows in a comprehensive manner the parts of the landing stage where there presently is an established operational concept (stabilized approach - green) and the parts where there is no such concept (at the crossing of the runway threshold - red).

SHK considers, for these reasons, that the airline industry and regulators should examine the possibility of introducing a Safe Landing concept (see figure 16).
