National Transportation Safety Board

Aviation Accident Final Report

Location:	San Bernardino, CA	Accident Number:	WPR16LA101
Date & Time:	05/06/2016, 1200 PDT	Registration:	N2AN
Aircraft:	ANTONOV AN2	Aircraft Damage:	Substantial
Defining Event:	Fuel contamination	Injuries:	2 None
Flight Conducted Under:	Part 91: General Aviation - Personal

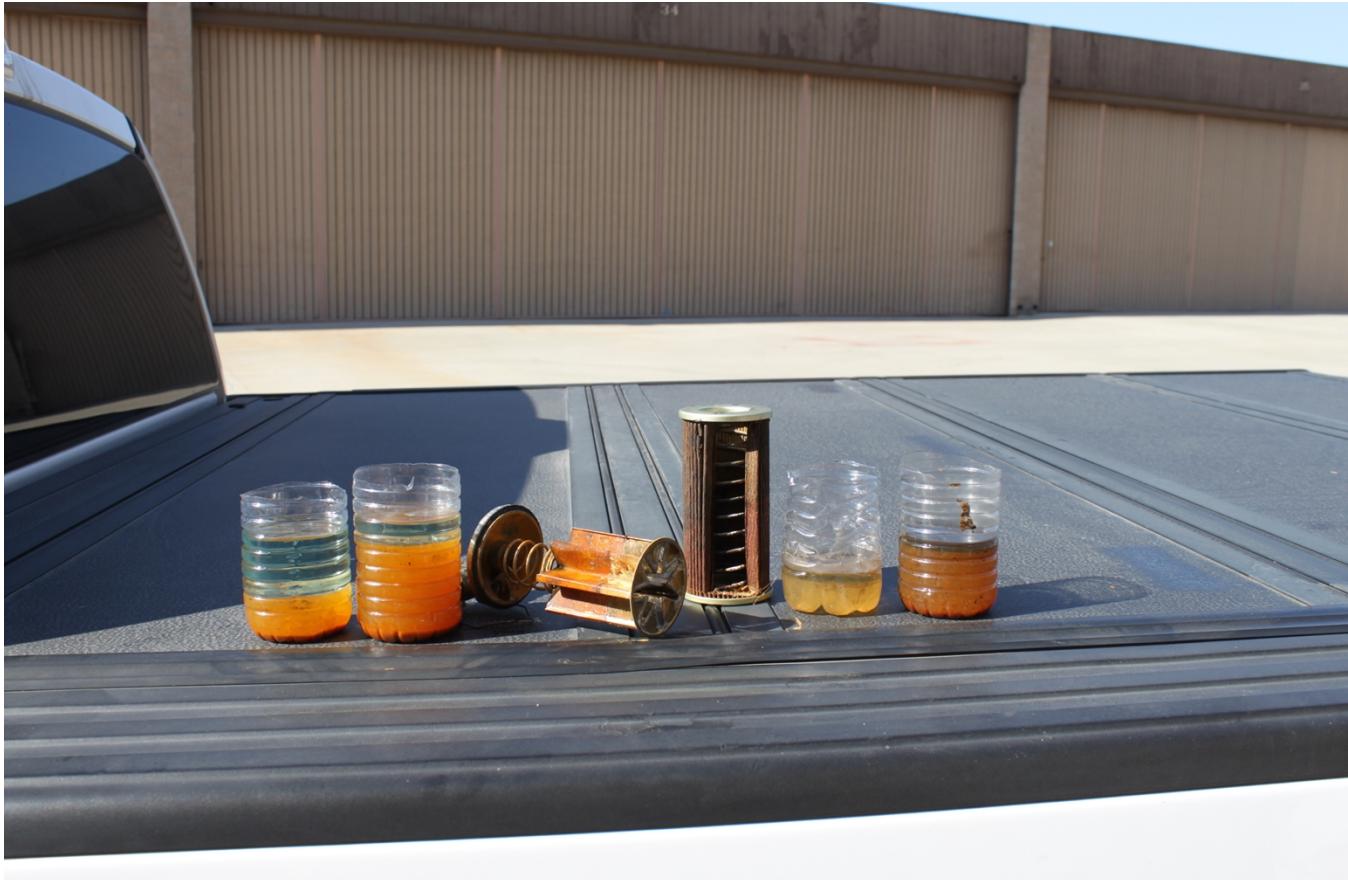
The mechanic's failure to inspect the fine fuel filter gascolator as required during the most recent inspection, which resulted in a total loss of engine power due to fuel contamination.

During the NTSB examination of the airplane, about 16 ounces of water was removed from the fuel system. Water was present in the lower gascolator, the fine fuel filter (upper gascolator), and subsequent fuel line to the carburetor inlet. A brass screen at the carburetor inlet and 2 carburetor fuel bowl thumb screens also contained corrosion, water and rust. (See Photo 1.)

Photo 1 - Fuel and contamination removed from fuel lines and gascolator

The approved aircraft inspection checklist called for washing the carburetor and main fuel filter every 50 hours and cleaning and/or replacing the fine fuel filter every 100 hours. The fine fuel filter located halfway up the firewall on the left side of the aircraft is not easily accessible and not in a position to be drained prior to flight. The mechanic that completed the most recent inspection stated that he did not drain or check the fine fuel filter. The last logbook entry that specifically stated the fuel filters were cleaned was in September 2012.
