AVIATION INVESTIGATION REPORT

A16O0066

Avionics compartment fire

Embraer ERJ 190-100 IGW, C-FHOS

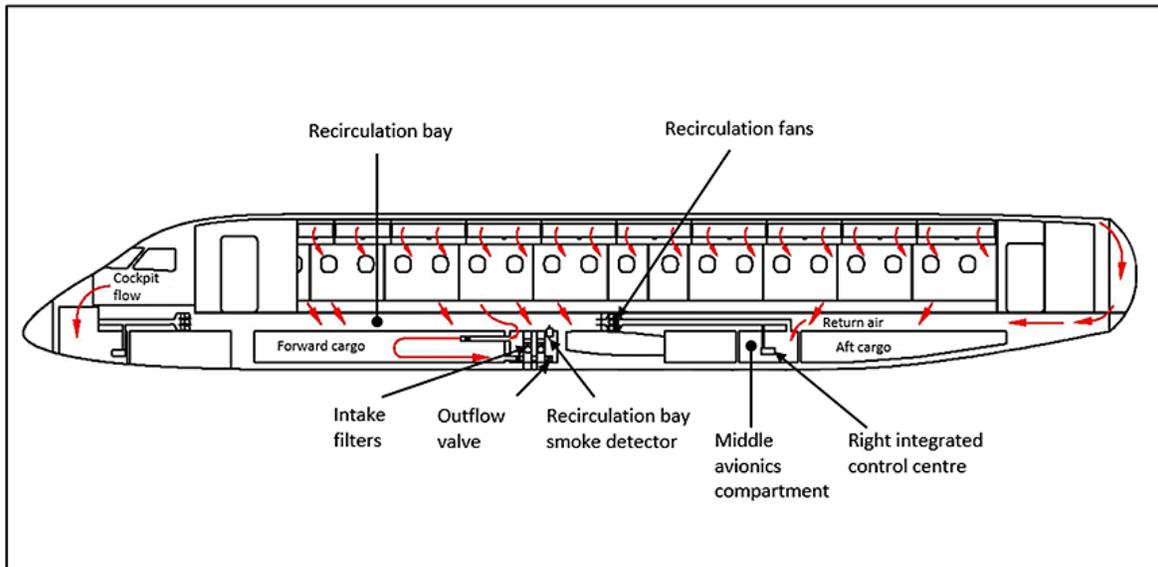
Figure 1. Schematic showing air recirculation on Embraer ERJ 190-100 IGW (Source: Air Canada, *E190 Aircraft Operating Manual*, Volume 2 (26 January 2015), section 2.21.20, p. P5, with TSB annotations.)

Air from the middle avionics compartment is normally circulated through the cabin via the recirculation bay as a means of providing heat for the cabin and cooling for the avionics (Figure 1). Recirculation fans and ductwork connect the 2 areas and are powered from AC BUS 2.

A smoke detector is located near the intake filters in the recirculation bay and is powered solely by DC BUS 2. The main purposes of the smoke detector are to alert the flight crew to the presence of smoke that has been generated in one of the connected compartments and to prevent the smoke from being recirculated into the cabin.

If smoke is detected in the recirculation bay, the flight crew receives a “RECIRC SMOKE” indication on the EICAS. There was no report of a smoke warning during the occurrence, and no smoke warning was recorded on either of the digital voice data recorders.

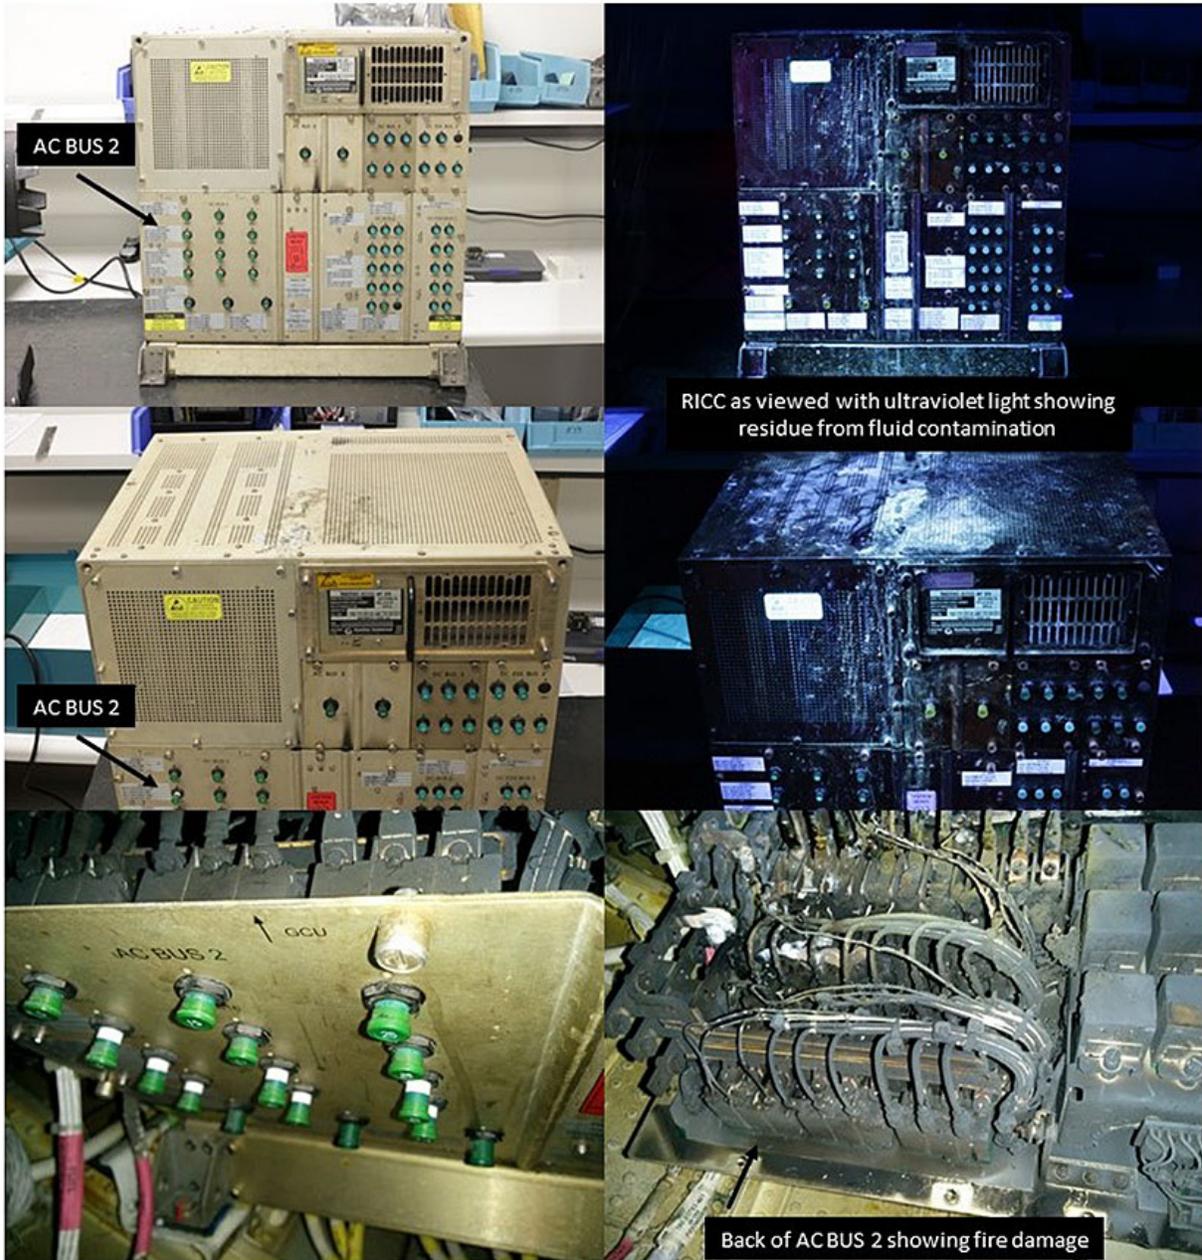
Appendix B – Damage to the right integrated control centre, viewed under normal and ultraviolet light

The initial inspection noted that there had been severe arcing of the 3-phase bus bars that connect to the thermal circuit breakers in AC BUS 2 (Appendix B). Further inspection revealed evidence of a fluid contaminant that had entered the vented top surface of the RICC and into the TRU 2 compartment.

It was determined that the fluid had been spilled directly on top of the RICC. The fluid then flowed down the face and through the interior of the RICC and entered the circuit breaker panel compartment, where it came into contact with the bus bars and other conductive surfaces, eventually causing the arcing that led to the smoke and fire.

The arcing, melting, and fire damaged AC BUS 2 and disabled power distribution to several connected systems, including TRU 2. The damage was limited to the RICC and did not spread to any other nearby components.

A sample of the dried fluid contaminant was examined and it was determined that the fluid was a beverage, possibly coffee or a soft drink.
