AIRCRAFT ACCIDENT INVESTIGATION REPORT

**ENGINE FIRE DURING TAKE-OFF ROLL
KOREAN AIR LINES CO., LTD.
BOEING 777-300, HL7534**

**ON RUNWAY 34R
AT TOKYO INTERNATIONAL AIRPORT
AT AROUND 12:38 JST, MAY 27, 2016**

July 6, 2018

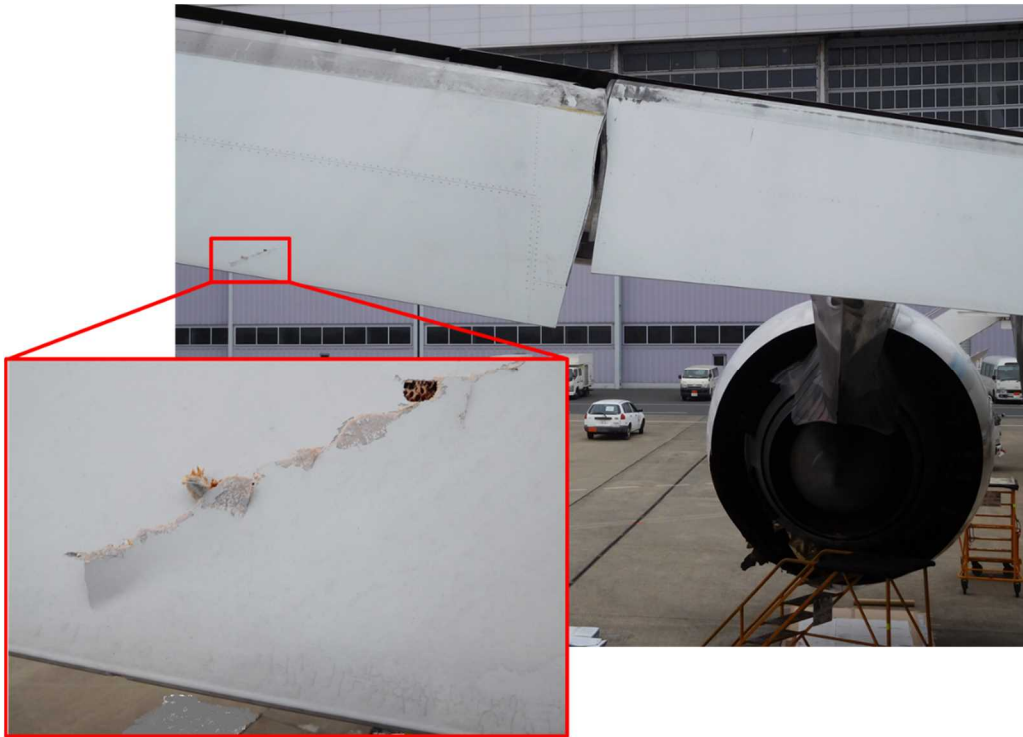
Photo 2. Outboard flap showing the cracks

flap showing the cracks.)

(Note: The flap position shown in this photo is differed from the takeoff flap position at the time of accident.)

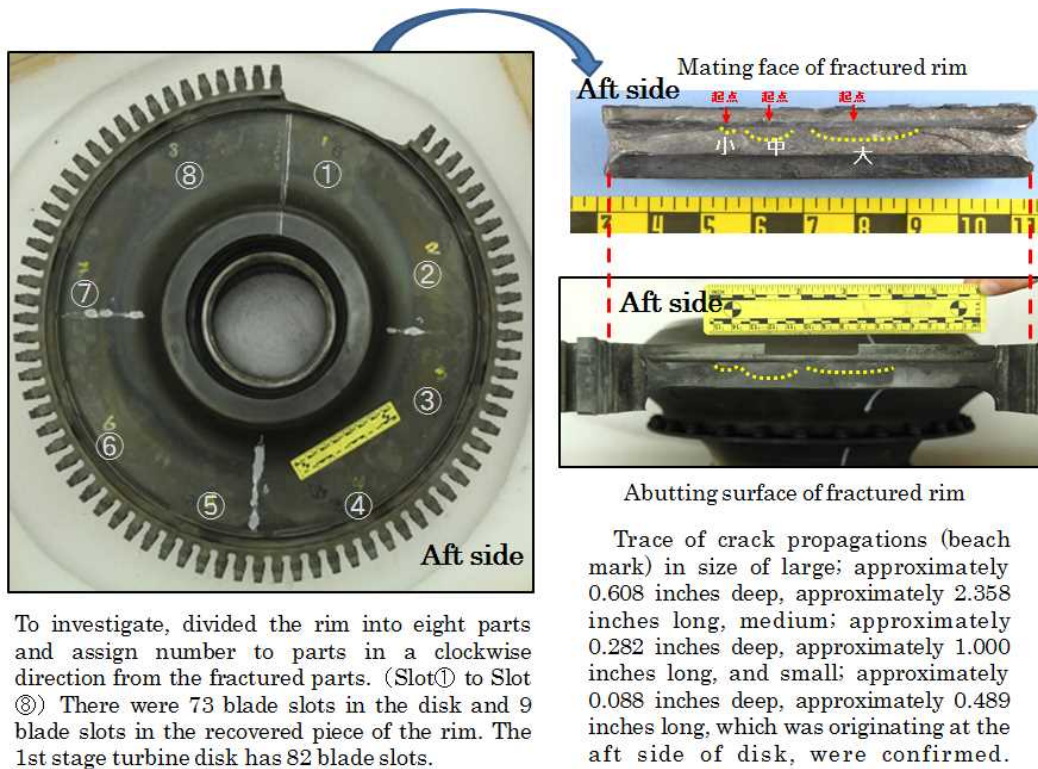
Photo 3-1. Fractured Rim

(0.224 mm x 1.241 mm)

(See Attachment 4. Photo of fracture face)

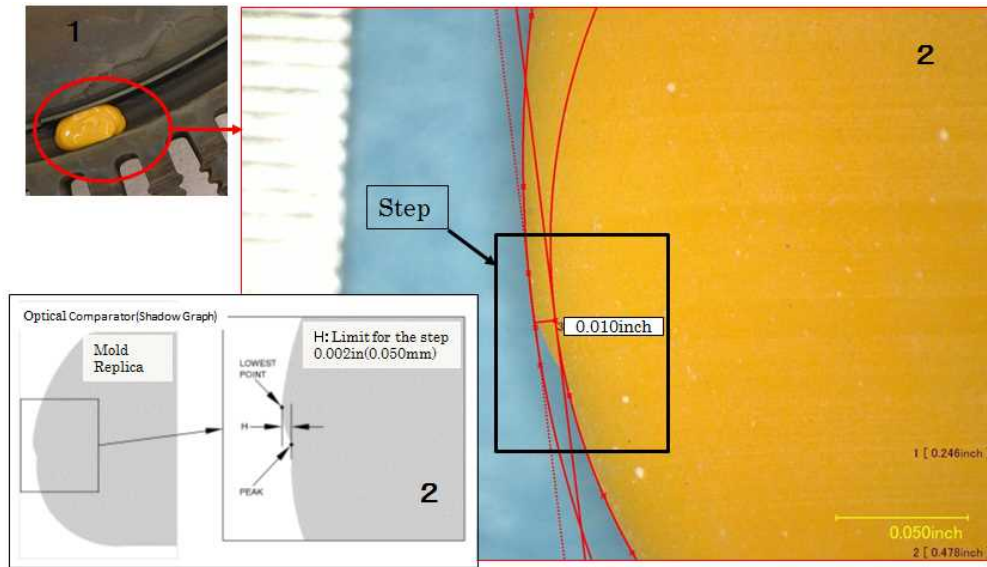
Photo 4. Created Replica of the Step

- 1 . The U-shaped groove was used to make multiple replicas using a thermosetting rubber compound.
- 2 . Setting the replica on an optical comparator, measure the machined step (mismatch) based on two machine radii. The step is 0.010 inch (0.25mm) *(Limit for the step is 0.002inch(0.050mm)).

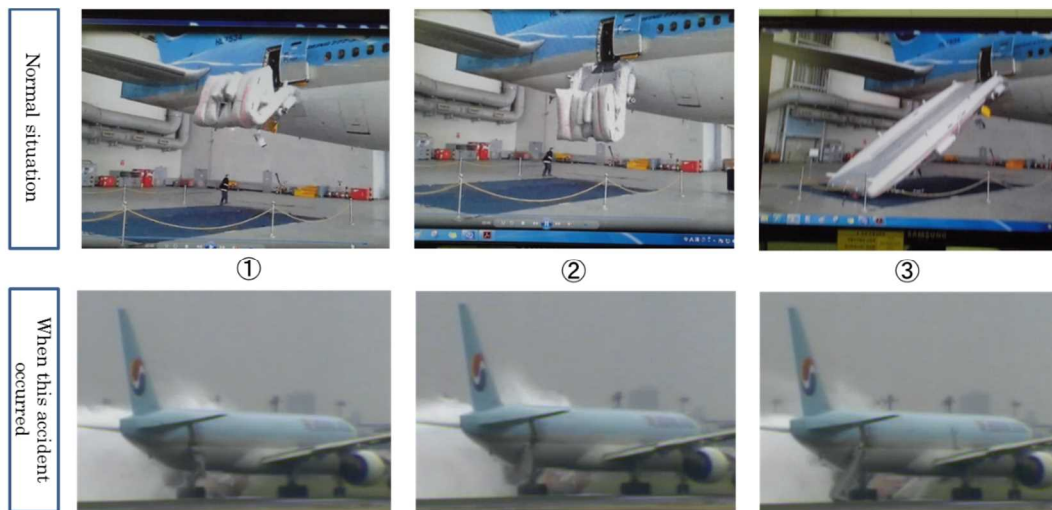
Photo 6. Comparison of R5 slide deploying status

According to the statements of the cabin attendants, they had deployed the doors at five locations of the right side of the Aircraft and attempted to evacuate, but the R5 door at the most rear side (hereinafter referred to as “R5 door”) was not fully deployed. For the door at the left side of the Aircraft, L1 door at the most front side had only the slide deployed, but it was not used. (See Photo 5. Emergency Evacuation Slide.) Furthermore, the situation of the emergency evacuation was recorded by the Monitoring camera at the Airport, it was confirmed that there were passengers with baggages to evacuate and no assistances at the bottom of the slide when the evacuation was started. Photo 6. shows the comparison of deploying R5 slide at the normal situation and at the accident.

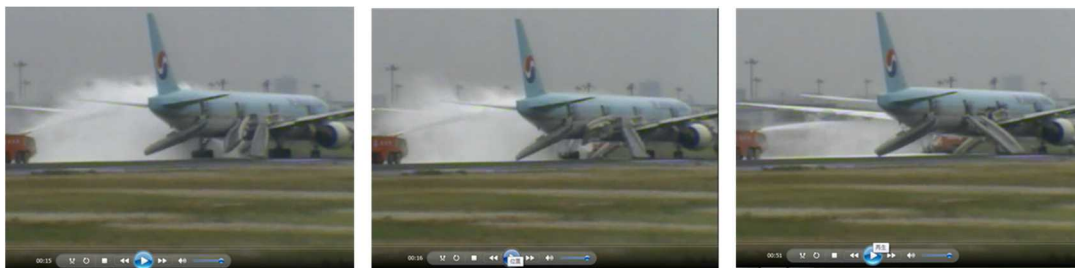
Photo 7. Deploying situations of slides at R3, R4 and R5

Photo 7. shows the deploying situations of R3, R4 and R5 slides of the Aircraft at the time of the accident. Furthermore, the R3 slide is narrower in width and shorter in length compared to the R4 and R5.

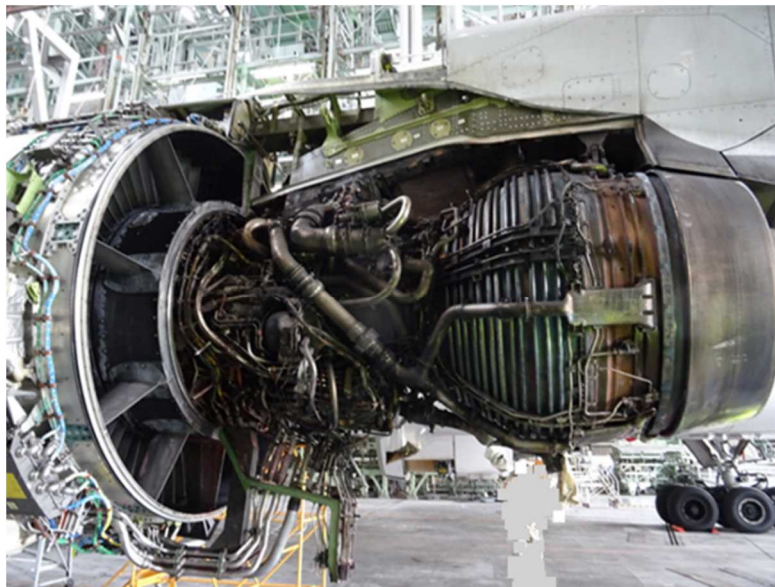
Photo #2. The left side of the No.1 engine

① The left side of the engine and the external accessories were burned and sooted.

The left side of the No.1 engine and the external components were burnt and sooted. (See Photo #2. The left side of the No.1 engine.) The right side of the engine did not have any sooting or thermal damage. The insulation blanket over the fuel and hydraulic lines and the covering on the lines was undamaged. (See Photo #3. the right side of the No.1 engine.) The main gearbox deoiler vent tube was severed in line with the hole in the HPT case.

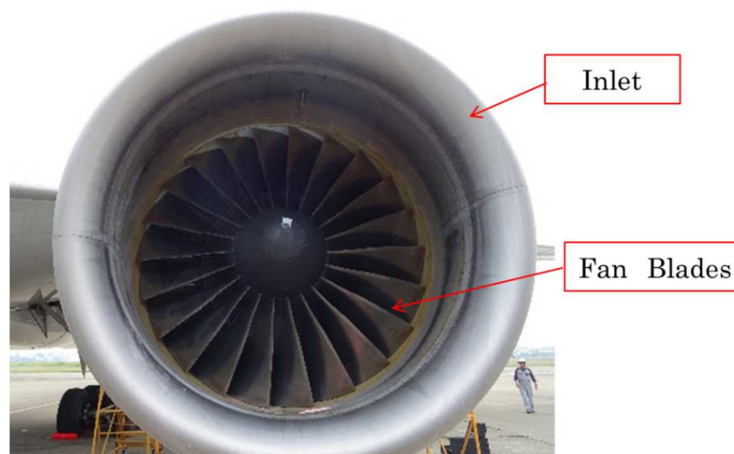
Photo#4. Inlet and Fan Blades

The inlet and fan blade did not have any apparent damage. There were no trace of sucking objects like birds from outside. When the fan was rotated, the LPT rotated concurrently. (See Photo #4. Inlet and Fan Blade.)

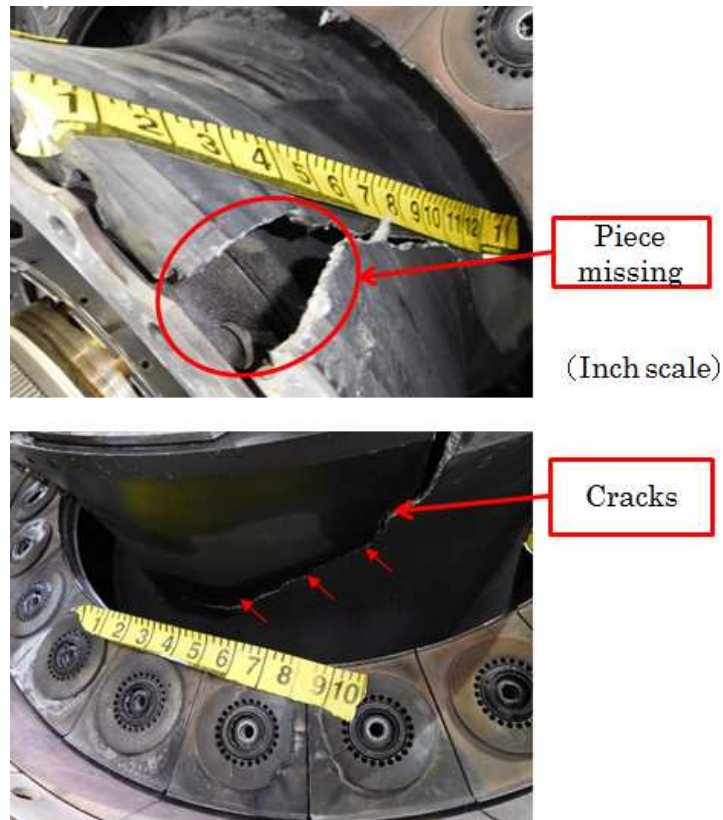
Photo #5. Inner diffuser case

② The rear flange of the diffuser¹² case at the position from about 5:30 to 6:30 o'clock was bent radially outward. The inner diffuser case had cracks between the aft flange and the center part of the case and at about 12 o'clock, there was a piece missing from the case.

The outer diffuser case did not have any indications of a rupture or thermal distress. The diffuser case rear flange between about 5:30 and 6:30 was bent radially outward. The inner diffuser case had five cracks between the aft flange and the center part of the case that varied in length from 1.5 (3.81) to 10.5(26.67 cm) inches. At about 12 o'clock, there was an approximately 2 inch (5.08 cm) by 1 inch (2.54 cm) piece missing from the case. (See Photo #5 Inner Diffuser Case)

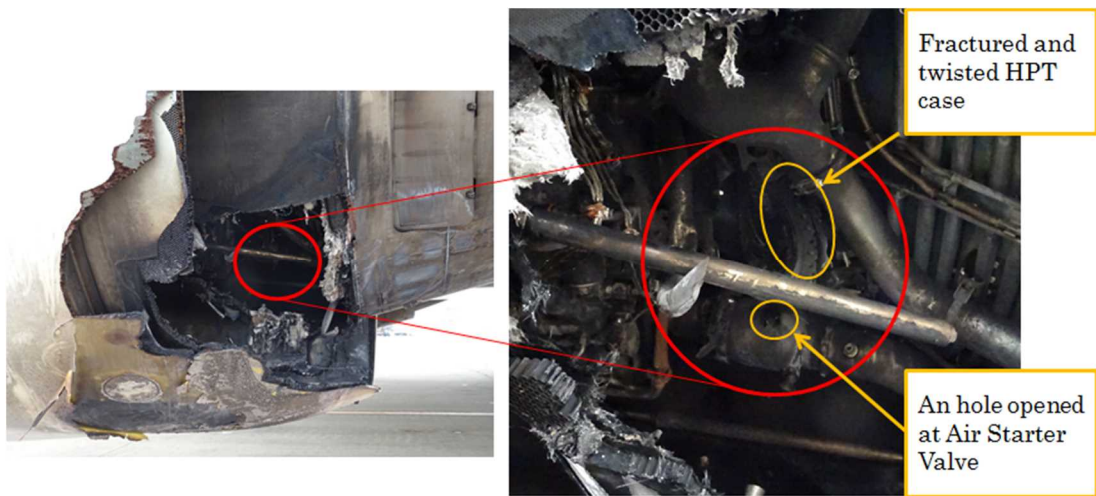
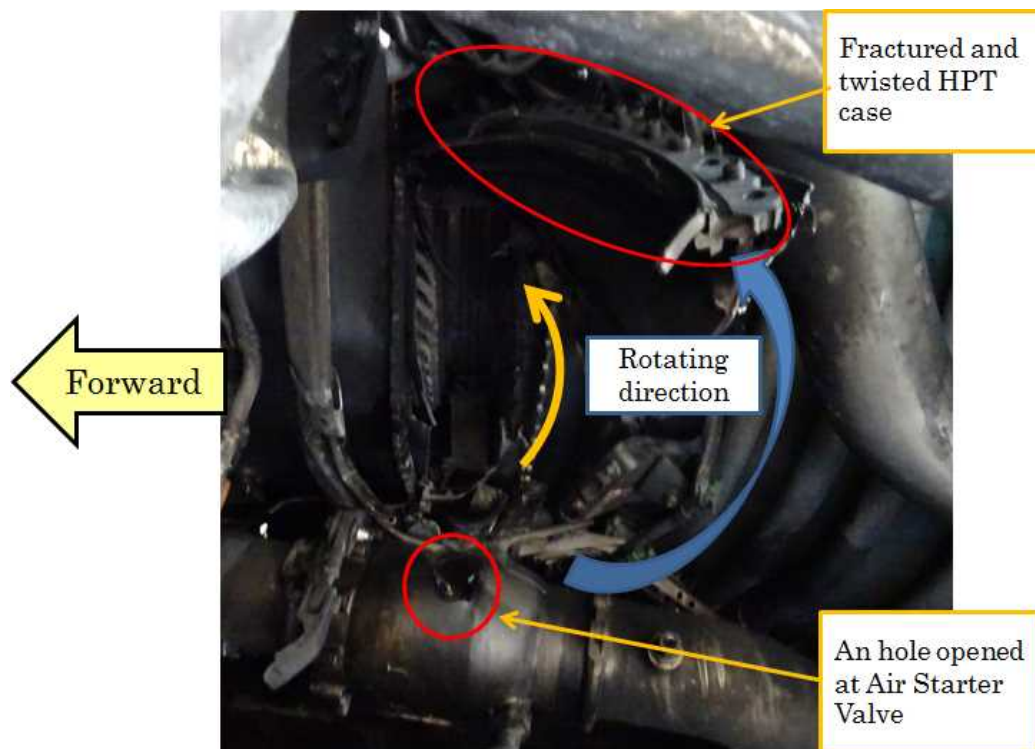
① The HPT case wall between 5:30 and 7 o'clock was bent radially outward and twisted which was approximately 36 cm (approximately 14 in) long and approximately 11.4 cm (4.5 in) wide along the periphery. (See Photo #6-1. The damage of the HPT case and Photo #6-2. The damage of the HPT case.)

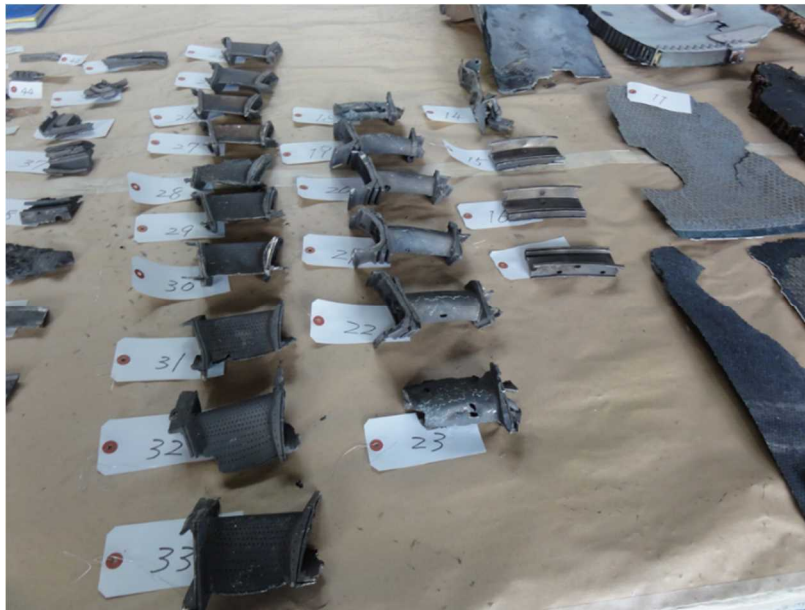
Photo #9. Recovered Stator Vanes and others

- ③ The HPT case's forward flange was missing bolts between 3:30 and 8:30 and the aft flange was missing bolts between 5:30 and 7:30.
- ④ Investigating the runway and an adjacent area after the accident, stator vanes and others of the 1st stage HPT and the 2nd stage HPT were recovered. (See Photo #9. Recovered Stator Vanes and others.)

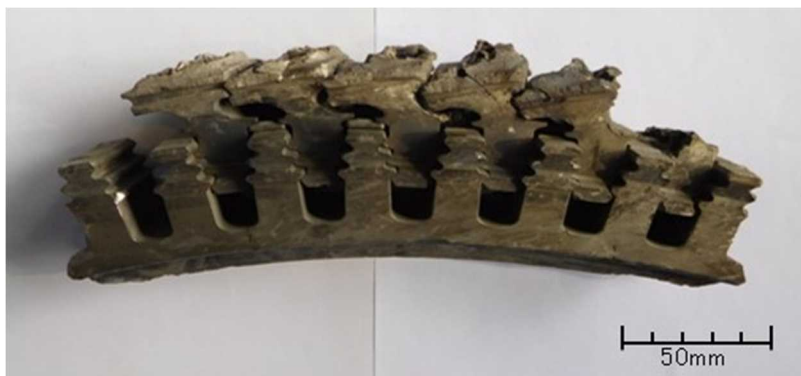
Photo #10. Piece of the 1st stage HPT disk rim

⑤ A piece was missing from the rim of the 1st stage HPT disk. (See Photo #10.)

- ⑤ A piece of the 1st stage turbine disk rim was recovered from amidst the debris that was recovered from Runway 34R. The piece was about 7.8 inches (20 cm) long and weighed 1.875 kg (4.134 lb) with seven blade slots. (See Photo #10. Piece of the 1st stage HPT disk rim.)

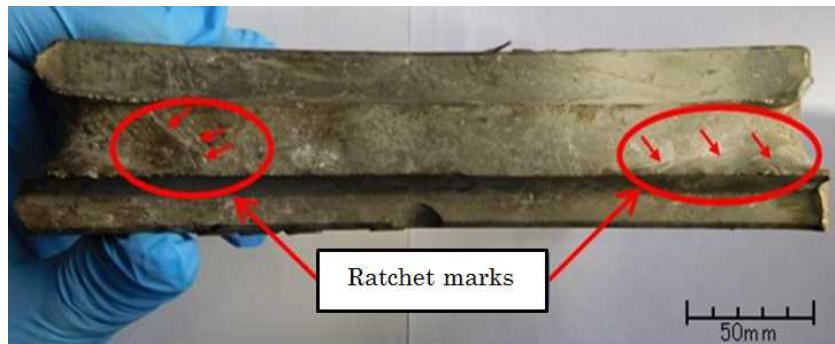
Photo #11. Ratchet Marks

There was a ratchet mark¹⁷ on the fracture surface at the 1st stage HPT disk rim. (See Photo #11. Ratchet Marks.)

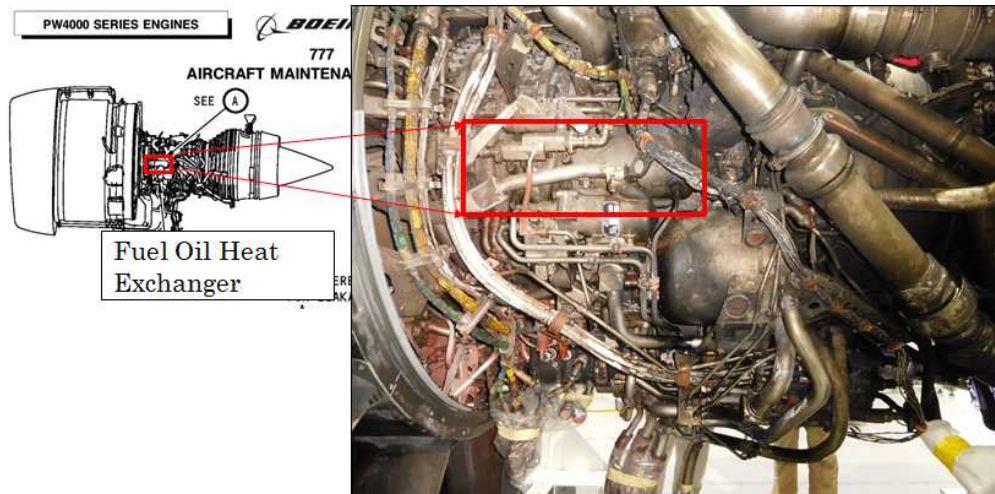
Photo #13-1. Fuel Oil Heat Exchanger

The main body case of Fuel Oil Heat Exchanger located at 8 o'clock of the HPT case had cracks and soot by thermal damage, but there were no damage impacted from outside. Three cracks were confirmed at the rear of the main body, and the longest crack was approximately 34 cm (13.4 in) long. (See Photo #13-1 Fuel Oil Heat Exchanger and Photo #13-2 Cracks of Fuel Oil Heat Exchanger.)

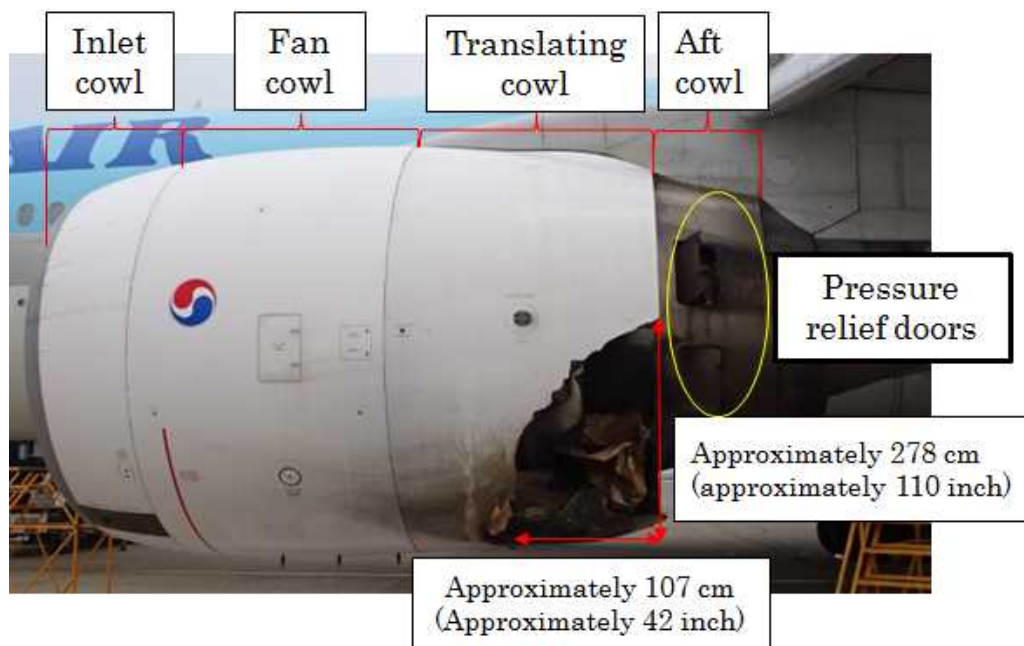
Photo # 14. Damage of Translating Cowl

The aft cowl pressure relief doors at 2, 4, 8 and 10 o'clock were all open.

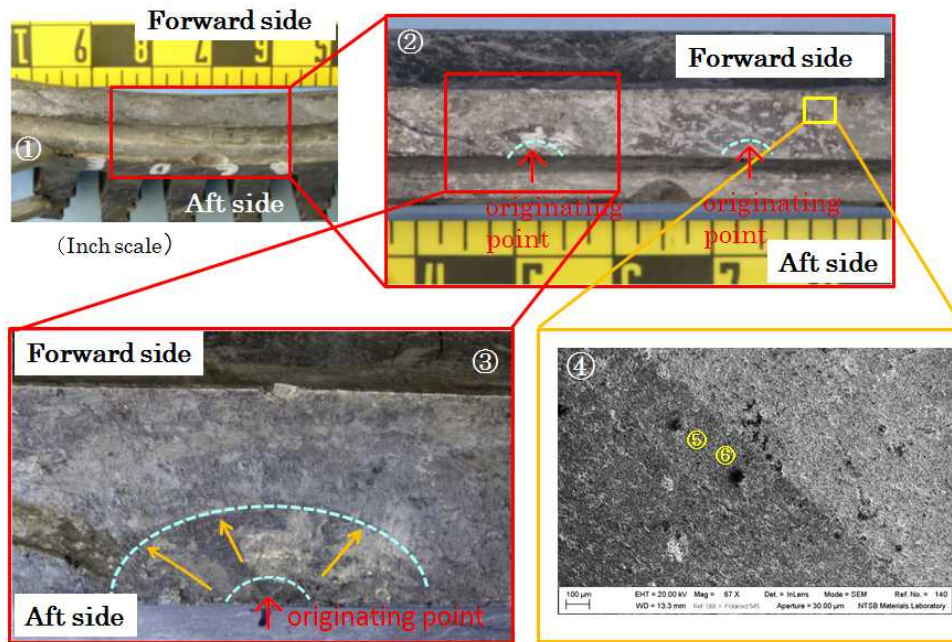
Photo ① and ②: Beach mark (Seashell pattern) from the originating point was confirmed at the fatigue crack propagation area at the fractured surface of fractured and ejected debris of the 1st stage HPT disk rim part.

Photo ③ : Crack propagates from originating point at the aft side of the disk to the forward side. The fractured surface exhibited significant mechanical damage. The fatigue progression exhibited a bluish heat tint.

Photos ⑤ and ⑥ was the pictures enlarged and photographed parts enclosed by yellow lines shown in Photo ④ via Scanning Electron Microscope (SEM) and striation which is a characteristics of fatigue fracture surface was confirmed.

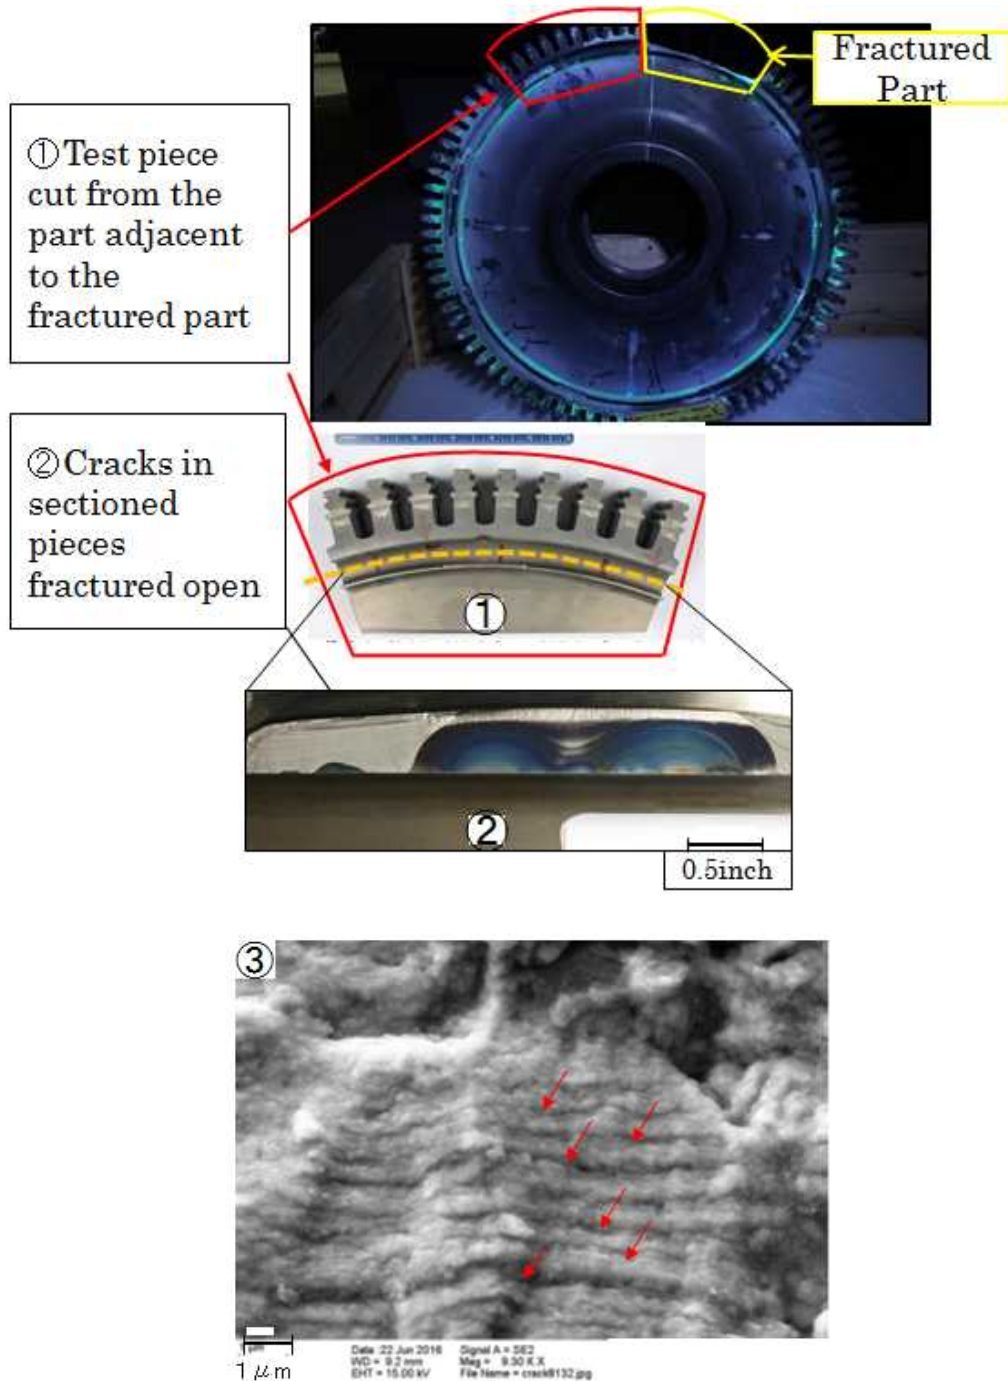
③ Magnify a crack via an electron microscope.
(Stable striations (Red Arrows) were confirmed.)
