FINAL REPORT

Investigation of a serious incident related to a loss of separation, realized on June 4, 2016 with involved Airbus A320-232 aircraft, registration marks TC-ATK, and Boeing B737-8F2 aircraft, registration marks TC-JGF in the controlled air space of the Republic of Bulgaria.

2017

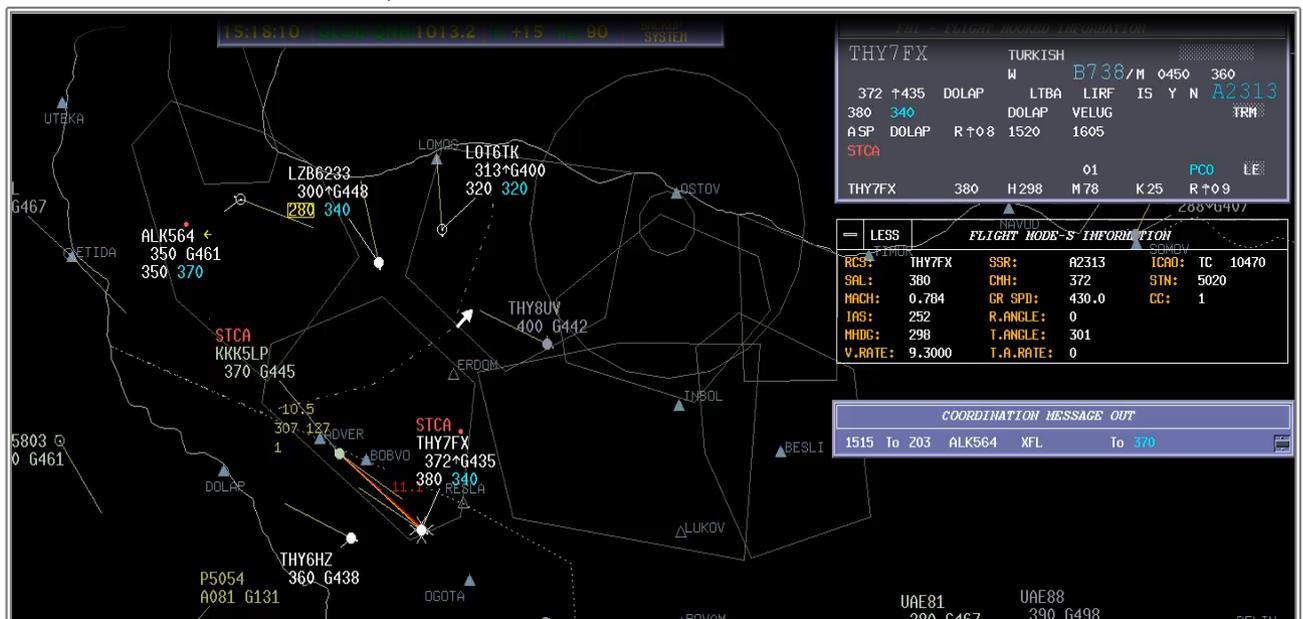
Fig. 1

At 15:18:02, ATCAS SELEX generates warning for STCA between A/C THY7FX and A/C KKK5LP, which is displayed at both the working positions of SCU and SCL sectors. The distance between the two aircraft is 12,8 NM.

At 15:18:10 EXE ATCO from SCU sector issues instructions to the flight crew of A/C KKK5LP for immediate turn to the left with 60°, after that specifies the instruction for turning left, heading 060: “KKK5LP, immediately turn left 60 degrees, KKK5LP immediately turn left heading 060“. At this moment, the aircraft is on FL370 level cruise. The flight crew does not confirm the instruction of the EXE ATCO for changing of heading. (See fig. 1)

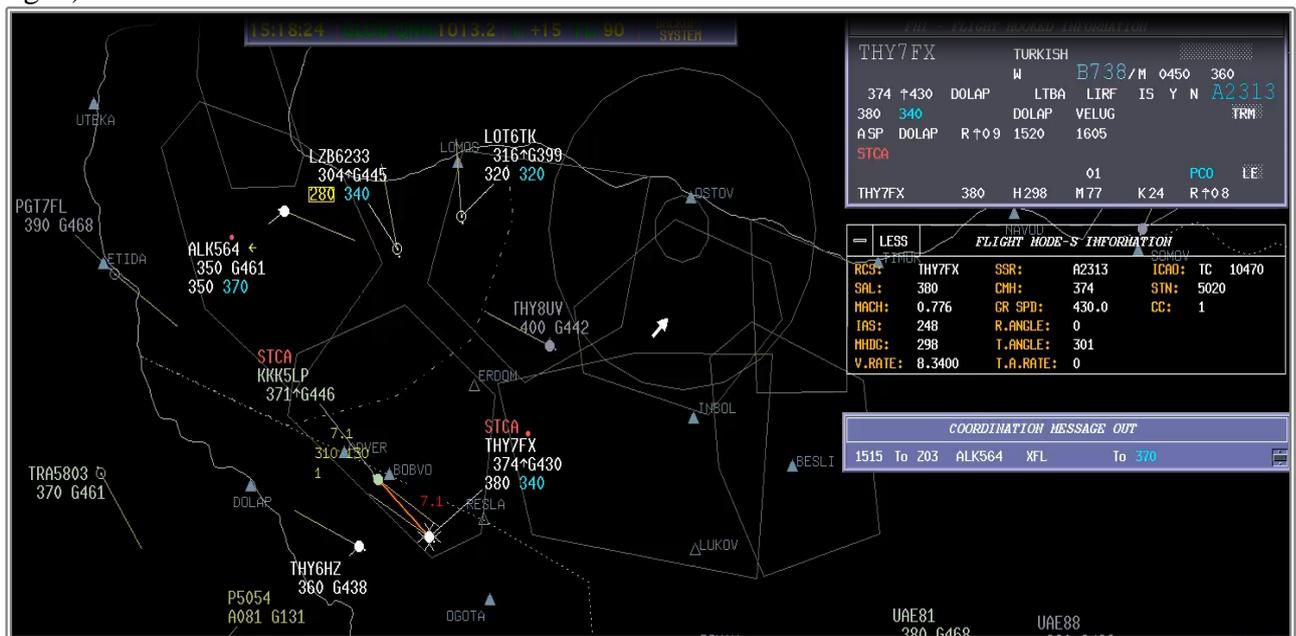
Fig. 2

At 15:18:24 A/C KKK5LP starts changing its altitude of FL370 climbing without instructions from EXE ATCO from SCU sector and without the flight crew informing of it. The distance between the two aircraft is 7.1 NM. The flight crew does not report TCAS RA yet. (See fig. 2)

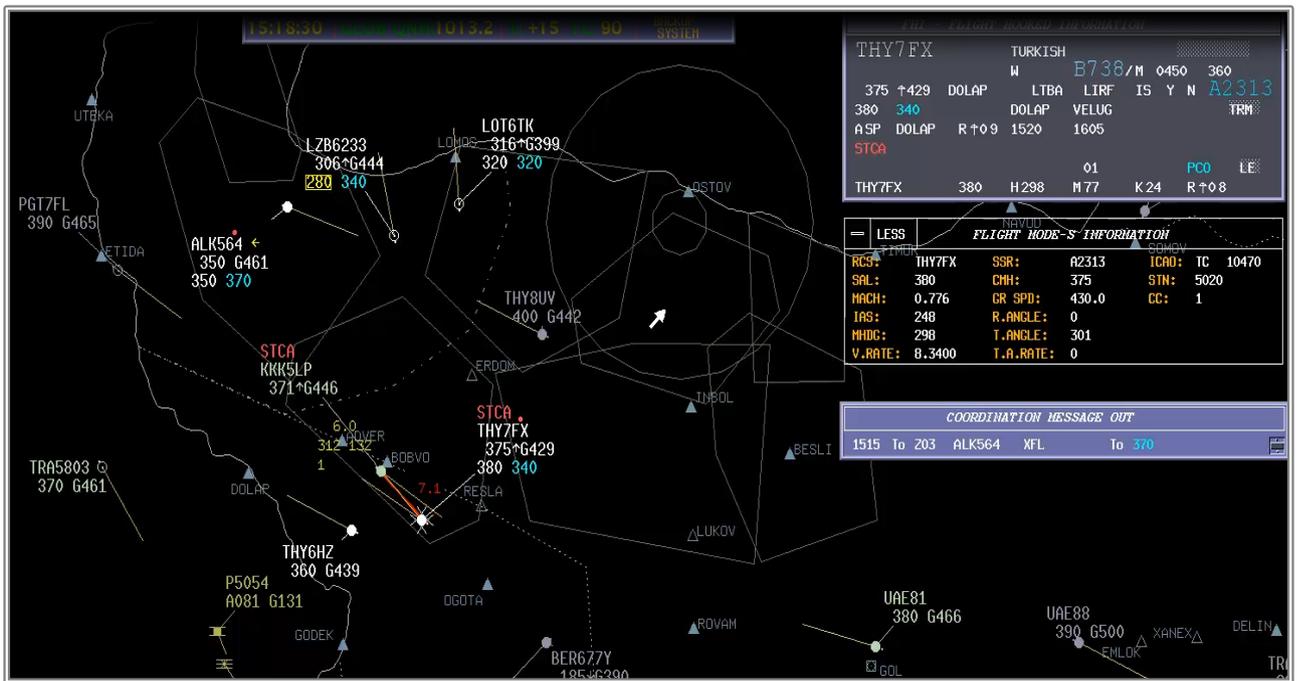
Fig.3

At 15:18:30, the EXE ATCO form SCL sector issues instructions to A/C THY7FX for immediate climb to FL380. The flight crew of THY7FX reports they have avoided the conflict traffic: “Now we are cleared of traffic, THY7FX. “ (See fig. 3). FDM reports that A/C THY7FX receives indication CLEAR OF CONFLICT at 15:18:32.

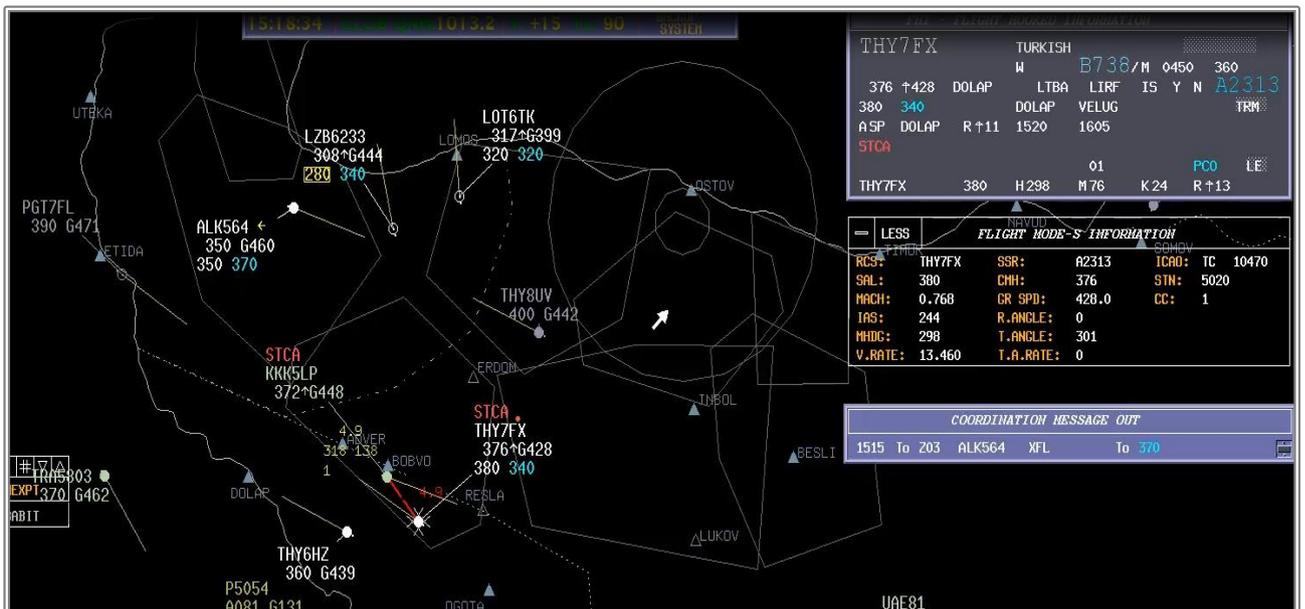
Fig. 4

At 15:18:34, the norm for minimal radar separation of 5 NM horizontally and 1000 ft. vertically is infringed (See fig. 4). FDR reports that A/C KKK5LP receives indication CLEAR OF CONFLICT at 15:18:34 while the A/C KKK5LP is still gaining altitude (currently passing 37264 ft) with increased pitch angle and changing its heading according the ATCO instruction.

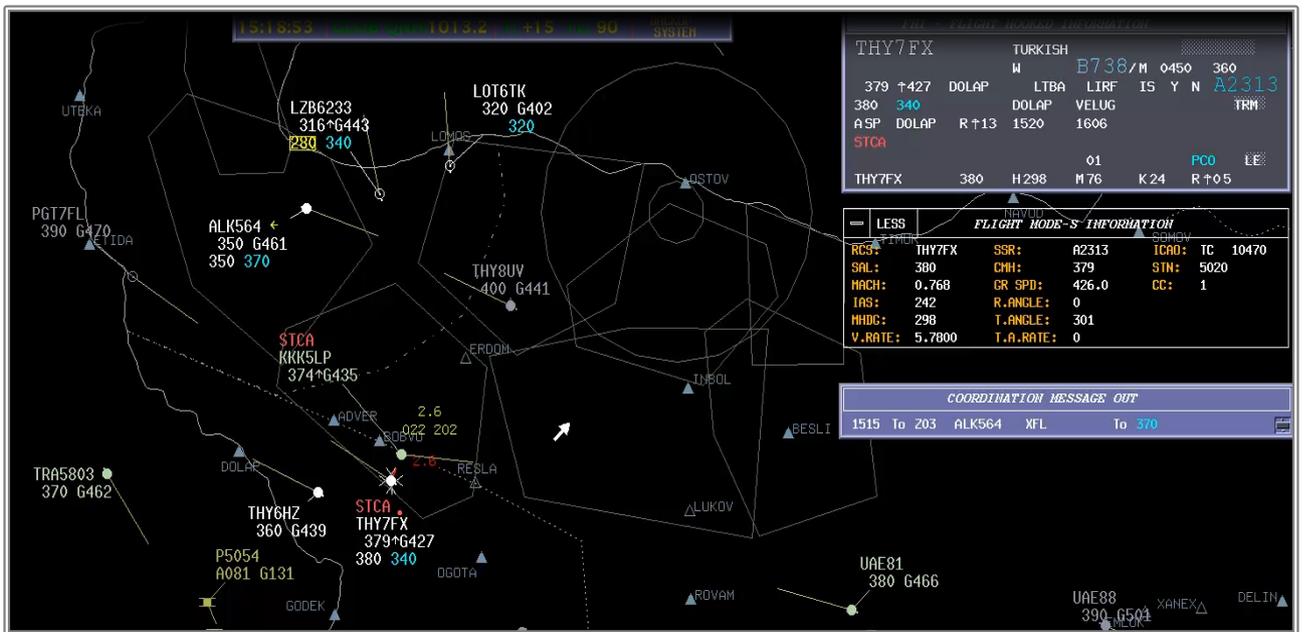
Fig. 5

At 15:18:53, the horizontal distance between A/C THY7FX and A/C KKK5LP is 2.6 NM and the difference in their heights is 500 ft., as determined by extrapolation of the radar plots. THY7FX crosses FL379 upon climbing and KKK5LP is flying at FL374 (See fig. 5).

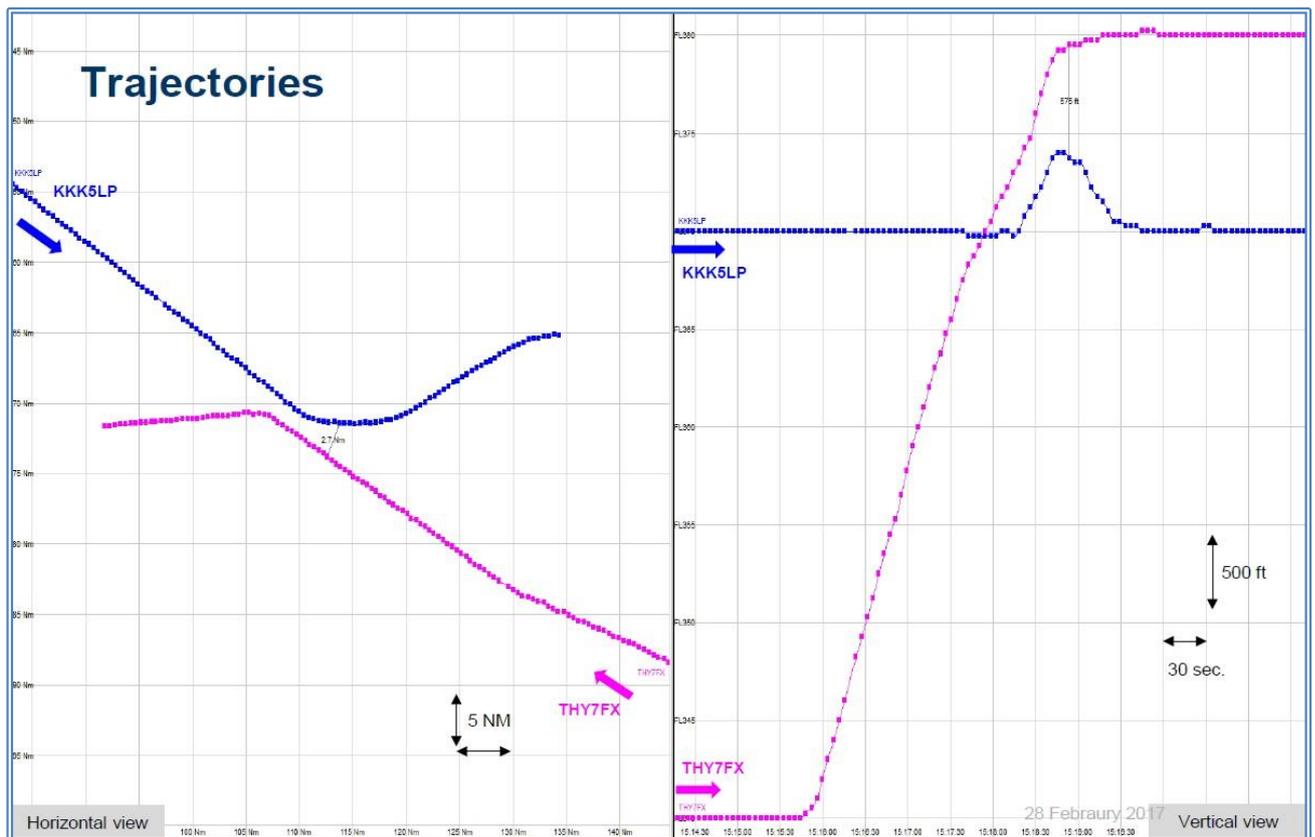
Fig. 6

According to the results from the simulation performed (Appendix 1), the closest point of approximation occurred at 15:18:54. The horizontal distance between the two aircraft is 2.65 NM, and the vertical distance is 575 ft. (See Fig. 6)

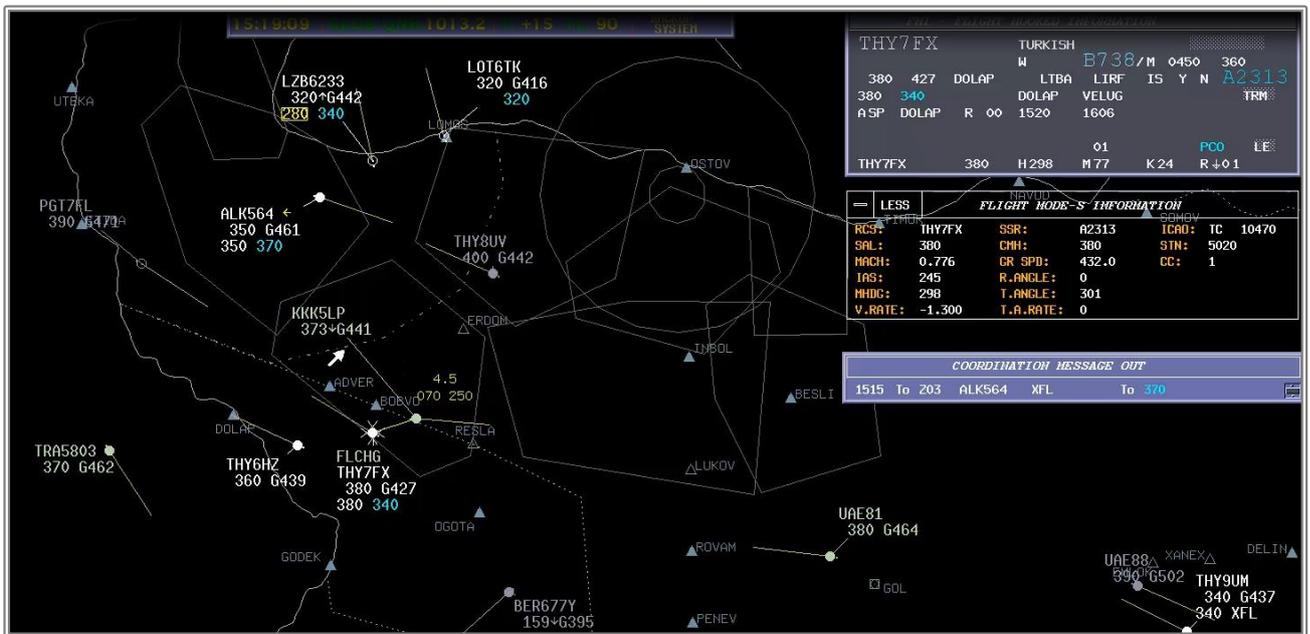
Fig.7

At 15:19:07, A/C KKK5LP starts descending to FL370 without reporting to EXE ATCO of SCU sector on this change still without reporting about the TCAS RA received (see fig.7).

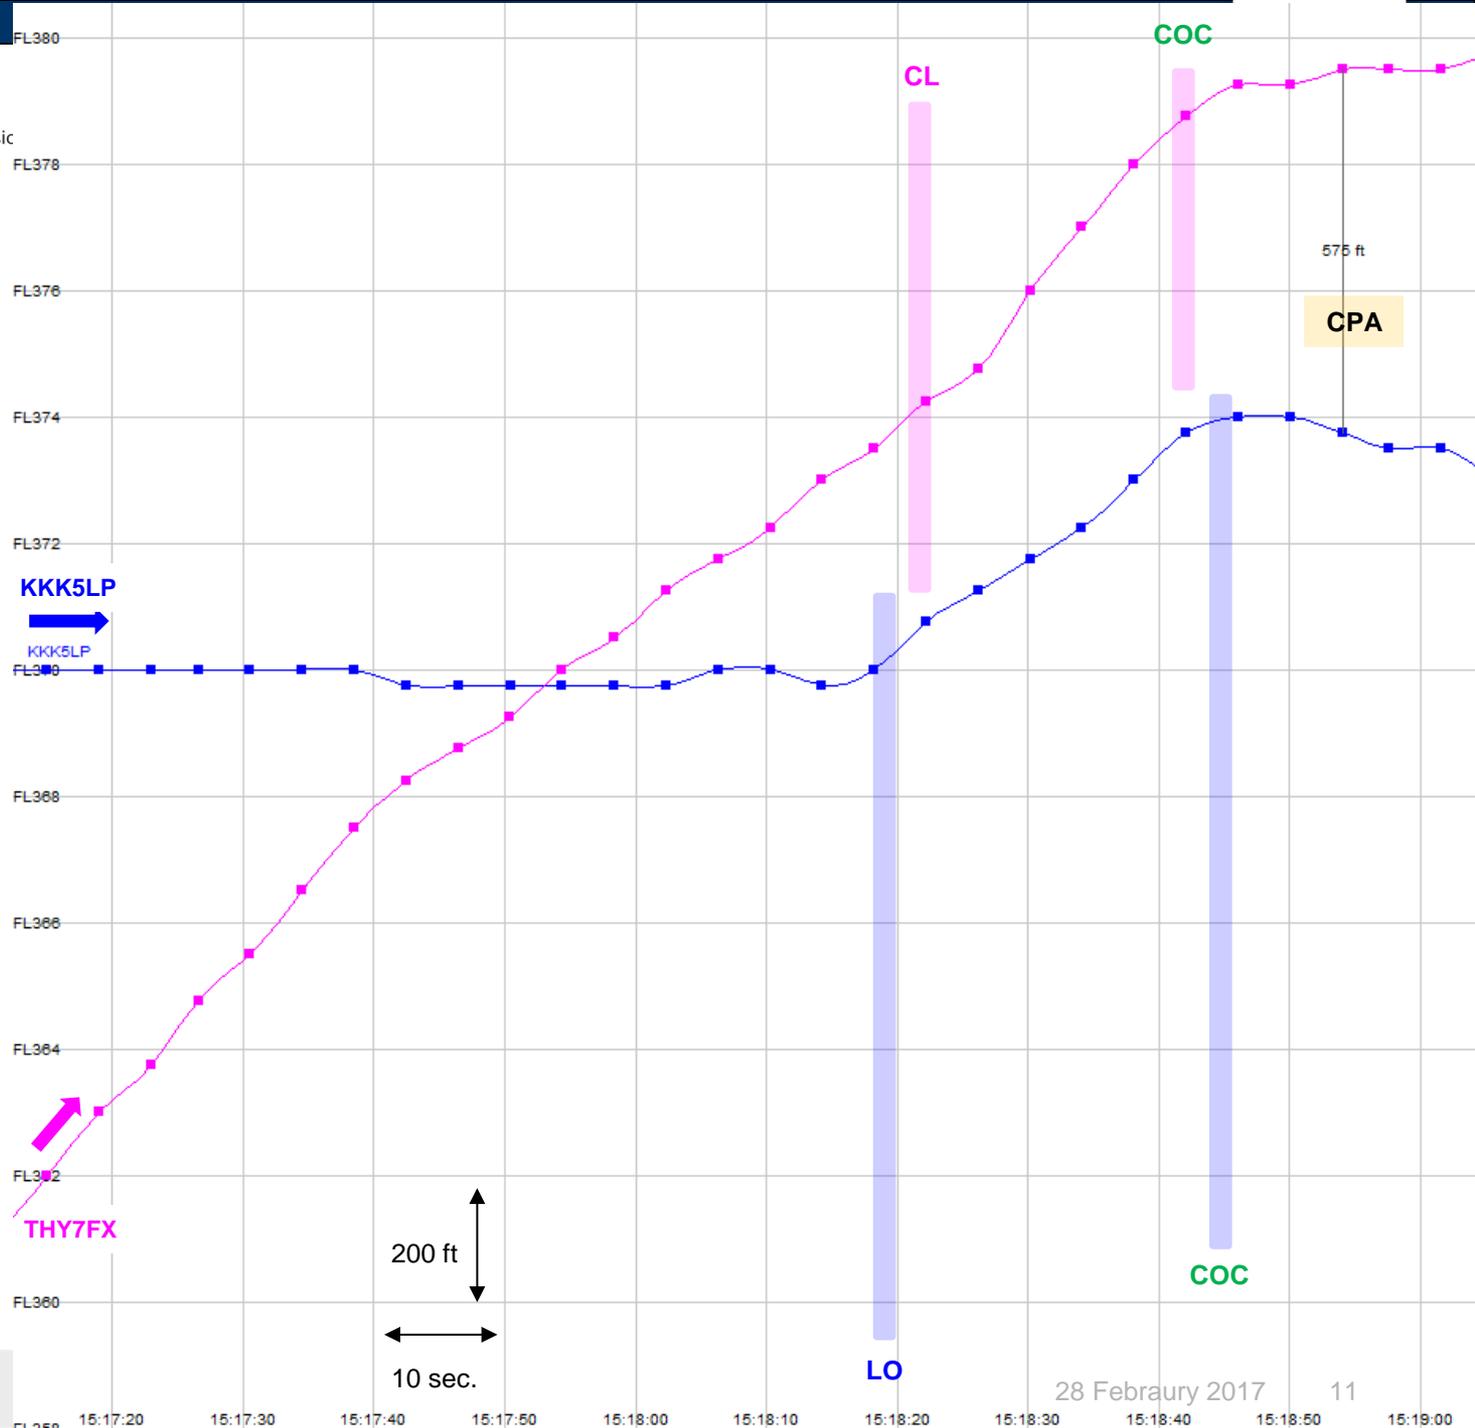
Vertical trajectories (close-up) & RAs

According to the radar information provided by BULATSA for the period of the incident including LEVEL OFF RA a decrease of the vertical speed of the aircraft was not observed, but on the contrary – observed was climbing from FL370 to FL374.
