# Accident Investigation Final Report

**State File Number:** 950330EPMOF  
**Type of Occurrence:** Accident  
**Date of Occurrence:** June 19<sup>th</sup> 2016  
**Place of Occurrence:** Khark Island Airport  
**Aircraft Type:** BAe146-300  
**Registration:** EP-MOF  
**Operator:** Mahan Airlines

Aircraft Model: BAe146-300

Registration: EP-MOF

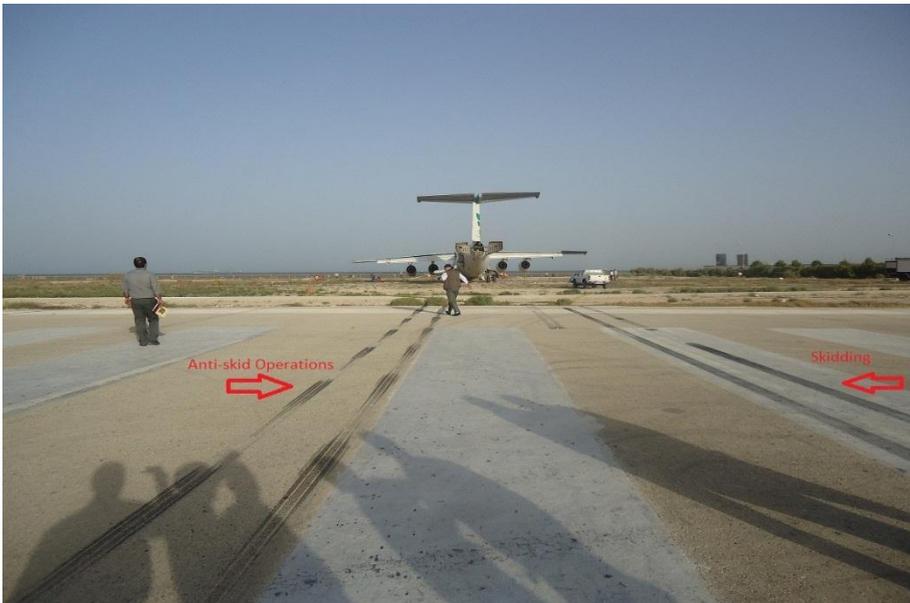
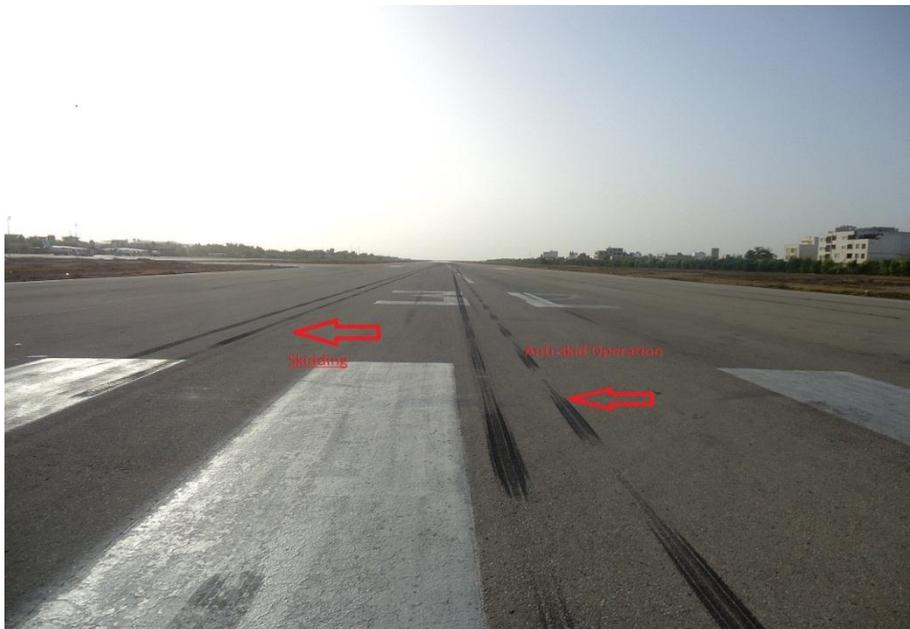
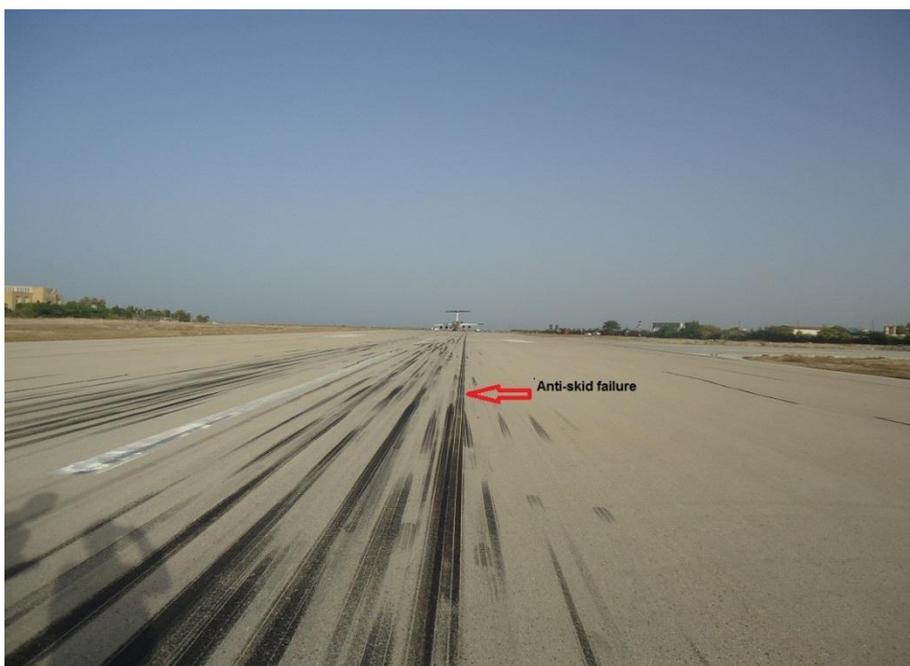
*Signs of anti-skid failure*

The conclusion of the test indicates the failure of Anti-skid System on the right main Landing gear.

- A un- stabilized approach was performed.
- Long distance of runway was passed at the time of touch down.
- The pilot used high brake effectivity to stop the aircraft but the failure of anti-skid on RH landing gear increased distance of landing.

- The manufacturer should investigate the possibility of improvement in the Cockpit for Anti-skid failure, which the cockpit crew can be warned about failure of the related system.

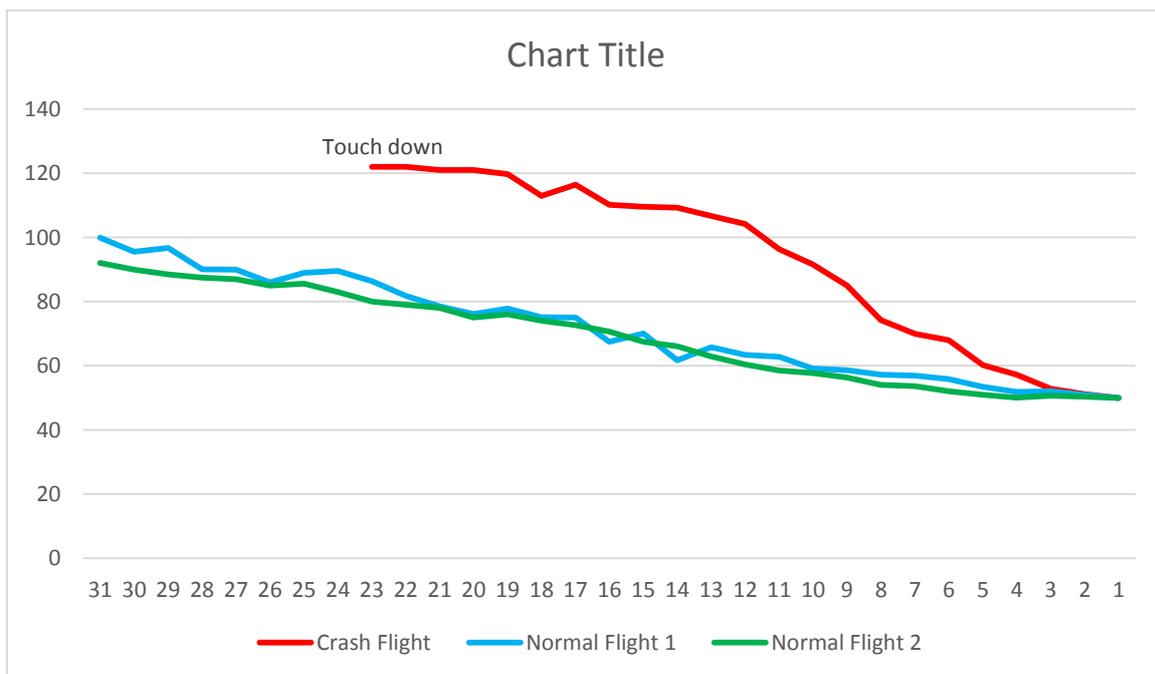
**Figure 1. Deceleration Comparison of 3 flights**

To examine the performance of run out deceleration systems, the period between touch down and reach point to 50 knot is studied. Table 1 illustrates speed decreasing of MOF during 3 flights in this period.

Apparent delayed touchdown was happened during crash flight. As it is shown by diagram, the aircraft touched the runway almost 8 seconds later than two other normal landings of itself. Therefore, a part of Landing Distance Available (LDA) was missed. Due to relatively short length of Khark runway, it could be a very effective factor to restrict safe landing assurance.
