FINAL REPORT

B777-300ER, REGISTRATION 9V-SWB ENGINE FIRE

AIB/AAI/CAS.122

**Transport Safety Investigation Bureau
Ministry of Transport
Singapore**

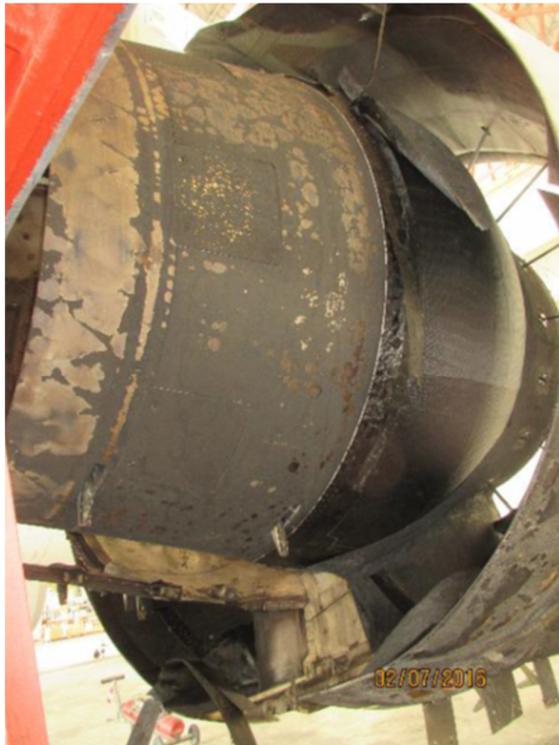
- Heat damage to the outboard TR aft cowl (**Figure 2**)

Figure 2: Outboard TR aft cowl

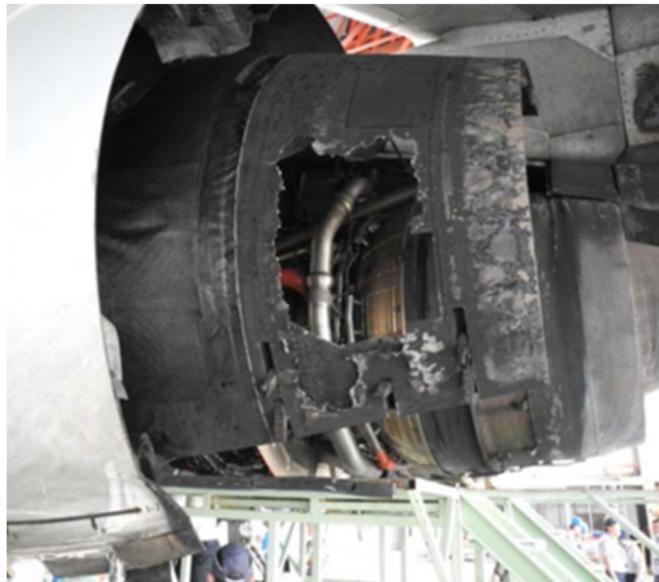
- Heat damage observed on all eight inboard TR blocker doors
- Heat damage to the four upper inboard TR blocker door links
- Four lower inboard TR blocker door links sustained heat damage and were severed 3-4 inches above the blocker doors
- Heat damage to the inboard TR aft cowl, with a section of material missing (measuring 21 inches vertically by 32 inches horizontally, including a 13 inches by 13.5 inches pressure relief door) (**Figure 4**)

Figure 4: Inboard TR aft cowl with missing material

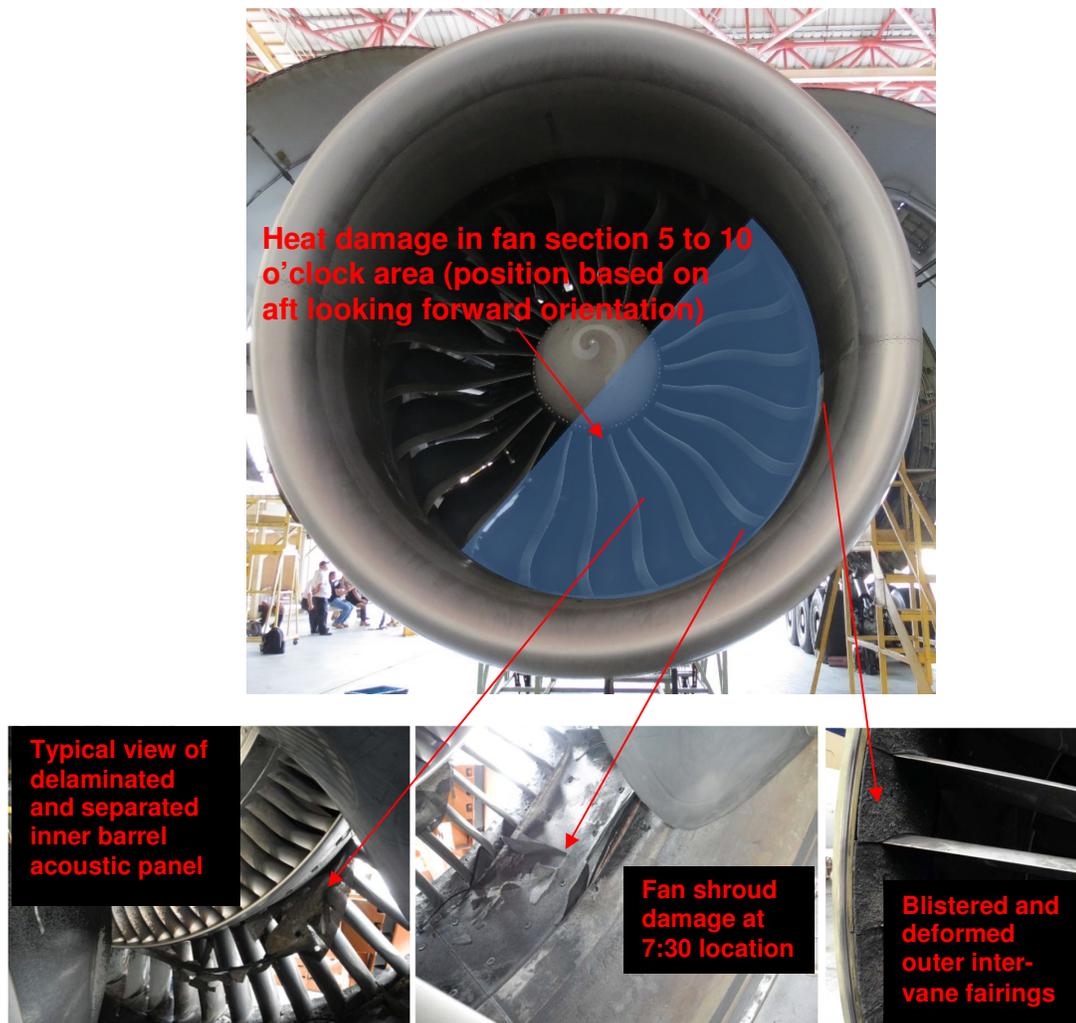
1.2.4.4 In the fan section area, heat damage was observed in the 5 to 10 o'clock area of the following areas (**Figure 7**):

- Fan shroud area with the most significant damage in the 7 to 9 o'clock area
- Outer aft acoustic panels, made of composite material, where the resin material was burnt, leaving the fabric delaminated and loose
- Inner barrel acoustic panels, made of composite material, with the most severe damage in the 6 to 8 o'clock area where the resin material was burnt, leaving the fabric delaminated and loose
- Blistering and fractures on the outlet guide vanes (OGVs)
- Outer inter-vane fairings displayed blistering and distortion, with the most affected region in the 6:30 to 8 o'clock area

Figure 7: Occurrence engine forward looking aft view

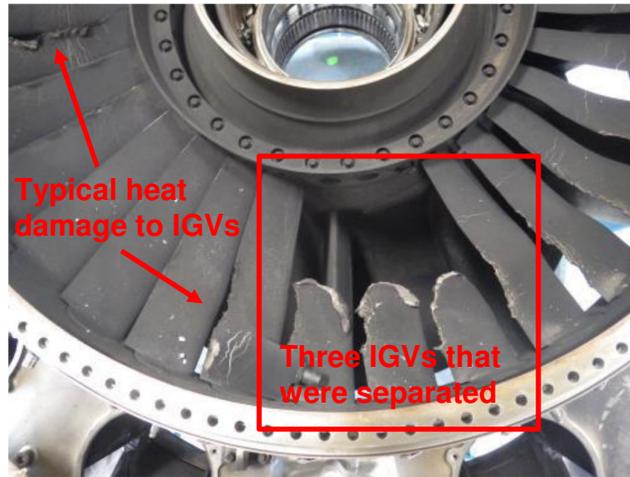
1.2.5.7 Heat damage was observed at the inlet guide vanes (IGV) of the high pressure compressor (HPC). Three IGVs which were installed at the 6 o'clock position were found separated due to melting near the inner trunnion which holds these IGVs in position (**Figure 10**). Several IGVs also exhibited signs of heat damage.

Figure 10: Damage to IGVs

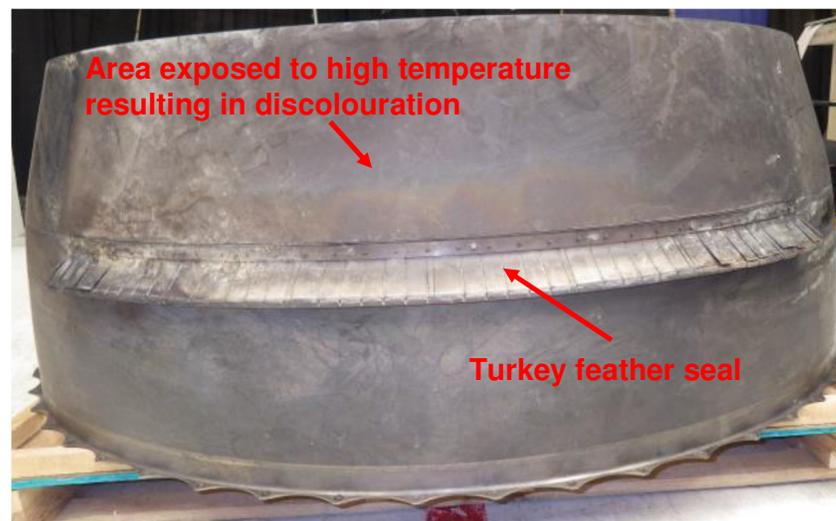
- 1.2.5.8 In the high pressure compressor (HPC), the heaviest evidence of soot collection was observed at the stage 1 rotor with decreasing level of soot collection towards the aft of the HPC (refer to **Figure 9**).
- 1.2.5.9 Localised discolouration due to high temperature exposure was observed at a section of the core exhaust nozzle, behind the feature known as the turkey feather seal¹⁰ (**Figure 11**).

Figure 11: Core exhaust nozzle

2.2.1 The investigation team has determined that the fire was a result of hot surface ignition²⁰ of leaked fuel at the area behind the turkey feather seal of the core exhaust nozzle. Based on recorded video footages and recorded data from the aircraft, the investigation team believes that the fire first started after the thrust reversers were deployed during the landing.

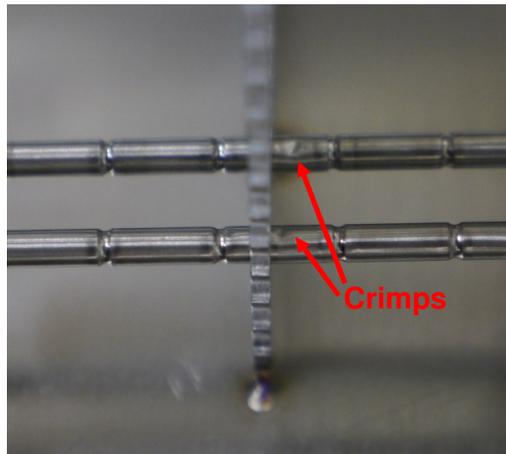
- 1.7.1.4 The manufacturing process involves crimping. Crimping is the application of a force to deform the tube slightly. The purpose of the crimping is to deform the cross-sectional shape of the tubes so that the tubes cannot slide freely through the round holes of the support plates. This prevents the support plates from moving during assembly (**Figure 14**).

Figure 14: Crimps on tubes

- 1.7.2.6 The cause of the crack in the August 2014 event, was determined by the engine and MFOHE manufacturers to be the variation in the crimp on the tube that resulted in contact between the support plate and crimped tube. The contact resulted in stress concentration that could have led to crack initiation.

1.7.2.3 In April 2014, the engine and MFOHE manufacturers conducted a review of the manufacturing operations. Improvements to the manufacturing process were made in May 2014. The improvements included using a standardised crimping tool to eliminate the variation in the crimps due to the use of hand tools. In addition, the crimped fuel tubes that have a history of cracking will be welded close at assembly.

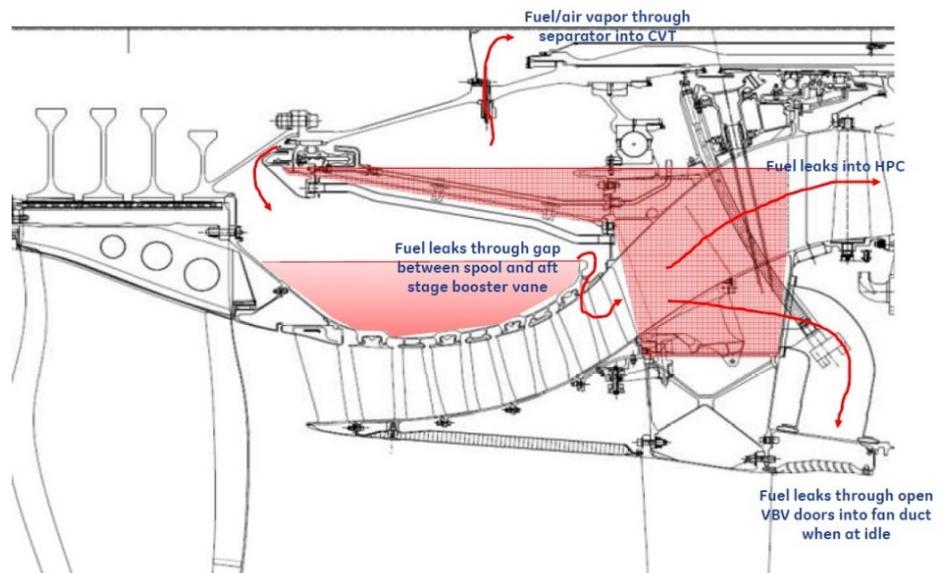
2.1.4 Once the booster spool cavity was filled up to the aft lip, the excess fuel leaked through a gap between the spool and aft stage booster vane into these areas (**Figure 16**):

- HPC through the core airflow
- Fan duct when the VBV doors are open at engine idle power

Figure 16: Leak path for fuel

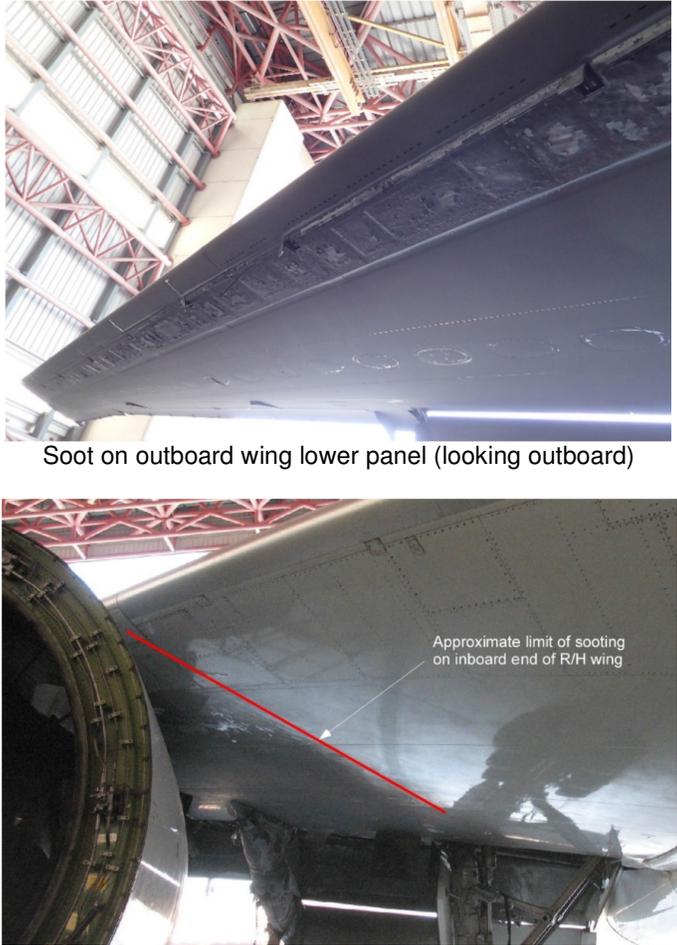
S/No	Description	Damage
1	Wing lower surface from the outboard of the engine strut towards the wing tip covered in heavy soot

<p data-bbox="724 877 1317 905">Soot on outboard wing lower panel (looking outboard)</p> <p data-bbox="1114 1066 1308 1108">Approximate limit of sooting on inboard end of R/H wing</p> <p data-bbox="800 1381 1243 1409">Inboard limits of soot (looking aft)</p>
2	Upper wing skin areas at the wing leading edge covered in light soot

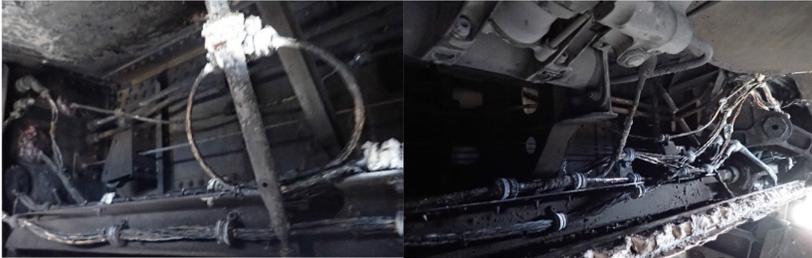
S/No	Description	Damage
3	Wing rear spar area and system components installed immediately behind and outboard of the right hand engine sustained fire damage

<p data-bbox="850 522 1192 558">Typical rear spar damage</p>
4	Lower fixed leading edge panels towards outboard of wing found with thermal damage on the exterior surface but the inboard surface was not damaged

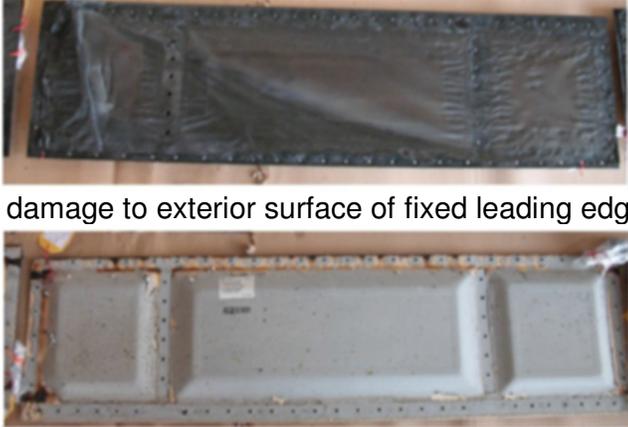
<p data-bbox="607 816 1435 852">Typical damage to exterior surface of fixed leading edge panel</p> <p data-bbox="607 1054 1435 1089">Typical condition of interior surface of fixed leading edge panel</p>
5	Upper fixed leading edge panels behind the slats exhibited discolouration due to heat exposure. The discolouration was more pronounced towards the outboard of the engine with the maximum discolouration occurring about mid-way between the engine and wing tip.

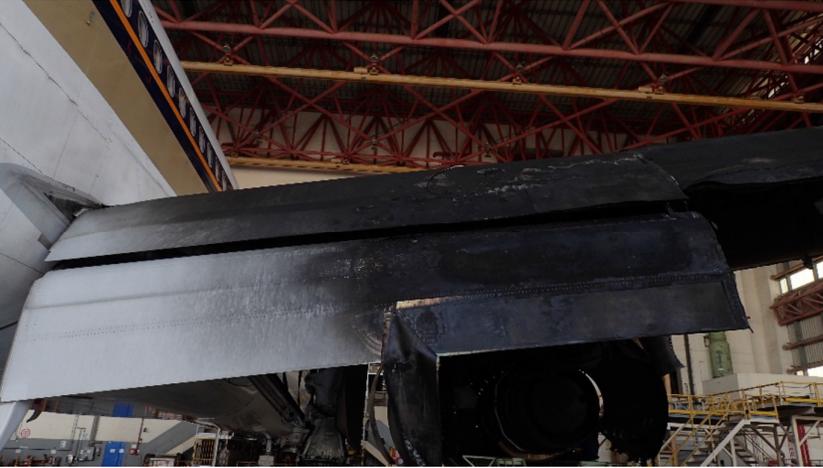
<p data-bbox="786 1803 1258 1833">Inboard main flap aft of right engine</p>

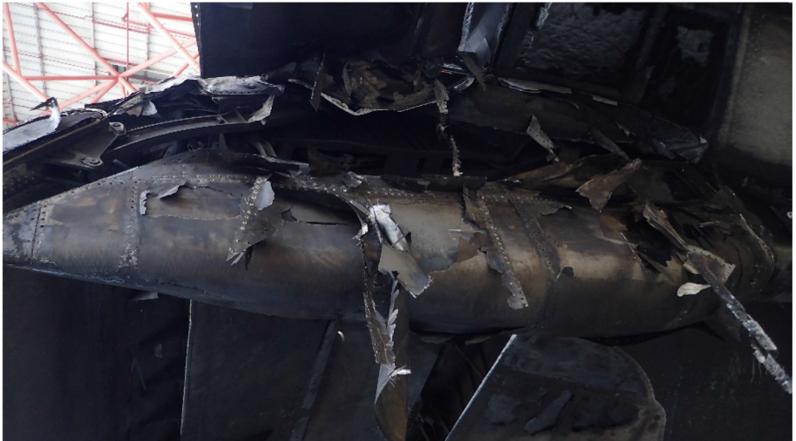
<p data-bbox="836 703 1209 745">Inner most flap track fairing</p>

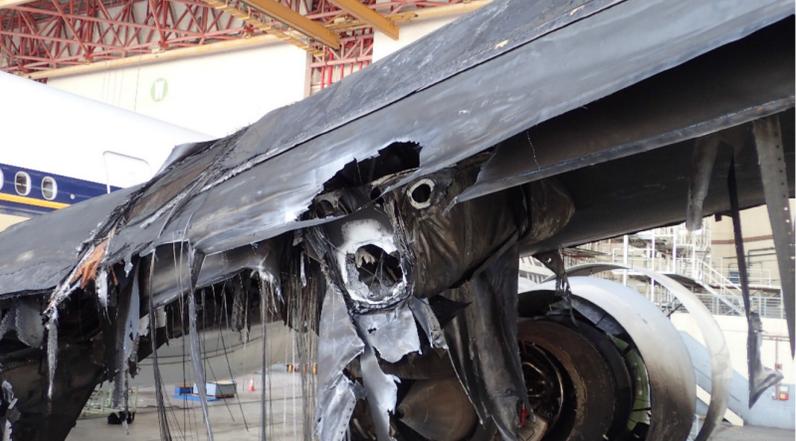
<p data-bbox="755 1218 1291 1260">Inner portion of right hand outboard flap</p>
8	Outboard facing side of right main landing gear shock strut door sustained heat damage
