Air Accident Investigation Sector

- Preliminary Report -

AAIS Case N°: AIFN/0008/2016

Runway Impact During Attempted Go-Around

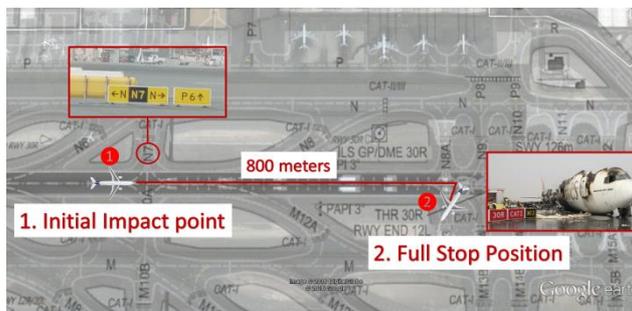
Figure 1. Aircraft Initial impact and final position

The point of impact of the Aircraft with the runway was approximately 2,530 meters from runway 12L threshold, adjacent to the November 7 taxiway. Marks on the runway indicated that the Aircraft slid for approximately 800 meters along the runway with the three landing gears not fully up. The Aircraft came to rest adjacent to the Mike 13 taxiway, having turned to the right onto a heading of approximately 240 degrees.

The Aircraft aft fuselage lower section impacted first, followed by the engines, the lower section of the aircraft belly fairing, and then the forward fuselage and nose landing gear doors. The No.2 engine separated, moved laterally on the right wing leading edge, and remained near the right wingtip until the Aircraft came to rest.

As it slid along the runway surface, various components detached from the Aircraft. These components included portions of the engine cowlings, secondary support structures and parts of the wing to body fairings, access panel doors, and systems components. (Figure 1).

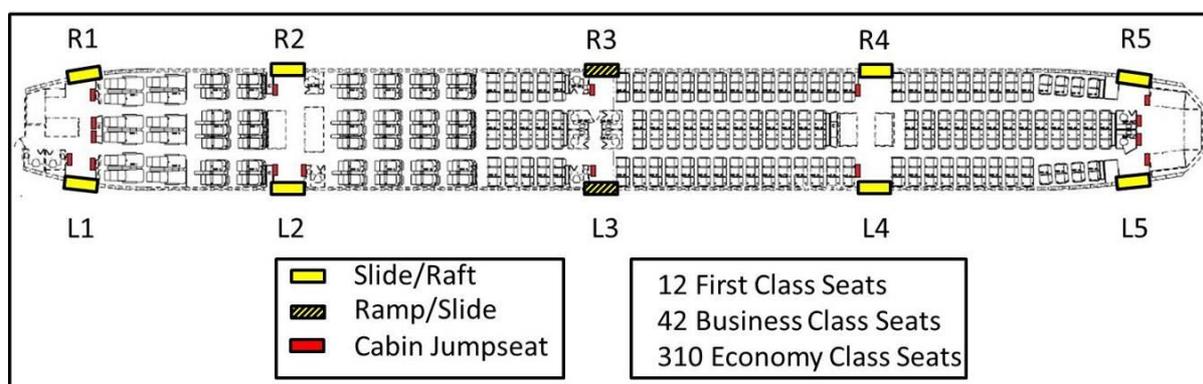
Figure 2. Cabin layout with door location
(Note: The cockpit evacuation windows are not shown)

The Aircraft was configured to seat 16 cabin crewmembers on jump seats located at each cabin door and in the forward cabin between L1 and R1 doors. Additional seats were located in the aft galley between L5 and R5 doors. The senior cabin crewmember's jump seat was located at L1 door, opposite the cabin crewmember jump seat. L2 door was equipped with an additional jump seat facing aft. All of the jump seats were occupied by cabin crewmembers (figure 2).

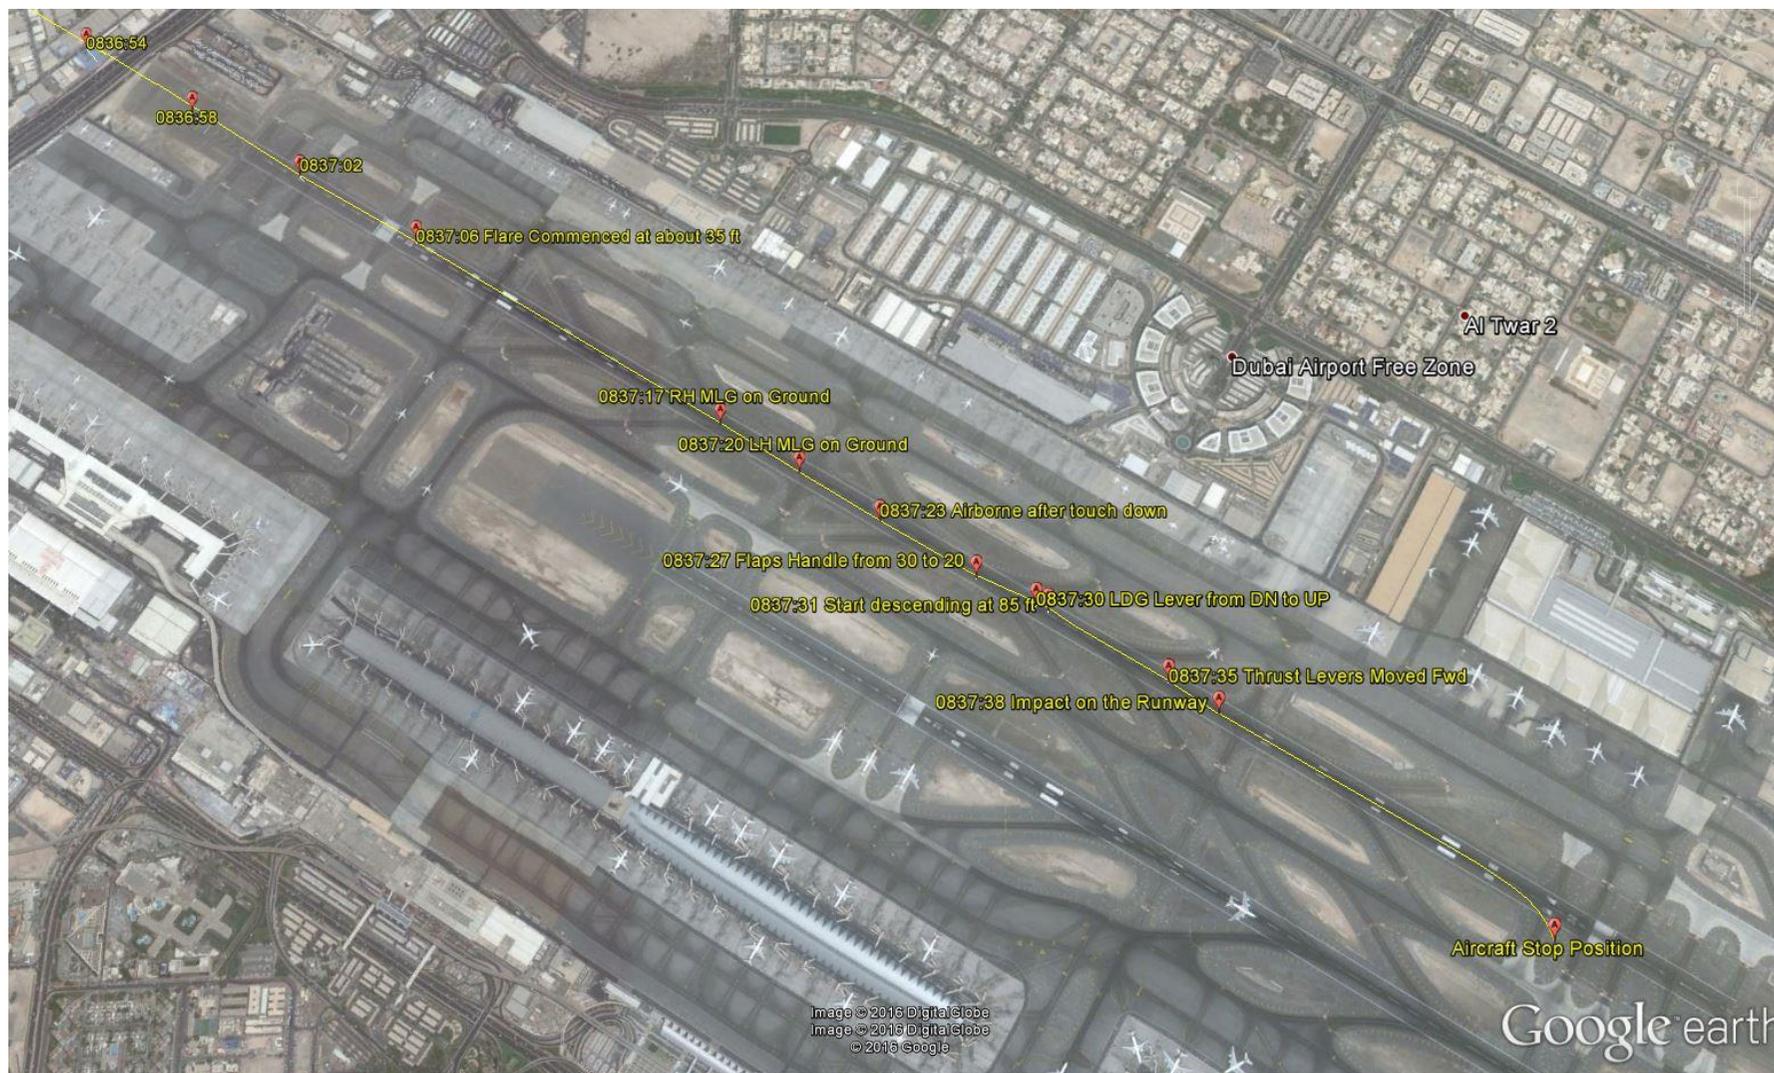
Appendix A. Final Flightpath

Appendix A to this Report illustrates the final flightpath from over the threshold until the Aircraft came to rest.
