FINAL REPORT

RUNWAY INCURSION BY A TOW TUG IN CHANGI AIRPORT 6 AUGUST 2016

AIB/AAI/CAS.123

**Transport Safety Investigation Bureau
Ministry of Transport
Singapore**

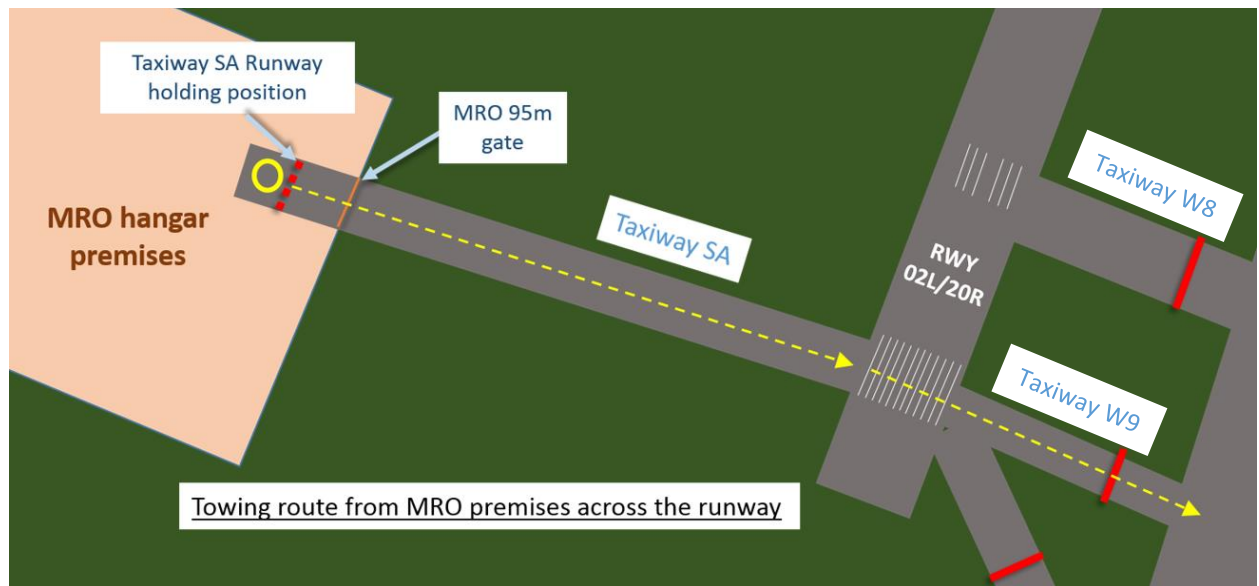
Figure 1. Planned towing route

- 1.1.1 In the early morning of 6 August 2016, a tow tug was to tow a B787 aircraft to Bay 300 in Singapore Changi Airport for the aircraft to be prepared for departure. The B787 had some maintenance work done by an aircraft maintenance, repair and overhaul organisation (MRO) located on the west side of the southern end of Runway 02L/20R. The towing would involve crossing Runway 02L/20R via Taxiway SA onto Taxiway W9 (see **Figure 1**).

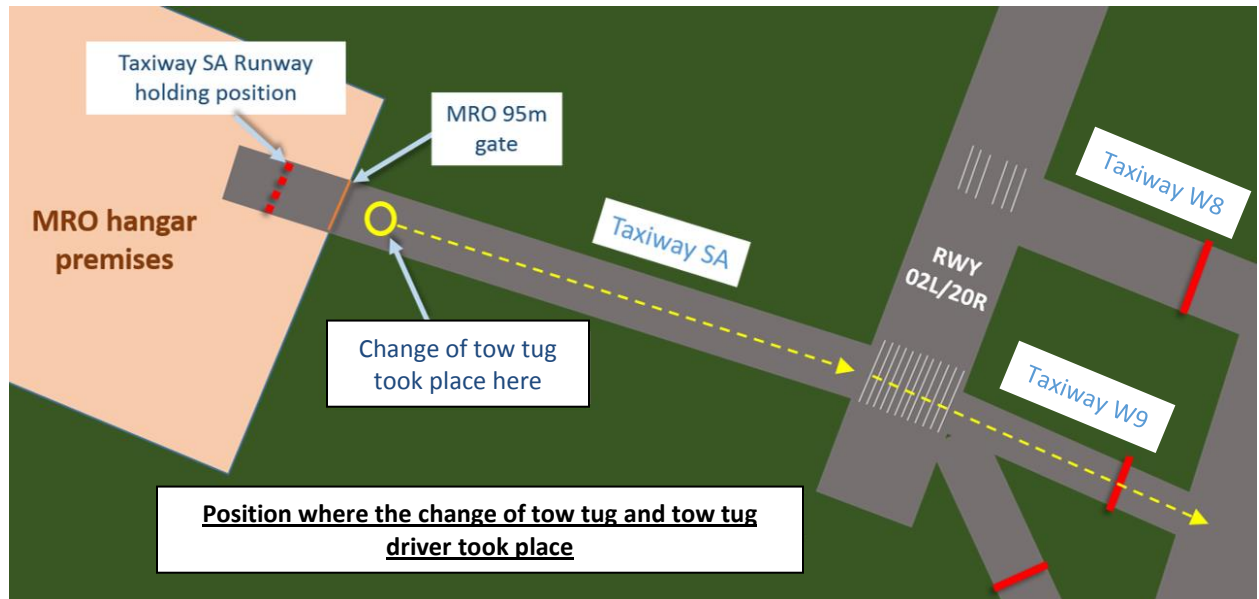
Figure 2. Change of tow tug and tow tug driver took place here

MRO's tow tug was just beyond the MRO's gate¹ to the aerodrome (the MRO called this the 95m gate because of its width) (see **Figure 2**). Here the MRO's tow tug and tow tug driver were replaced by a tow tug and tow tug driver from a ground service provider (GSP) at Changi Airport engaged by the MRO.

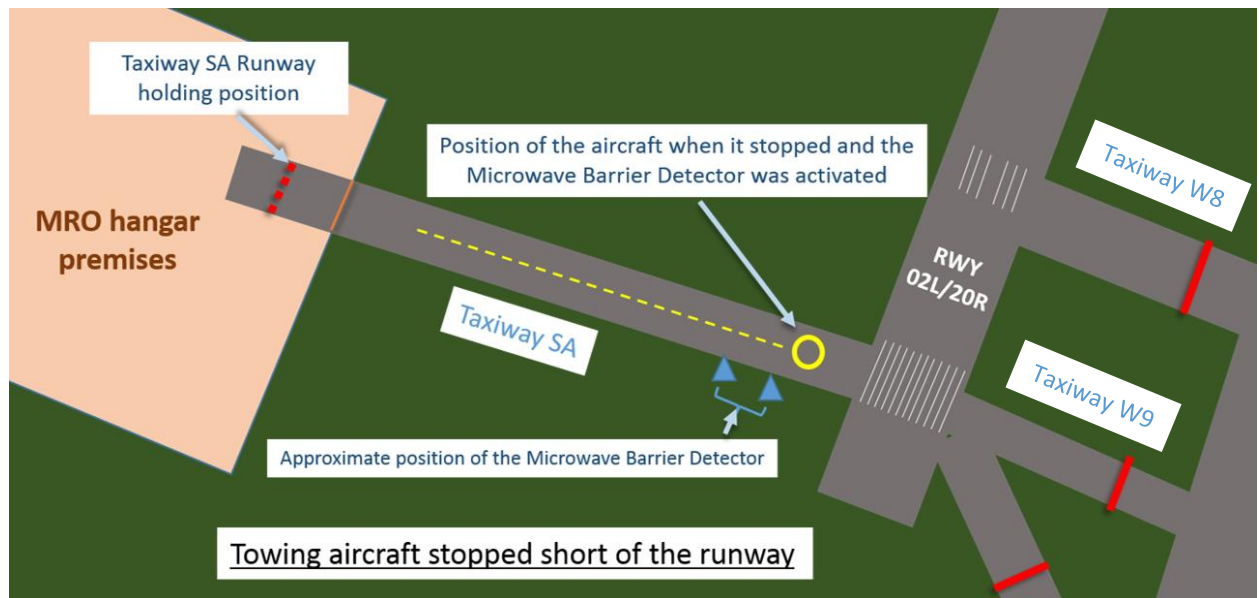
Figure 3. Approximate position of MBD

- 1.1.7 As the towing column was moving forward, the tow tug driver spotted an aircraft approaching the airport from the north. He informed the headset man who was beside him. The headset man in turn informed the EIC. The EIC and engineers at the cockpit saw the aircraft and instructed the tow tug driver to stop. The EIC reported to the runway controller that they saw an aircraft approaching Runway 02L/20R. The runway controller saw that the towing column was apparently not moving and told the EIC that he was not given clearance to cross the runway³.
- 1.1.8 In the meantime, the microwave barrier detector (MBD) of the airport's runway incursion alerting system⁴ installed at Taxiway SA (see **Figure 3**) also triggered an alarm that alerted the runway controller.

- 1.1.9 The arriving aircraft landed safely and vacated the runway at Taxiway W8 without any incident. The towing column had stopped at about 115m from the centreline of Runway 02L/20R (i.e. 85m from the edge of the runway⁵).

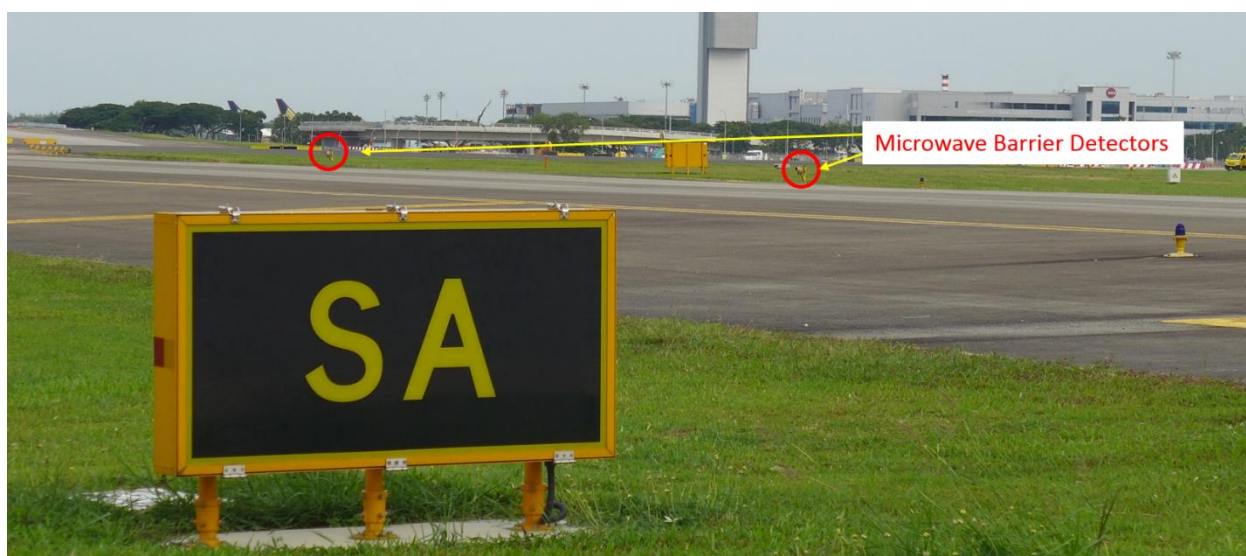
Figure 4. Microwave Barrier Detectors on Taxiway SA

1.6.1.1 The aerodrome has a runway incursion alerting system comprising a number of microwave barrier detectors (MBDs) for the detection of unauthorised entry of aircraft or vehicles into the runway. The MBDs (see **Figure 4**) are installed at all taxiways leading to a runway and are controlled by controllers at Changi Control Tower with the same switch that controls the red stop bar lights.

- 1.6.1.4 The MBD at Taxiway SA is located about 85m away from the edge of the Runway 02L/20R.
- 1.6.2 Taxiway SA
- 1.6.2.1 The MRO had a cluster of hangars on the west side of the southern end of Runway 02L/20R. Taxiway SA linked the MRO's hangar premises directly to Runway 02L/20R. Under an agreement with the then aerodrome operator⁷ in June 1993, the MRO constructed Taxiway SA (as well as the associated runway holding position, and the related markings, signage and lightings on the ground), as approved by the then aerodrome operator, when it developed its hangar facilities. The agreement also required the MRO to operate and maintain Taxiway SA.

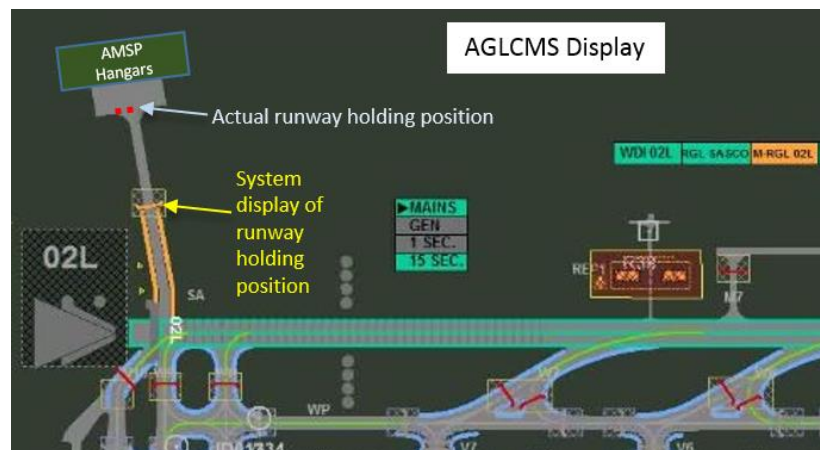
1.6.4.3 Although the runway holding position for Taxiway SA was within the MRO's premises, it was marked as being located within the aerodrome both on the AGLCMS display panel at Changi Control Tower (see **Figure 5**) and in the aerodrome chart in the Singapore Aeronautical Information Publication.

Figure 5. Incorrect display of Taxiway SA's runway holding position on the AGLCMS

- 2.3.2 Although the AGLCMS display panel at Changi Control Tower showed an incorrect location of Taxiway SA's runway holding position and red stop bar lights, the MBD detected the unauthorised entry by the towing column and set off an alarm to warn the controllers at Changi Control Tower of an impending runway incursion.

- 3.1.2 The display panel of the AGLCMS at Changi Control Tower and the aerodrome chart in the Singapore Aeronautical Information Publication were amended to reflect the correct location of the runway holding position.
- 3.1.3 The aerodrome operator and air traffic service provider also verified that the working of all the red stop bar lights in the aerodrome corresponded to the switch control by Changi Control Tower personnel.
- 3.1.4 The aerodrome operator reviewed the need for runway guard lights at the intersection of Taxiway SA and Runway 02L/20R and decided to install the guard lights. The lights became operational on 14 December 2016.
- 3.1.5 The aerodrome operator inspected all the runway holding positions in the aerodrome to ensure that all visual aids were in compliance with the Manual of Aerodrome Standards of the aerodrome regulator.

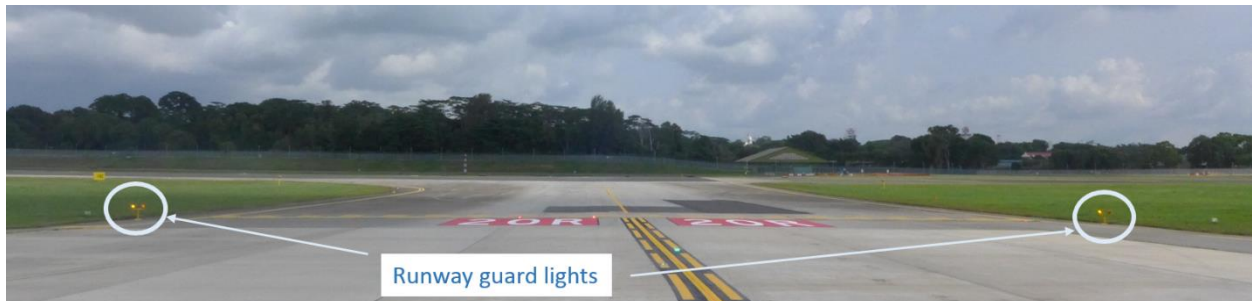
1.6.5.1 Runway guard lights (see **Figure 6**) are required¹⁴ at each taxiway/runway intersection associated with a runway intended for use in:

1.6.5.2 Runway guard lights are for warning pilots of aircraft and drivers of vehicles when they are about to enter a runway from the taxiway. For Runway 02L/20R, the runway guard lights shall be at least 107.5m from the runway centreline¹⁵.

Figure 6. Runway guard lights at the side of a taxiway

1.6.5.3 There were no runway guard lights at the intersection of Taxiway SA and Runway 02L/20R.

- 2.6 Runway guard lights at intersection of Taxiway SA and Runway 02L/20R
 - 2.6.1 The investigation team could not establish why there were no runway guard lights at the intersection of Taxiway SA and Runway 02L/20R, although it could be surmised that the reason had to do with the fact that there were red

2.6.2 Following the incident, the MRO installed runway guard lights at the intersection of Taxiway SA and Runway 02L/20R with assistance from the aerodrome operator (see paragraph 3.1.4).

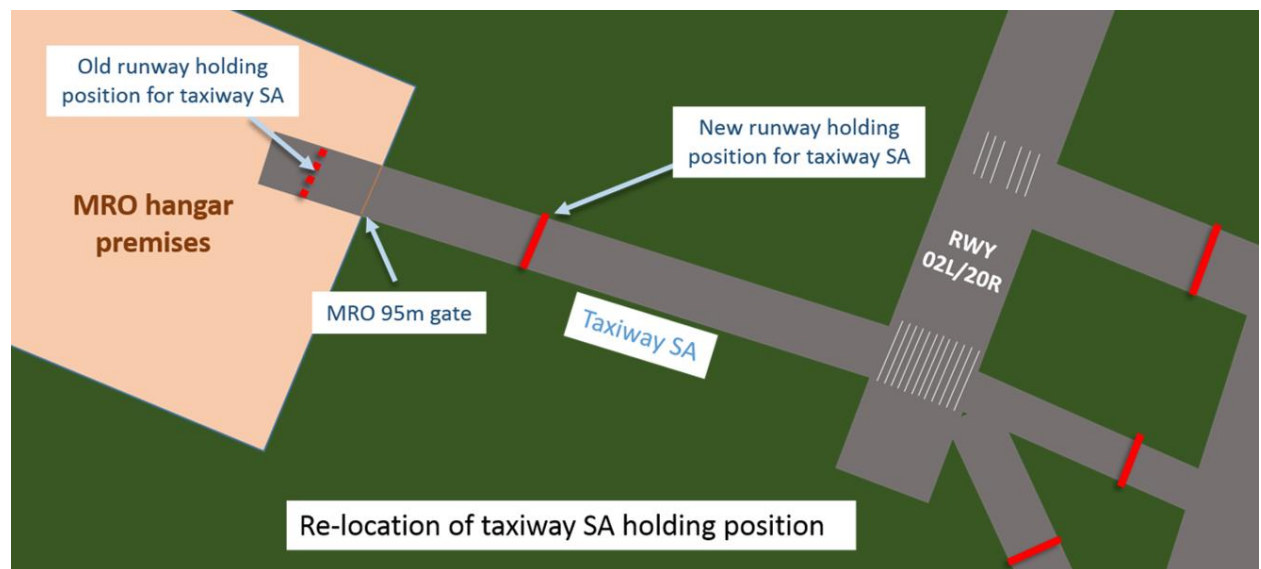
Figure 7. New Taxiway SA runway holding position

- 3.1.1 Following discussions with the stakeholders concerned, the MRO relocated the runway holding position and red stop bar lights for Taxiway SA to a location about 220m from the edge of Runway 02L/20R (see **Figure 7**) with assistance from the aerodrome operator. This location is outside the MRO's premises. The new runway holding position became operational on 14 December 2016¹⁷.
