**KOMITE NASIONAL KESELAMATAN TRANSPORTASI  
REPUBLIC OF INDONESIA**

**Aircraft Accident Investigation Report**

**Boeing 737-300F; PK-YSY**

**Wamena Airport, Papua**

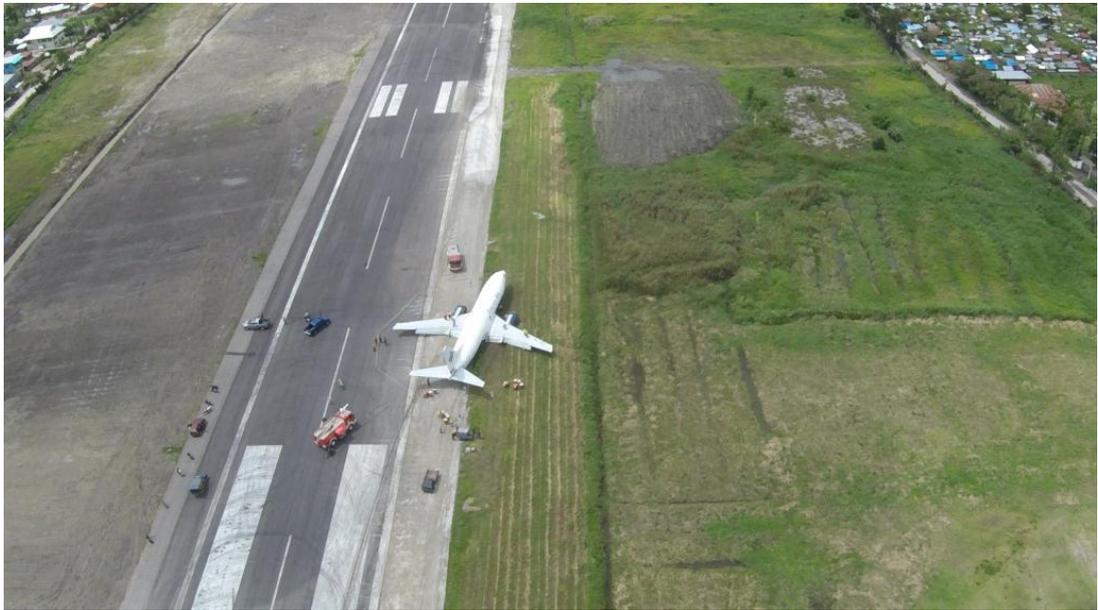
**Figure 1: The aircraft final position**

Both of main landings gear collapsed. The left main landing gear detached and found on runway. The engine and lower fuselage contacted to the runway surface. The aircraft veer to the right and stopped at approximately 1,890 meters from the beginning of the runway 15.

No one was injured on this occurrence and the aircraft had substantially damage.

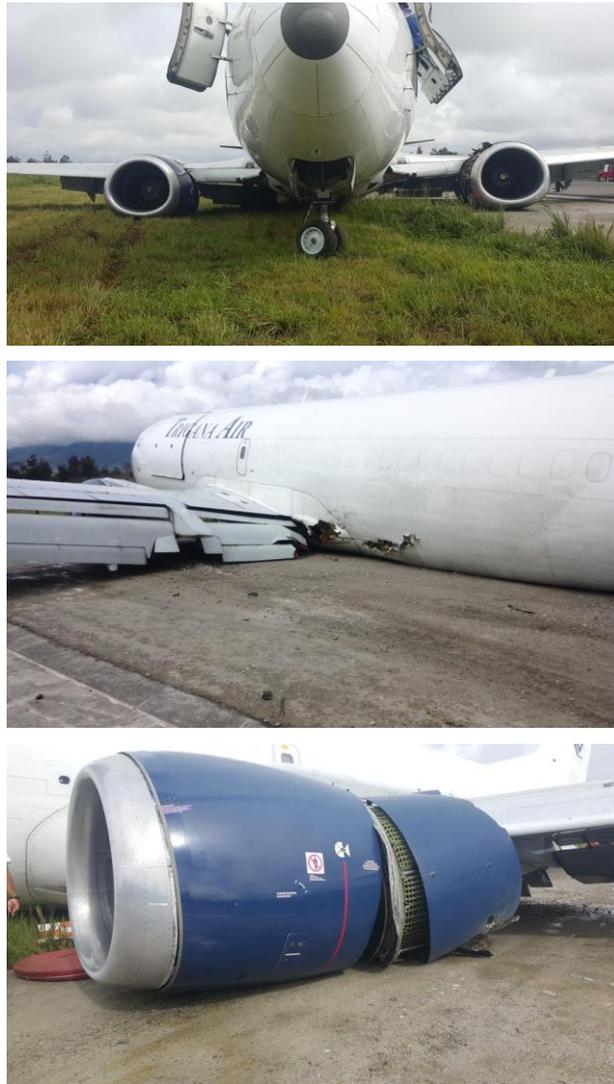
**Figure 2: Damages to aircraft**

The aircraft substantially damaged, the detail damaged were as follows:

- Both of main landing gears collapsed;
- Left main landing gear assembly detached;
- Right main landing gear assembly broken
- Tire number 2 blown out;
- Both inner flaps broken;
- Left engine cowling were detached;
- Leading edge of right horizontal stabilizer dent;
- Lower skin of right horizontal stabilizer perforated;
- Aft lower fuselage scratched;

- Left wing to fuselage fairing torn

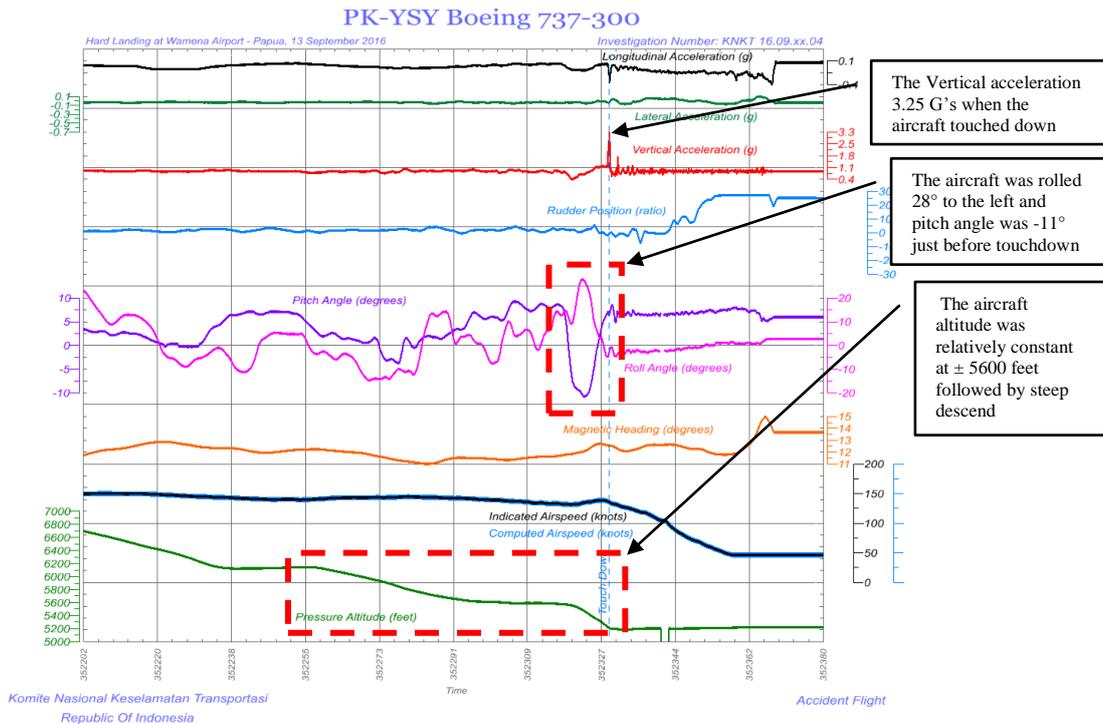
Figure 5: Several FDR parameters on approach and landing

The Flight Data Recorder recorded the vertical acceleration was 3.25 g on

touchdown at about 2230 UTC.

The aircraft was equipped with a Fairchild F1000 Flight Data Recorder (FDR) with part number S703-1000-00 and serial number 00343. Following the accident, the recorder was transported to KNKT recorder facility for data downloading process. The FDR recorded 20 parameters which was containing 52 flights including the occurrence flight.

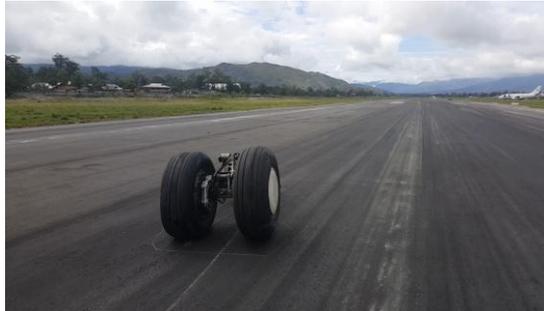
**Figure 6. the left main landing gear found on the left side of the white paint scratch mark**

After touchdown, both main landing gears collapsed and the left main landing gear detached and found on the runway. The aircraft travelled with the engine cowling and lower fuselage contacted to the runway surface until the aircraft stopped at approximately 1,890 meters from the beginning of the runway 15.

The investigation found the tire marks of left main landing gear on the runway at approximately 125 meters from the runway threshold, followed by the tire mark of the right main landing gear. Following these marks, a white paint between two purple paint scratch marks that changed to metal scratch marks found along the aircraft trajectory.
