Report IN-038/2016

Incident involving a BOEING 737-400, registration SP-ENA, operated by ENTER AIR, and a CESSNA 172, registration EC-JOB, operated by BARCELONA FLIGHT SCHOOL, at the Barcelona TMA (Spain) on 28 September 2016

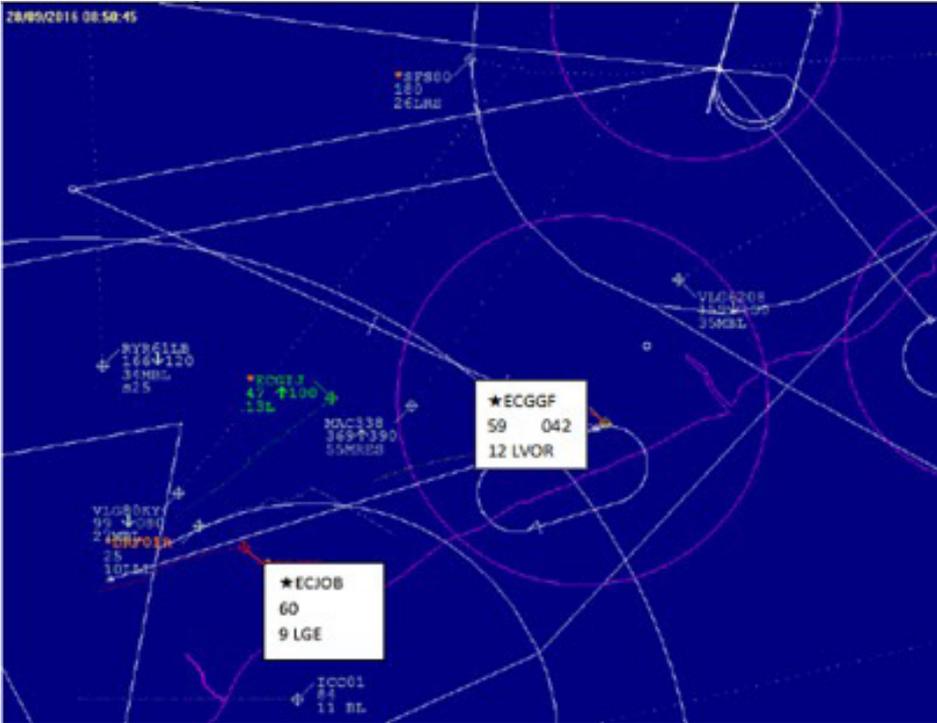
Figure 6. Aircraft EC-GGF on approach to LEGE (08:50:45)

08:48:17 Aircraft EC-GGF, under IFR from LELL to LEGE, approaches CLE, holding at 6000 ft, and reports to sector T1. The ATCO in the sector tries to communicate with the Girona TWR, to no avail. The traffic is instructed to descend to 4200 ft and complete the VOR/DME approach to runway 02 at Girona.

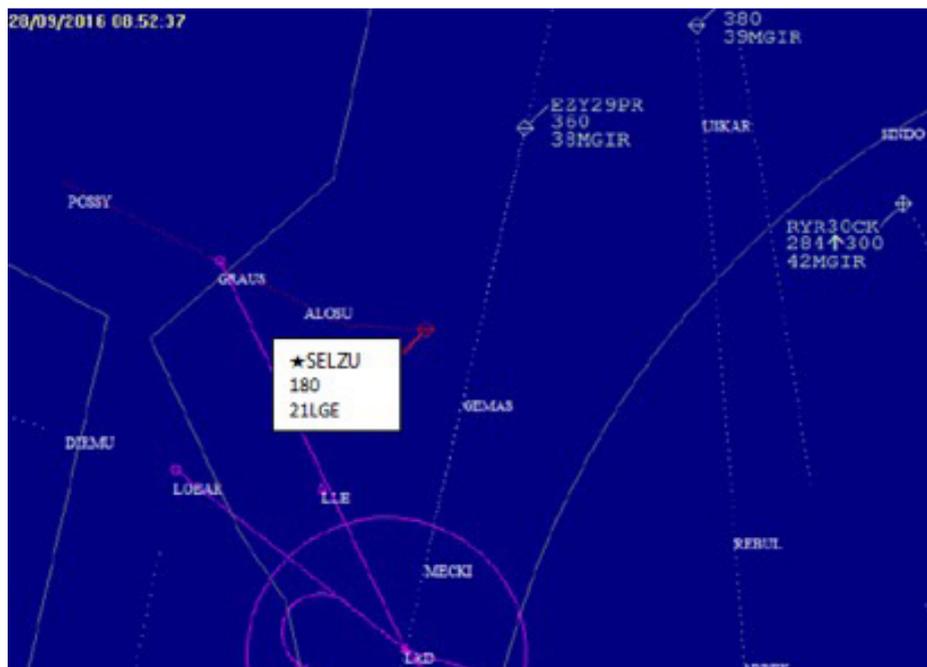
Figure 7. SELZU aerial work traffic (08:52:37)

08:52:37 The sector T4 ATCO informs the ATCO in T1E of the presence of an aircraft at FL180 that is doing aerial work near GEMAS (visible in Figure 7, with call sign SELZU).

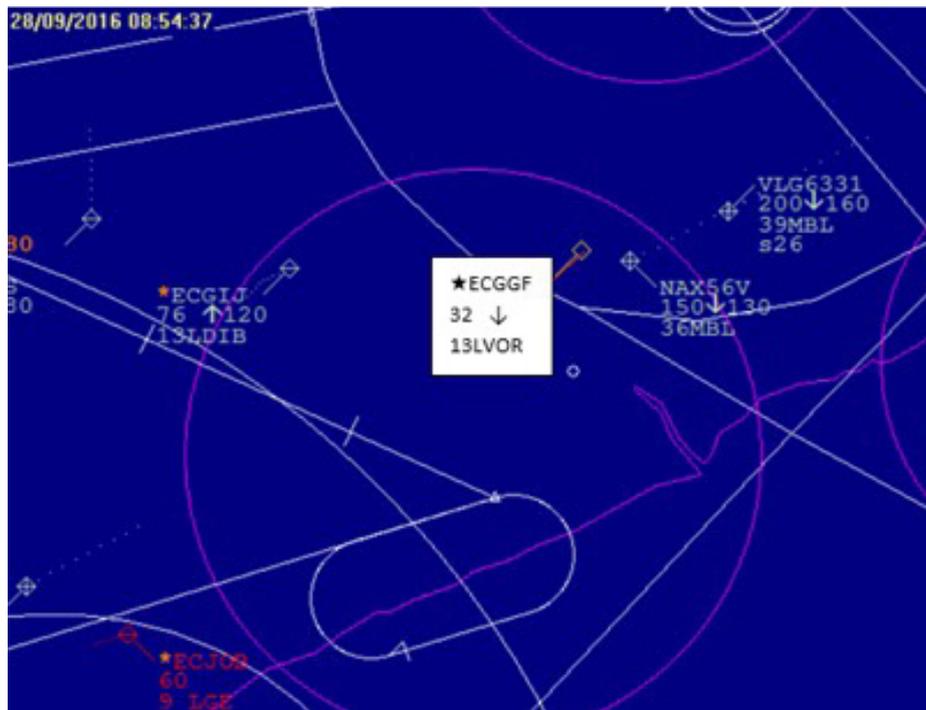
Figure 8. Last radar track for EC-GGF (08:54:37)

08:54:37 At approximately 08:44, the REDAN network goes offline at the Girona Airport. This prevents receiving information from the Girona radar, and results in the signals from aircraft below 3200 ft being lost on the displays at the Barcelona ACC and the Girona TWR. The track for EC-GGF, which is in the Girona CTR and descending through 3200 ft, disappears.

Under these conditions, it is sector TGR that handles approaches to runway 02 at Girona. When this sector was opened, its controllers were not informed about the aircraft flying from Sabadell to Girona (ECGGF, ECJOB and ECGIJ), and thus they were initially unaware of said traffic. Although the Girona tower controller checked with sector TGR about flight ECJOB at 08:55:42, he did not receive a reply since the ATCO at said sector was unaware of the existence of ECJOB. This traffic was visible on the display, but the sector's ATCO was focused on finding out the position of ECGGF, which had been transferred to the Girona TWR at 08:50:45 by sector T1E and was completing its approach without being visible on the radar due to the loss of the network. The last radar blip for this traffic had been at 08:54:37, when it descended below 3200 ft, as shown in Figure 8.

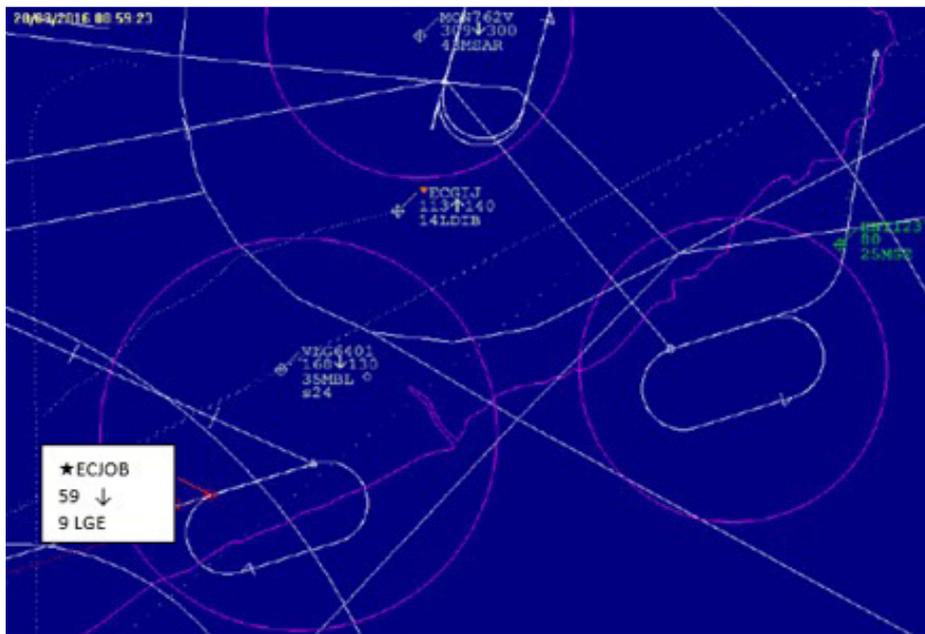
08:59:23 The D1E sector ATCO instructs EC_JOB to descend to 4200 ft and complete the VOR approach to RWY02 at Girona, as shown in Figure 9.

Figure 9. EC-JOB descending (08:59:23)

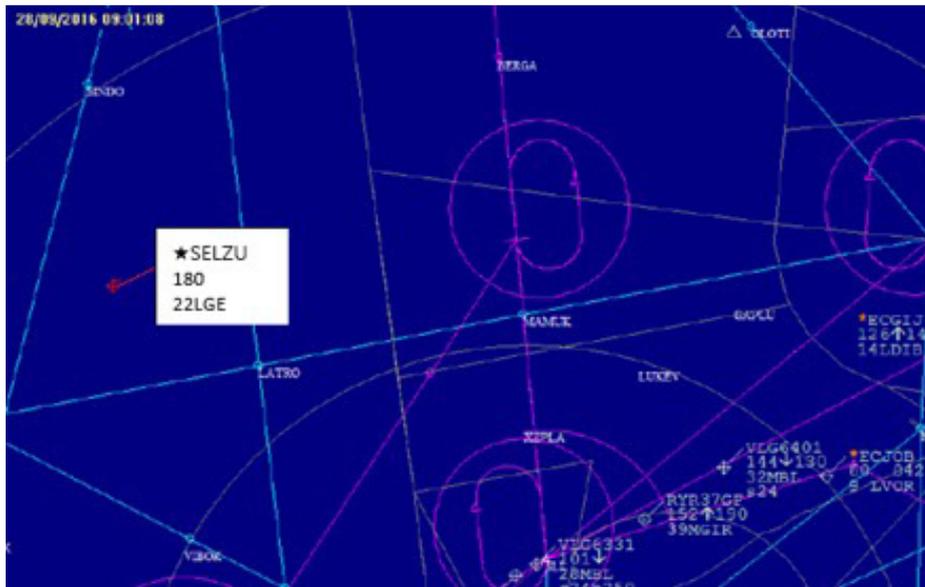
Figure 10. Traffic SELZU transferred to D1E (09:01:08)

09:01:01 Sector T4E transfers aircraft SELZU to sector D1E.

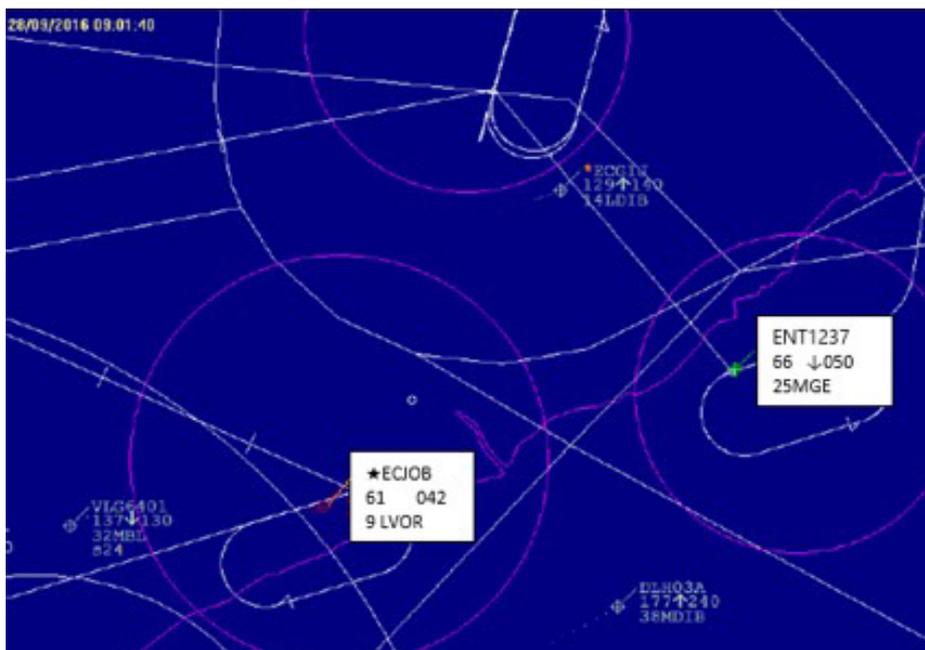
09:01:40 Sector TGR transfers ENT1237 to the Girona TWR. This aircraft is over point OKETA, as shown in Figure 11.

Figure 11. ENT1237 transferred to LEGE TWR (09:01:40)

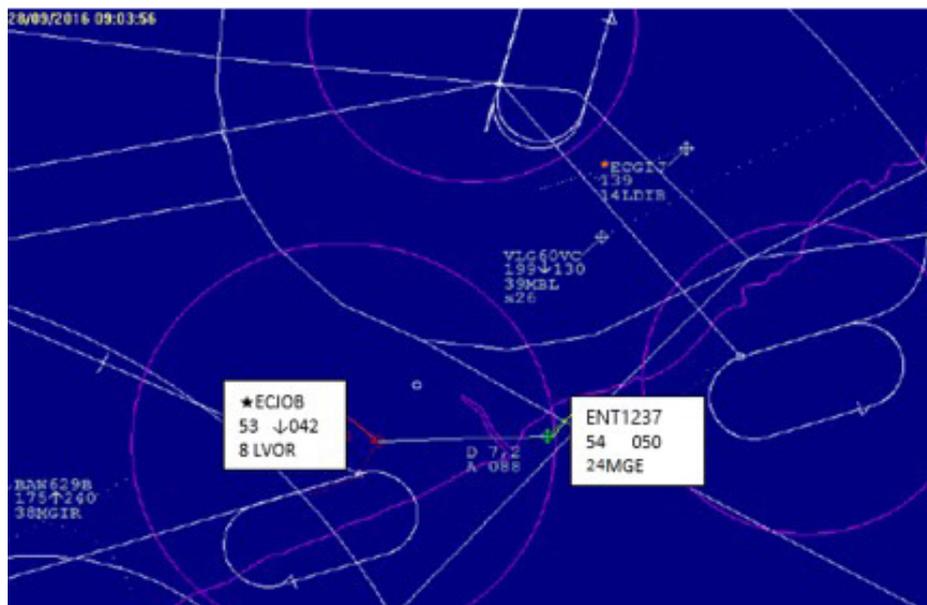
Figura 12. EC-JOB en aproximación a LEGE (09:03:56)

09:03:56 The D1E sector ATCO transfers EC-JOB to Girona. The traffic is 3 NM away from TISGO.

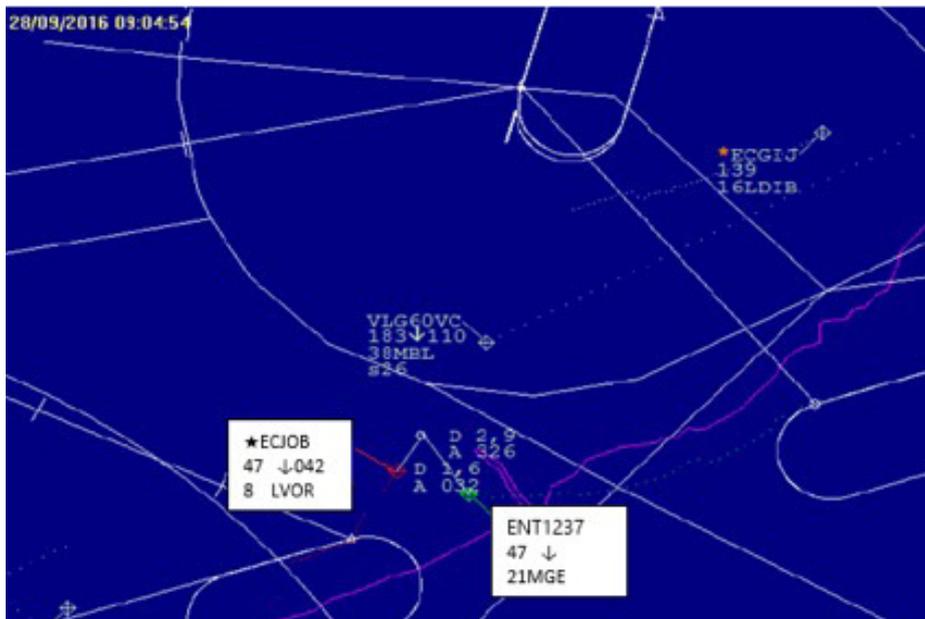
Figura 13. Pérdida de separación entre ECJOB y ENT1237 (09:04:54)

09:04:54 Separation lost between the two aircraft proceeding to TISGO.

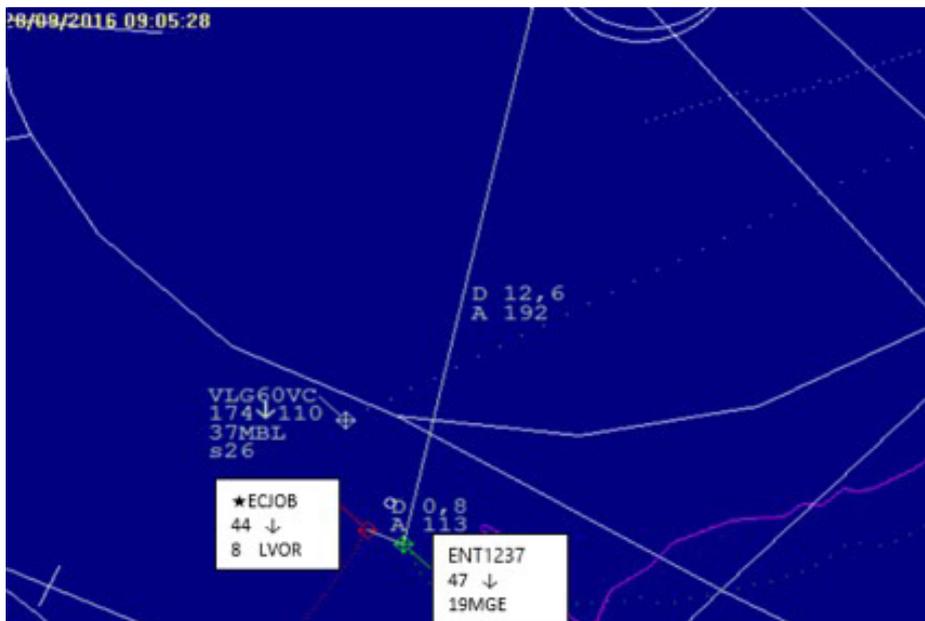
Figure 14. Approach between the two aircraft (09:05:28)

09:05:29 The TGR sector planner contacts Girona TWR to inform it of the presence of EC-JOB very close to ENT1237.

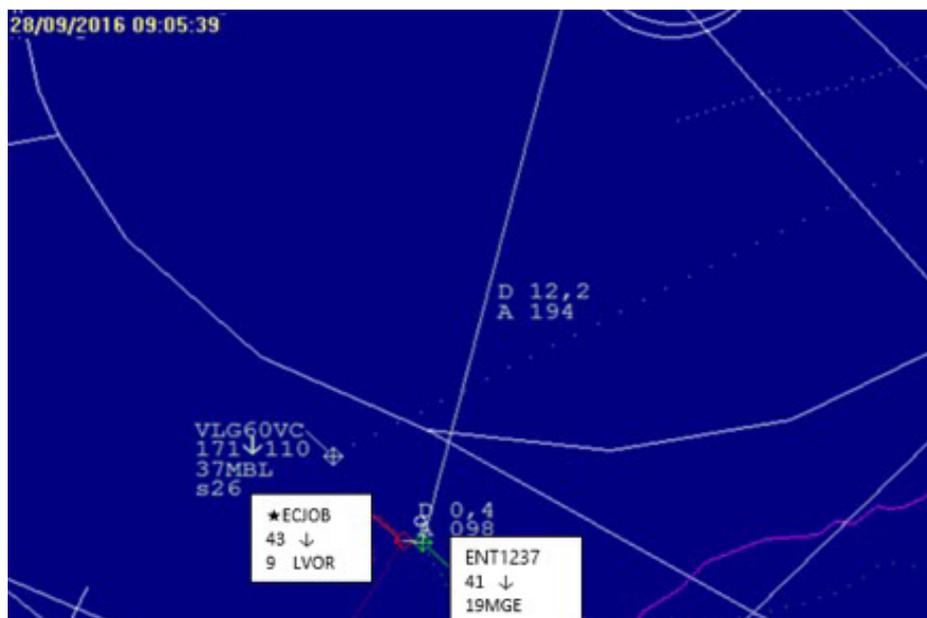
Figure 15. Minimum distance between the two aircraft (09:05:39)

09:05:39 The aircraft reach their closest point of approach.

in Figure 15. Weather conditions allowed the crews of both aircraft to remain in visual contact at all times. The crew of aircraft EC-JOB decided to turn left to separate from SP-ENA, while the latter continued its approach without disengaging the autopilot, eventually landing on runway 02.
