SERIOUS INCIDENT

Aircraft Type and Registration:	Airbus A319-131, G-EUPM
No & Type of Engines:	2 International Aero Engine V2522-A5 turbofan engines
Year of Manufacture:	2000 (Serial no: 1258)
Date & Time (UTC):	19 October 2016 at 0759 hrs
Location:	Manchester Airport
Type of Flight:	Commercial Air Transport (Passenger)
Persons on Board:	Crew - 7 Passengers - 117
Injuries:	Crew - None Passengers - None
Nature of Damage:	Damage to nose landing gear barrel, axle, torque links, steering actuator cylinder and wiring harnesses
Commander's Licence:	Airline Transport Pilot's Licence
Commander's Age:	46 years
Commander's Flying Experience:	11,900 hours (of which 10,700 were on type) Last 90 days - 169 hours Last 28 days - 62 hours
Information Source:	AAIB Field Investigation

Synopsis

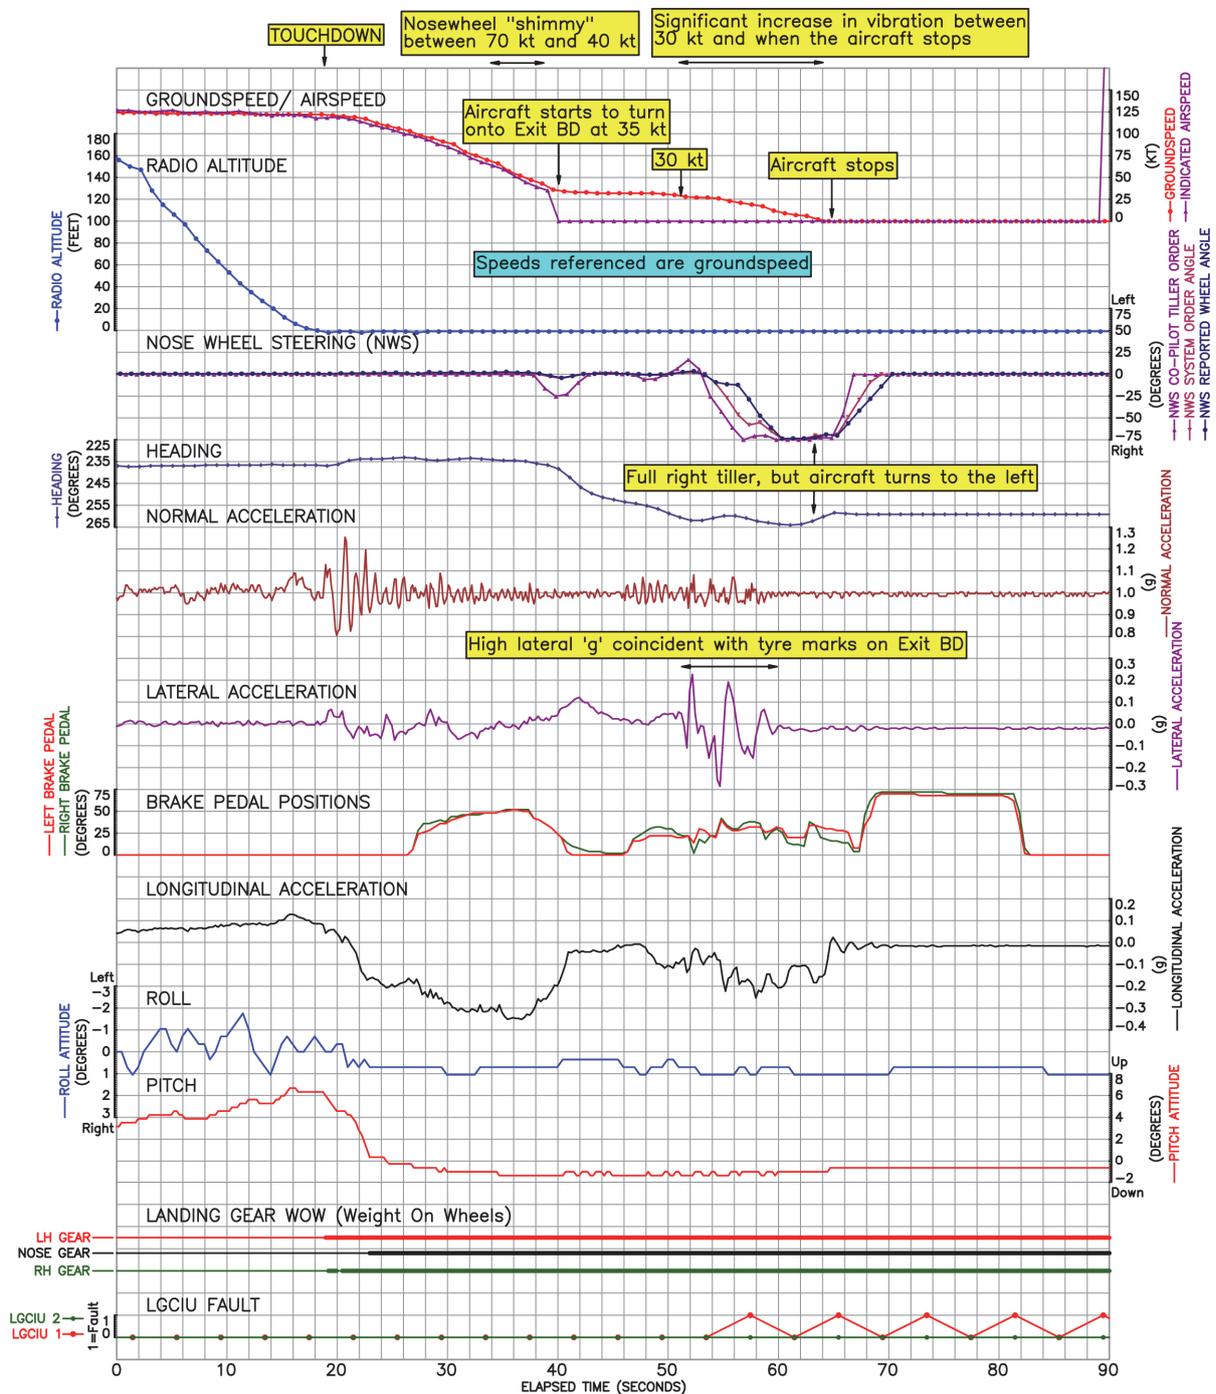
Figure 3
Landing at Manchester Airport

The aircraft manufacturer reviewed the FDR data from G-EUPM and confirmed that the LGCIU 1 fault was triggered due to damage to the left WOW proximity sensor. This resulted in the LGCIU 1 signal to the flight recording system being set to the 'air' condition and so both recorders continued to operate after the engines were shut down.

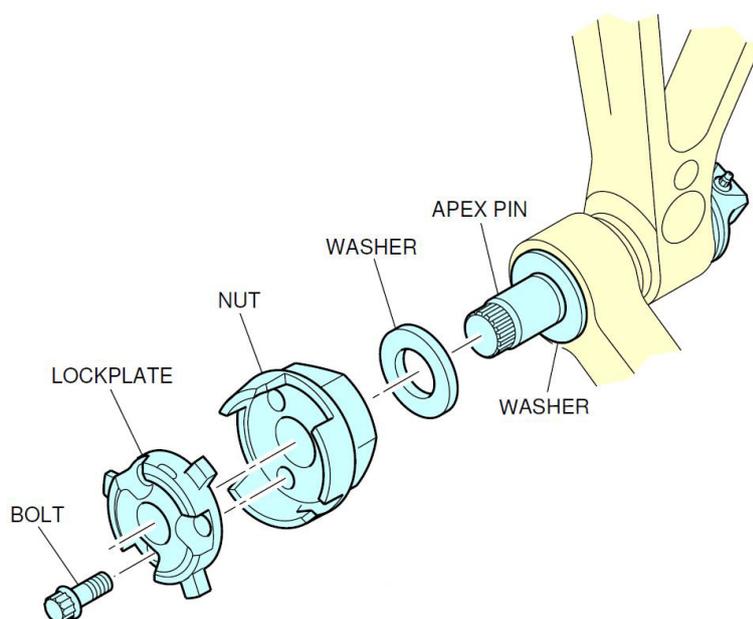
Figure 9

In 2009, in response to in-service NLG apex pin fracture events, the aircraft manufacturer launched a redesign of the apex pin assembly. This activity resulted in a *'Technical Follow-up'* notice to operators, TFU 32.21.27.002, which described the in-service cases of NLG torque link separation following apex pin rupture due to TBL tractor contacts. This TFU also drew attention to Service Bulletin (SB) A320-32-1400, issued in June 2012, which introduced a new apex pin with a redesigned nut assembly, reducing the lateral projection of the apex pin nut by 7 mm. In addition to other improvements, the new design was *'developed to reduce the exposure to towbarless tractors'*, and was introduced as standard equipment on production A320-series aircraft at MSN 5154 (although, due to aircraft and parts sequencing during production, not every MSN immediately thereafter is to the post-modification standard). The aircraft manufacturer confirmed that approximately 2,400 in-service A320-series aircraft have been delivered with this modification embodied during production and none of these aircraft has experienced a torque link separation event. SB A320-32-1400 is available for retrofit to all A320-series aircraft.

New design of NLG apex pin, nut and locking assembly introduced with SB A320-32-1400

As a result of this event, the operator is considering the embodiment of Service Bulletin A320-32-1400 on its A320-series fleet, in a rolling programme as the aircraft undergo scheduled maintenance.
