ACCIDENT

Aircraft Type and Registration:	Dassault Falcon 7X, VQ-BSO	
No & Type of Engines:	3 Pratt & Whitney Canada PW307A engines	
Year of Manufacture:	2009 (Serial no: 64)	
Date & Time (UTC):	24 November 2016 at 1450 hrs	
Location:	London City Airport	
Type of Flight:	Commercial Air Transport (Passenger)	
Persons on Board:	Crew - 3	Passengers - 1
Injuries:	Crew - None	Passengers - None
Nature of Damage:	Minor abrasions to the right winglet	
Commander's Licence:	Airline Transport Pilot's Licence	
Commander's Age:	43 years	
Commander's Flying Experience:	7,900 hours (of which 2,687 were on type) Last 90 days - 65 hours Last 28 days - 37 hours	
Information Source:	Aircraft Accident Report Form submitted by the pilot

Synopsis

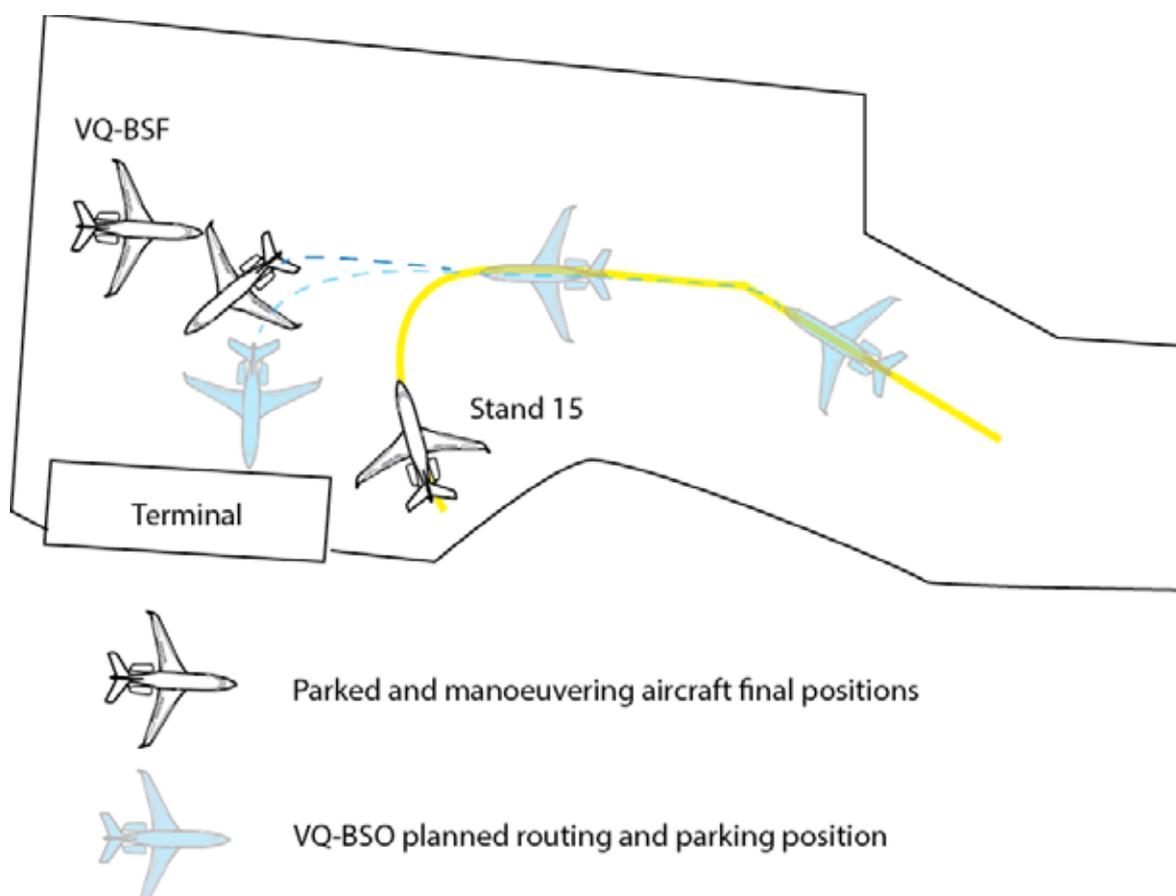
Figure 2 (not to scale)

Other aircraft were parked on the apron and a marshaller and two 'wing walkers' were in position to guide VQ-BSO between two parked aircraft - their approximate positions on the apron and the intended taxi route for VQ-BSO are shown at Figure 2. VQ-BSF was parked on the western end of the apron further forward than normal and its flight crew were in their seats, as they were shortly due to depart. Another Falcon 7X was parked on Stand 15, facing approximately north.

Diagram of the intended and actual routing of VQ-BSO, and the parked aircraft

The London City Airport operator also carried out an internal investigation. Their assessment of the cause of the accident was the failure of the marshaller to observe the non-standard STOP signals given by the right wing walker when VQ-BSO's winglet became close to the nose of VQ-BSF, the parked aircraft. At that moment, the marshaller was watching the left wing tip walker to his right. The flight crew were watching the marshaller and the rate of the left turn had also increased the speed of the right wing tip, which gave the right wing walker less time to initiate the STOP signal.

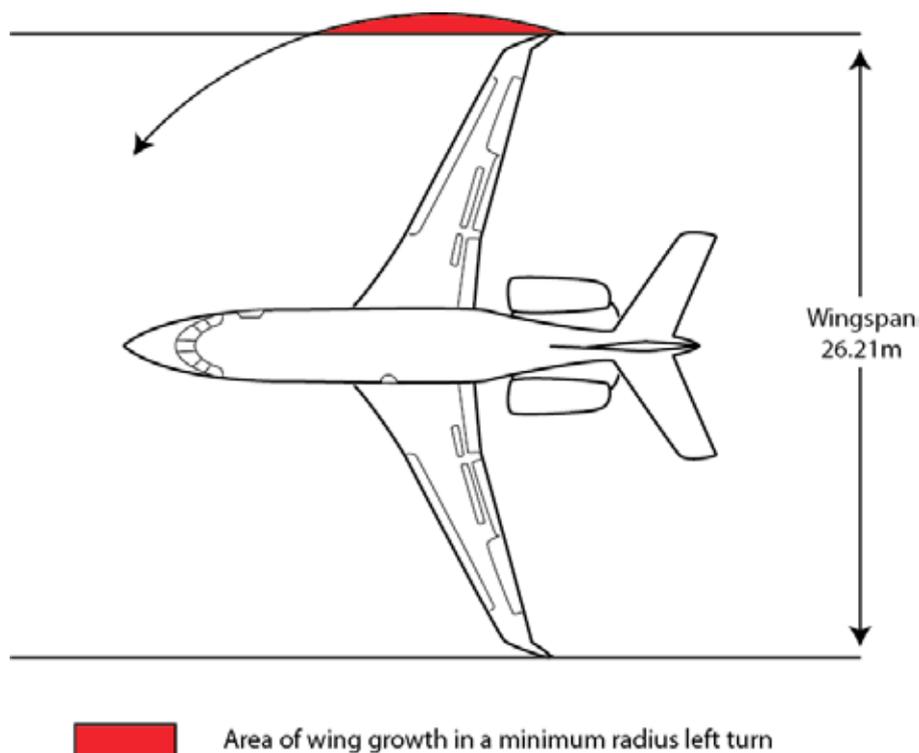
**Figure 4**

Wing growth is peculiar to swept-wing aircraft, such as the Falcon 7X. When moving in a straight line, the width of the area over which the wing structure passes equates to the wingspan. In the case of the Falcon 7X this is 26.21m. When a sharp turn is made to the left around the stationary left wheel, the radius of turn is from the left main wheel to the right wing tip, the arc of which subtends a greater distance out from the centre of the fuselage. This increase in radius or wing growth is illustrated at Figure 4.

Wing growth
