FINAL REPORT

BOEING B787, REGISTRATION 9V-OJF ENGINE FAILURE

26 NOVEMBER 2016

AIB/AAI/CAS.130

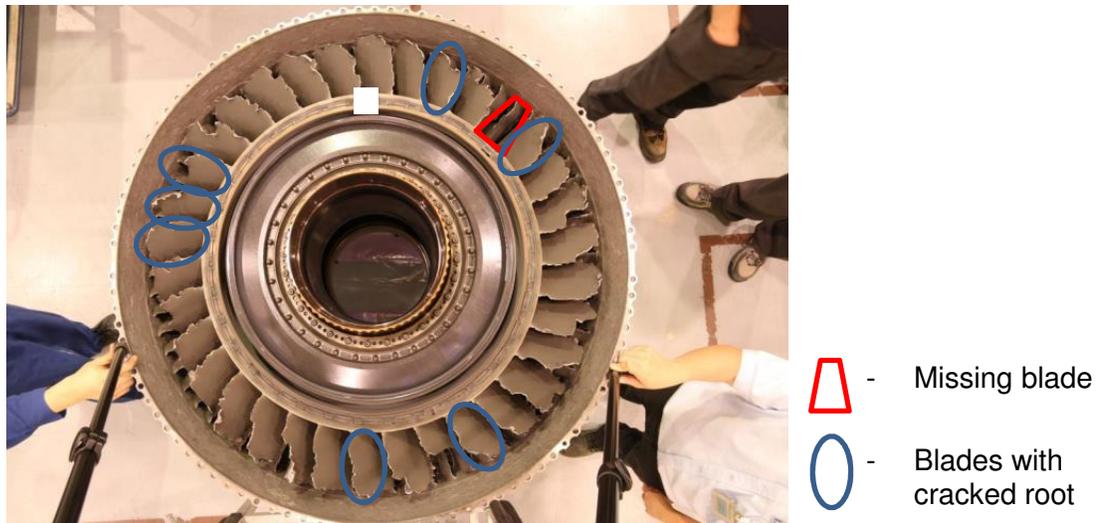
- 1.1.7 Inspections by the ground maintenance personnel revealed the following damage within the No. 2 engine:
- (a) One blade from the first stage of the Intermediate Pressure (IP) compressor was missing;

- 1.2.2 Detailed inspection of the No. 2 engine at the workshop revealed that, in addition to the missing blade, seven blades from the first stage of the IP compressor (see **Figure 1**) had each a crack of about 30.5mm on the front obtuse corner of the blade root and extending across the front face and along the top of the bedding flank (see **Figure 2**).

Figure 1: Damage on first stage of IP compressor

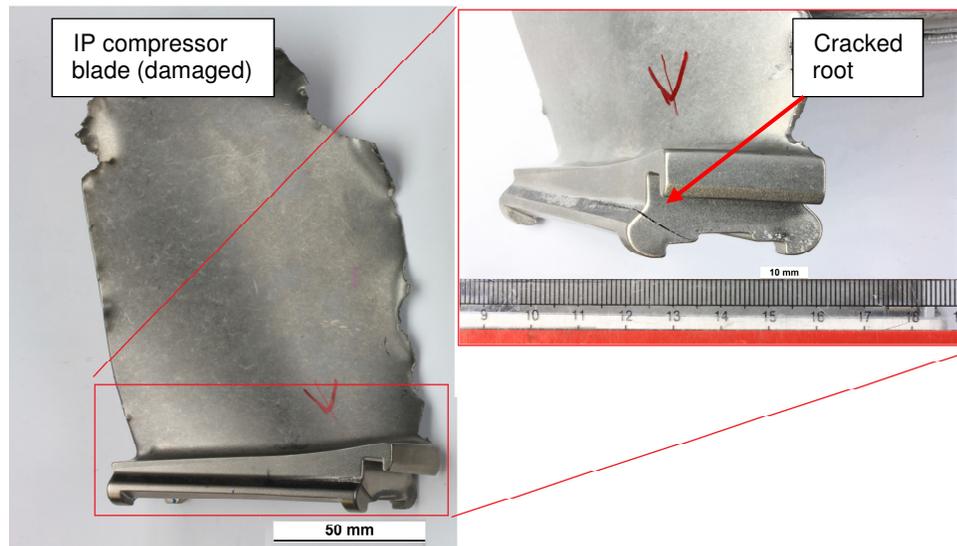
Figure 2: Cracked IP compressor blade root

1.2.3 Three of the seven cracked IP compressor blade roots were randomly selected and their cracks were opened up and subjected to a fractographic examination. It was observed that each of the opened cracks had a fatigue origin between 1.5mm and 2.0mm from the forward face of the root⁷.

⁷ This was consistent with the location of highest calculated stress in the IP compressor stage 1 blade root.

2.1.1 One of the first stage IP compressor blade was missing and seven blades had cracks at the blade roots. It is probable that the first stage IP compressor blade that went missing also had a crack at its blade root.

2.1.3 The blade root cracks were probably a result of material fatigue. Once the crack was formed, the cyclical application of force in the engine environment then caused the failure of the blade root.

- 3.1 It would be difficult to detect crack root of Intermediate Pressure (IP) compressor blades using boroscope inspection with on-wing engine. The engine manufacturer has instead developed a new ultrasonic inspection technique to detect cracks at the IP compressor blade root with engine fitted on wing. The engine manufacturer issued Non Modification Service Bulletin (NMSB) 72-AJ814 in August 2017 for this inspection. The NMSB required engines that have been inspected and found to be without cracked IP compressor stage 1 blade roots to be re-inspected within 200 flight cycles.

- 4.1 The engine manufacturer review the design of the IP compressor blade to prevent the development of cracks. [TSIB Recommendation RA-2017-034]
- 4.2 The European Aviation Safety Agency require the engine manufacturer to review the design of the IP compressor blade to prevent the development of cracks. [TSIB Recommendation RA-2017-035]

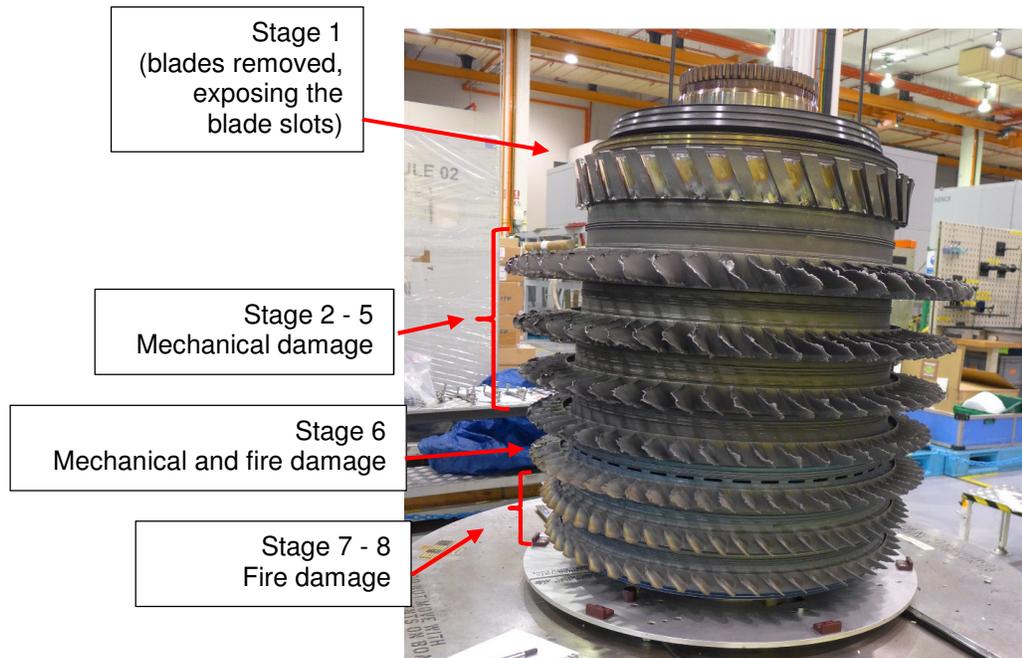
1.2.4 The aerofoils in all the stages of the IP compressor sustained mechanical damage (due to contact with the released IP compressor blade) and fire

damage (due to titanium fire⁸) (see **Figure 3**). All the High Pressure (HP) compressor blade aerofoils were missing (see **Figure 4**). The heat damage at the aft stages (6 to 8) of the IP compressor, as well as the corresponding heat damage to the HP compressor blades, were consistent with a surge of the IP compressor and HP compressor, which would be expected as a result of the liberated IP compressor stage 1 blade.

Figure 3: Damage to IP compressor blade aerofoils

⁸ IP compressor blades were made of titanium. A titanium fire is a rapid combustion of components containing titanium (often as a result of rubbing/friction) which generates extreme heat. In this incident, the fire was contained within the core of the engine.

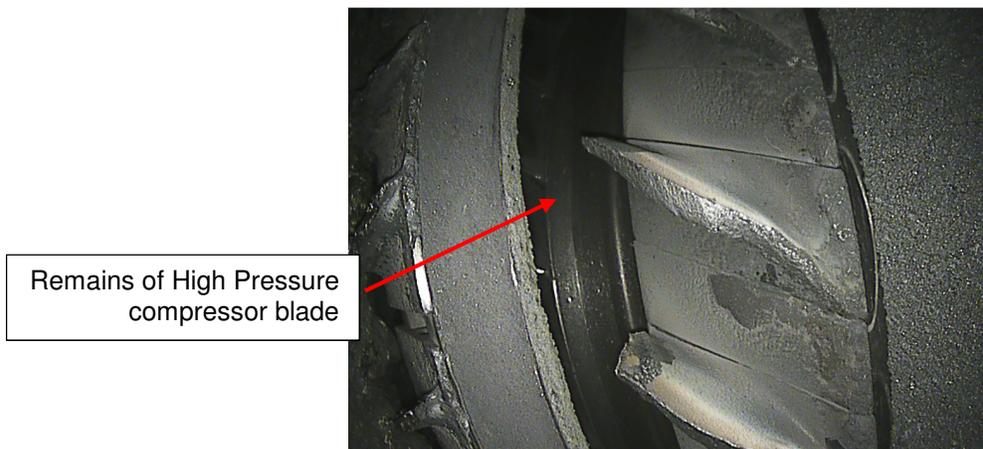
Figure 4: All HP compressor blade aerofoils missing

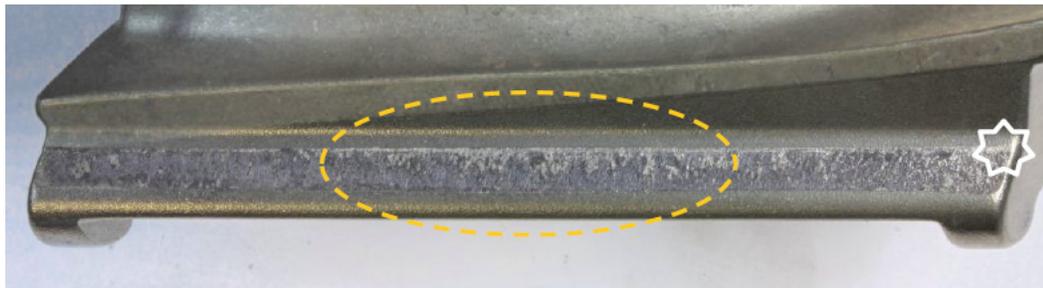
- 1.2.5 There was no evidence to suggest that the failure of the IP compressor blade aerofoils was caused by foreign object debris (FOD).
- 1.2.6 Although some Variable Inlet Guide Vanes (VIGV) levers were twisted and deformed and the VIGV mechanism was damaged, the engine manufacturer had assessed that the VIGV mechanism had been correctly rigged prior to the incident.
- 1.2.7 All the first stage IP compressor blades showed evidence of galling (see **Figure 5**) at the root area, with the heaviest galling located typically at the mid-flank on the convex side of the blades (circled in **Figure 5**). The galling was assessed to be the result of the rubbing of the surfaces of the blade roots and their respective slots as occasioned by the engine vibration. There was no noticeable difference in depth and appearance between the galling on the cracked and non-cracked blades.

Figure 5: Galling observed at IP compressor blade root
