Taxiing collision involving Boeing 737s, VH-YFT and VH-VUP

Hobart Airport, Tasmania, 7 December 2016

ATSB Transport Safety Report
Aviation Occurrence Investigation
AO-2016-167
Final – 24 May 2017

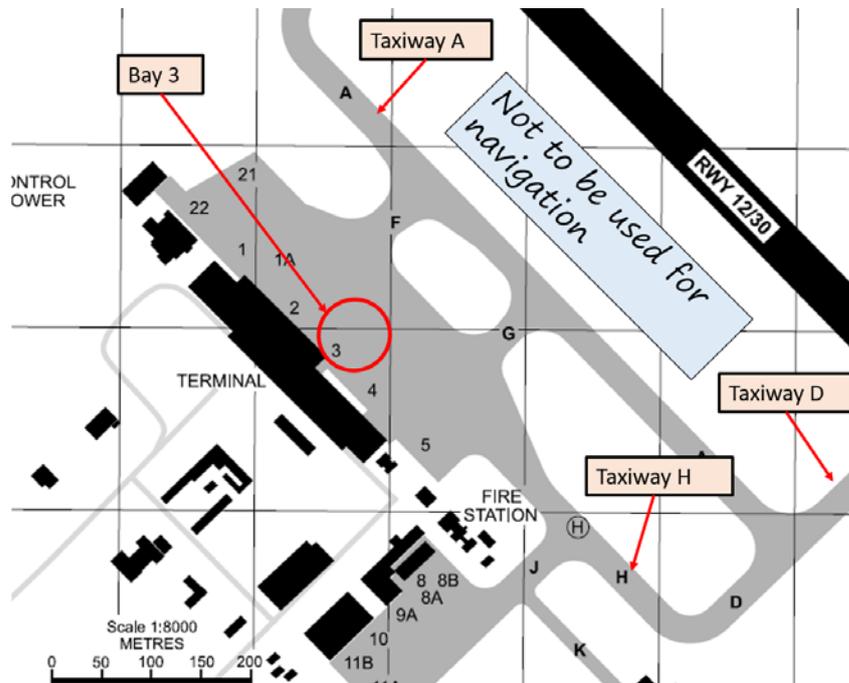
Figure 1: Hobart Airport – aerodrome diagram

On 7 December 2016, a Boeing 737-8FE aircraft, registered VH-YFT (YFT) was parked on bay 3 (Figure 1) at Hobart Airport, Tasmania, as the crew prepared to conduct Virgin Australia flight VA1531 to Sydney, New South Wales. The flight crew consisted of a captain and first officer, and a check captain seated in the jump seat between them.

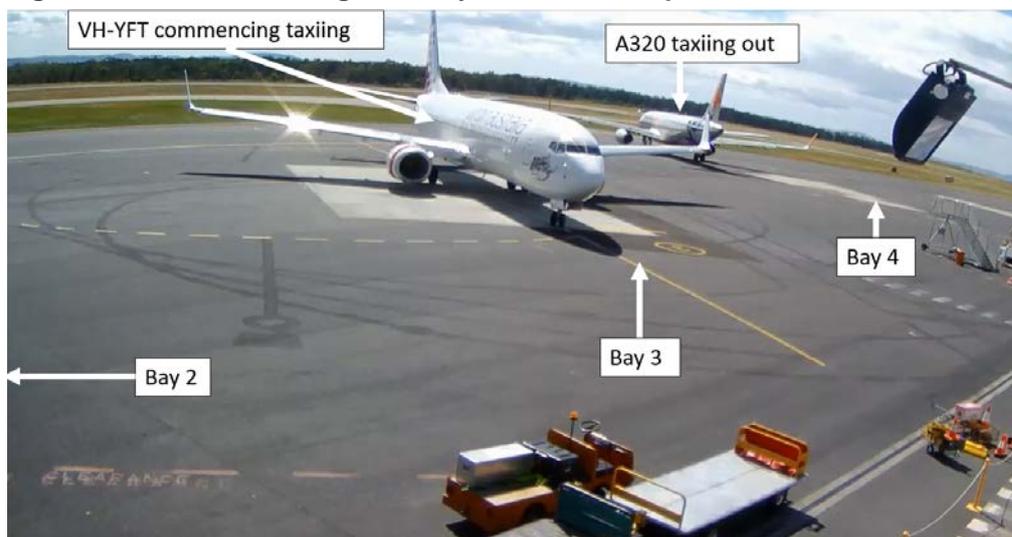
Figure 2: YFT starts taxiing from bay 3 at Hobart Airport

Airbus A320 aircraft that had commenced taxiing from bay 4, to vacate the apron area via taxiway H (Figure 2).

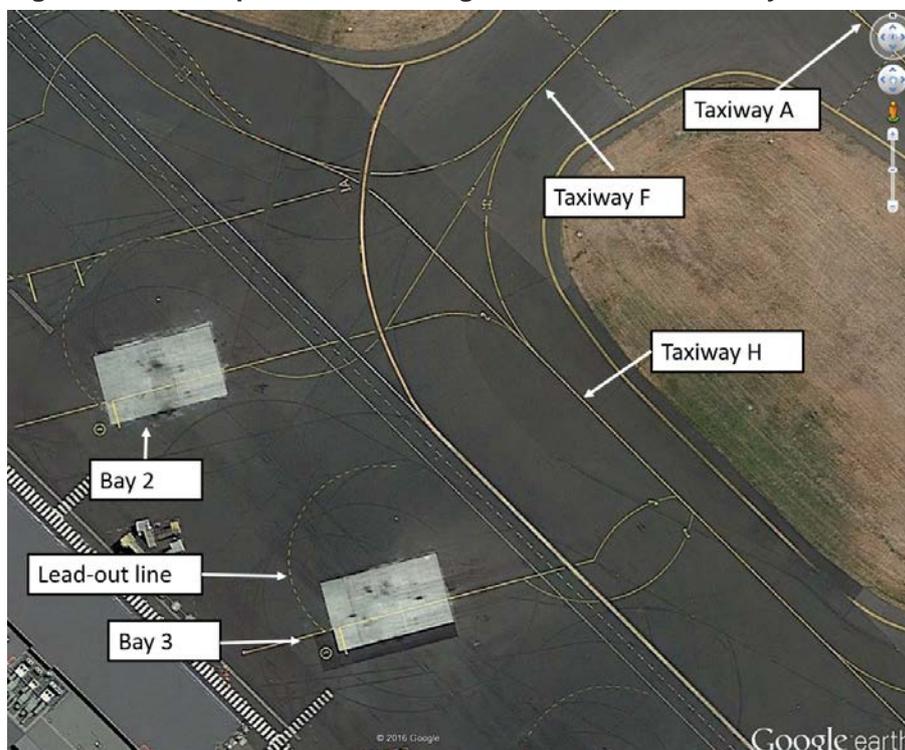
Figure 3: Hobart apron area showing the lead-out line on bay 3

The SMC then advised the crew of YFT that the A320 on their 'left hand side' was taxiing out via H and that they were to follow that aircraft via H (and D) to holding point D for runway 30. The first officer read back 'follow Jetstar A320 behind, behind him via hotel holding point delta runway 30'. At about 1013, the captain commenced turning the aircraft to the right, out of the bay, with the nose wheels just inside the marked lead-out line (Figure 3).

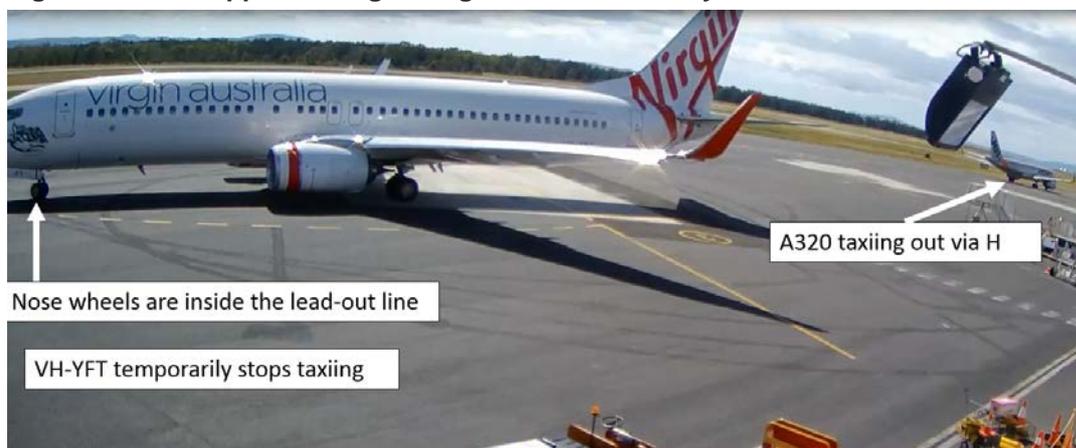
Figure 4: YFT stopped taxiing during the turn out of bay 3

The captain elected to stop the aircraft and clarify their taxi clearance. YFT stopped part way through the turn, about 90° from its parked position (Figure 4). At that time, the nose wheels were inside the lead-out line, and the aircraft was pointing towards the left wingtip of VUP.

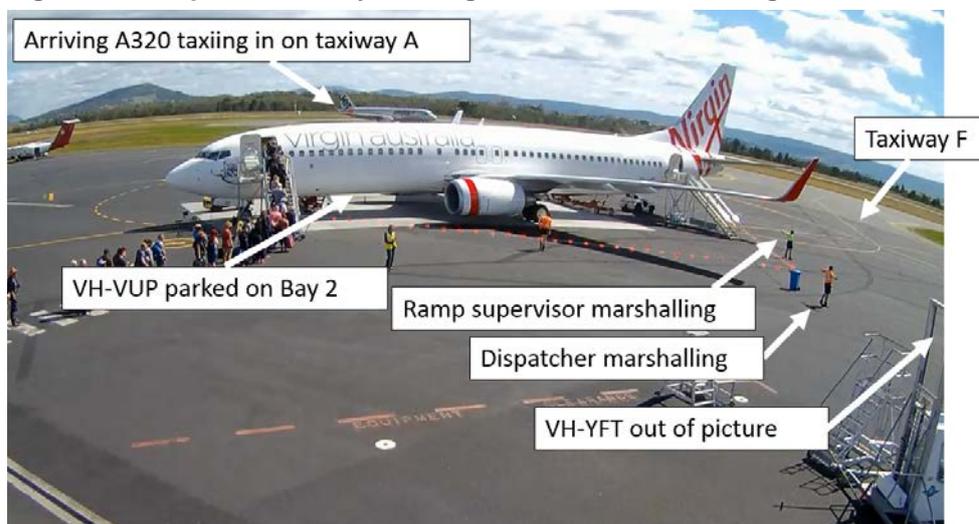
Figure 5: VUP parked on bay 2 with ground crew marshalling and A320 inbound

The ramp supervisor⁴ was at the far side of the parked aircraft (VUP) preparing it for departure, when YFT stopped. The ramp supervisor saw that YFT had stopped during the turn out, which was unusual, therefore moved to a position near the dispatcher, who was at the left wingtip of VUP, to where they could communicate with the flight crew if required and have line of sight to check for wingtip clearance between the two aircraft (Figure 5).

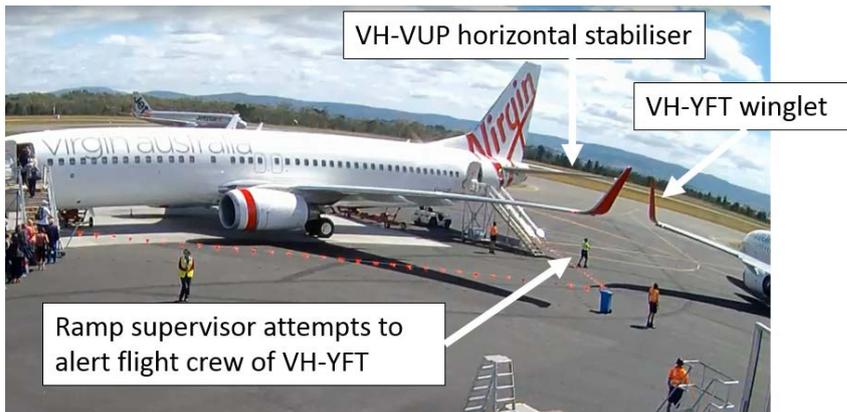
Figure 6: Collision imminent

As the aircraft recommenced taxiing, the dispatcher initially observed the wingtips of the two aircraft clear each other. However, as YFT then tracked towards the tail of the parked aircraft as it started to turn, the ramp supervisor assessed that a collision between the left wingtip of YFT and left horizontal stabiliser of VUP was imminent. The ramp supervisor commented that they then lowered their arms towards a crossed position to show that clearance between the two aircraft was reducing,⁶ and attempted (unsuccessfully) to make eye contact with the flight crew (Figure 6).

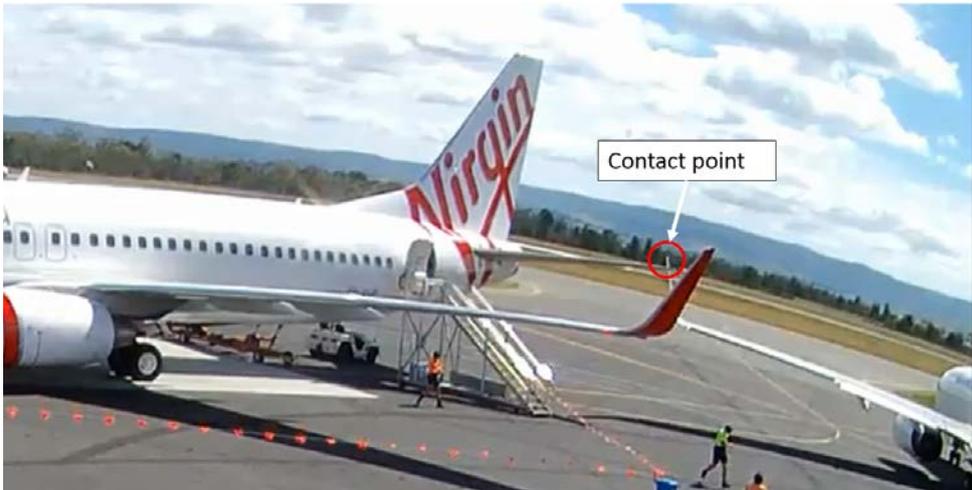
Figure 7: Contact between YFT left winglet and VUP left horizontal stabiliser

About 30 seconds after recommencing the taxi, as YFT continued to turn, the left wingtip collided with the horizontal stabiliser (tailplane) of VUP (Figure 7).

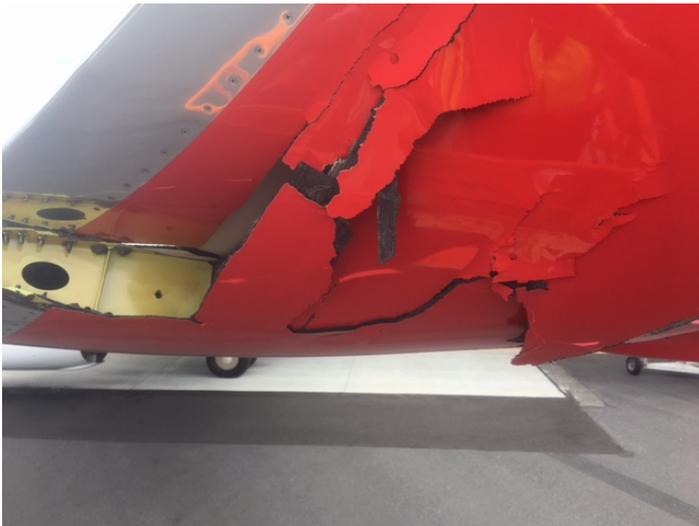
Figure 8: Damage to YFT left winglet

The winglet of YFT was damaged (Figure 8) as was the horizontal stabiliser of VUP (Figure 9). No one was injured.

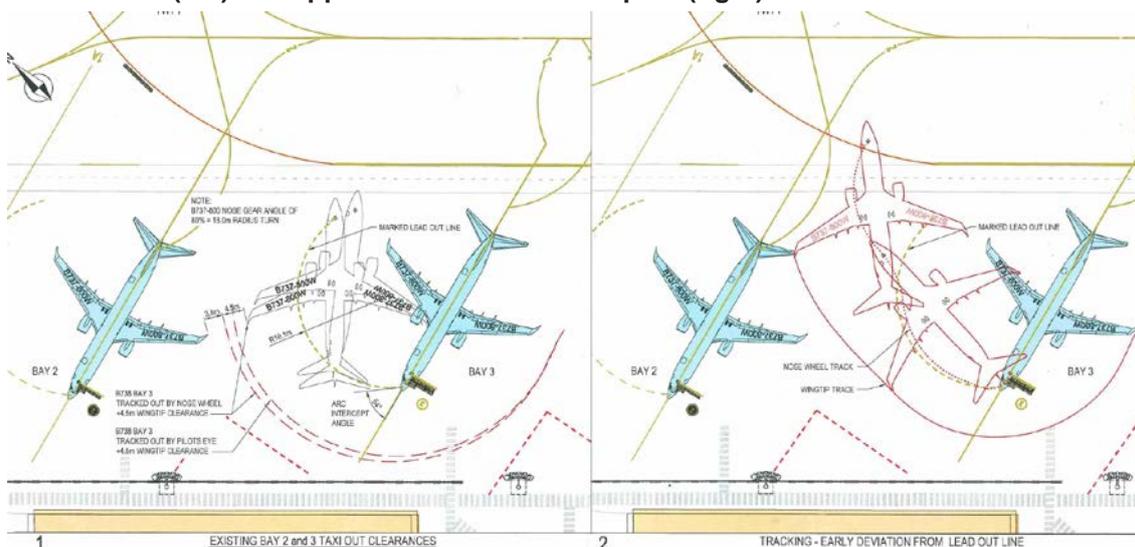
Figure 10: Airport survey markings showing B737 aircraft taxi track with nose wheel on lead-out line (left) and approximate incident taxi path (right)

The Hobart Airport operator reported that the bays were surveyed regularly to ensure they met the required standards. The airport operator constructed a schematic diagram of the aircraft's taxi path from the CCTV footage and the aircraft dimensions on the surveyed apron markings (Figure 10).

When the aircraft stopped, the nose wheels straightened and the aircraft subsequently taxied outside the marked turning circle.

When YFT stopped, the nose wheels were inside the lead-out line. If the nose wheels track on (or inside) the lead-out line, the wingtip will clear a correctly parked aircraft on the adjacent bay, but it is necessary to keep a continuous turn going. The check captain commented that if you stop the aircraft, particularly if it is heavy, a significant amount of thrust is required to then keep the aircraft on the line. The captain commented that they used caution with the thrust setting because of passengers boarding the aircraft on the adjacent bay. The check captain also stated that there was not a lot of manoeuvring room with ‘power-out’ bays. There is a risk that the aircraft has to go straight ahead for 2-3 m to get the turn going again and there is no allowance made for that in the geometry of the bay.

After stopping, the captain could no longer see the lead-out line, which was then beneath and behind the cockpit. The aircraft taxied forward across the lead-out for about 1–2 seconds then turned to the right towards the H taxiway line. There was no marked line connecting the lead-out line with taxiway H.
