Summary Report

| Aircraft | BD700-1A10 (Global 6000) | M-ARGO | | |
| Type of serious incident | Loss of cabin pressure, use of oxygen masks | | | |

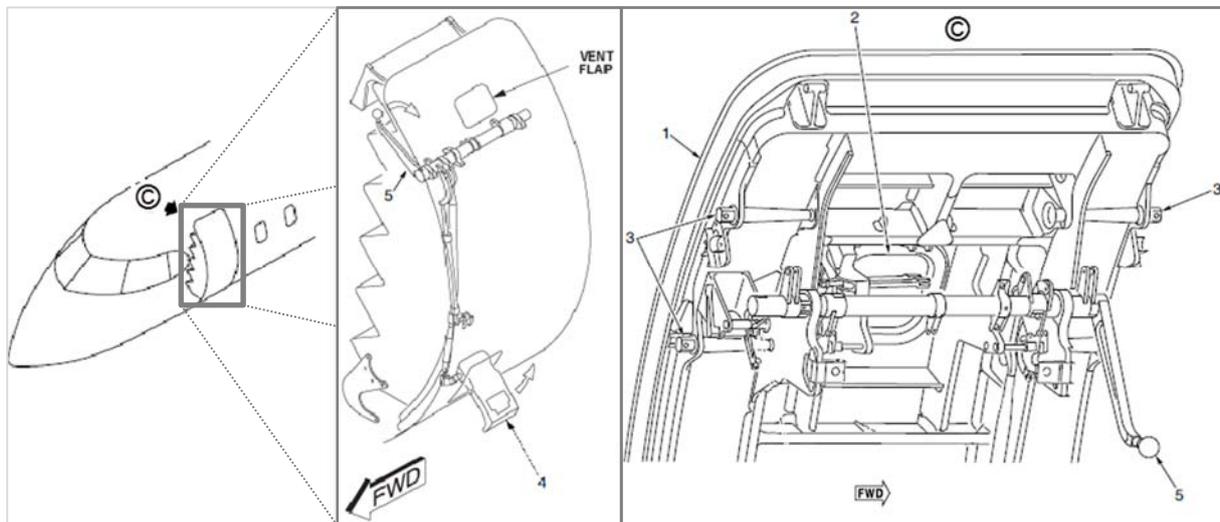
The remainder of the descent and approach into Basel was flown without further events as stated by the flight crew later on. After landing, a ground engineer observed that the vent flap of the passenger door was partially open.

Figure 1: Technical drawing of the passenger door from outside (middle) and as seen from the cabin ©: door (1), vent flap (2), door abutments (3), internal (4) and external (5) door handle, drawing out of the aircraft maintenance manual adapted by the STSB.

From a technical point of view, the various tests on the day after the serious incident did not reveal any clues as to why the cabin pressure did not build up properly. The observation of the partially open vent flap after landing in Basel leads to the conclusion that the passenger door was not correctly closed and locked before the commencement of the flight. This also explains the strong noise noticed by the flight crew after take-off.
