**Occurrence - Investigation Report**  
**Right Main Landing Gear Damaged at Landing**  
**Jordan Aviation**  
**Boeing 737-400 JY-JAQ**  
**Kabul International Airport**  
**Kabul, Afghanistan**  
**SFW 502**  
**OAHR-OAKB**  
**10 December 2016**

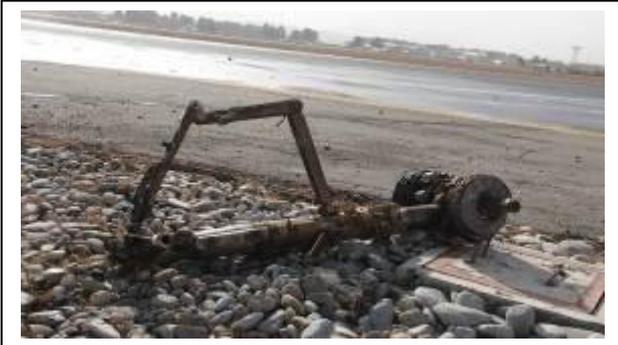
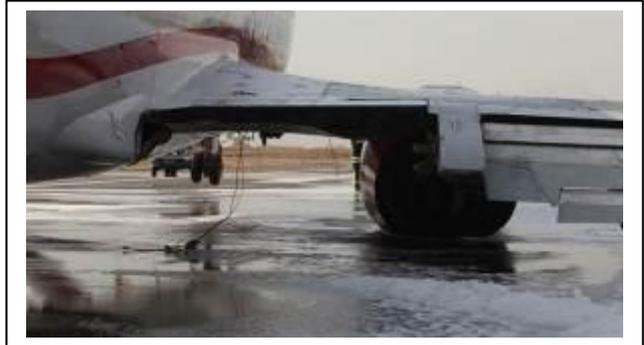
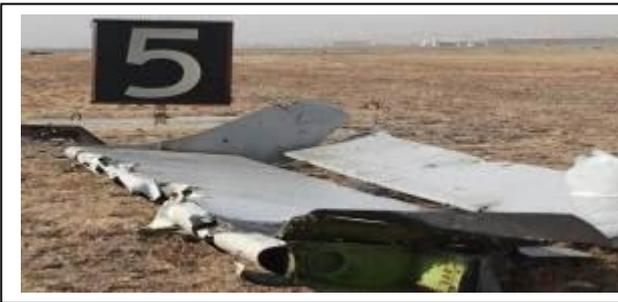
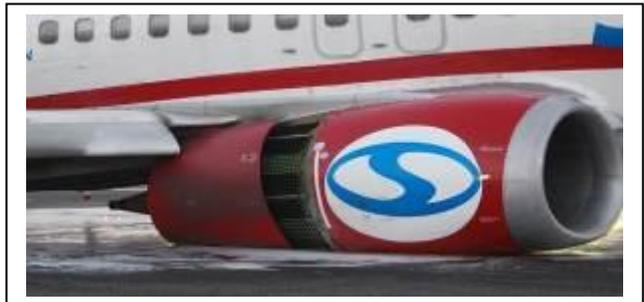
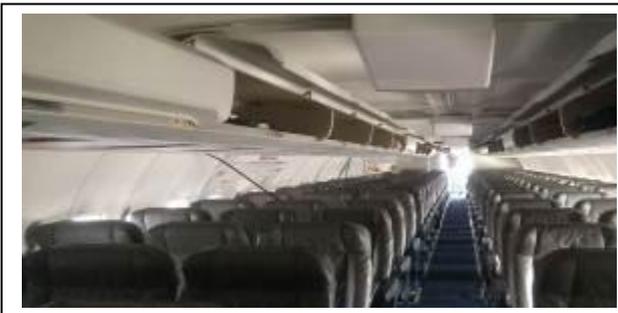
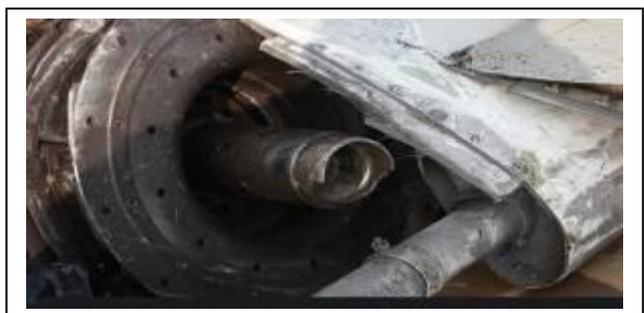
The Aircraft sustained a substantial damage as it can be seen from the pictures, the actual damages and status of the aircraft will be determined in the damage report, in addition to the pictures shown below the following estimation for the damage can be summarized with the following;

Right Main Landing Gear was detached from its place; Right trailing inboard flap was detached due to the impact of separated parts of the landing gear. In the absence of the right MLG, the aircraft was skidding on its Engine # 2 hence an additional damage to the underside of the right engine nacelle occurred as it was sliding along the surface during the landing roll.

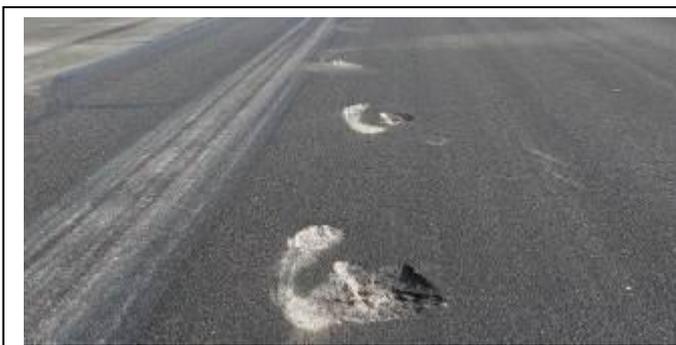
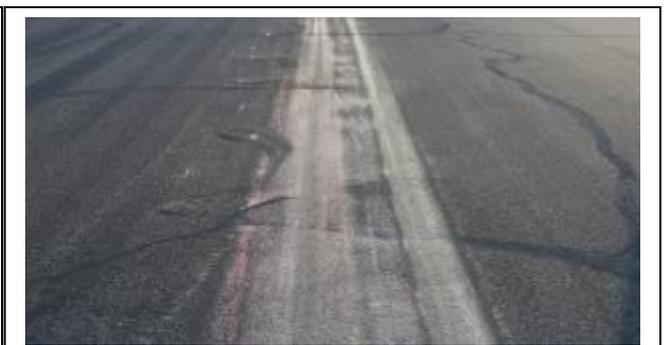
The separation of the Right Main Landing Gear caused damages to the runway surface and might cause damages to runway lights.

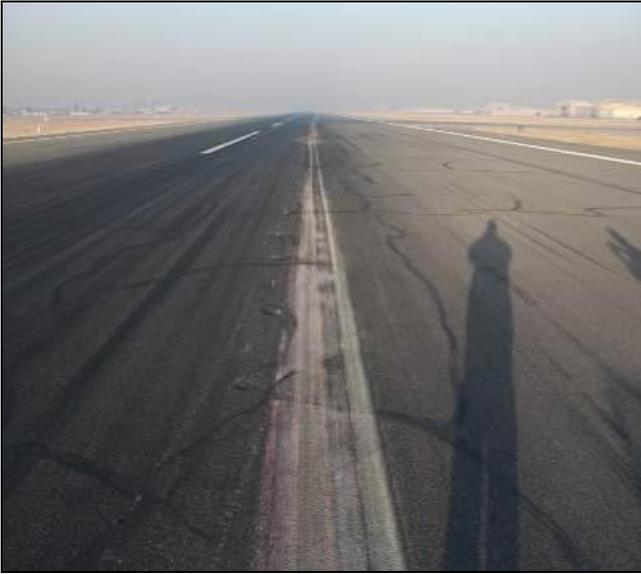
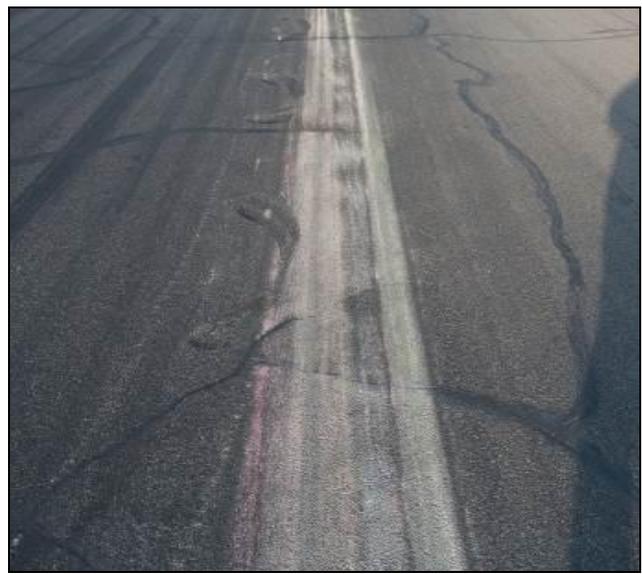
The tyres suffered damage no several locations, the tires were showing damage on the side walls.

The aircraft's right-hand main landing gear inboard tire shaking tire marks occurred for a distance of approximately 400 - 500 m, at this time the right main landing gear had detached and was dragged away, causing the right wing to drop. There was evidence of runway surface damage at almost similar intervals of appearing together with the hard tire contact marks, and this may also indicate that both tires were damaged after the shimmy damper failed and the oscillations were occurring.

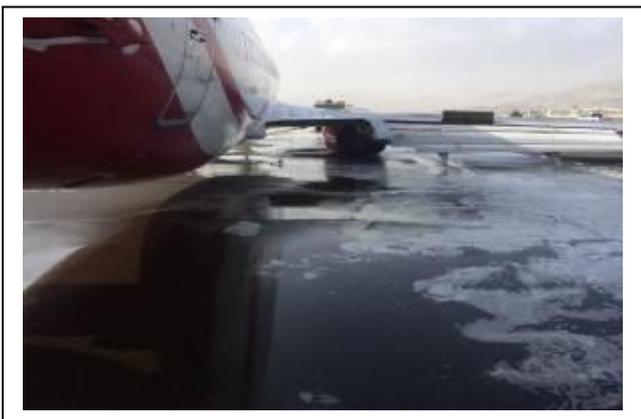
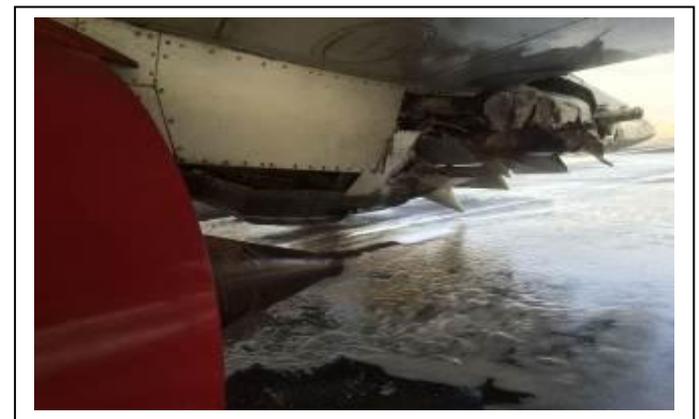
Fire warning from engine number 2 was dispensed, some smoke was seen around engine number 2, and engine drill was accomplished including engine fire extinguishers activation, at the end of the landing run at KBL Airport Fire and Rescue Service vehicles had been pre-positioned close to the runway, both behind and ahead of where the aircraft came to rest. A foam blanket was applied to the ground and the right side of the aircraft.

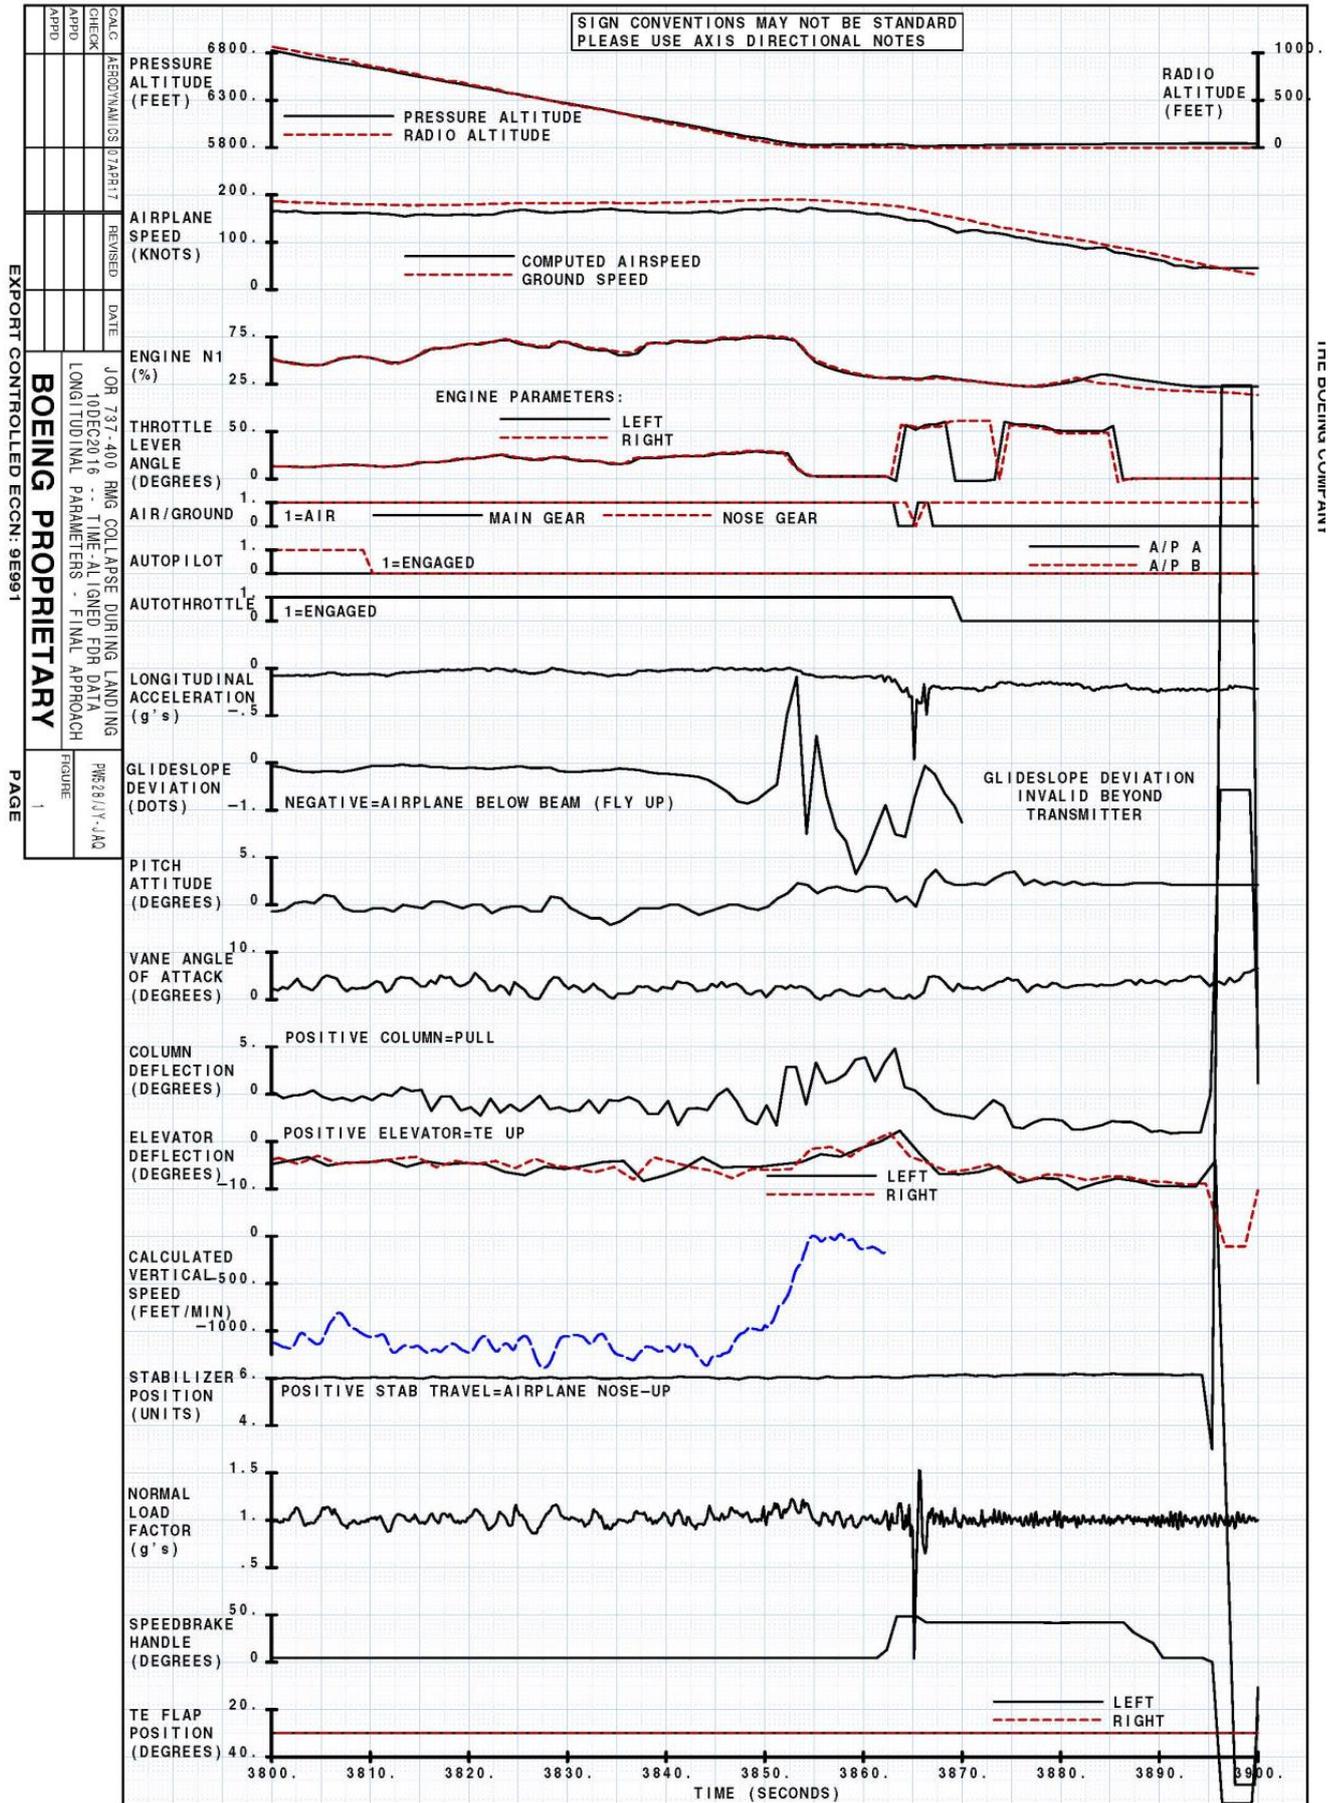
FDR Analysis – Figure1

The ground track analysis results indicate that the airplane crossed over the runway threshold at 40 feet radio altitude and flare was initiated immediately after. Initial main gear contact occurred 3500 feet beyond the threshold as evidenced by the decrease in longitudinal acceleration and the speedbrake handle deployed soon after. The main gear air/ground discrete transitioned to GROUND at 3750 feet beyond the threshold. Large spikes in all three acceleration parameters occurred at 4350 feet beyond the threshold, which most likely correlates with the loss of the right main gear, followed by the bank angle increasing to the right with control wheel commanded to the left. The main gear discrete temporarily transitioned to AIR after the first set of acceleration spikes and the nose gear discrete transitioned to GROUND for 1 data point. At 4700 feet beyond the threshold, a second set of spikes was observed in the acceleration parameters just as the bank angle neared its maximum value of 6 degrees to the right, which most likely correlates to the airplane settling onto the right engine nacelle. At this point, the nose gear discrete transitioned back to AIR and the main gear discrete transitioned back to GROUND. The remainder of the landing rollout was performed on the left main gear and right engine nacelle, with the airplane pitch attitude between 2 and 3.6 degrees nose-up and the bank angle at approximately 6 degrees to the right. The estimated final stopping location of the airplane was 10,450 feet beyond the runway threshold and 20 feet to the left of the runway centerline.

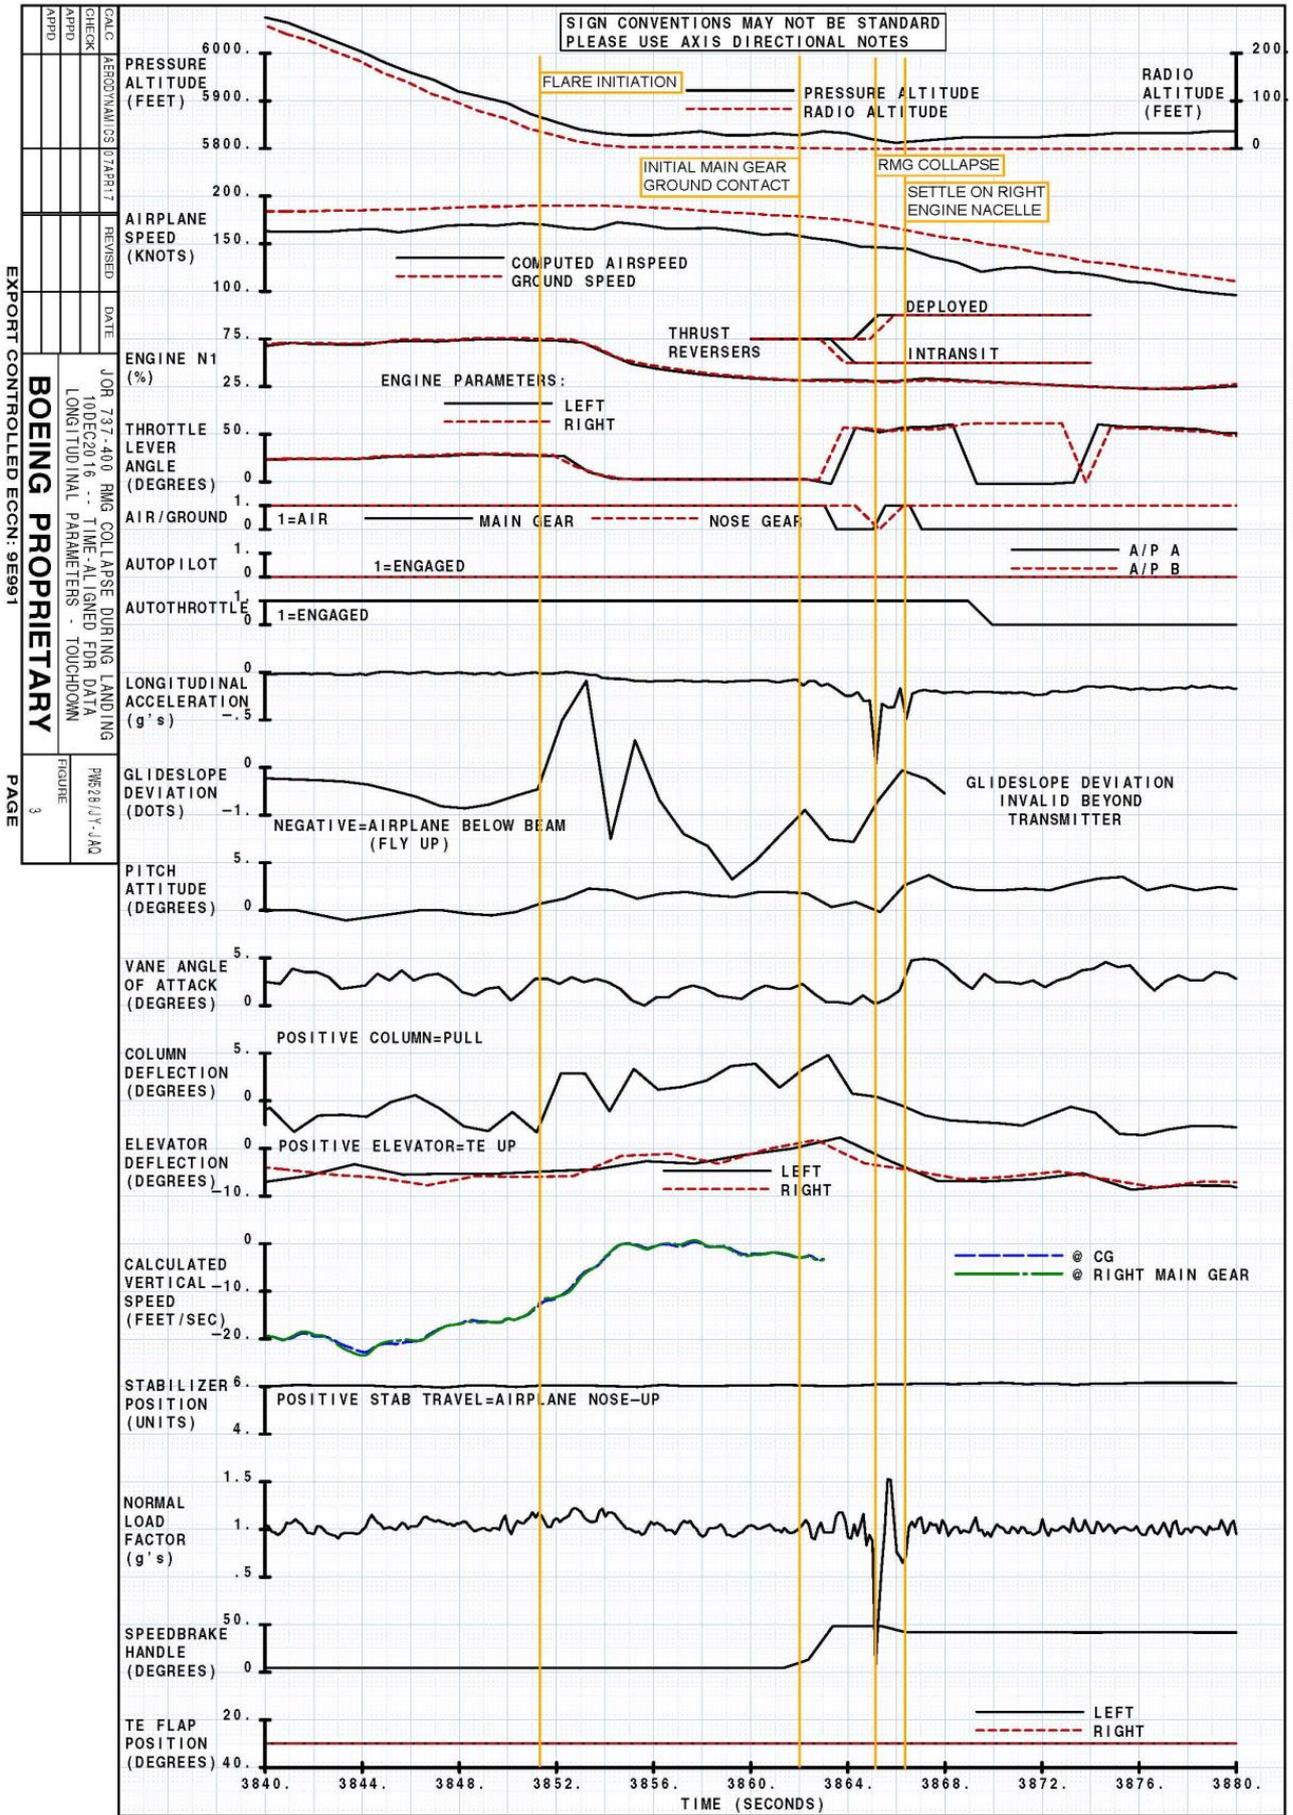
FDR Analysis - Figure 3

Following the initial main gear ground contact, the speedbrakes deployed at about time 3862 seconds and approximately 1 second later the throttle levers began to transition to the reverse idle detent (Figure 3). At time 3865 seconds, large spikes in all three acceleration parameters were observed (Figures 3 and 4). These large spikes corresponded with the initiation of a bank angle change from 1 degree to 6 degrees to the right, the main gear discrete momentary transition to AIR for 1 second, and the nose gear discrete transition to GROUND for 1 data point. As the bank angle increased to the right, a left control wheel input was commanded to 35 degrees (Figure 4). A second set of smaller spikes in the acceleration data occurred just after time 3866 seconds as the bank angle reached 6 degrees and nose gear discrete transitioned to AIR [Figures 3 and 4]. The airplane came to rest at approximately time 3906 seconds while closely maintaining the runway heading (not shown).

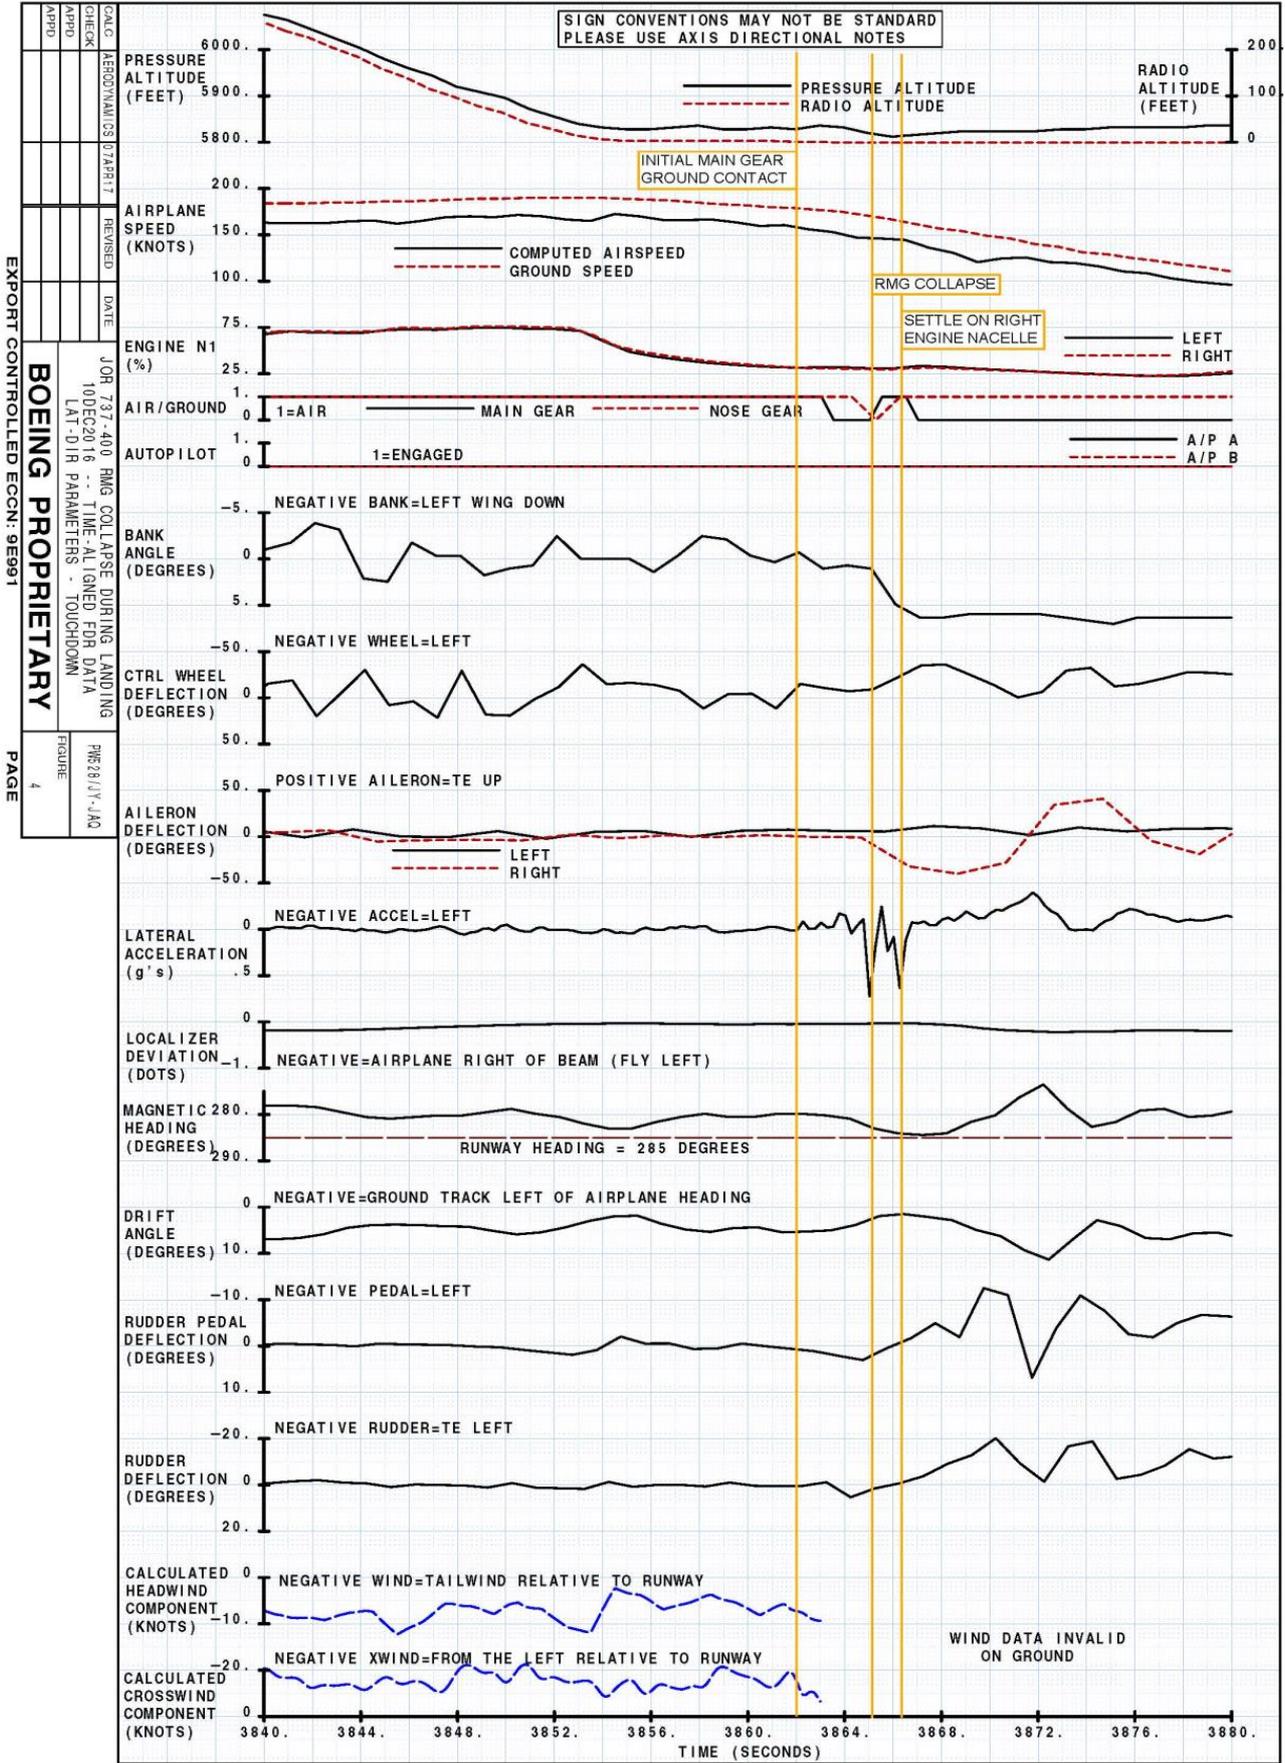
FDR Analysis - Figure 4

Between the initial main gear ground contact and the air/ground discrete transition to GROUND, the normal load factor, longitudinal acceleration, and lateral acceleration began to fluctuate until approximately time 3865 seconds when the large spikes in the accelerations were observed (Figures 3 and 4). In addition, the fluctuations in the lateral acceleration increased in magnitude during this time (Figure 4). Due to the report in the SR that the right main gear departed the airplane during the landing rollout, it was deduced that the first set of large acceleration spikes most likely corresponded to the loss of the right main gear. This is also the time that the bank angle began to increase to the right. The second set of acceleration spikes most likely corresponded to the airplane settling onto the right engine nacelle after banking to the right as a result of the loss of the right main gear. The airplane completed the landing rollout balanced on the left main gear and the right nacelle with a pitch attitude of approximately 2 to 3.6 degrees nose-up and bank angle of approximately 6 degrees to the right (Figures 3 and 4). Additional damage to the right wing control surfaces can be observed in the right aileron deflection. The deflection limits of the ailerons is +/-20 degrees. After the right main gear collapse at time 3865 seconds, the right aileron deflection increased to +/-40 degrees, whereas the left aileron deflection remained in the expected range (Figure 4).
