ACCIDENT

Aircraft Type and Registration:	DHC-8-402 Dash 8 (Q400), G-PRPC	
No & Type of Engines:	2 Pratt & Whitney Canada PW150A turboprop engines	
Year of Manufacture:	2010 (Serial no: 4338)	
Date & Time (UTC):	14 December 2016 at 0624 hrs	
Location:	On departure from Manchester Airport	
Type of Flight:	Commercial Air Transport (Passenger)	
Persons on Board:	Crew - 4	Passengers - 27
Injuries:	Crew - None	Passengers - None
Nature of Damage:	Damage to engine access panel, impact damage to vertical stabiliser and VOR/LOC antennas	
Commander's Licence:	Airline Transport Pilot Licence (Aeroplanes)	
Commander's Age:	45 years	
Commander's Flying Experience:	7,120 hours (of which 142 were on type) Last 90 days – 142 hours Last 28 days – 63 hours	
Information Source:	AAIB Field Investigation

Synopsis

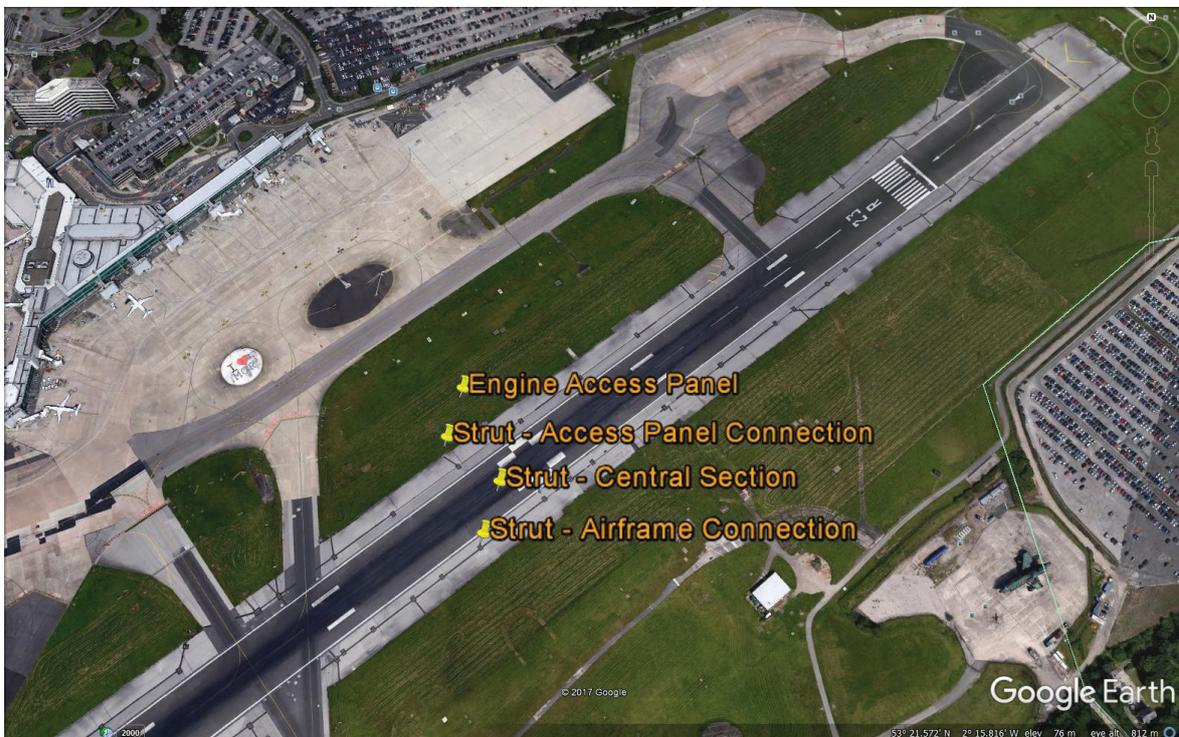
Figure 1

After the aircraft had parked on the stand and the passengers had disembarked, the ground crew informed the cabin crew that a panel was missing from the No 1 engine. The message was relayed to the flight crew, who inspected the aircraft prior to contacting the operator's maintenance control department. The operator informed Manchester Airport operations staff at 0836 hrs, who then conducted an inspection of Runway 23R. The panel was recovered from a grass area to the side of the runway, approximately 440 m from the runway threshold. Sections of the panel hold-open strut were also recovered from the runway and adjacent paved areas in the same vicinity (Figure 1).

Location of items released from the aircraft during takeoff

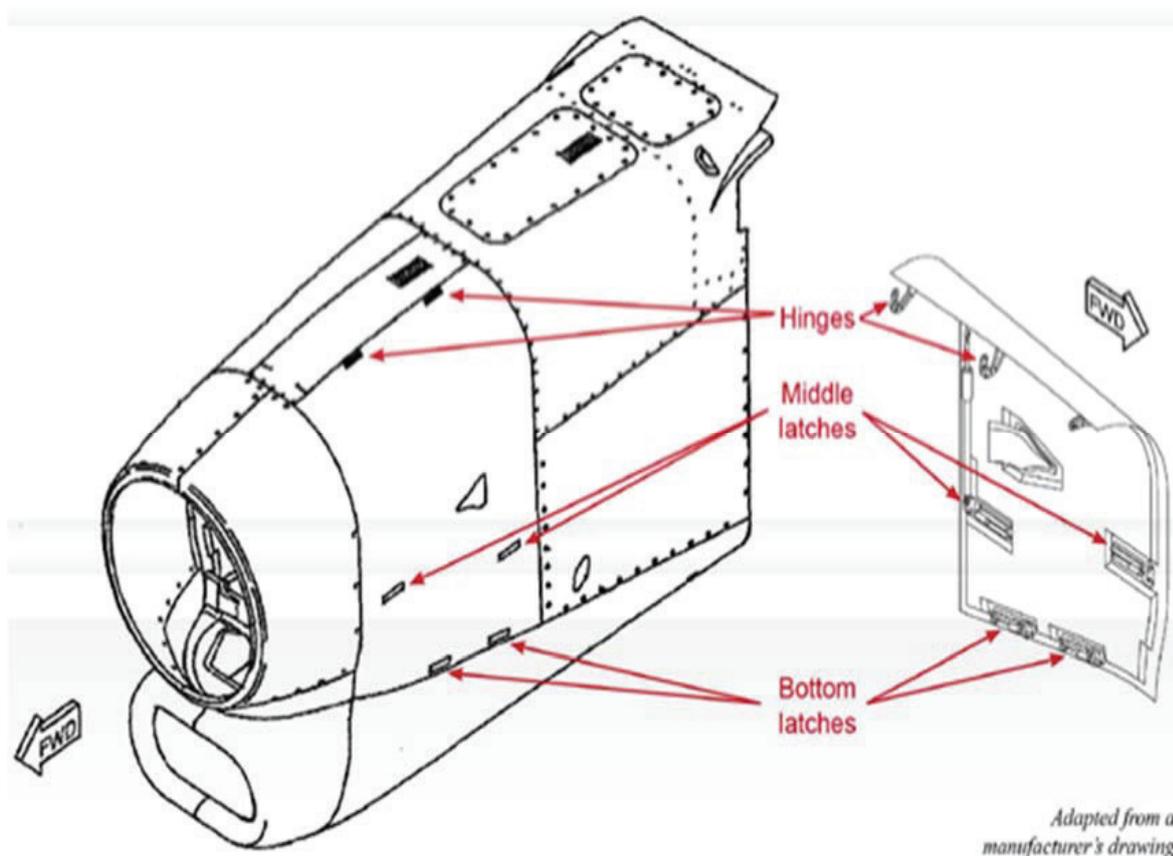
Figure 2

Forward engine bay access panel

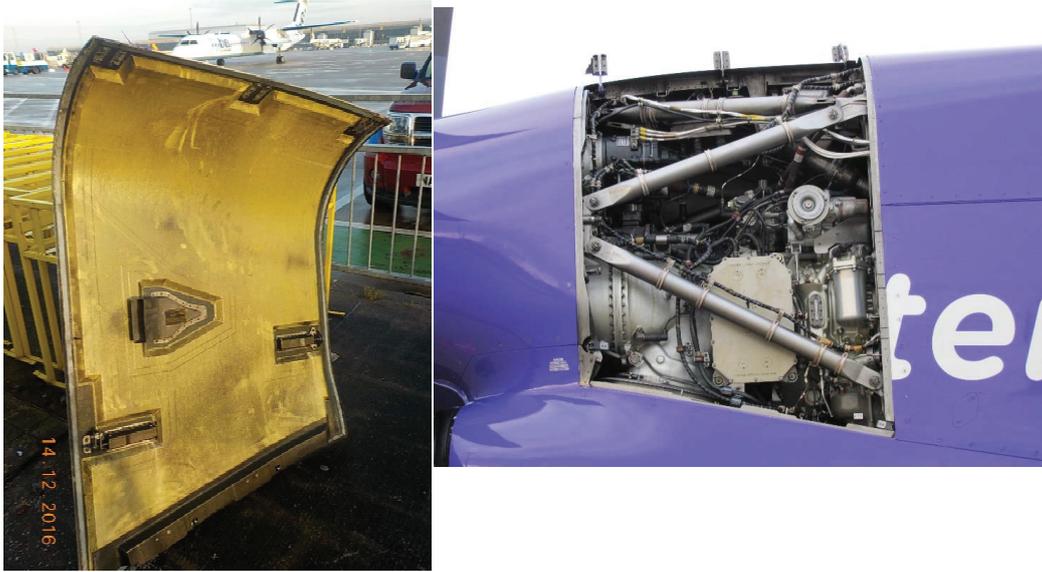
Figure 3

On inspection of the recovered panel all four latches were found to be in the closed and latched position. There was no damage to the latch bolts or the receiving fixtures on the nacelle (Figure 3).

Engine access panel and nacelle

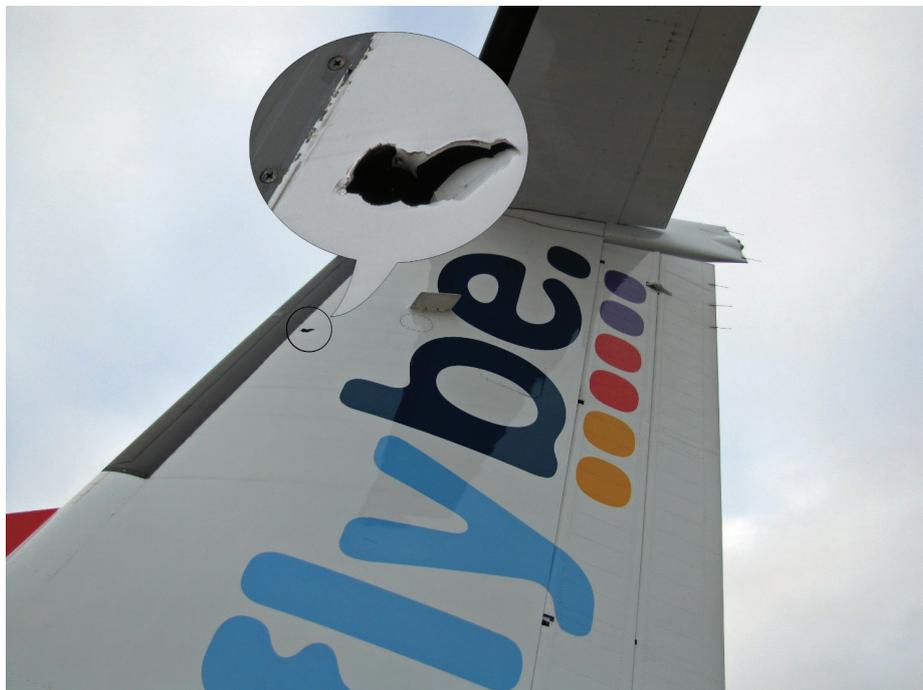
Figure 4

Inspection of the aircraft vertical stabiliser showed puncture holes in the skin on both sides, with impact marks also present on the leading edge de-icing boot. There was also impact damage to both VOR/LOC antennas.

Damage to vertical stabiliser (similar damage occurred on both sides of the vertical stabiliser)

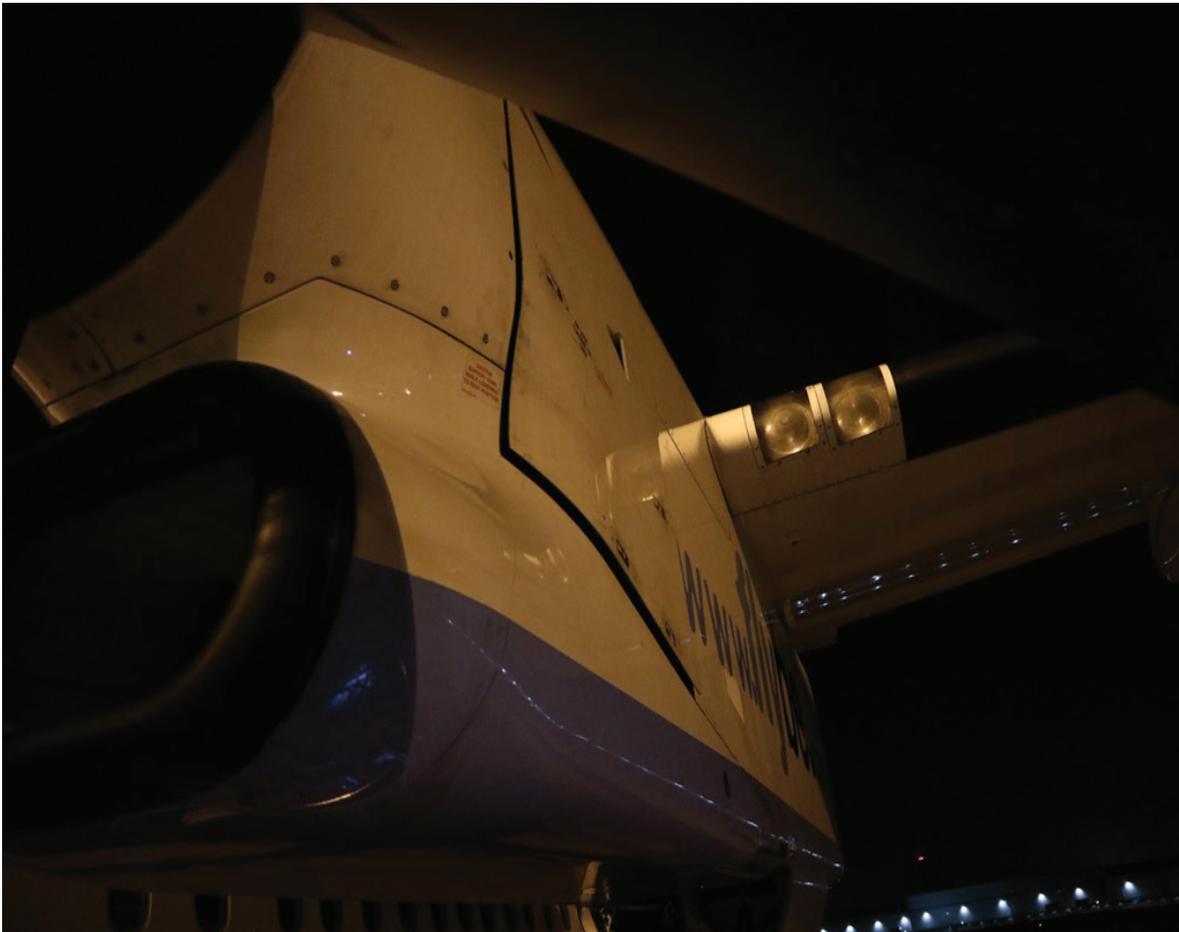
Figure 5

Interviews with the engineers involved in both the first and second incidents identified a common technique used to secure the engine access panel. This involved closing the two upper latches first, followed by the two lower ones. Practical assessment of this technique showed that occasionally, as a result of a slight misalignment of the panel, it did not close correctly into the gap in the engine nacelle. Given the height of the panel and shorter distance to the hinge line, it was difficult to apply the necessary force to fully engage the panel at the level of the top latches, when compared to applying a similar force at the bottom of the panel. This could result in the top latches being closed, without the panel being properly located. As a consequence, the locking pin would not be engaged in the receiving fixture on the nacelle side, but the latch would externally look and feel as if it was properly closed. Once the upper latches were closed in this manner, the panel would rest on the

upper latch pins. Significant force could then be applied to the bottom of the panel while the lower latches were closed, but the pins would not engage in their receiving fixtures. The only external visual confirmation of the incorrect closure of the panel, was a small gap between the access panel and the surrounding nacelle panels (Figure 5).

Panel gap resulting from an incorrectly latched panel (viewed from the ground under similar lighting conditions to both incidents)

The operator subsequently revised NTE 22 post-incident to introduce a procedure where a sticker is placed over the bottom of the panel, when it is closed post-maintenance. This provides visual and tactile confirmation to the engineer that the panel is correctly closed and secured.

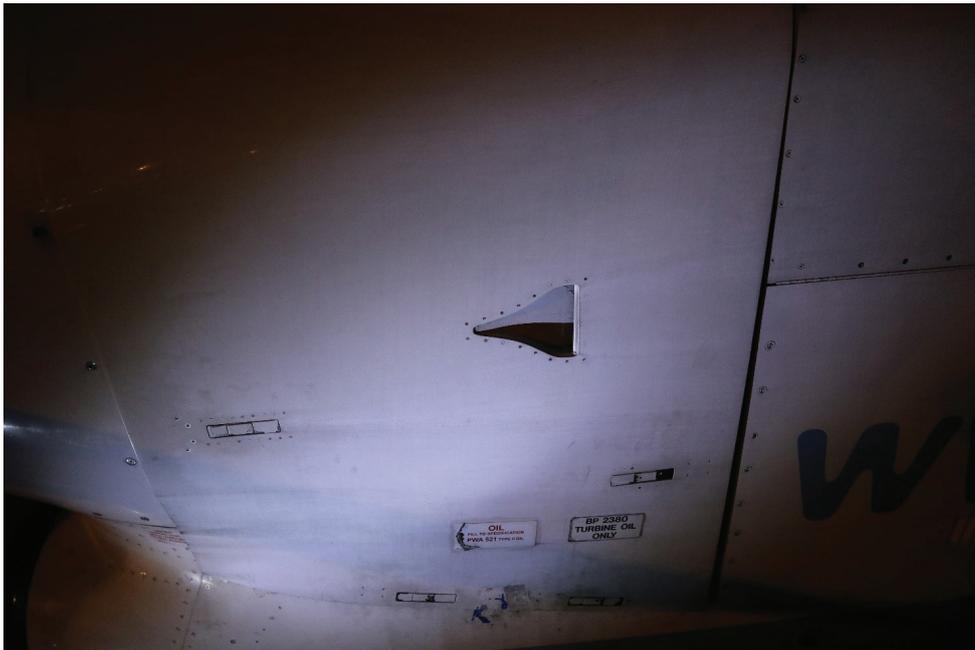
The engineers in both incidents involving G-PRPC were standing on steps to access the engine which meant once the access panel was closed, they were looking downwards at the panel and using a head torch to supplement the ambient lighting on the stand. Figure 6 shows how the perspective of the gap in the panel changes, when viewed under these circumstances. This would have been further exacerbated on the incident aircraft as the surrounding panels were painted purple rather than white, providing much less contrast to the shadow cast by the access panel.

View of the panel gap following incorrect closure, from the perspective of the engineer conducting the task.

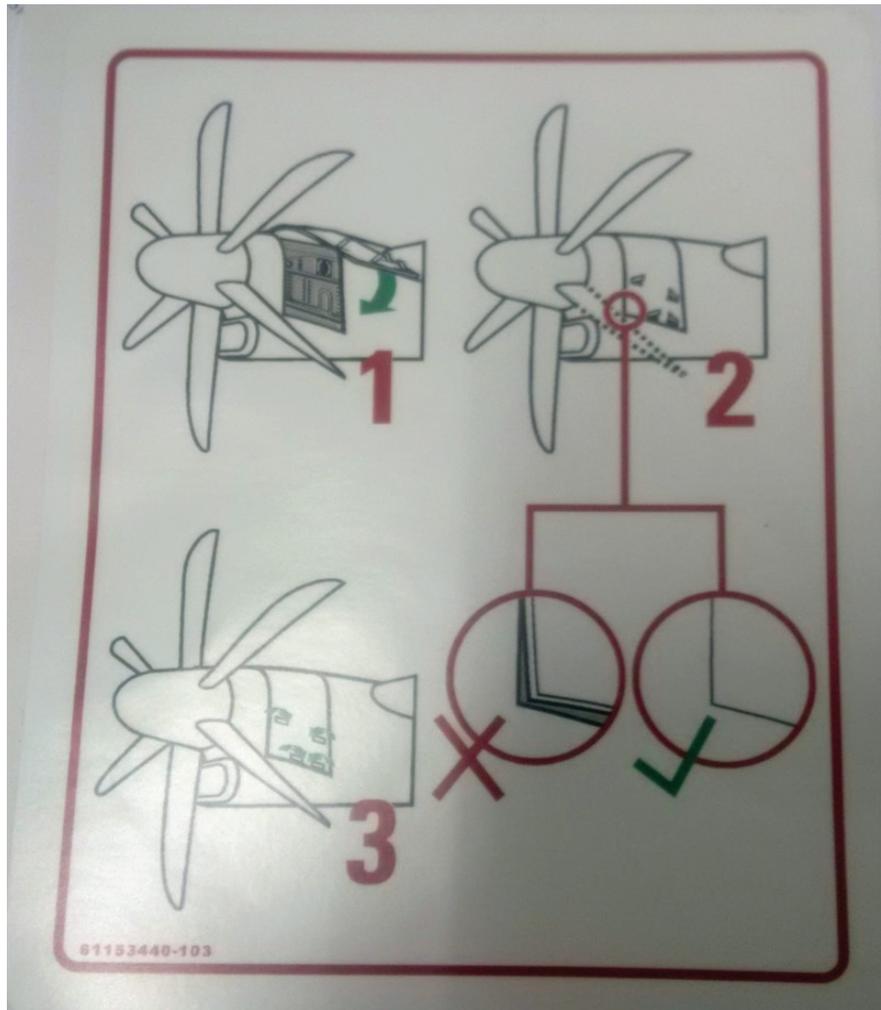
Figure 7

Advisory label modification

The aircraft manufacturer has commenced development of a modification to add an advisory label to the access panel which provides pictorial guidance on how to ensure the panel is correctly closed and latched (Figure 7).

The manufacturer's addition of an advisory label on the panel will assist in raising awareness of the implications of a gap/shadow around the panel. At the time of this accident the AMM did not contain a procedure for opening/closing the panel. Evidence from this investigation suggested that using the technique of shutting the top latches first could, in some circumstances, increase the likelihood of the panel being closed incorrectly and not being secured. It would therefore have been beneficial for an approved technique for closing the panel to be included in the AMM. The aircraft manufacturer has since published Temporary Revision 71-197 to the AMM to introduce these instructions.
