**KOMITE NASIONAL KESELAMATAN TRANSPORTASI
REPUBLIC OF INDONESIA**

Aircraft Accident Investigation Report

PT. Wings Abadi Airlines

ATR 72-212A; PK-WGW

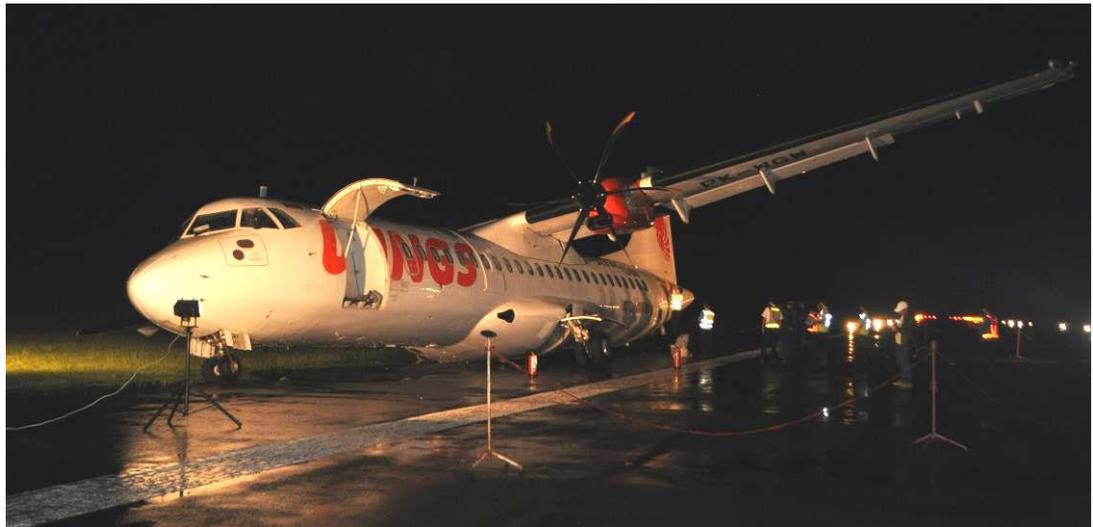
Figure 1: The aircraft condition after stopped

At 11:25:13 UTC, the FDR recorded the ground speed 0, which indicated the aircraft stopped. The aircraft stopped near the taxiway D, tilted to the right and the right propeller scratched the runway shoulder as the right main landing gear collapsed. This condition considered as abnormal condition.

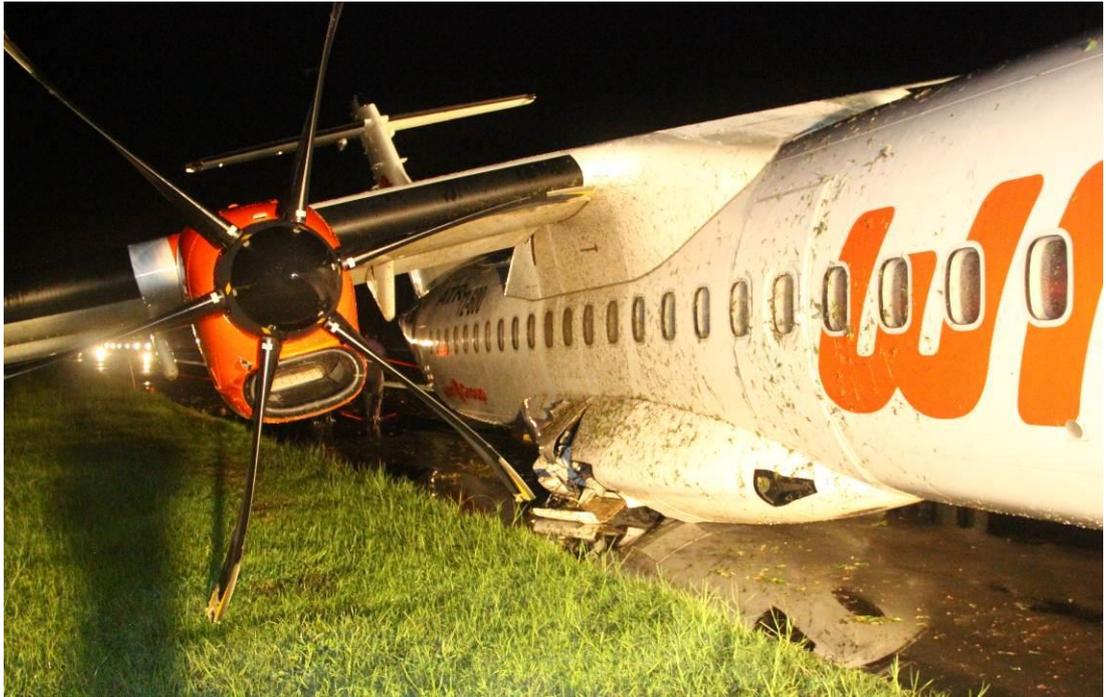
The aircraft was substantially damaged. The right main landing gear folded inward and the propeller tips of the engine number 2 broken at about 26 cm from the tip.

Figure 2: The damaged main landing gear and propeller

The right main landing gear was examined in the metallurgical engineering laboratory of Institute Technology of Bandung (*Institut Teknonogi Bandung*). The examination found no previous defect on the landing gear. The examination concluded that the failure of the right main landing gear was due to excessive impact forces.

The excessive rate of descend on the first touchdown might have degraded the landing gear strength, followed by landing with vertical acceleration of 6 g which sustained solely by the right main landing gear resulted in the failure of the right main landing gear.

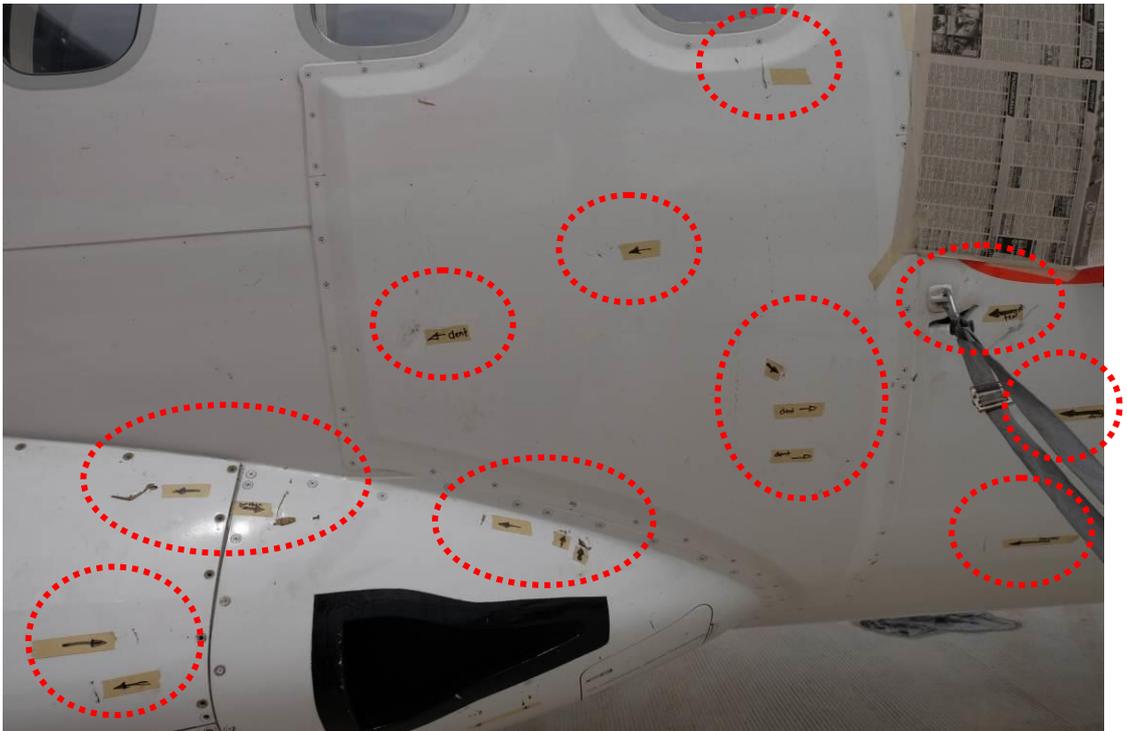
On the right fuselage of the aircraft, found several dents and punctures.

Figure 3: Several dents and damages on the right fuselage

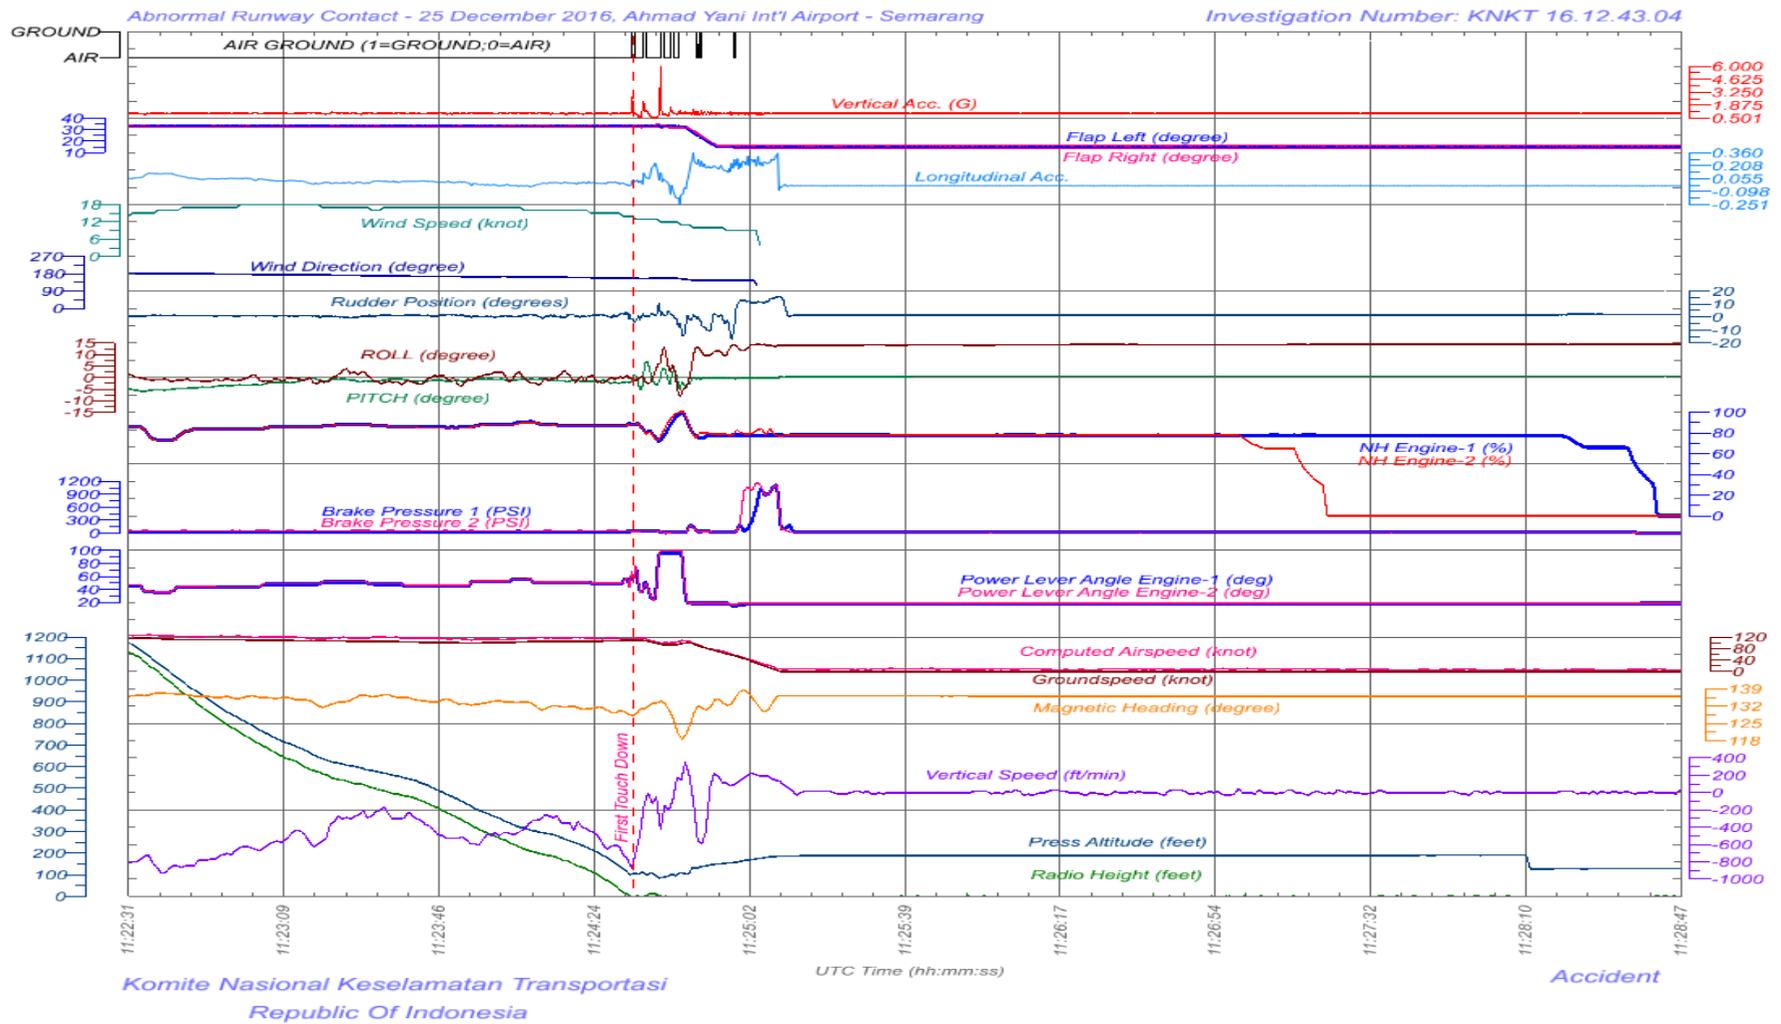
Figure 8: The FDR parameters from approach until engines shutdown

- Th FDR recorded the aircraft bounces for 5 times.

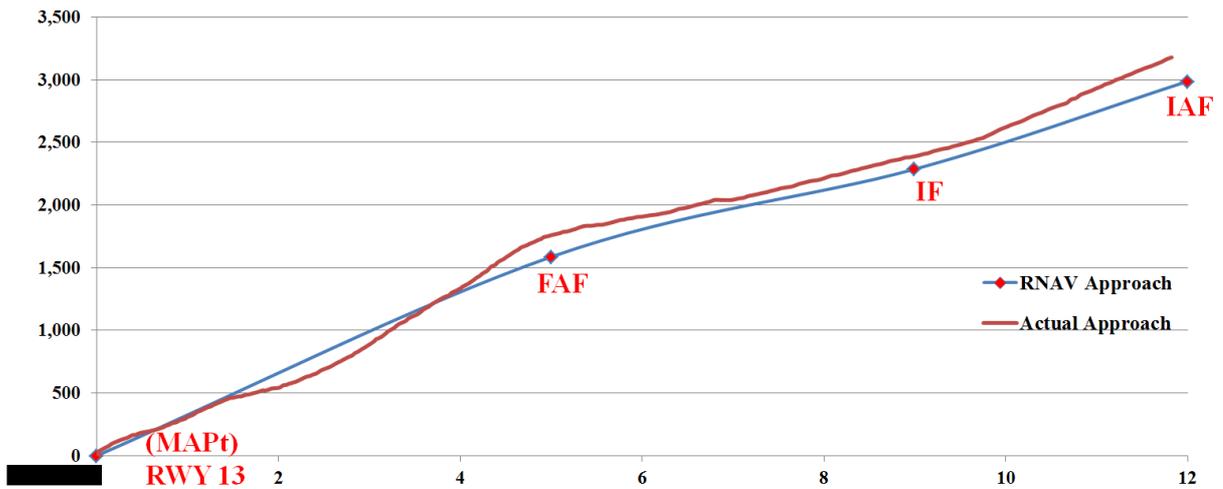
The following figure was the descent profile when the aircraft passed KENDA (Instrument Approach Fix/IAF), which was 12 nm from runway threshold compared with descent profile on RNAV approach chart published in AIP.

Figure 9: Descent profile from point KENDA (IAF)

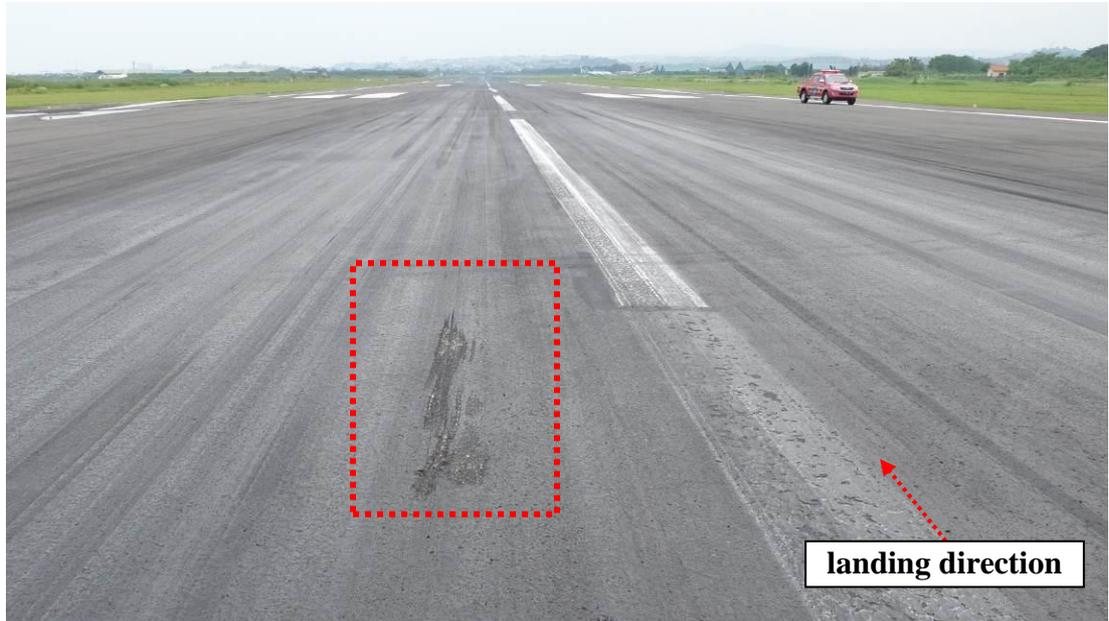
Several scratch marks were found on the runway, the first scratch mark was found at about 500 meters from the beginning runway 13 on the left of runway centerline, the dimension was 150 cm long and 20 cm width (figure 9).

Figure 10: The first scratch

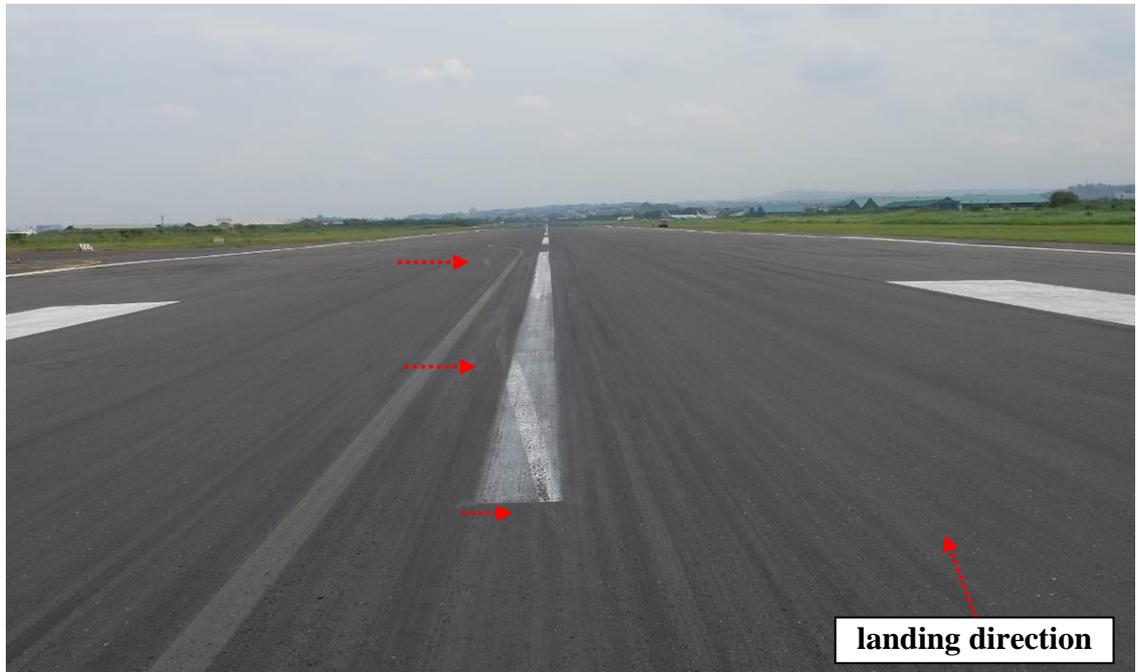
Figure 11: The white marking crossed from left to right runway centreline

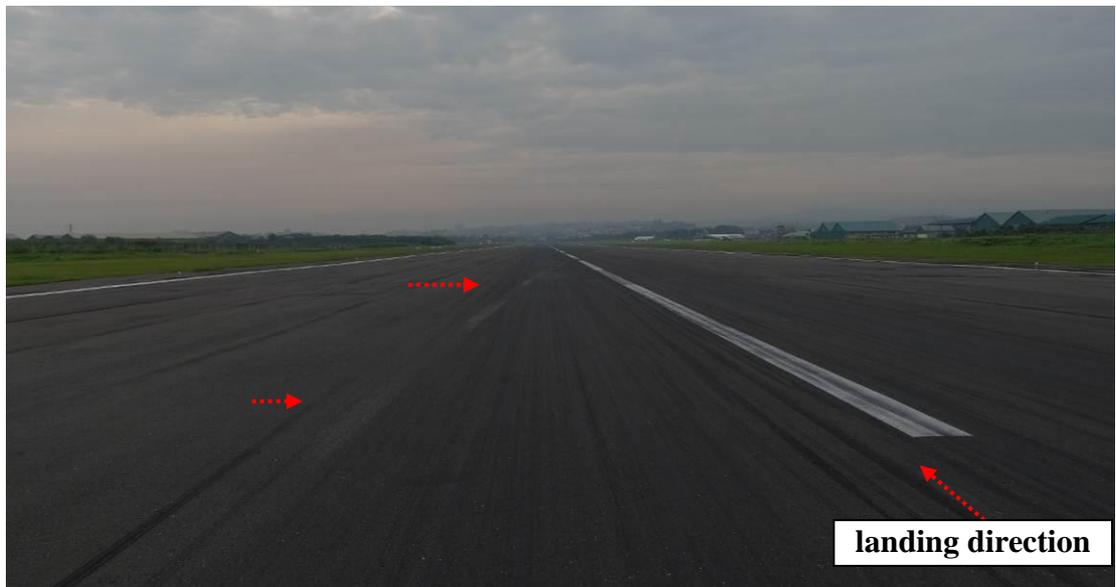
At about 390 meters from the first scratch mark, it was found white paint mark which crossed from right to the left of runway centerline (figure 10) and then at about 190 meters the white paint mark continued to cross from right to left runway centerline until the location of the aircraft stopped (figure 11).

Figure 12: The white marking crossed from right to left runway centreline

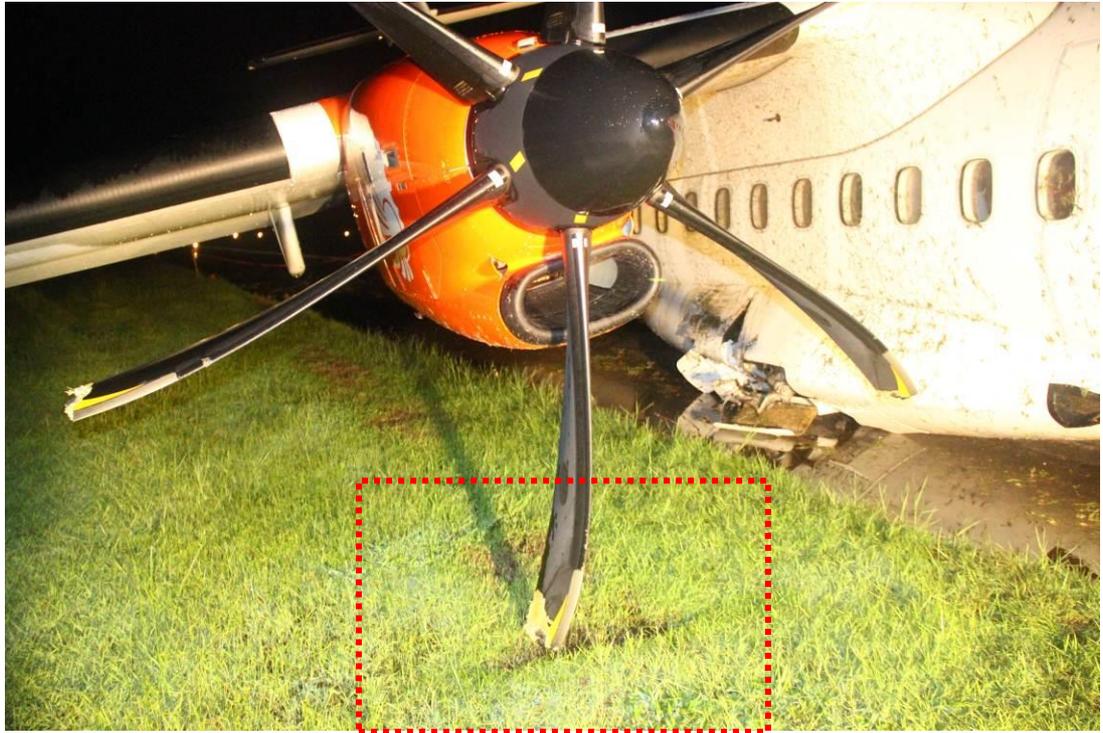
On the right shoulder near the aircraft stopped there was propeller mark on the ground (figure 12).

Figure 13: The propellers condition and scratch mark on the ground

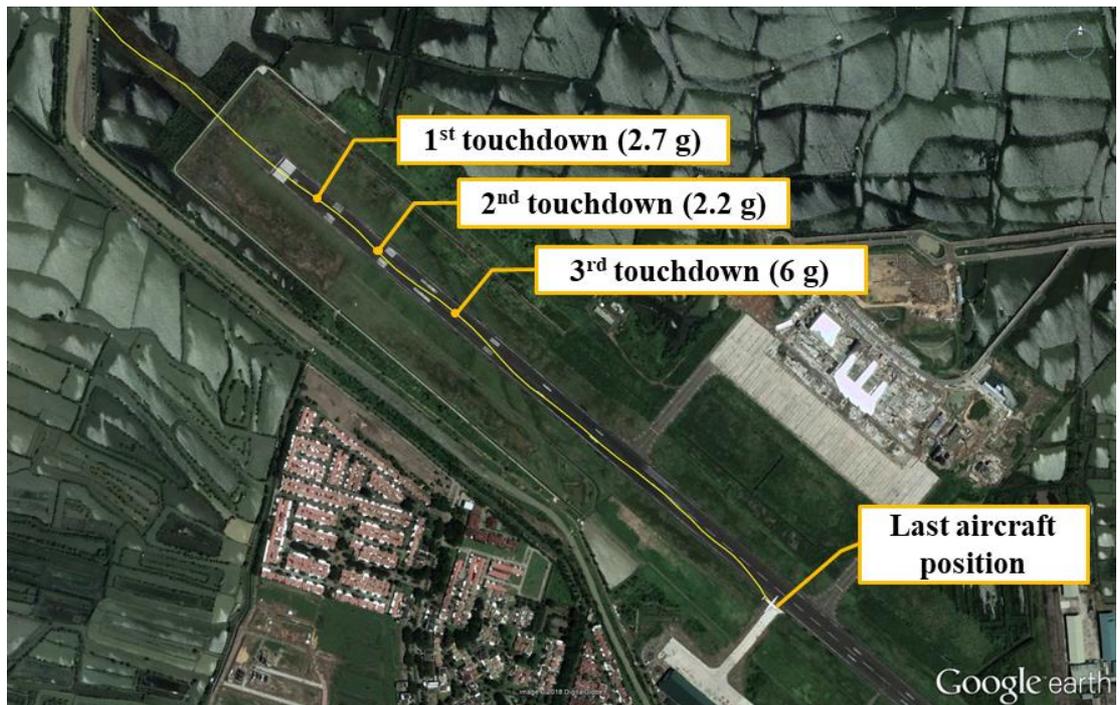
The aircraft movement based on the FDR data and the first scratch mark was found near the area of the third touchdown. The figure is as follow:

Figure 14: The aircraft trajectory based on FDR
