## Summary Report

<b>Aircraft</b>	ERJ 190-100 LR	HB-JVN
<b>Operator</b>	Helvetic Airways AG, 8058 Zurich, Switzerland	
<b>Owner</b>	Bernina Aircraft Leasing Inc. Fort Street 75, 1-1108 Grand Cayman, PO Box 1350, Cayman Islands	
<b>Commander</b>	Swiss citizen, born 1969	
<b>Licence</b>	Airline transport pilot licence aeroplane (ATPL(A)) in accordance with European Aviation Safety Agency (EASA) standards, issued by the Federal Office of Civil Aviation (FOCA)	
<b>Flying hours</b>	<b>total</b> 10 244 hours	<b>during the last 90 days</b> 171 hours
	<b>on the incident type</b> 1085 hours	<b>during the last 90 days</b> 171 hours
<b>Copilot</b>	Swiss citizen, born 1981	
<b>Licence</b>	Commercial pilot licence aeroplane (CPL(A)) in accordance with EASA standards, issued by the FOCA	
<b>Flying hours</b>	<b>total</b> 1123 hours	<b>during the last 90 days</b> 131 hours
	<b>on the incident type</b> 909 hours	<b>during the last 90 days</b> 131 hours

<b>Location</b>	10 km west of Kempten (Germany)	
<b>Coordinates</b>	804 855 / 293 083 (SwissGrid) N 47°45' 22" / E 010°10'18" (WGS 84)	<b>Altitude</b> Flight level 200
<b>Date and time</b>	12 January 2017, 07:33:02 UTC	
<b>Type of operation</b>	Sch

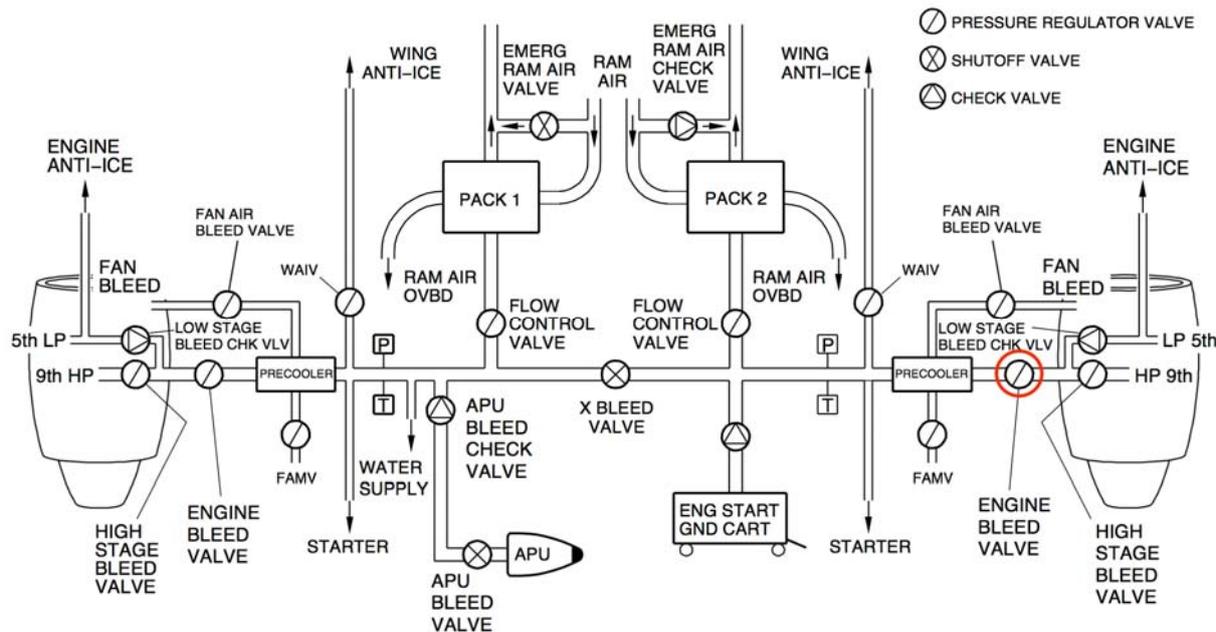
**Figure 1:** Schematic representation of the bleed air system. The right engine pressure regulator valve (engine bleed valve) is circled in red. Source: aircraft manufacturer's AOM<sup>4</sup>.

As described in the prehistory, the BLEED 2 FAIL warning was displayed after the right engine was started. Since a reset according to the checklist was not successful, the maintenance company inspected the right engine pressure regulating shut off valve (PRSOV) (see Figure 1, valve circled in red) after the aircraft landed in Zurich. This revealed that the valve was jammed in the closed position. The PRSOV was then replaced and subjected to a function check, which indicated that the fault had been remedied.

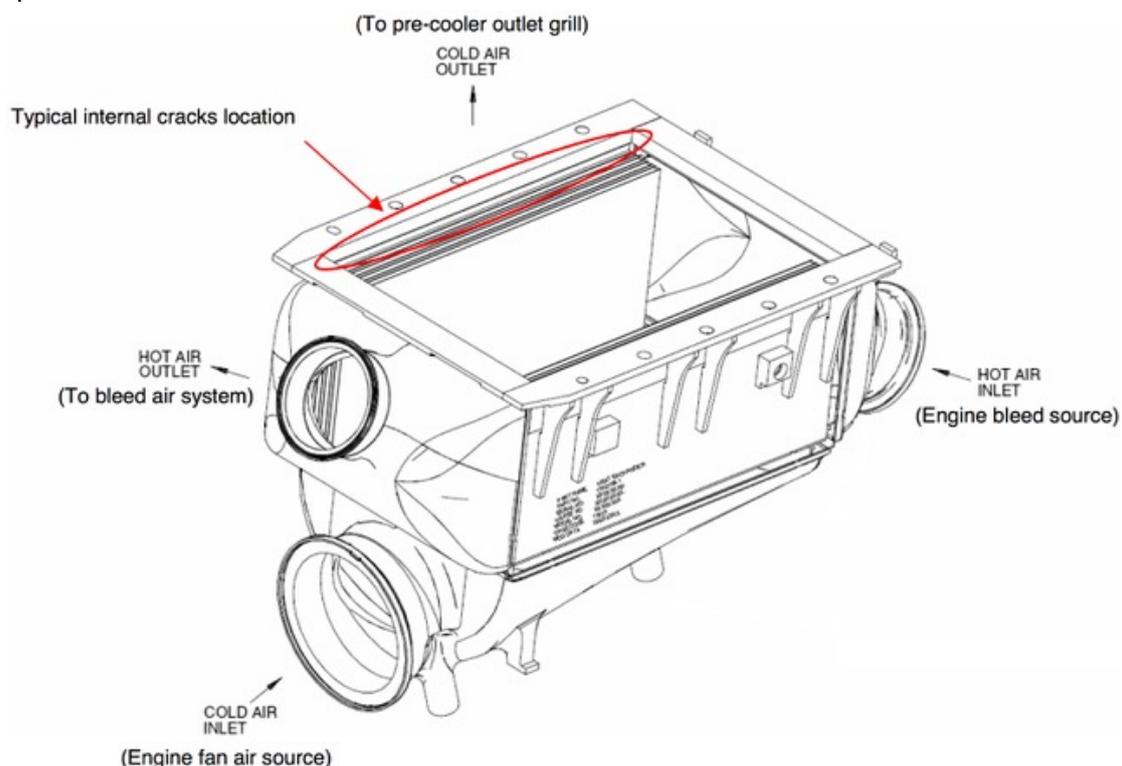
The second check consisted of checking the pre-cooler outlet duct seal (see Figure 1) in accordance with SNL 190-36-0021R02. This check revealed that the pre-cooler outlet grill (see Figure 2) exhibited small cracks and that the duct seal had become loose. This would only be visible from inside the pre-cooler and could therefore not be seen during the first check which was performed.

**Figure 2:** Pre-cooler (Source: SNL 190-36-0021R0)

A faulty pre-cooler seal allowed hot bleed air to escape. This activated one of the ODS over-heat detection sensors at 07:33:02 UTC. The BLEED 1 LEAK warning message was then generated and the engine 1 bleed air valve was closed. The checklist that the flight crew processed eight minutes later did not change the valve position, but confirmed the shutdown conducted by the automatic system and caused the amber striped bar on the push button to go out. The same checklist requires the crossbleed valve to be closed. The fact that this only occurred eight minutes after the warning appeared was inconsequential in the present case, since the crossbleed valve had automatically been closed as well and no bleed air was available anyway.

A post-mod pre-cooler grill, Part Number (PN) 191-08757-401, was installed on aircraft HB-JVN. This was replaced as a result of the findings of the check results. Together with the aircraft manufacturer, the maintenance company came to the unambiguous conclusion that the pre-cooler leak discovered had triggered the BLEED 1 LEAK warning.

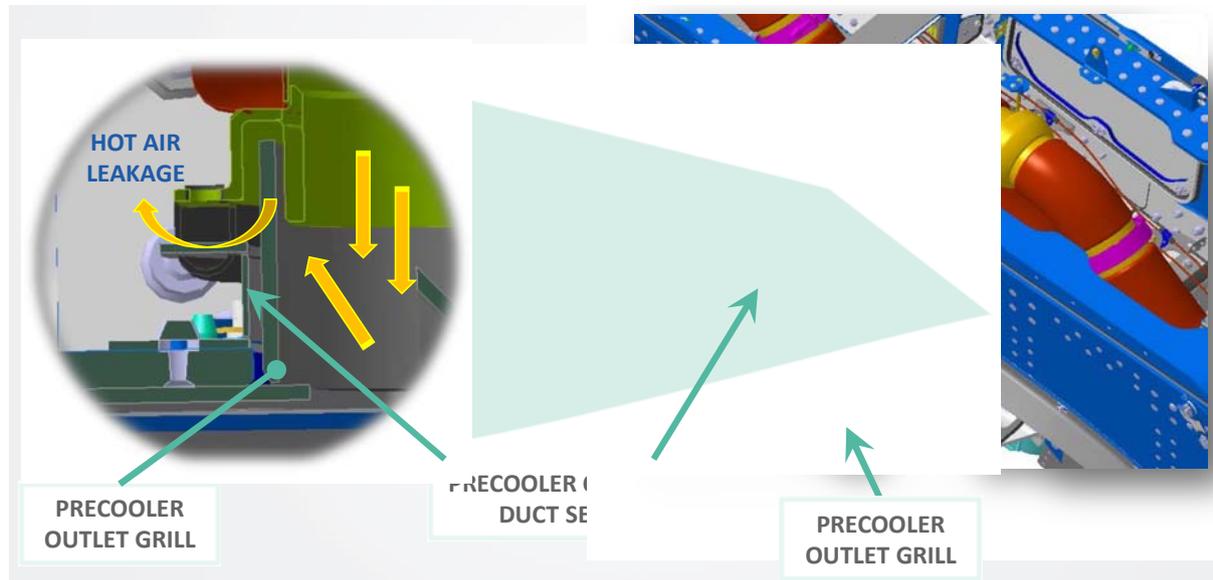
At the Embraer Operators Conference (EOC) in 2015, the aircraft manufacturer drew the attention of the operators of its aircraft to this problem with information including the following image. The manufacturer also provided the following written information: “Precooler exhaust duct seal damage in aircraft post-mod pre-cooler grill PN 191-08757-401 leading to real leakage.”

**Figure 3:** Schematic representation of the pre-cooler outlet duct and pylon grill (Source: EOC 2015)
