**FINAL INVESTIGATION REPORT OF
SERIOUS INCIDENT TO M/S JET AIRWAYS
LTD. B737-800 AIRCRAFT VT-JTD
AT DHAKA ON 22/01/2017**

**AIRCRAFT ACCIDENT INVESTIGATION BUREAU
MINISTRY OF CIVIL AVIATION
GOVERNMENT OF INDIA**

1.	Aircraft Type	B737-800
2.	Nationality	INDIAN
3.	Registration	VT - JTD
4.	Owner	M/s AerCap Ireland Ltd
5.	Operator	Jet Airways Ltd
6.	Pilot – in –Command	Holder of ATPL
7.	Co-Pilot	Holder of CPL
8.	Place of incident	Dhaka
9.	Co-ordinates of incident Site	23°50'47.81"N, 90°24'9.44"E
10.	Last point of Departure	Mumbai
11.	Intended place of Landing	Dhaka Airport
12.	Date & Time of incident	22 nd Jan 2017, 0556 UTC
13.	Passengers on Board	160
14.	Extent of Injuries	NIL
15.	Crew on Board	08 (02+06)
16.	Extent of Injuries	NIL
17.	Phase of Operation	Landing
18.	Type of Incident:	Tail Strike during landing

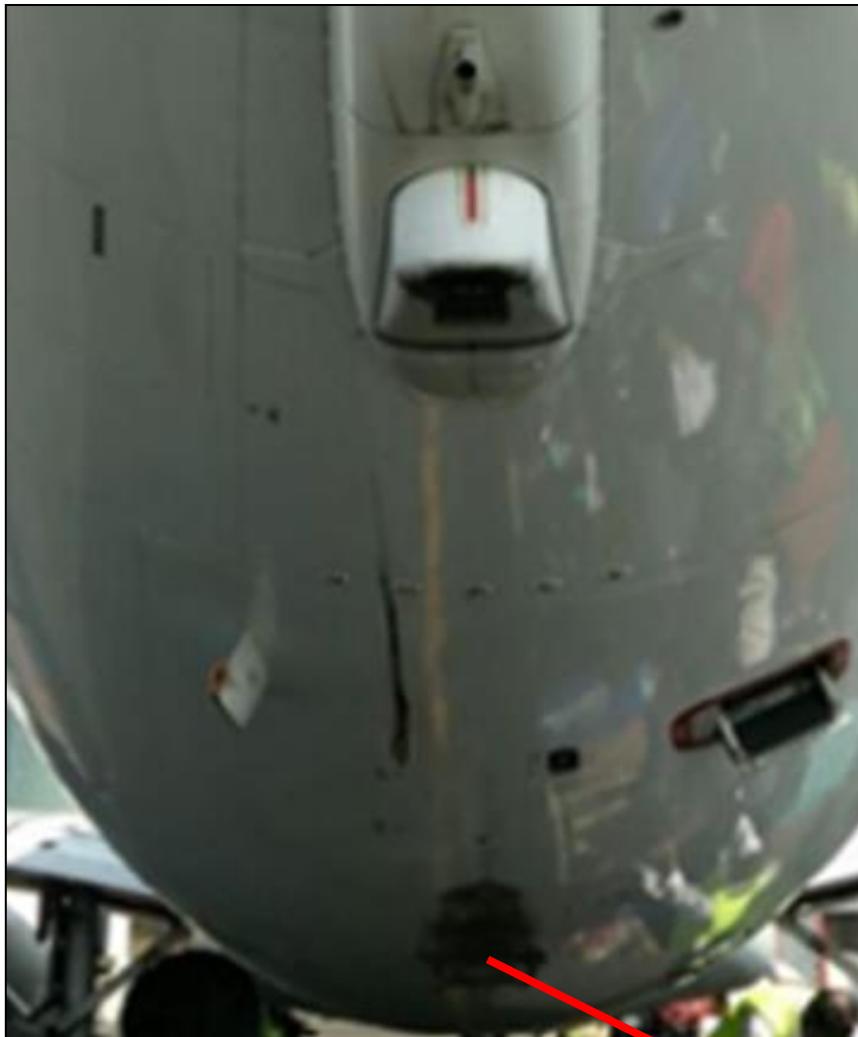
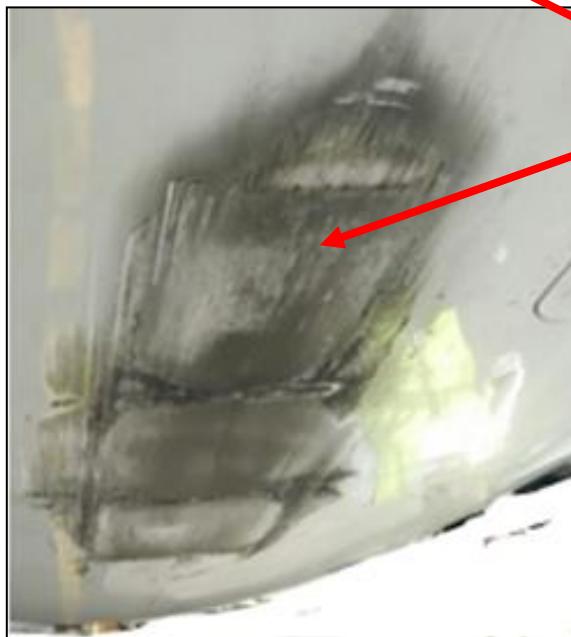
**Exploded
View of Rub
Markings**

- **External Damages : Following are the external damages observed in the aircraft**
- On Fuselage skin Deep Scratch/Gouge marks observed for a total length of 79 inch, the Gouge marks were located between STA (station) 867 and STA 927.

Deep Gouge were starting from 14 inch forward of STA 867 and ending at 3.8 inch just aft of STA 927,

- All the Gouge marks were located between STR (stringer) 27L & 27R, The skin scrap was deep and skin material was found missing at 3 frame stations.
- At STA 927 frame location, skin deep scrap observed with more than 1/3rd of skin material missing
- At STA 907 frame location skin was missing between stringer 27 L & R. Material missing which was 8.27 inch in length and 1.7 inch in width. Also dent observed between station 887 & 907 is 0.6 inch deep.
- At STA 887frame location skin was missing between stringer 27 L & R. Material missing which was 8.2 inch in length and 0.8 inch in width.

- At STA 867 STR 27L stringer clip found buckled
- At STA 887 between STR 27L & R the shear Tie bend & twisted on the skin attachment leg, also at STR 27L& R stringer clip was found buckled and skin Splice strap twisted
- At STA 907 between STR 27L & R the shear Tie to frame attachment fastener sheared off , also at STR 27L stringer clip found buckled and shear tie was damaged.

The aircraft attitude due to the combination of all the above at the time of second touchdown resulted in the fuselage bottom rubbing the ground as observed after the incident.

Temporary repair scheme was suggested by M/s Boeing Company, wherein doublers were installed on the damaged skin area and after that aircraft carried out an unpressurised ferry flight to Mumbai for permanent repair.

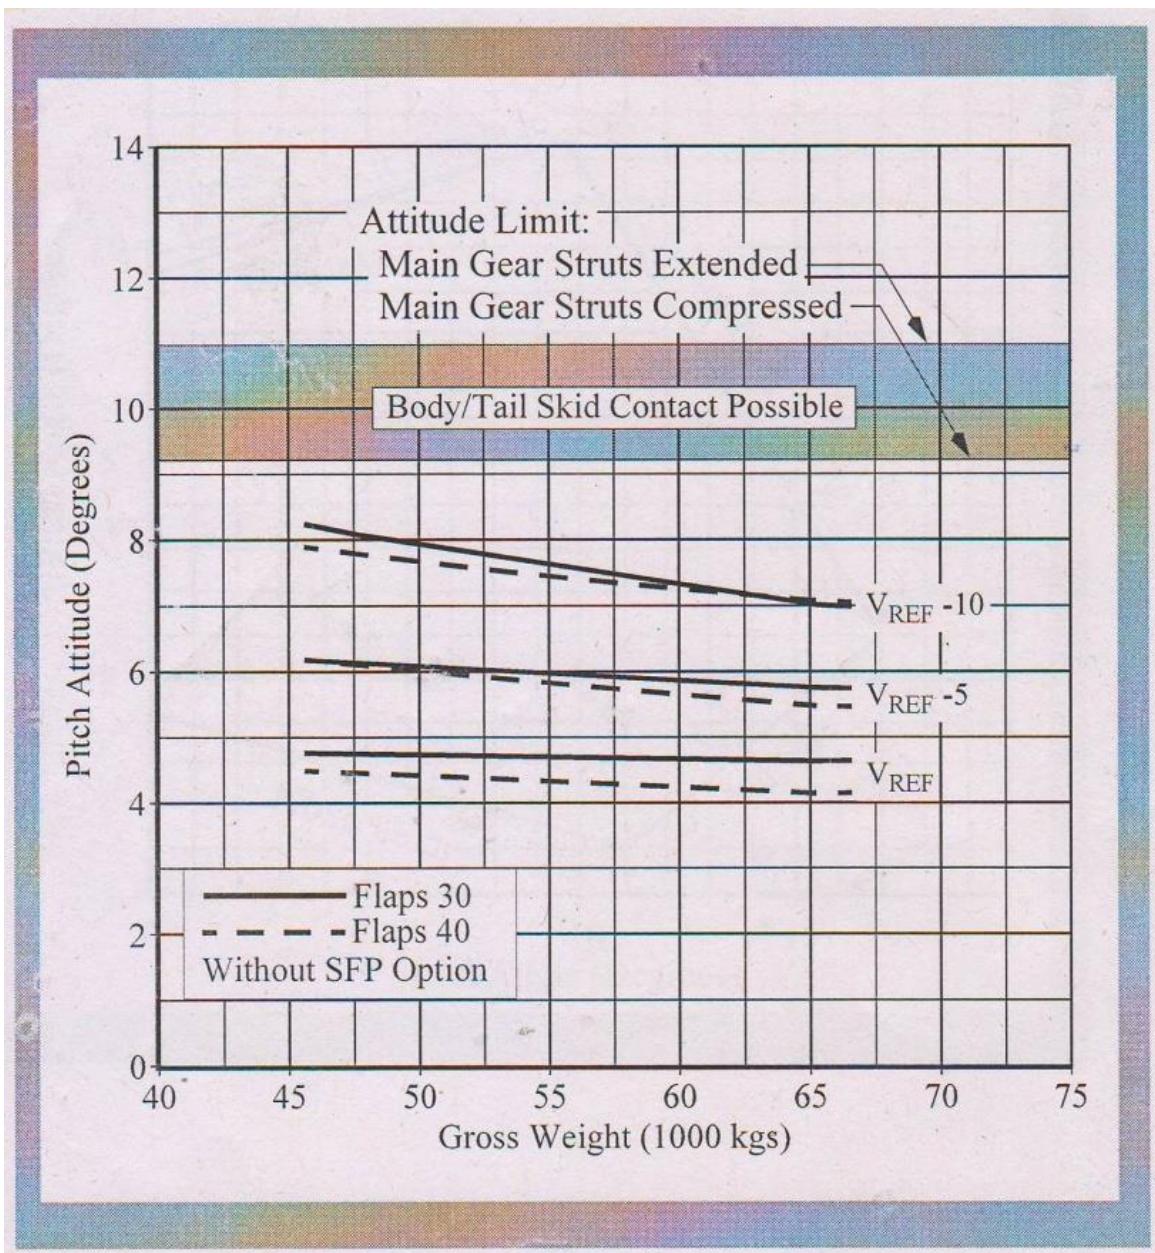
It shows airplane attitude at a normal touchdown speed (V_{REF} to V_{REF} - 5 knots) for flaps 30 and flaps 40. It also shows that touchdown at a speed below normal touchdown speed, in this case V_{REF} - 10 knots, seriously reduces aft body-runway clearance.

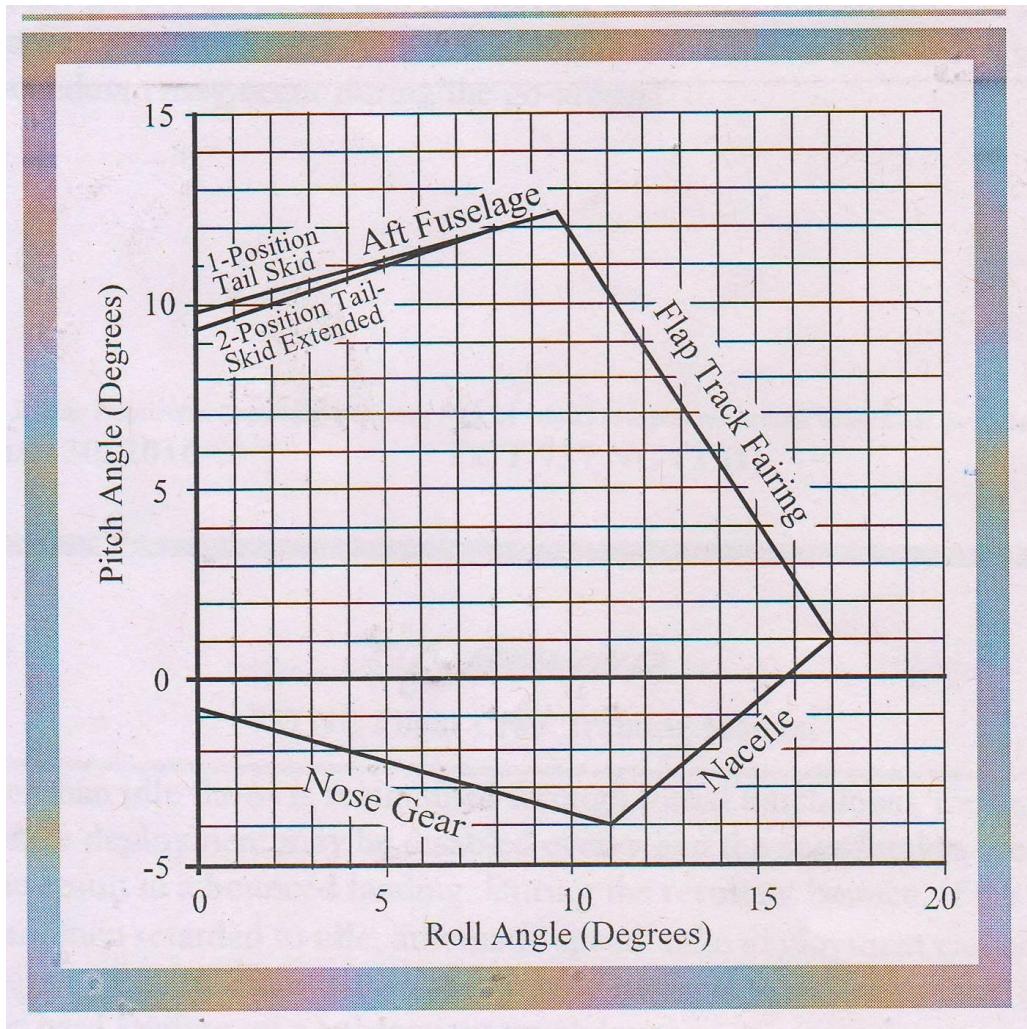
1.18.4 Ground Contact Angles - Normal Landing (737-800)

The line labeled “1-Position Tail Skid” is for airplanes without the Short Field Procedure (SFP) option and airplanes with the SFP option and a 1 position tail skid. The line labeled “2-Position Tail Skid Extended” is for airplanes with the SFP option and a 2 position tail skid.

of 9.67 degrees which is more than the pitch attitude limit for body/ tail skid contact.
