Technical Report A-003/2017

Accident occurred on April 10, 2017,
to the Boeing 757-200 aircraft operated
by Jet2.com, registration G-LSAI,
during the landing manoeuvre
at Alicante-Elche airport (Spain)

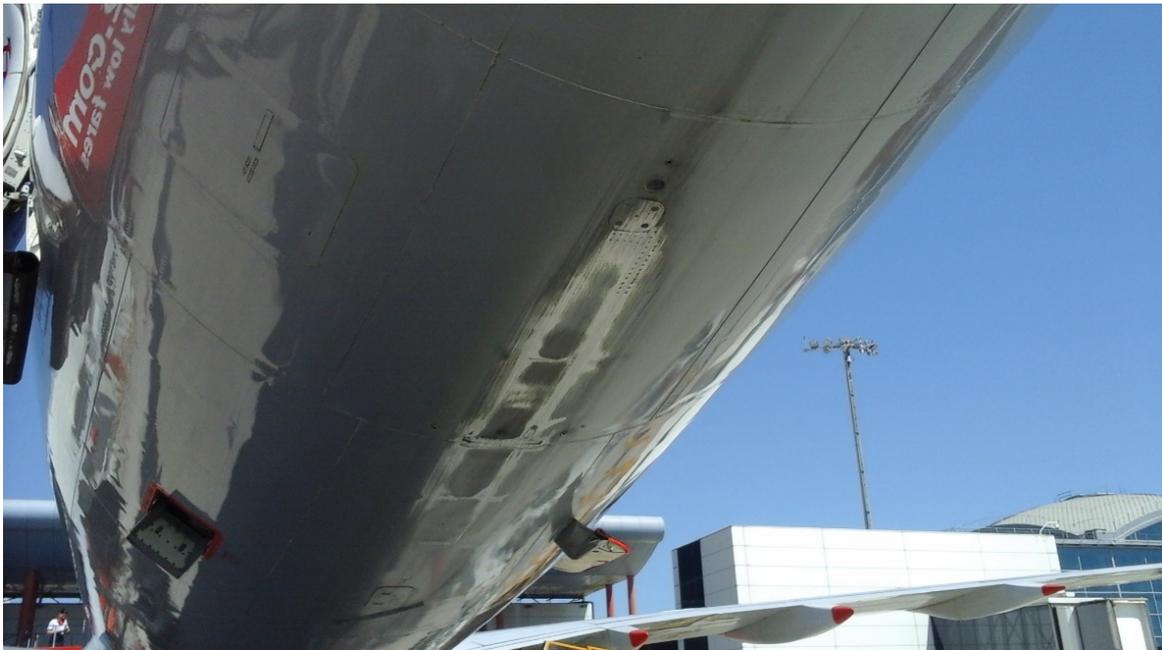
The aircraft struck runway 10 at the Alicante-Elche airport with the bottom of its tail zone. Abrasive damage was caused to the underside of the fuselage, the rear sewage drainage probe and the VHF antenna located in the lower rear part. Damage to the partition bulkhead of the rear loading hold was additionally discovered.

Fig. 1. Damage to the rear underside of the fuselage.

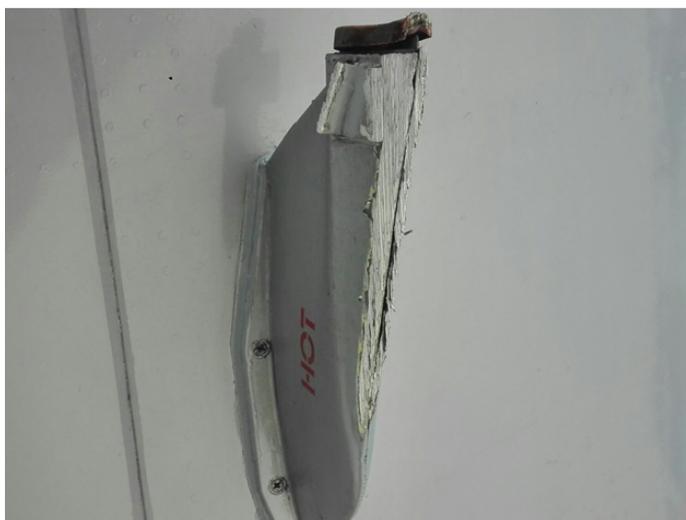
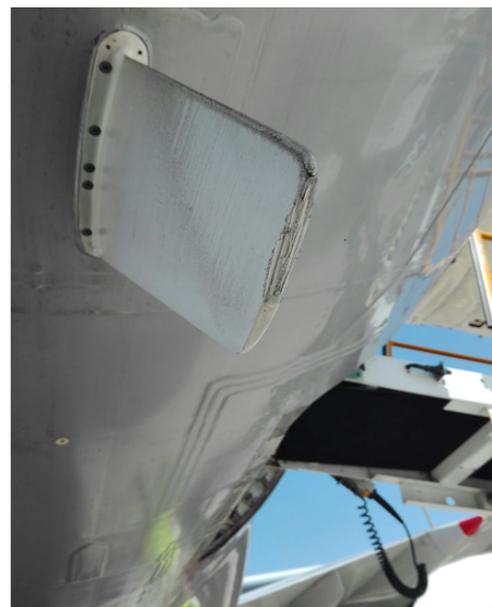
Fig. 2. Details: VHF antenna and sewage drainage probe damages.

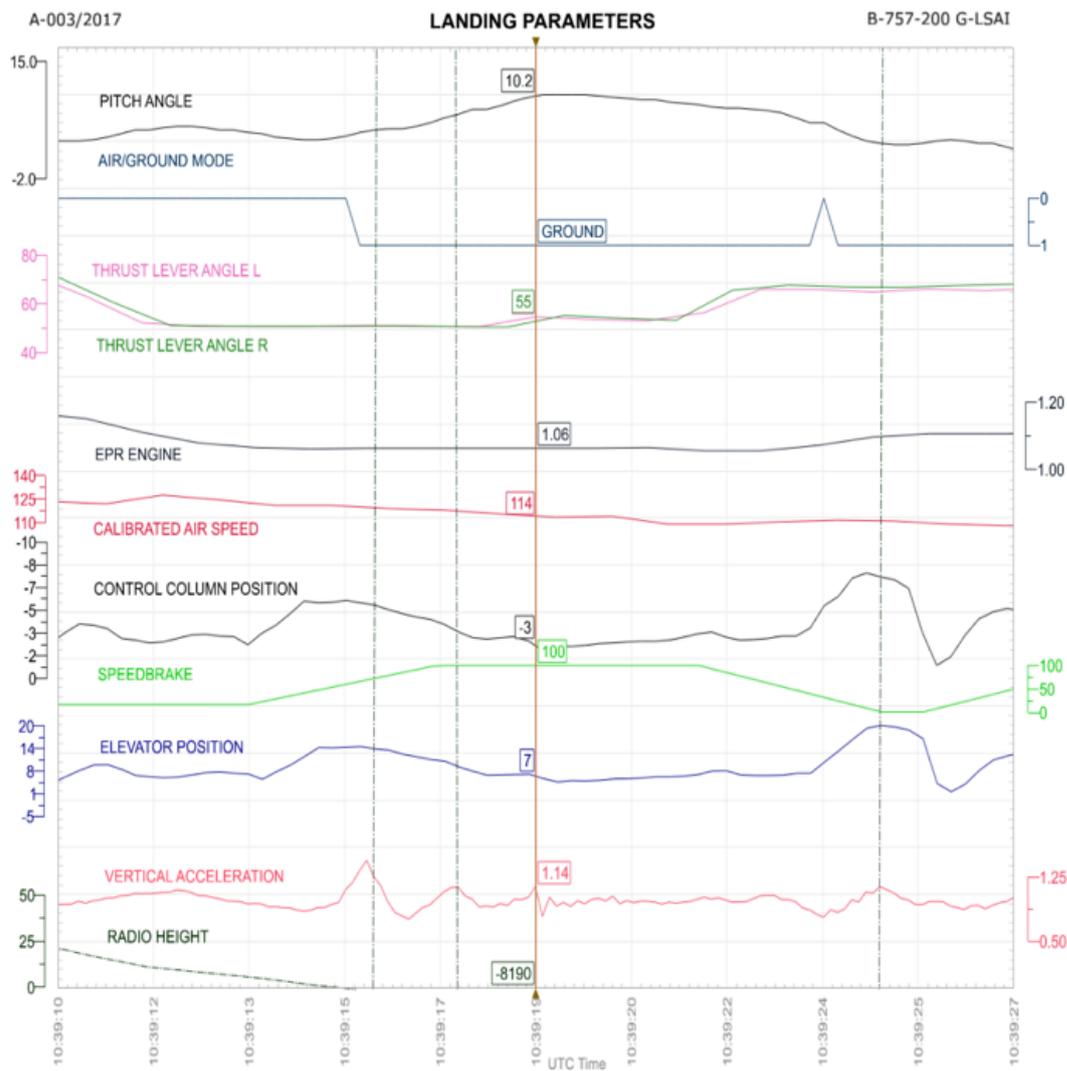
Fig. 3. Relevant parameters during landing.

The control column position was slackened slightly after touchdown was made, but the pitch attitude increase tendency continued until it reached a value of 10.2° at 10:39:19, reaching a 1.14 G vertical acceleration value. This attitude continued for one second.

According to the FCTM, this is the indicated approximate pitch attitude for the rear of the aircraft to make touchdown with levelled wings. When the pitch attitude reached 10.2°, a peak in the normal load factor was observed, providing further evidence that the aircraft's tail probably hit the ground at this moment.

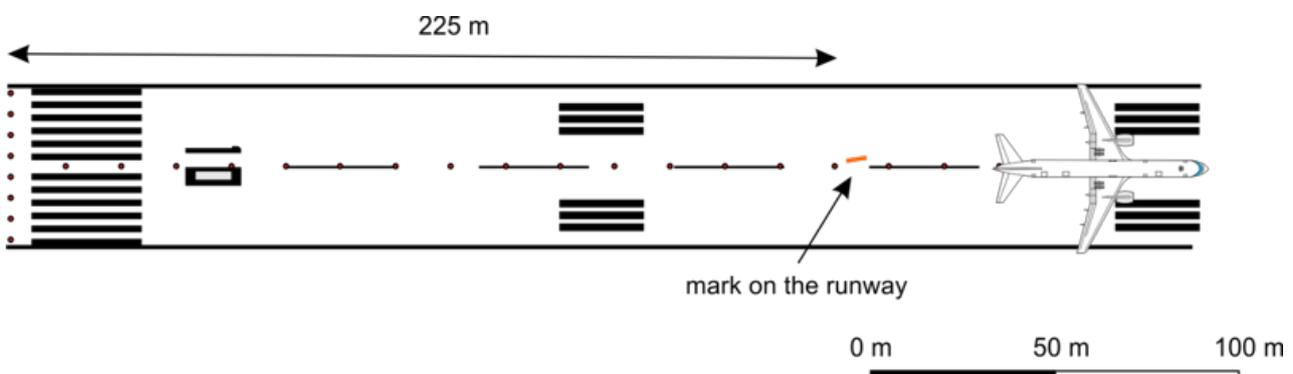
The aircraft's lower tail cone section hit the pavement on runway 10 at Alicante-Elche airport. Dragging (just one) took place between beacons 15 and 16 on the runway axis (neither of them was damaged) about 2 m from the first one and slightly to the left of the runway axis.

The length of the trail left on the pavement was 4 m.

Fig. 4. Sketch of marks on the runway.
