Tyre failure and flap asymmetry event involving Boeing 787, VH-VKA

Near Singapore Changi Airport, Singapore, 13 May 2017

ATSB Transport Safety Report
Aviation Occurrence Investigation
AO-2017-051
Final – 30 August 2017

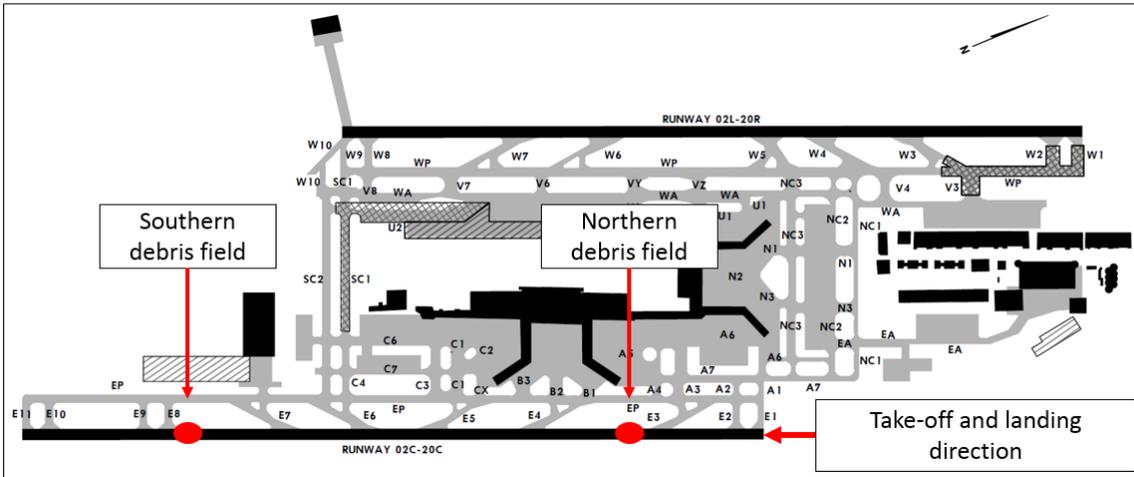
Figure 1: Tyre debris on runway 20C

The aircraft landed without incident and was taxied to the gate with emergency service vehicles in attendance. The captain noted on the engine-indicating and crew alerting system that there was a high brake temperature on one of the right landing gear brakes after landing and reported this to the engineering staff after shutdown. Before the flight crew exited the aircraft an engineering staff member entered the flight deck to report that they found damage to the left wing. This was followed by a report from a ground handling staff member that rubber debris was found on runway

20C (Figure 1). The captain annotated the FLAPS DRIVE fault and overweight landing with a ‘positive’⁷ touchdown in the aircraft technical log.

The flap drive fault the flight crew received on departure from Singapore Changi Airport was the result of the delamination of the number 6 wheel tyre tread during take-off. The airport operator found two debris fields on runway 20C, which was used for the take-off and landing. The delamination on take-off likely occurred at the southern end of the runway, when the tyre was at high speed, which provided sufficient energy for the tread to penetrate the left under wing panel and break a flap torque tube. The runway 20C northern debris field was likely the result of further tyre delamination on landing as a result of the touchdown and wheel acceleration.

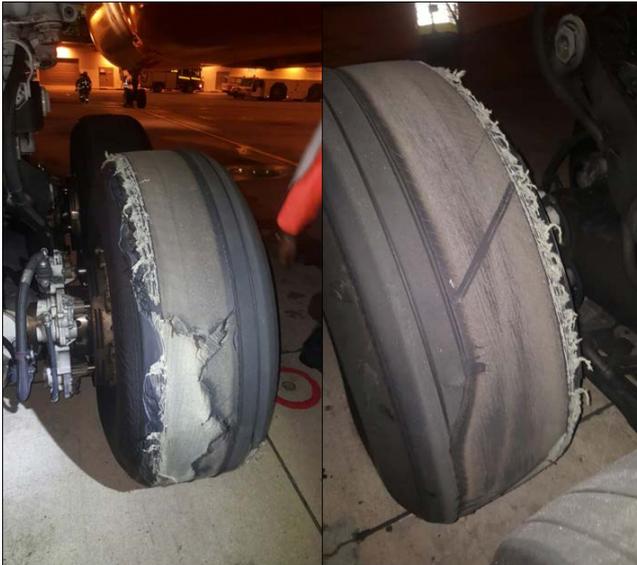
Figure 4: Number 6 wheel tyre (left picture looking forward and the right looking rearwards)

Inspection of the aircraft found the number 6 wheel tyre tread had delaminated (Figure 4). Damage to the airframe included the left inboard wing panel (above the number 6 wheel) was punctured (Figure 5 left), an area of the trailing edge of the left inboard flap was cracked, and the left inboard flap torque tube was broken (Figure 5 right). A broken torque tube will interrupt the flap drive system for flaps outboard of the break. Consequently, a change in the flap setting will trigger a misalignment between the flap skew sensors.

- The number 6 wheel tyre experienced shoulder step-wear, which led to cracking and undercutting of the tyre tread and a subsequent delamination of the number 6 tyre, which occurred in less than the normal average life cycles.
- Debris from the delaminated tyre penetrated the left under wing panel and damaged the flap torque tube, resulting in an asymmetric flap condition when the flaps were commanded to retract.
- When retracting the wing flaps, the crew received a flap drive fault indication, which resulted in a return to the departure airport and a high-speed overweight landing.
- Following the damage to the flap torque tube, the aircraft protective systems operated as designed and the flight crew completed the checklist as published.

The operator issued a quality notice to their maintenance line stations and external maintenance organisations on the subject *787 Main Landing Gear Tyre Inspections (Shoulder Wear)*. The notice explained the incident and highlighted the inspection and tyre replacement requirements for tyre shoulder damage.

The operator issued a flight standing order to their 787 pilots on the subject of *Tyre Wear* to highlight the shoulder area of the tyre as requiring extra attention during pre-flight inspections.

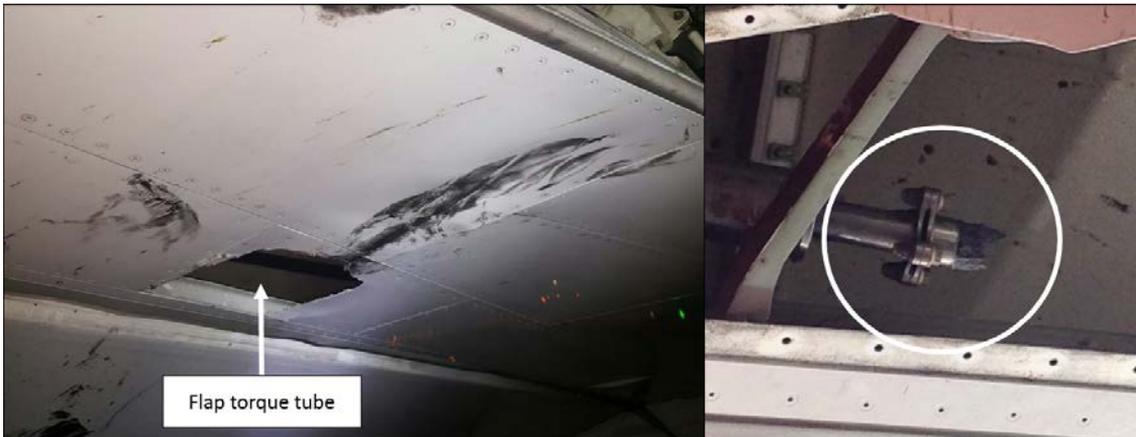
Figure 5: Punctured panel (left) and broken flap torque tube (right) (panel removed)

When the flight crew moved the flap selector from the flaps setting of 5 to 1, the left inboard and outboard flaps were unable to move, due to the broken torque tube. The right flaps started to move, which generated a flap misalignment signal. The flight control electronics cabinets shut down the flap drive system in response to the misalignment and generated the FLAPS DRIVE fault message. The flight crew then completed the FLAPS DRIVE checklist. While the crew did not know about the tyre damage, the aircraft protective systems and crew actions allowed for a safe return and landing, despite the aircraft being overweight and at a higher than normal landing speed.

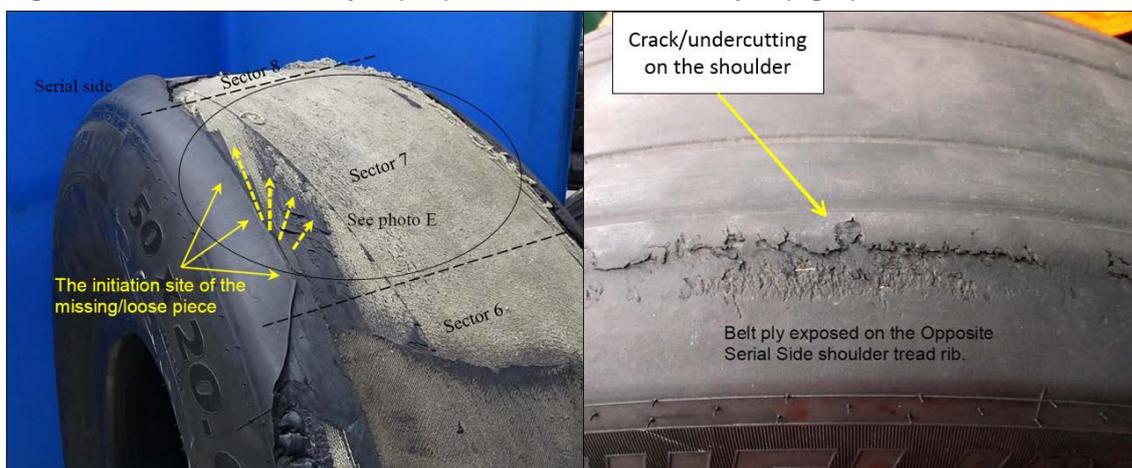
Figure 7: Number 6 wheel tyre (left) and number 5 wheel tyre (right)

The damaged tyre was Michelin part number M42202 for the Boeing 787, which was a replacement for the previous M42201. The damaged tyre and the number 5 wheel tyre (mate tyre) were returned to the tyre manufacturer for tyre analysis. The manufacturer’s report noted that 360° of tread was missing and the reinforcing plies were exposed and abraded in areas (Figure 7 left). There was shoulder step-wear and a crack along the serial side⁸ shoulder (outboard of main landing gear truck) that had propagated through the tread reinforcing ply. There were no indications of rolling under low pressure.

The manufacturer’s report concluded that the shoulder step-wear allowed for a raised tread rib, which was subjected to a lateral force strong enough to tear the tread rubber with continued use. The cracking ‘propagated through the tread reinforcing ply and generated the thrown tread as the consequence’ (Figure 7 left). The number 5 wheel tyre was found with cracking on the opposite serial side shoulder (inboard of main landing gear truck), which had started to propagate through the tread reinforcing ply (Figure 7 right). They concluded that chevron cutting around the tread of both tyres indicated that they had been operated on an aggressive runway surface.

When asked to clarify the reference to an ‘aggressive runway surface’, the manufacturer indicated that chevron cutting is linked to grooved runways. The forces required to accelerate the tyre to ground speed during the touchdown phase generate a tearing action, which results in the chevron cutting damage.

The tyre manufacturer concluded that the tyre had operated over its life on a grooved runway surface, which generated chevron cutting damage. Before departure the aircraft tyres were certificated as inspected in accordance with the aircraft manufacturer's general visual inspection requirements. While no faults were recorded for the arrival and pre-departure service checks, it was possible that the tyre shoulder was already subject to undercutting of the tread before departure. The arrival inspection likely occurred during daylight hours, but the aircraft may have been parked with the tyre tread positioned such that the initiation site was not visible to the inspector. However, this was not confirmed by the ATSB. However, the certification for the pre-departure service check was likely an acknowledgement that the tyre check was not required, rather than that it was performed.
