**Banjul Accord Group**  
**Accident Investigation Agency (BAGAIA)**

# AIRCRAFT ACCIDENT REPORT

CVK/2017/07/29/F

Report of the Accident involving CAVOK Airlines CVK  
7087 AN-74TK-100 Aircraft registered UR-CKC which  
occurred at Sao Tome International Airport, Sao Tome  
on 29<sup>th</sup> July, 2017

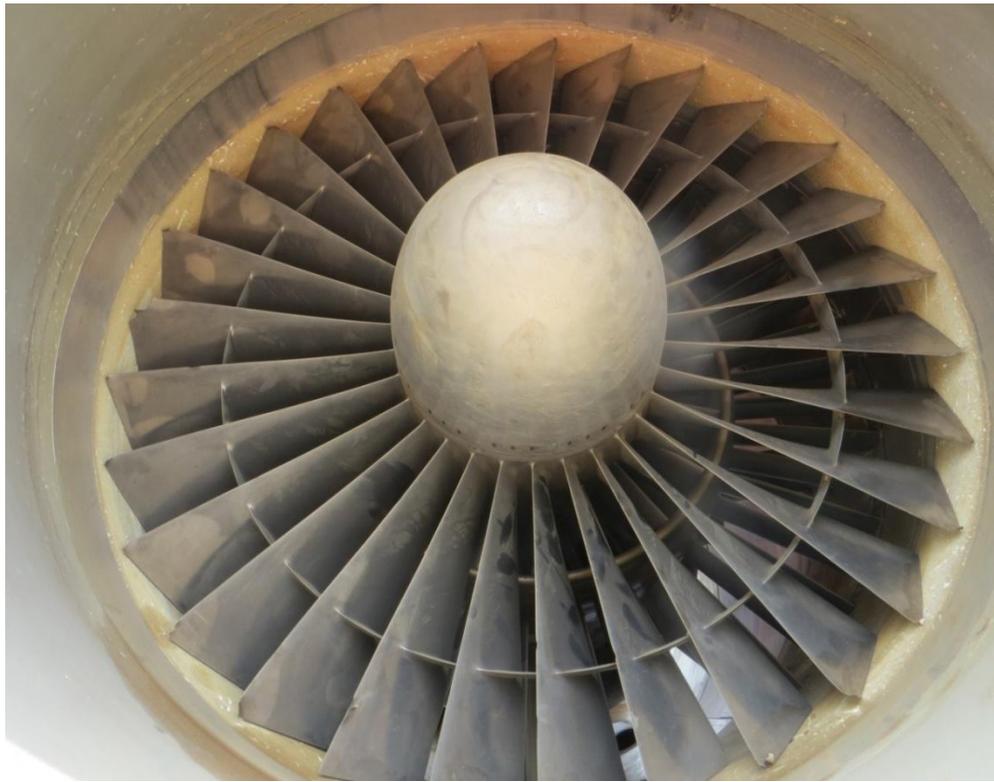
**Figure 1: Picture showing engine number 1 air intake/nacelle**

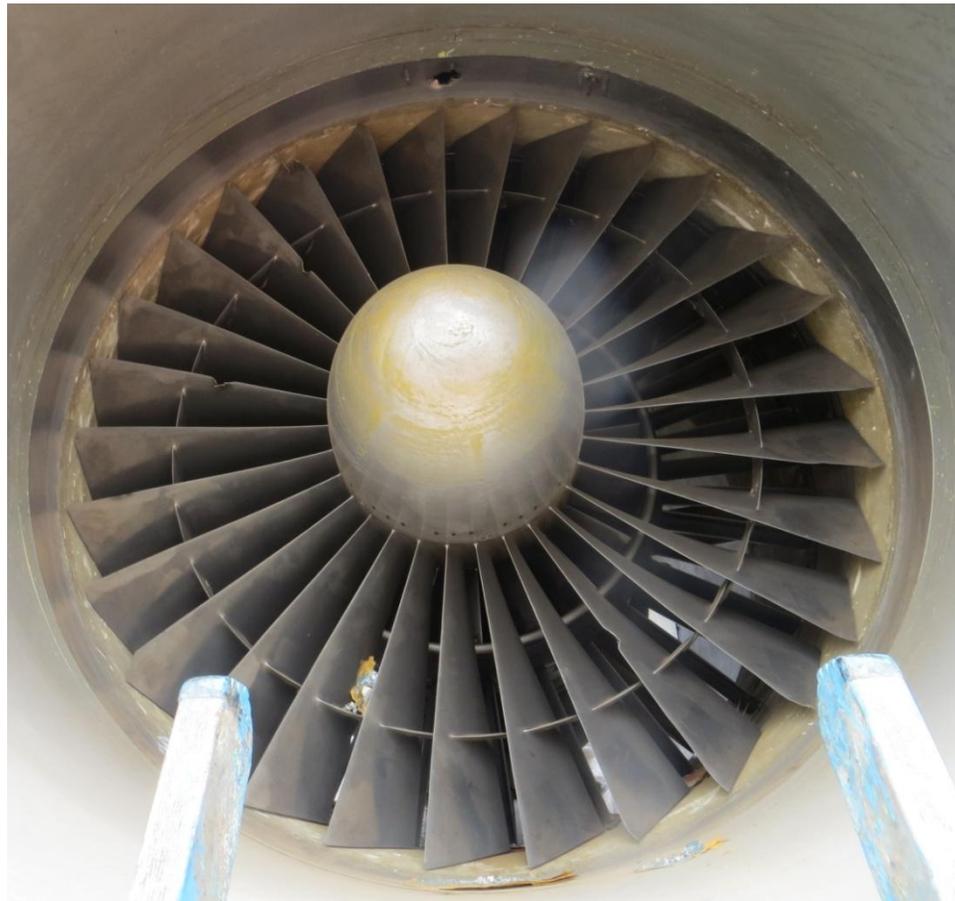
**Figure 2: Picture showing engine number 2 air intake/nacelle**

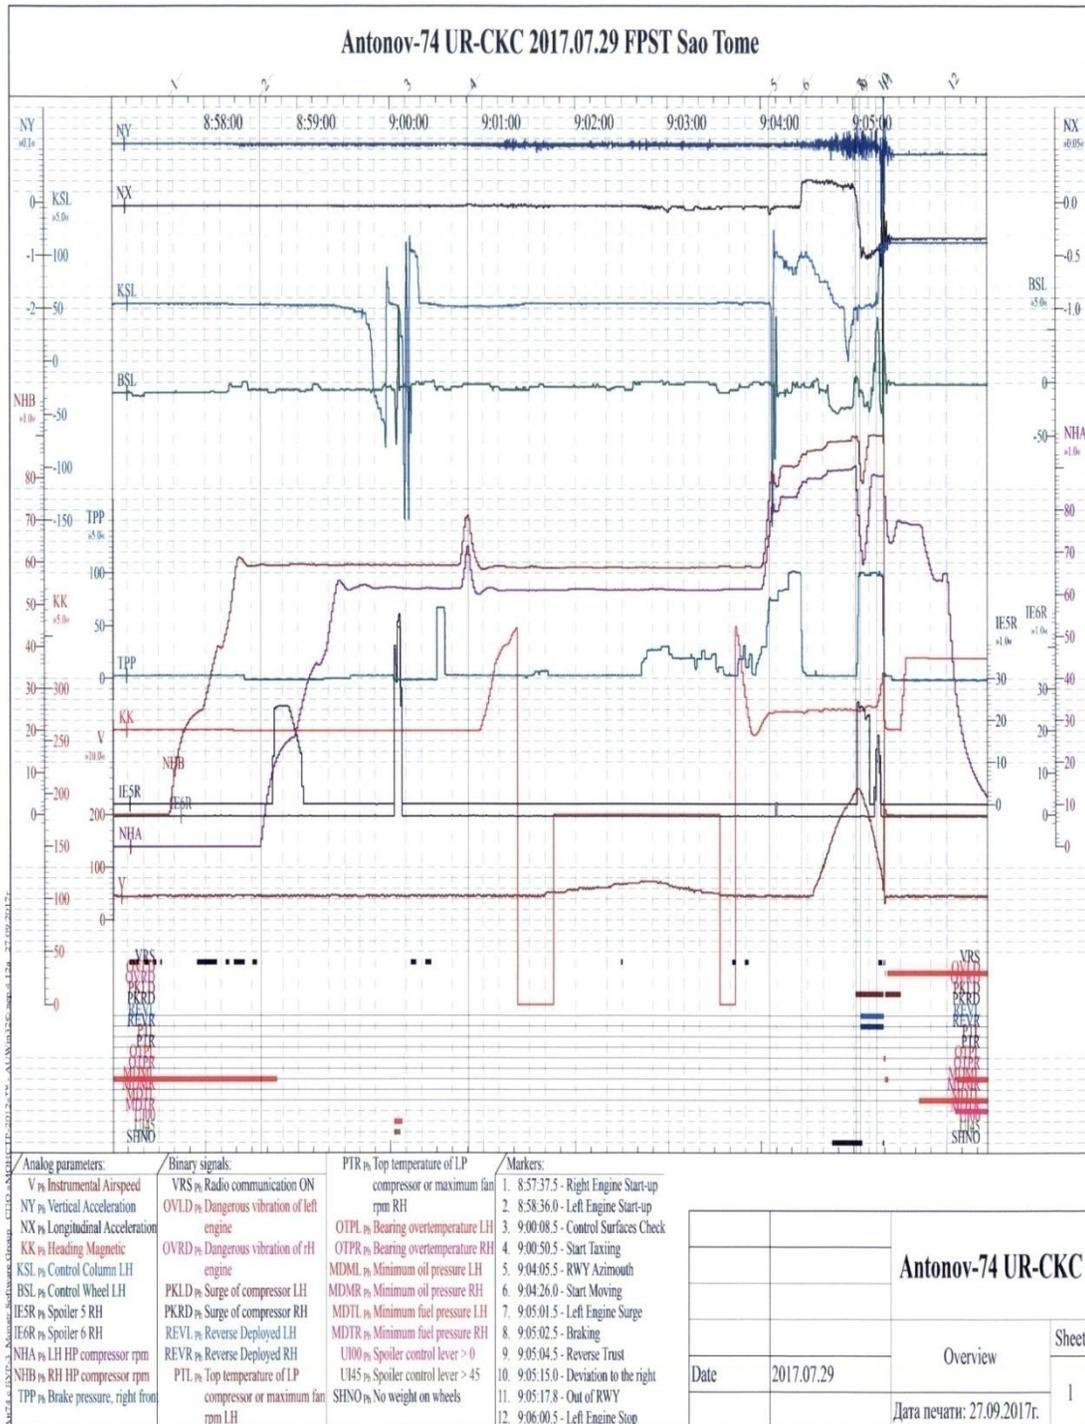
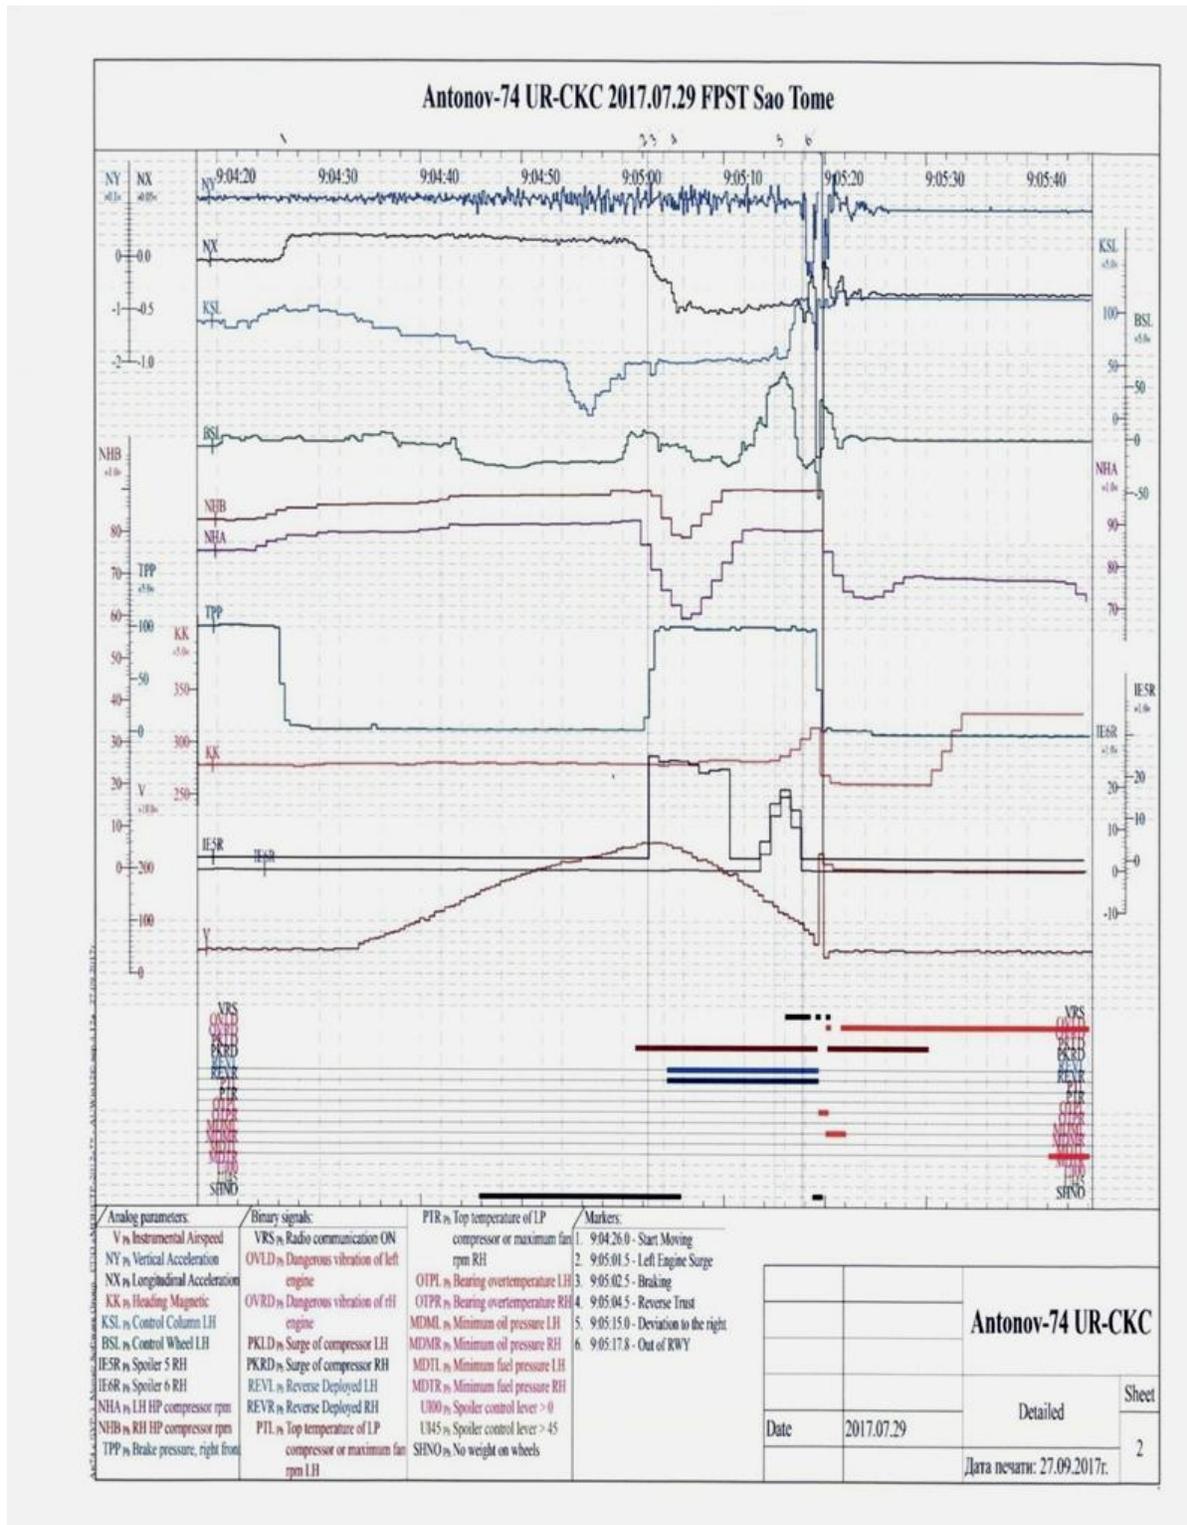
The recorders were successfully downloaded at the Scientific and Research Laboratory of the Institute of Computer Systems of the National Aviation University, Ukraine. The FDR graphical readouts are as shown in Figures 4 and 5.

The FDR acceleration and the air speed traces showed that the aircraft accelerated normally and the air speed indication was valid when the aircraft reached about 227km/h, but it became sporadic thereafter even though the aircraft continued to accelerate up to the point of the attempted reject. However, another picture showed the cross section of the nose wheel gear assembly being impacted by a large bird.

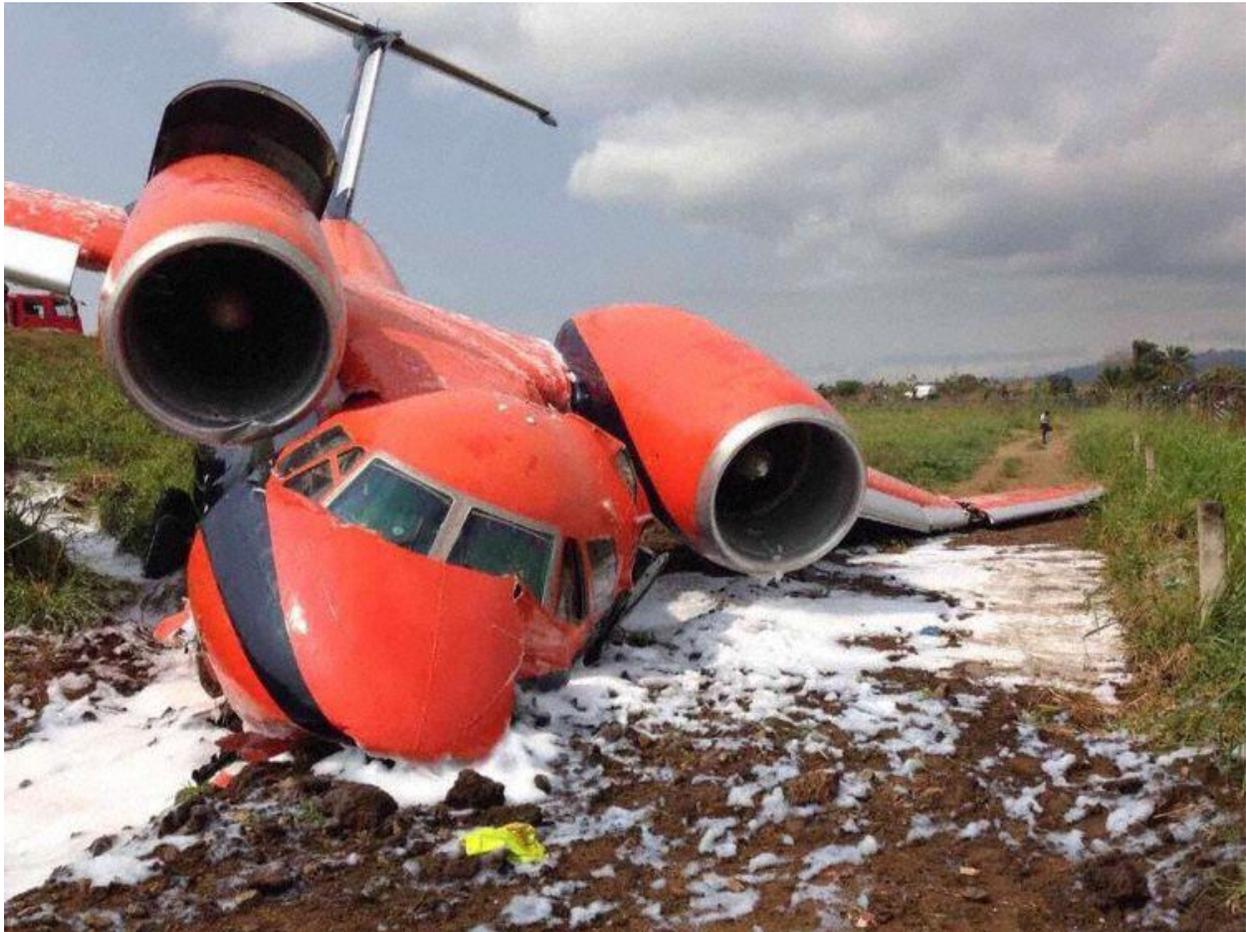
The aircraft exited the runway at a speed of approximately 76 km/h and approximately 60m before the end of the runway. The clearway was an additional 60m in length. The aircraft plunged into the ravine and came to rest approximately 30m after the end of the clearway and 25m to the right of the clearway. The forward fuselage separated from the bulkhead located immediately after the cockpit section.

**Figure 6: Picture showing the wreckage of the aircraft after the Impact**

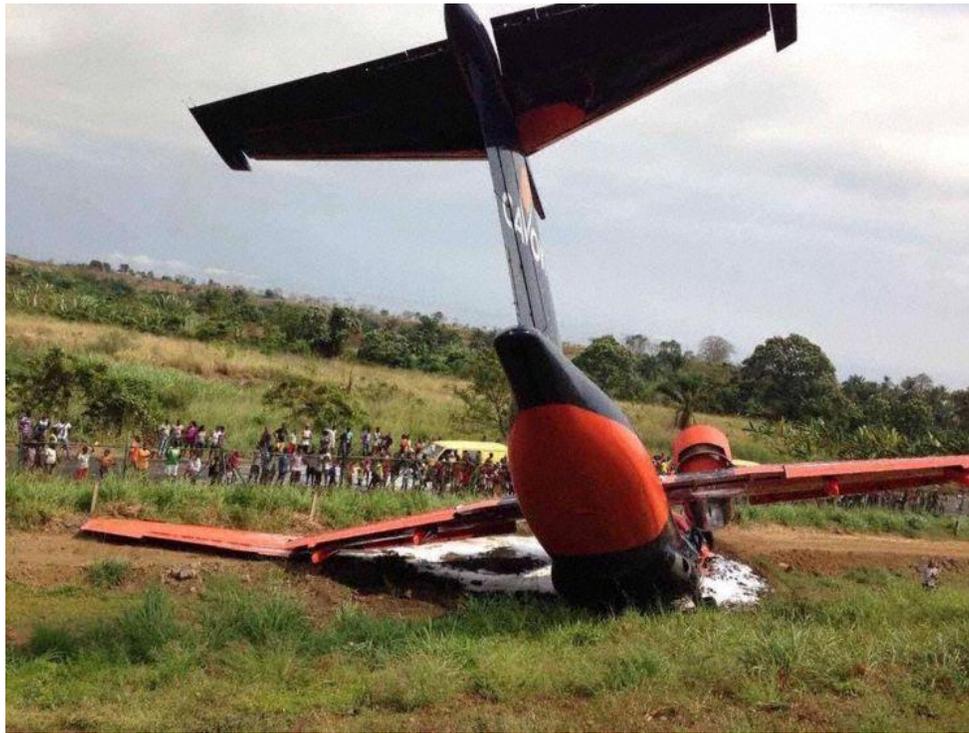
**Figure 7: Picture showing the aircraft in the ravine**

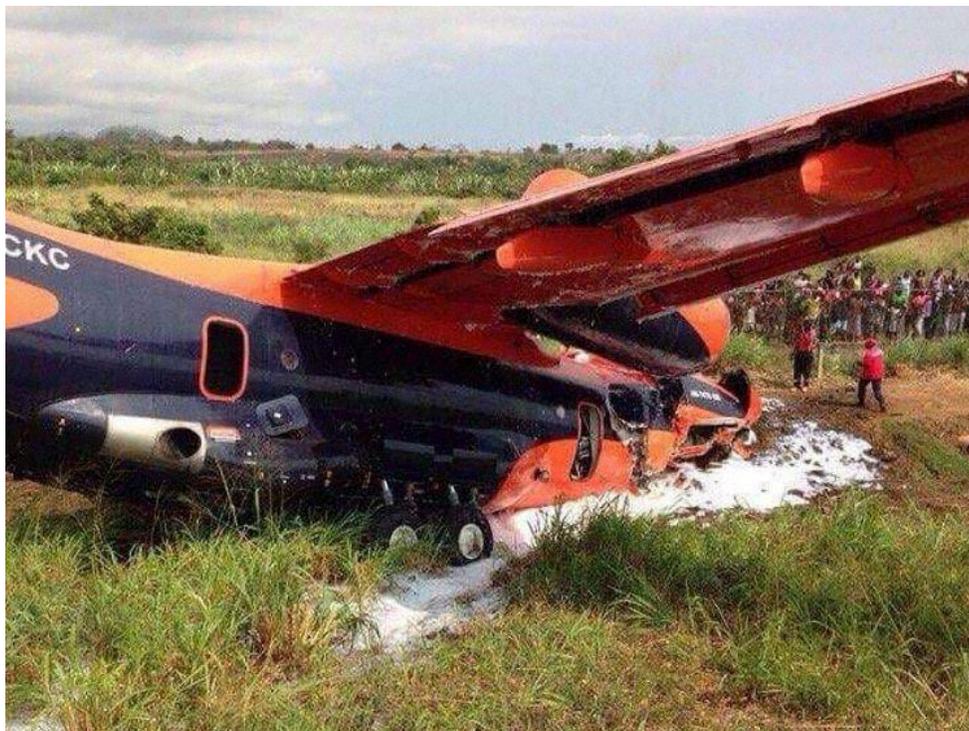
**Figure 8: Picture showing the aircraft resting on its left side**

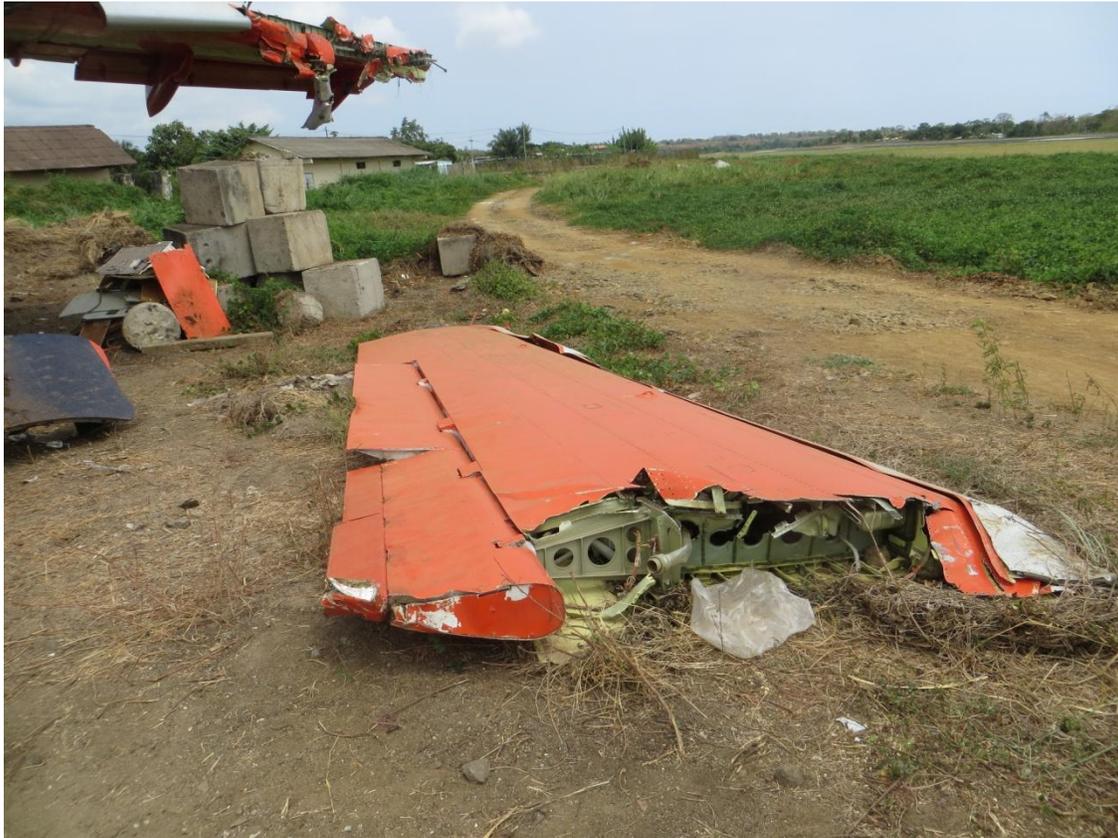
**Figure 9: Picture showing the detached portion of the left wing**

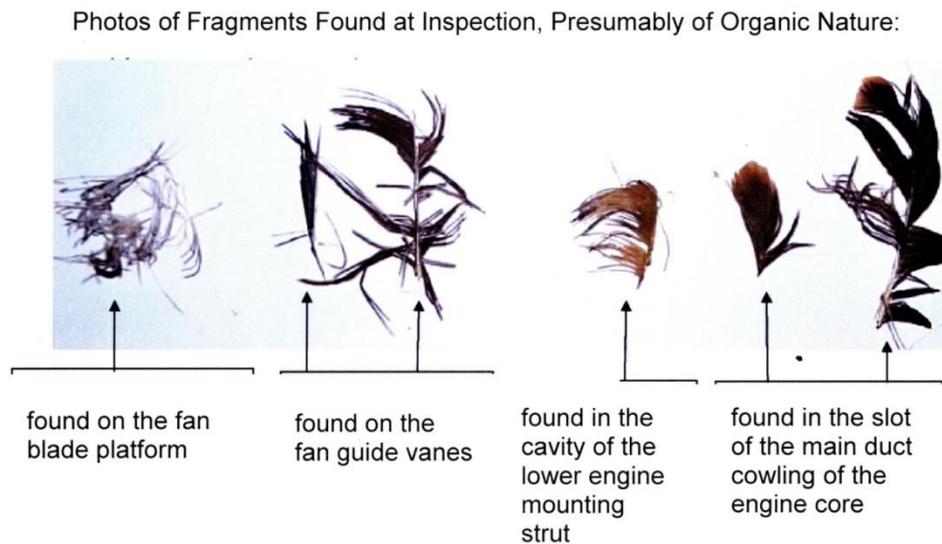
the juvenile specimen of diurnal carnivorous bird of Falconiformes of the Hawk Family (Accipitridae) – Common Honey Buzzard, *Pernis apivorus* L.

**Figure 11: Feather Specimen found at different locations on the left engine**

Further inspection of the fragments of feathers found at various locations inside the left engine was conducted by the Zoological Museum of the National Museum of Natural History of NAS, Ukraine. The report suggested that the fragments of feathers belonged to the dead bird found on the runway. It might have penetrated into the left engine as a result of being “overtaken” by the aircraft from behind on take-off during which part of its left feather was pulled out.

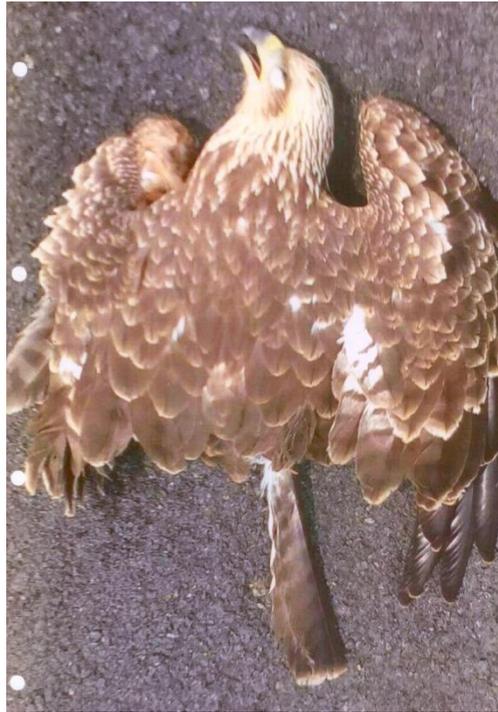
However, according to the INAC CARs (STP CAR-Part 14) Aerodrome Certification and operation section 14.20.D.10 (3), states that *“wildlife remains found within 60 meters of a runway or an airside pavement area are presumed to be a wildlife strike unless another cause of death is identified.”*

**Figure 18: Picture showing the dead bird found on the runway**

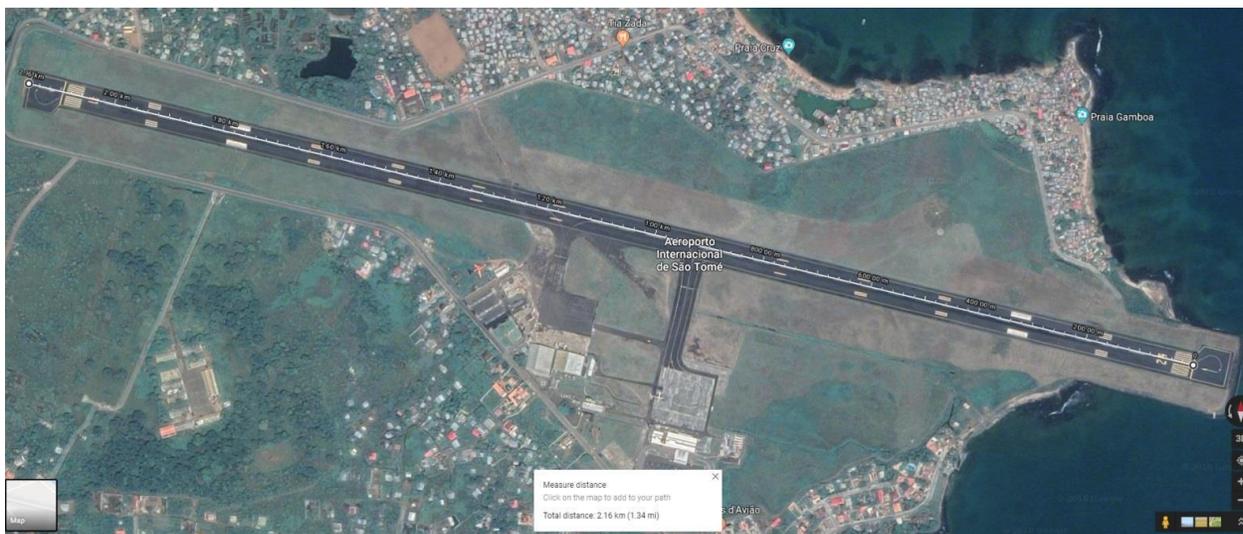
Runway 29 is 2160m long. Runway 29 has neither RESA, nor Stopway, and the airfield does not meet ICAO standards for a runway strip (FPST runway strip extends beyond the end of the runway for the distance of 10m). There is a ravine at 15m from the end of the runway 29 in addition to a major road adjacent to the airport's perimeter fence. Clearway on RWY 29 is 60m long. Information of the ravine at the end of RWY 29 is absent in AIP. At both ends of RWY 11/29, the areas are provided with the runway turn-around pads 60m long each, one of which (at the end of the runway) is included in RWY 29 length of 2160 m.

**Figure 20: Length of Runway 29**

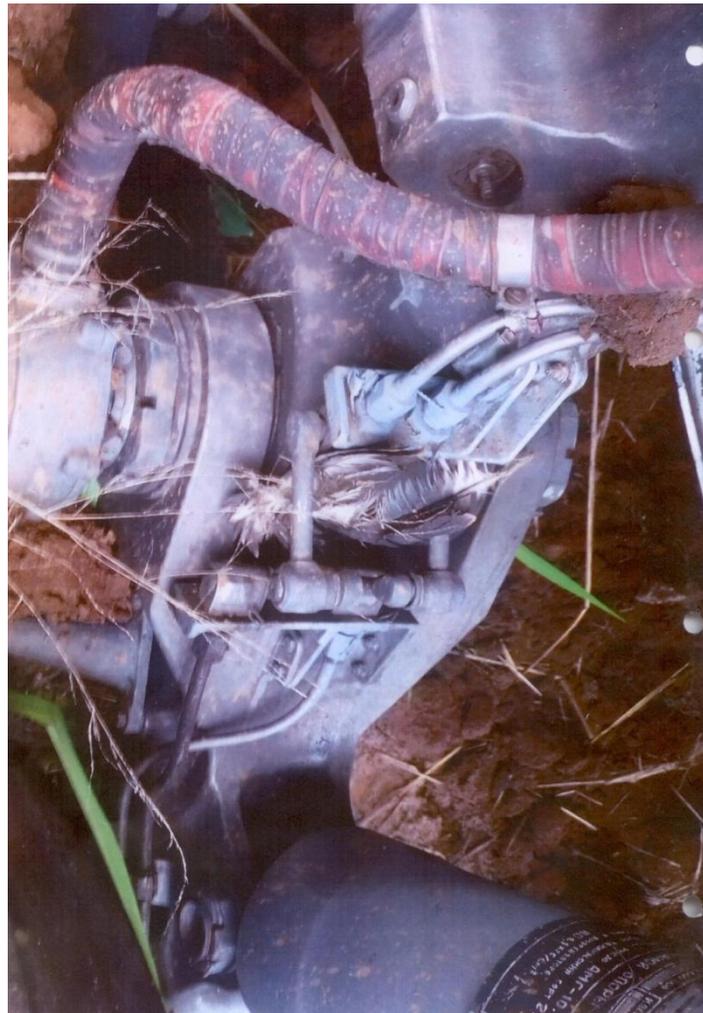
**Figure 21: Picture showing the bird remains entangled in the nose wheel.**
