Collision with runway lighting involving Embraer ERJ-135, VH-JGB

Middlemount Airport, Queensland, 8 August 2017

ATSB Transport Safety Report
Aviation Occurrence Investigation
AO-2017-080
Final – 5 December 2017

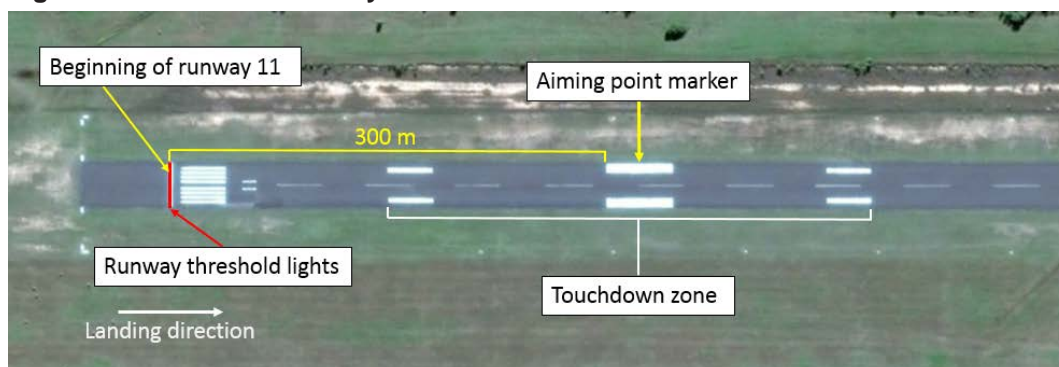
Figure 1: Overview of runway 11 threshold

A runway inspection was not carried out prior to the arrival of the second scheduled flight. The second flight arrived without incident, the ARO noted that the touchdown point for this flight appeared to be in the normal touchdown zone (Figure 1).

Image shows the positions of the beginning of the runway, runway threshold lights, aiming point markers and touchdown zone.
Source: Google earth, annotate by ATSB

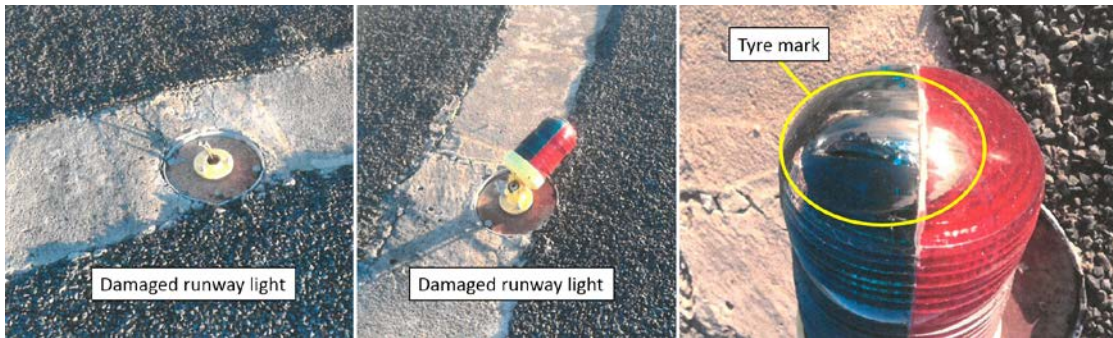
Figure 2: Damaged runway threshold lights

At about 1840, the ARO conducted an inspection of the runway prior to the departure of the two aircraft. During the inspection, the ARO identified two damaged runway threshold lights (Figure 2) and fresh tyre marks (Figure 3) about four meters further along the runway from the damaged lights. The ARO immediately proceeded to VH-JGB, and advised the flight crew that he believed they had damaged the runway threshold lights during their landing. The training captain inspected the aircraft tyres and landing gear, and determined that the aircraft had not sustained any damage.

Images shows the damage to the runway threshold lights (left and centre), and a tyre mark on a damaged light (right).
Source: Airport operator, annotated by ATSB

During final approach the aircraft descended below the final approach path, and the aircraft landed prior to the selected aim point. Prior to landing, the main landing gear tyres collided with two runway threshold lights.

- Landings at Middlemount will be made by captains only.
- Line training flights will not operate to Middlemount.
- Training for operations without approach slope guidance will be conducted as standalone training following a period of consolidation of line flying after the completion line training.

- Aircrew notices were circulated to all flight crew, providing education on operations without vertical profile guidance and Middlemount operations. The landing technique contained within the FCOM was amended to include addition information regarding runway visual illusions.

- The flight crew involved in the incident underwent additional training in approaches without visual approach slope guidance prior to resuming operations to aerodromes without visual approach slope guidance.

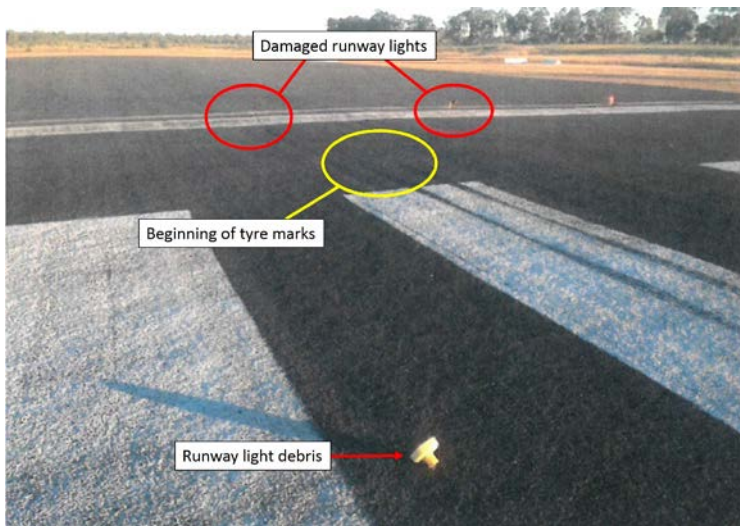
Figure 3: Runway 11 threshold

Image shows the damaged runway lights, touchdown tyre marks and runway light debris.
Source: Airport operator, annotated by ATSB

The recorded touchdown point of the aircraft was consistent with the fresh tyre marks observed by the ARO.

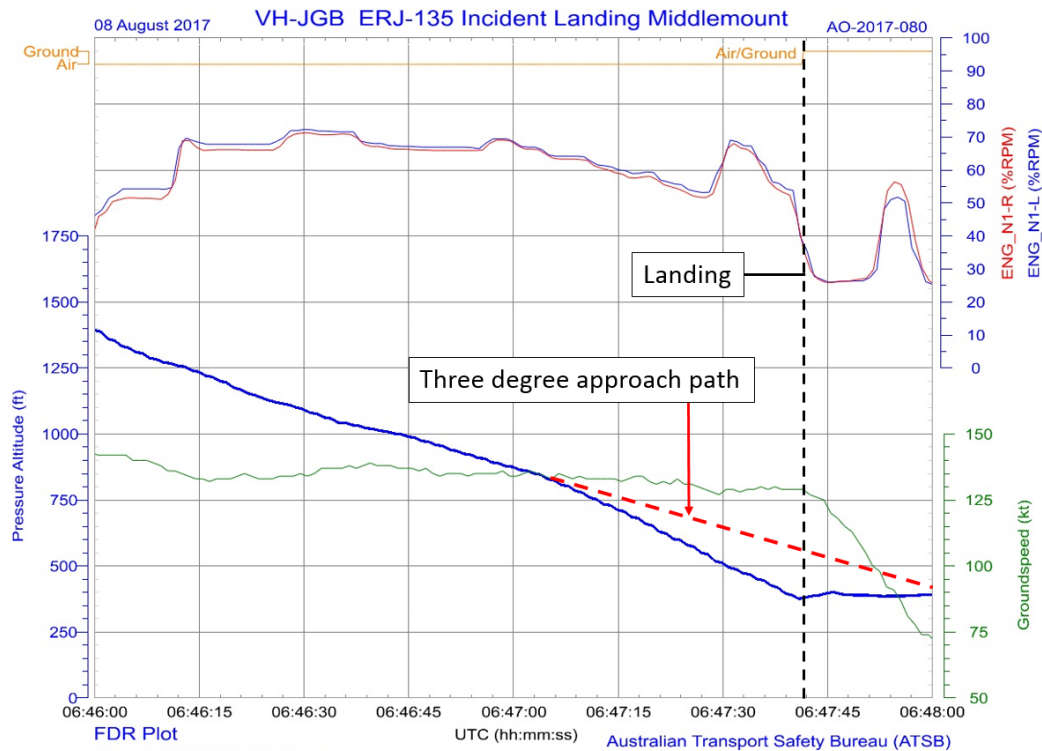
Figure 4: Graphical representation of recorded flight data

The flight data shows (Figure 4) that at 16:47:10, the aircraft was positioned on about a three degree approach path. At this time, the descent angle increased until the aircraft flared for landing.

The data plot shows the main landing gear air/ground switch position, engine power, ground speed and pressure altitude. A representative three degree approach path and the landing are annotated.
Source: ATSB
