Accident Investigation Coordinating Committee

Aircraft Accident Report 2017/02

Final Report on the Accident to
Viking Air DHC-6-300, 8Q-ISB
Velana International Airport, Maldives
4 October 2017

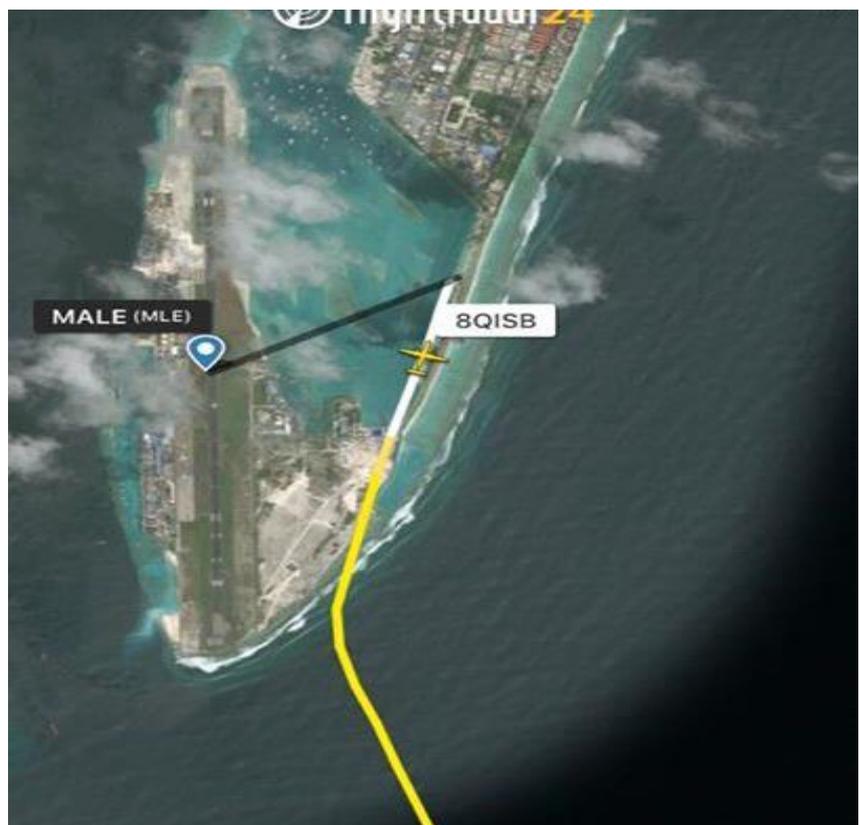
Figure 1: 8Q-ISB aircraft final approach path to RWY NR

The aircraft touched down in the intended landing area (Figure 1), on the left float first and bounced, then contacted the water a second time on the right float. The co-pilot reduced power by pulling the power levers back. At the same time, as stated by the Captain, he placed his right hand on the power levers (over the co-pilot's left hand) and pushed the power levers fully forward, applying full power with the intention of going around whilst calling "Max power". The Captain neither announced that he was taking over control, nor called for flaps 10°, as per the procedures. There was no response from the co-pilot in handing over of controls to the Captain.

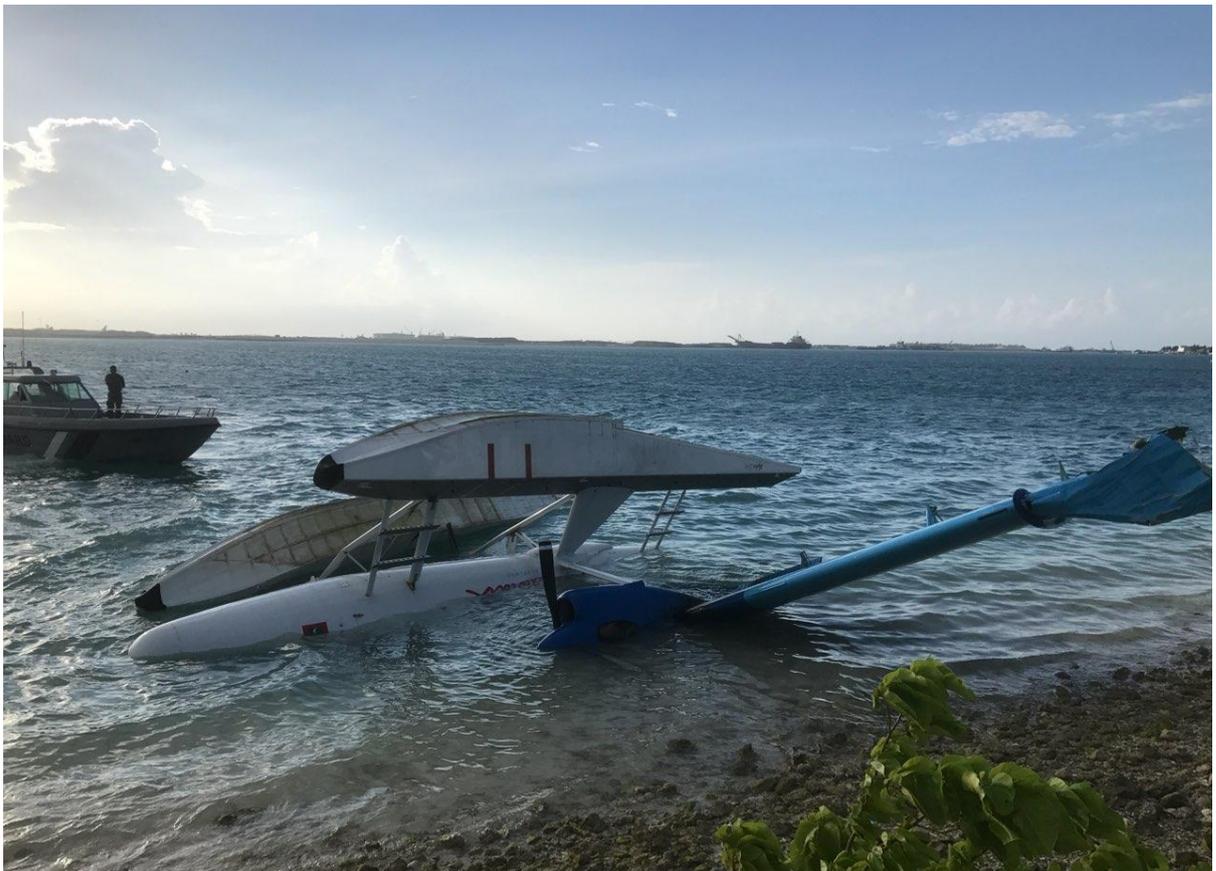
Figure 2: The aircraft wreckage

The aircraft banked sharply to the right, turning right and crashed. The aircraft finally flipped over and came to rest upside down, facing south and was partly submerged.

(Figure 2).

- LH wing detached from fuselage at wing adaptor
- RH Wing severely damaged from STA310
- LH Engine nacelle torn off
- LH Wing strut detached from fuselage attachment lower point

- LH skin punctured at STA391 floor level
- Skin dent at STA262 to STA239
- Bottom wing step severely damaged
- Floor skin punctured at STA86 floor
- Floor skin punctured at STA20 floor
- RH wing dented at STA262 to 239
- Rear cargo door skin damaged
- Air stair door skin damaged
- LH AFT cabin door damaged
- LH wing strut attachment damaged
- RH engine control cable pulley set at cabin roof found damaged
- All antennas damaged
