National Transportation Safety Board Aviation Accident Final Report

Location:	Anchorage, AK	Accident Number:	ANC18LA005
Date & Time:	10/21/2017, 0530 AKD	Registration:	N363JH
Aircraft:	RAYTHEON AIRCRAFT COMPANY B200	Aircraft Damage:	Substantial
Defining Event:	Landing gear not configured	Injuries:	4 None
Flight Conducted Under:	Part 135: Air Taxi & Commuter - Non-scheduled - Air Medical (Medical Emergency)

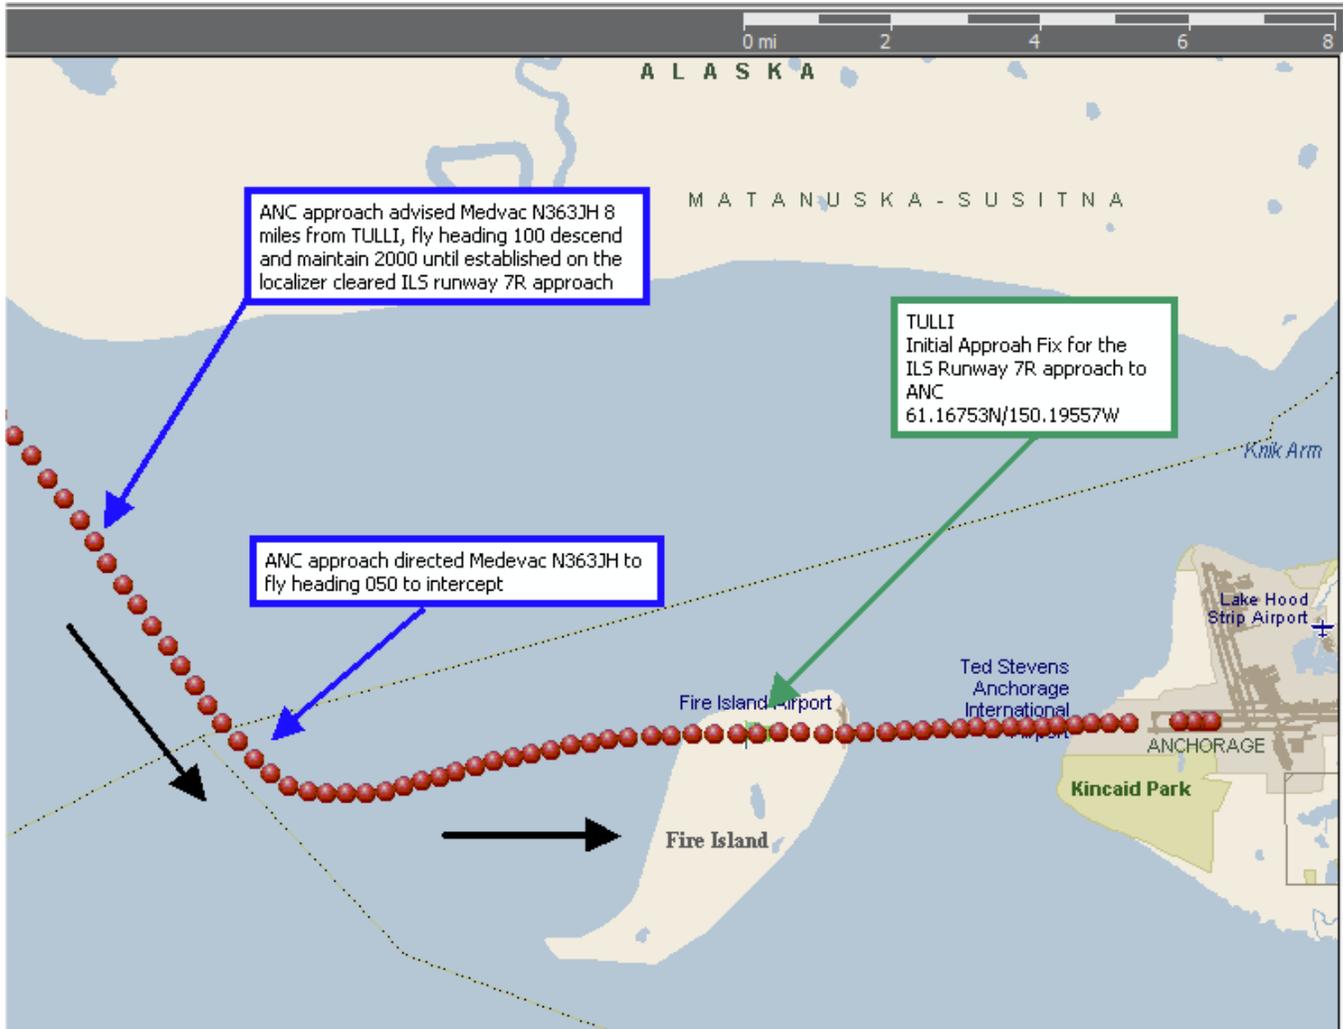
The controller responded back with a vector for the instrument landing system (ILS) runway 7 right approach. The pilot reported his groundspeed was about 210 kts indicated airspeed, he joined the final approach course, and was cleared to land. He reported he believes he was given a vector heading that was too close to the final approach fix and the airplane went through the final approach fix. The pilot then received another heading and he re-established himself on the final approach course. The radar flight track data is shown below in figure 1.

Figure 1 – Radar flight track data of the airplane, showing the initial approach fix and the destination airport.

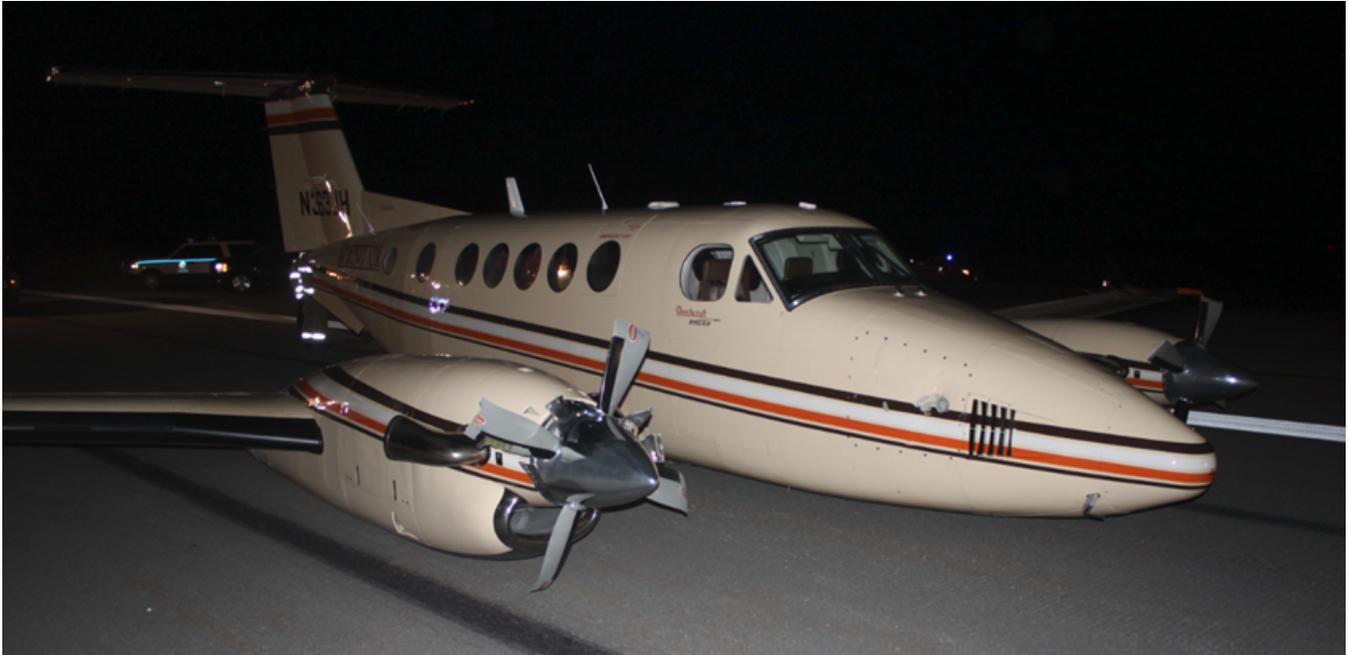
For the landing, the pilot selected the approach flaps setting. He reported he failed to visually check and confirm for the three-landing gear down and locked indication lights in the cockpit. Upon touchdown on the runway with the landing gear not extended, the airplane skid on the pod installed on the underside of the fuselage along with the two engine nacelle assemblies on each wing. During the landing sequence, the metal 4-blade Hartzell HC-E4N-3G propellers for each engine separated about midspan due to runway impact damage as shown below in figure 2. The right side forward fuselage sustained minor damage from various separated propeller blade debris impacts. The airplane came to rest on the runway, and the occupants egressed without further incident.

Figure 2 – View of the right side of the airplane on the runway.

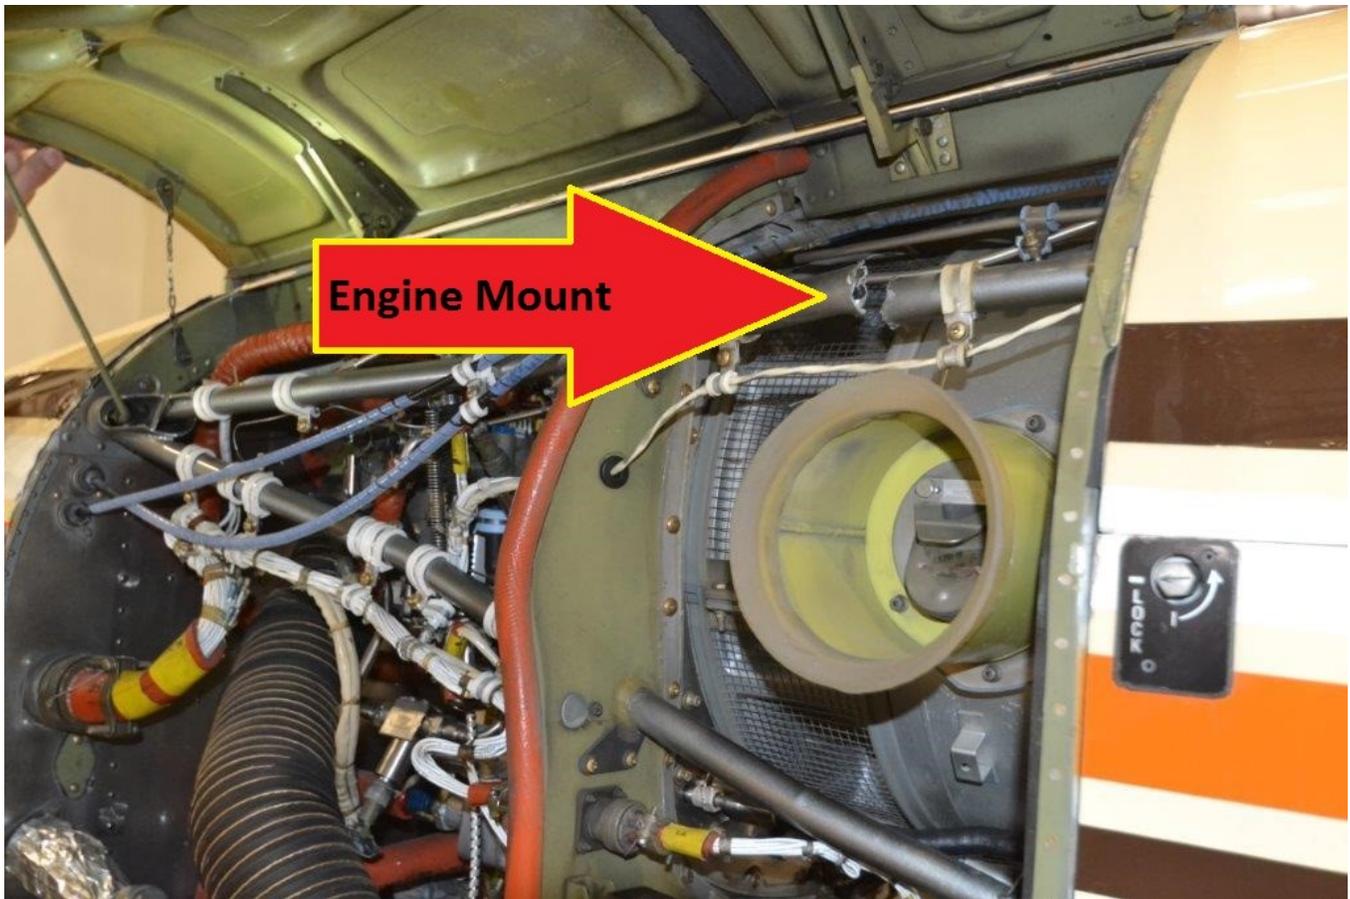
The airplane sustained substantial damage to the right engine mount. Although the landing gear switch was found in the down position, it could not be determined when it was placed in that position.

The airplane was recovered and transported to secure location for a comprehensive damage assessment. The airplane sustained substantial damage to the right engine mount as shown below in figure 3.

Figure 3 – View of the fractured right engine mount (courtesy of Bering Air).

The Bering Air director of maintenance reported that after an internal inspection of both Pratt & Whitney Canada PT6A-61 turbo prop engines, it was determined that it was not economically feasible to repair both engines as two new engines were purchased instead.
